Review Article

Liquefaction Incidents of Mineral Cargoes on Board Bulk Carriers

Michael C. Munro and Abbas Mohajerani

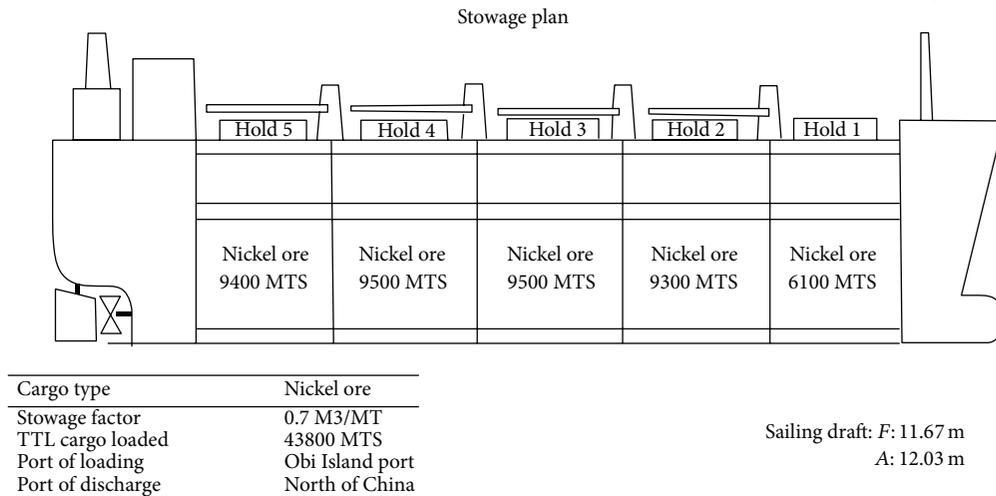
FIGURE 11: Stowage plan for the Jian Fu Star [23].

The stowage plan for the Jian Fu Star for this voyage can be seen in Figure 11.

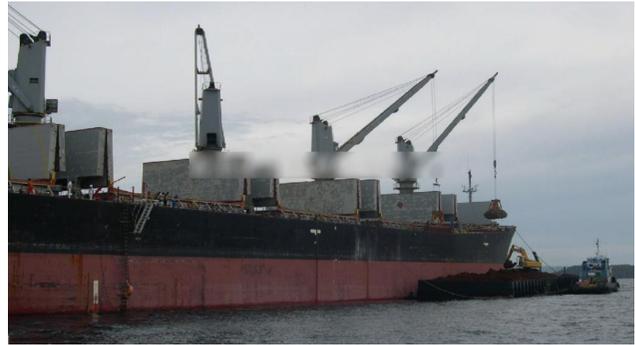
FIGURE 14: Loading operation at Kolonodale, Indonesia, similar to that of the Nasco Diamond and Hong Wei [26].

2.4.1. Summary of Incident. On 18 October 2010 at 2130, the Nasco Diamond arrived at Kolonodale, Central Sulawesi, Indonesia, seen in Figure 13, to begin loading a cargo of nickel ore from shore barges, similar to what is seen in Figure 14. Loading operations commenced at 2245 on 19 October. The same day, the flow table test was carried out on a sample of the cargo that was to be loaded on the Nasco Diamond.

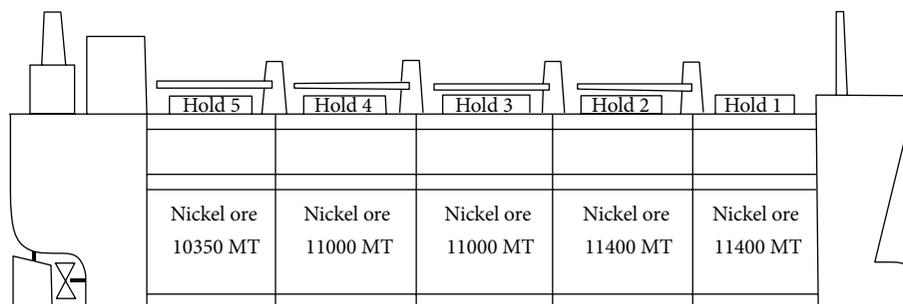
FIGURE 16: Nasco Diamond stowage plan [26].

On 4 November at 1230, after the loading of 55,150 tonnes of nickel ore was complete, the Nasco Diamond departed Kolonodale, Indonesia. The stowage plan can be seen in Figure 16. The vessel was reported to be in normal working condition at the time of its departure [26].

The journey was uneventful until 9 November at 1111 when the Master reported to his respective supervisor that the vessel was listing 3 degrees to port. After inspections of all five holds, slurry was observed. It was noted that slurry was observed in the aft section of hold number 1, in the aft section of hold number 4 (approximately 50 to 60 cm depth), and in the aft section of hold number 5 (approximately 20 to 40 cm

depth). Holds numbers 2 and 3 were dry with no formation of slurry [26].

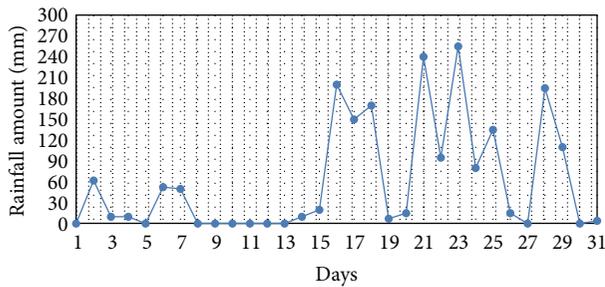
FIGURE 25: December rainfall at the Port of Kuantan, Malaysia [28].

The east coast of Malaysia had endured record-breaking rainfall over the month of December, recording the highest monthly rainfall in the history of Kuantan at 1806.4 mm over a 22-day period, as seen in Figure 25. The loading operations continued for an extended period of time due to heavy rain

and technical delays. During periods of rain, vessels generally close their hatch covers to prevent any moisture from entering cargo holds and maintain the cargo in a dry condition. However, any cargo left on the quayside is left uncovered and therefore exposed to the elements. It is very likely that the moisture content of the bauxite increased during this time [28].

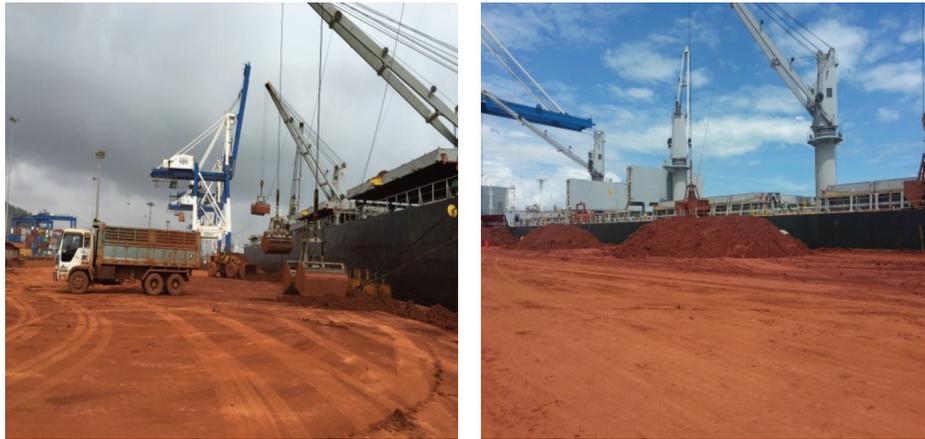
FIGURE 26: Cargo being loaded onto a bulk carrier from the quayside at the Port of Kuantan, Malaysia [28].

Loading of Bauxite onto bulk carriers at the Port of Kuantan is achieved using the on-board cranes, as seen in

Figure 26. The bauxite is transported to the port on load trucks where they either store the cargo in stockpiles or storage facilities or transport the bauxite directly to the quayside. Noted in the investigation was that during transport and storage the bauxite is generally not covered to protect it from rain [28].
