## Research Article

# Analysis of Instability Mechanism and Induced Cause of Urban Pavement in Xining City, China

Received 26 November 2021; Revised 13 December 2021; Accepted 24 January 2022; Published 8 February 2022

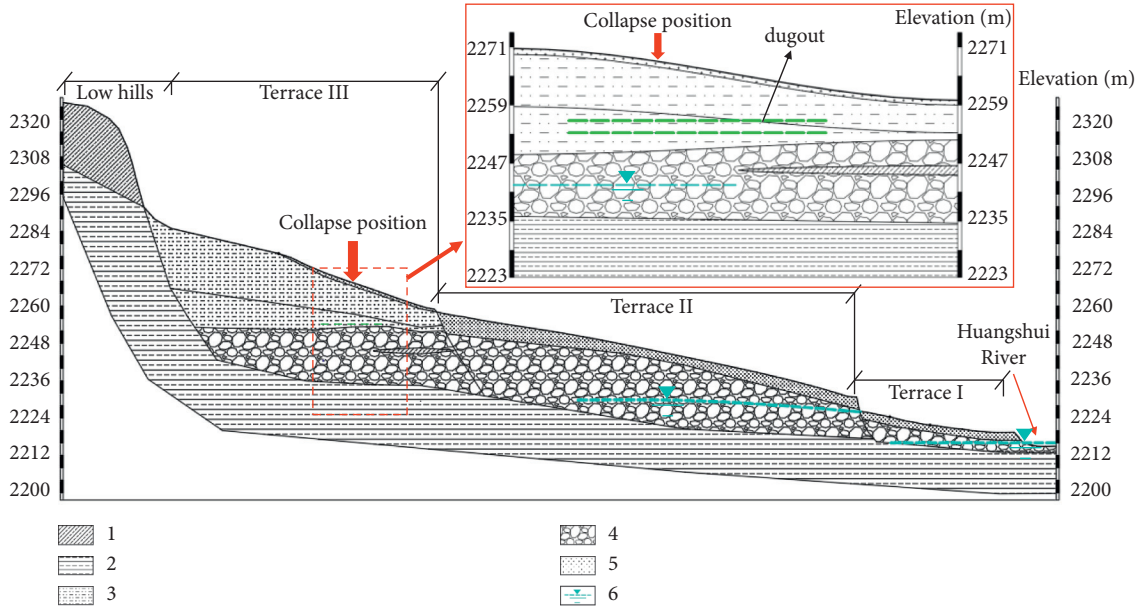
FIGURE 3: Engineering geological section. (1) Silty clay; (2) mudstone; (3) loess; (4) pebble; (5) miscellaneous fill; (6) groundwater level.

**3.1. Engineering Geological Structure Model.** After the accident, through the detailed investigation of the spatial structure of the collapse location, it is determined that there is an air raid shelter with a width of 1.5 m and a height of 2.5 m at the depth of 11.6 m from the ground, which is a rubble precast arch structure, and the location is roughly coincident with the collapse area. Combined with the results of geological survey of hydraulic engineering environment, based on the geomorphic unit as the main division basis, considering the characteristics of geotechnical engineering

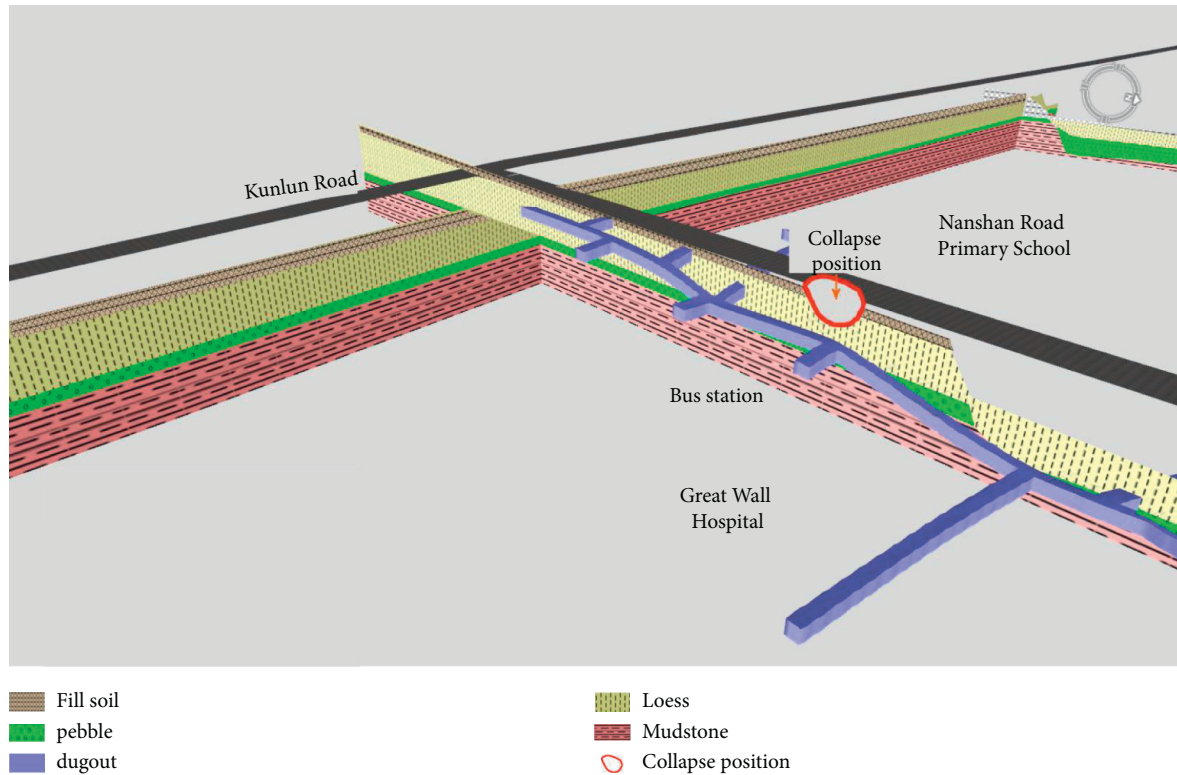
FIGURE 4: 3D geological structure model of collapse location.

geomechanics, and based on the spatial analysis function of MAPGIS, a three-dimensional engineering geological structure model of the main urban area of Xining City is established, which stereoscopically shows the stratum situation and underground space distribution of the accident area in Figure 4.

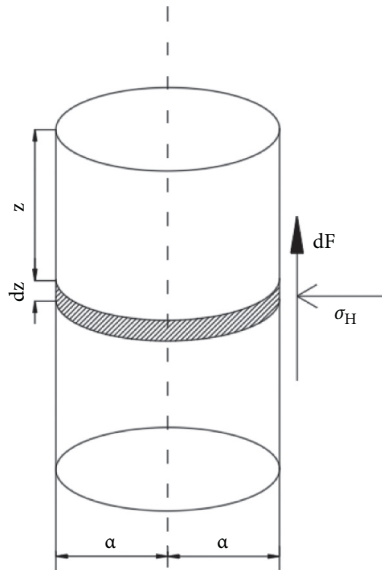
FIGURE 5: Calculation model of collapse balance method.

The collapse equilibrium method not only considers the influence of the mechanical properties of the rock and soil but also considers the stress state of the surrounding rock of the collapse pit, especially the influence of the lateral stress. This method is suitable for the collapse pit whose shape is round or arched. According to the equilibrium condition of the collapse body, when the shear force of the rock and soil mass on the top of the collapse pit is equal to the self-weight of the upper rock and soil mass and the external additional load, the roof thickness of the collapse pit is considered as the critical thickness. The calculation model is shown in Figure 5.

According to the calculation results, the critical thickness of the roof above the air raid shelter is about 22 m.

According to the data, the actual thickness of the roof above the air raid shelter is about 11.6 m, which is far less than the critical thickness of the roof, which will lead to the deformation and uneven settlement of the subgrade above the area under long-term repeated load. The thickness of the roof thinning is gradually made. Then, when the upper load

exceeds the ultimate bearing capacity of subgrade, the instantaneous collapse may occur.

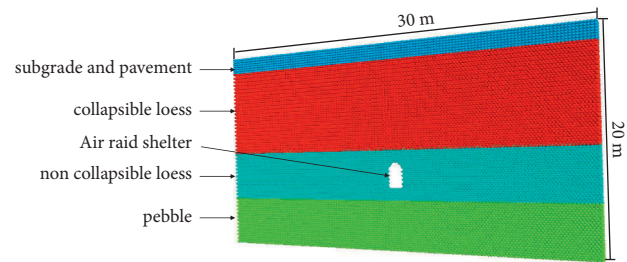
FIGURE 8: Soil model.

**3.3.1. The Establishment of the Model.** According to the actual situation of the site, the mode of “subgrade and pavement + collapsible loess + noncollapsible loess + underground air raid shelter + pebble” is adopted, as shown in Figure 8. The model size is  $30\text{ m} \times 1\text{ m} \times 20\text{ m}$  (length  $\times$  width  $\times$  height). According to the linear contact model from top to bottom, the subgrade and pavement with height of 1.5 m, collapsible loess layer with height of 8.8 m, noncollapsible loess layer with height of 3.6 m, and pebble layer with height of 4.8 m are generated, respectively. Combined with the statistical table of physical and mechanical properties, different mechanical parameters were given to all particles in the model to exert gravity and reach equilibrium state. If the model is generated according to the actual diameter of soil particles, the number of them is far more than 100 million. In this case, it is impossible to calculate by computer. Therefore, the diameter of soil particles is expanded to 0.1 m.

The diameter of the simulated water supply pipe is 0.5 m, and the upper edge of the pipe is 1.5 m below the ground. The air raid shelter and the pipe need to be simulated with Rhino 6.0 and imported into PFC as a wall unit. The vault of the air raid shelter is 11.6 m deep, 2.5 m high, and 1.5 m wide. The seepage crack on the air raid shelter is assumed to be a square hole, which is located on the vault of the air raid shelter.

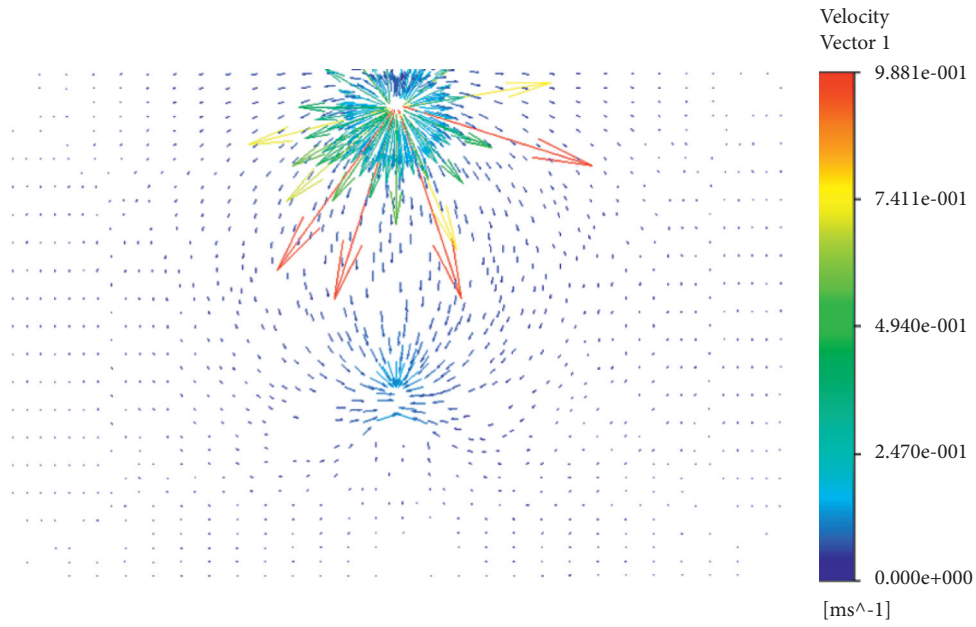
FIGURE 9: Flow field vector diagram.

Fluent was used to calculate the flow field and porous medium model was used to simulate the flow field. The viscous resistance coefficient of soil was set to  $6.8 \times 10^9$ . Because of the uncertainty of the leakage location of the water supply pipe, the surface of the water supply pipe is selected as the inlet of the flow field, the velocity is set at 4 m/s, the surface of the air raid shelter is set as the outlet boundary, and the other boundaries are set as impermeable boundaries. The obtained flow field is shown in Figure 9. The flow velocity between the water supply pipe and the air raid shelter is larger than that in other areas, which is in line with the hydrodynamic properties.

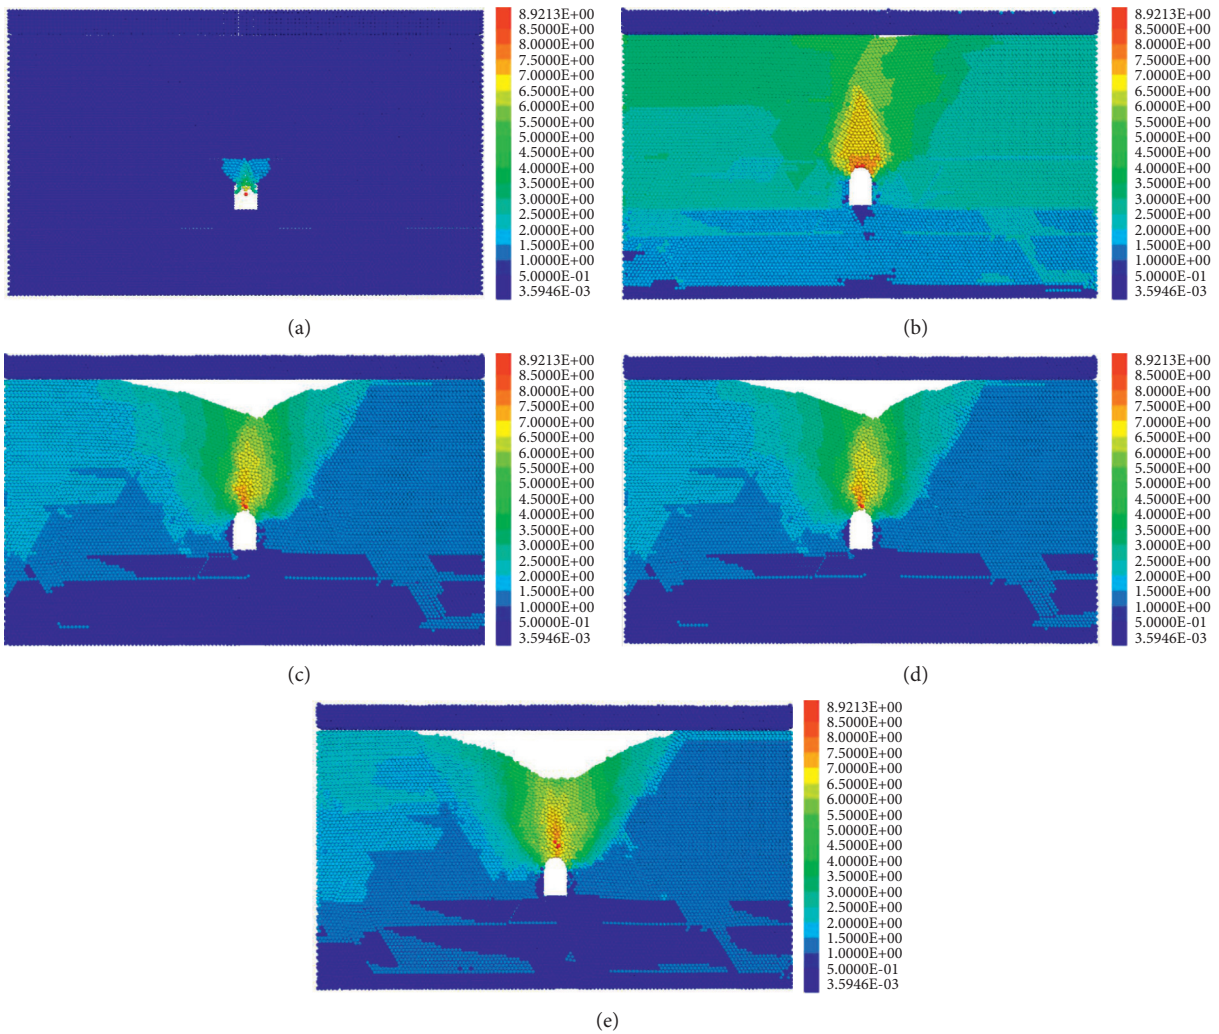
FIGURE 10: Displacement cloud map of each soil layer in the stratum. (a) Run 5000 steps. (b) Run 10000 steps. (c) Run 30000 steps. (d) Run 80000 steps. (e) Run 100000 steps.

**3.3.2. Analysis of Calculation Results.** The flow field is introduced into the soil model, and PFC is used for joint calculation. The crack size on the air raid shelter model is 0.75 times of the particle size. Figure 10 shows the whole process of underground cavity formation. In the early stage of leakage, the mixture of soil and water mainly flows through the air raid shelter into the air raid shelter, so the larger disturbance area of soil is concentrated near the vault of the air raid shelter. With the progress of the calculation, the soil disturbance area continues to develop horizontally and vertically and finally extends to the ground below, forming “asphalt concrete bridge.” In this case, if the pavement is repeatedly affected by external loads, and no timely discovery and remedial measures are taken, it will lead to the deformation of the pavement until sudden collapse, which poses a threat to the safety of human life and property.

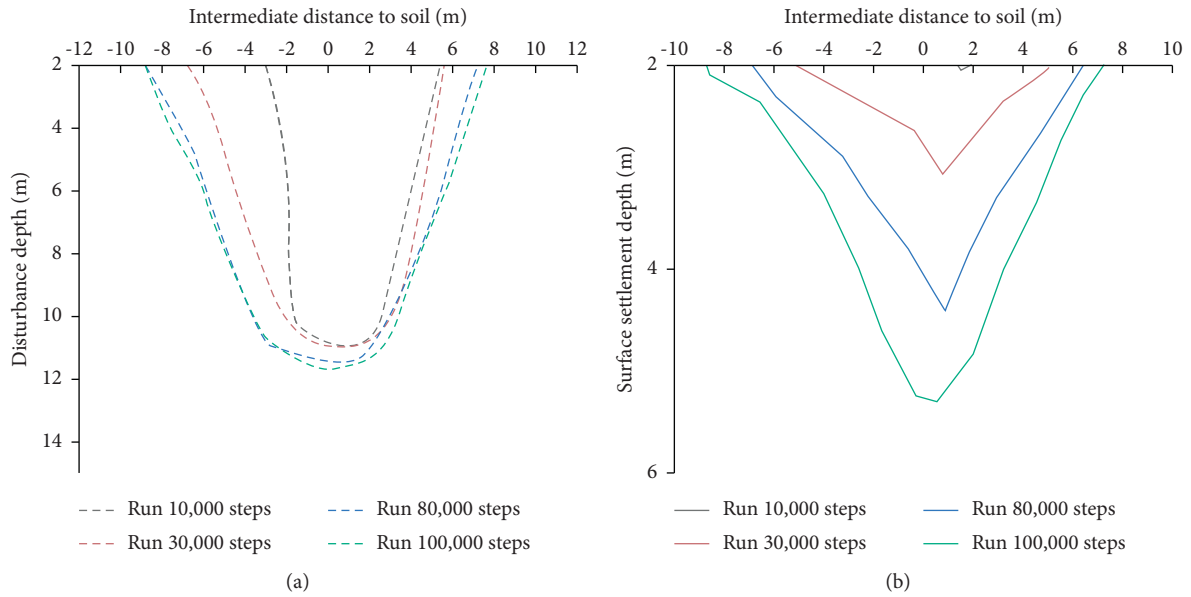
FIGURE 11: Envelope of disturbance zone and surface settlement curve. (a) Envelope of disturbed region. (b) Surface subsidence curve.

In order to describe the ground settlement caused by leakage, the stratum deformation under different calculation steps is described, as shown in the figure. The calculation results show that the plastic zone tends to develop around with the progress of calculation (Figure 11). When the calculation steps are 100000, the deformation range of stratum is about 16 m, and the height of cavity is about 9 m. The maximum settlement occurred above the air raid shelter, and a more obvious underground cavity has been formed.
