# Fatigue Failure Analysis of a Gear in Automobile Engine Coolant Pump

Gear is a reliable part of power transmission. This article presents a metallurgical failure analysis of a failed gear used in automobile engine coolant pumps. In gear, the soft microstructure of pearlite and ferrite is witnessed in metallographic analysis. Significant wear is perceived in gear teeth, and significant deformation is observed in the keyway. The crack initiated from the corner radius of the keyway and propagated towards to the root of the teeth, which is evidence of the failure due to fatigue. Recommendations are given to improve the fatigue strength of gear.

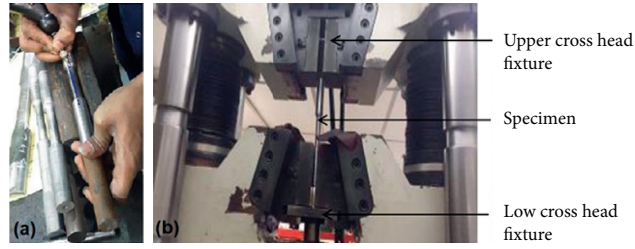
The cylindrical test specimens are prepared using a turning center and the dimensions of the specimen are as per the ASTM E8 standard. The specimens are made up of EN353 material. Four specimens are prepared as shown in Figure 6(a). Specimens 1 and 2 are not heat-treated (soft) condition, and specimens 3 and 4 are heat-treated by the case hardening process. Specimens 1 and 3 have undergone hardness testing. Specimens 2 and 4 have been submitted for tensile testing.

cross head is the fixed end and the lower is the movable end. The specimen is fixed between two ends as shown in Figure 6(b).

FIGURE 6: (a) Sample specimens. (b) Tensile test (UTM) machine setup.
