Research Article

Corrosion Investigation of Rock Anchors Served over 10 Years in Underground Powerhouse of a Hydropower Station

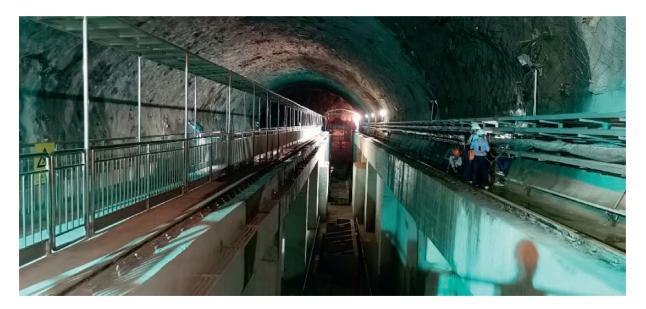
The main powerhouse and the main transformer room are completely with reinforced concrete after excavation, and the anchor cables installed cannot be observed. Thus, the field investigation was mainly conducted in the tailrace surge chamber (Figure 1). 602 prestressed anchor cables were used to reinforce the surrounding rocks of the chamber. Unbonded anchor cables were adopted, and their structure is shown in Figure 2. The designed locked force of the anchors is 1000 kN, 1500 kN, and 2000 kN, with 7 steel strands, 10 steel strands, and 14 steel strands for each. The steel strand is 1x7-15.2-1860 [20].

FIGURE 1: The field investigation in the tailrace surge chamber.

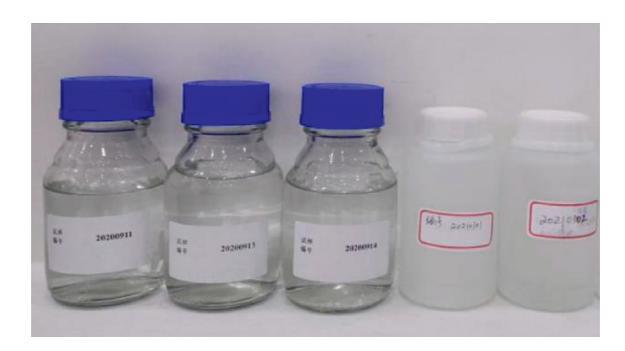
3.1. Groundwater. Steel corrosion in underground engineering is related to the soluble salt content and pH in the groundwater. During the investigation, it was found that there was a groundwater seepage in the upstream sidewall of the tailwater surge chamber. The groundwater was sampled at the seepage point to analyze its corrosivity. The groundwater samples were carried out on the 1^{st} floor and the 2^{nd} floor drainage galleries near the tailrace surge chamber for comparison (Figure 6).

The groundwater in the tailrace surge chamber, drainage galleries and main powerhouse are slightly corrosive, which means the groundwater is not likely to cause serious corrosion of the anchor cable.

FIGURE 6: Groundwater samples from the tailrace surge chamber and adjacent drainage galleries.

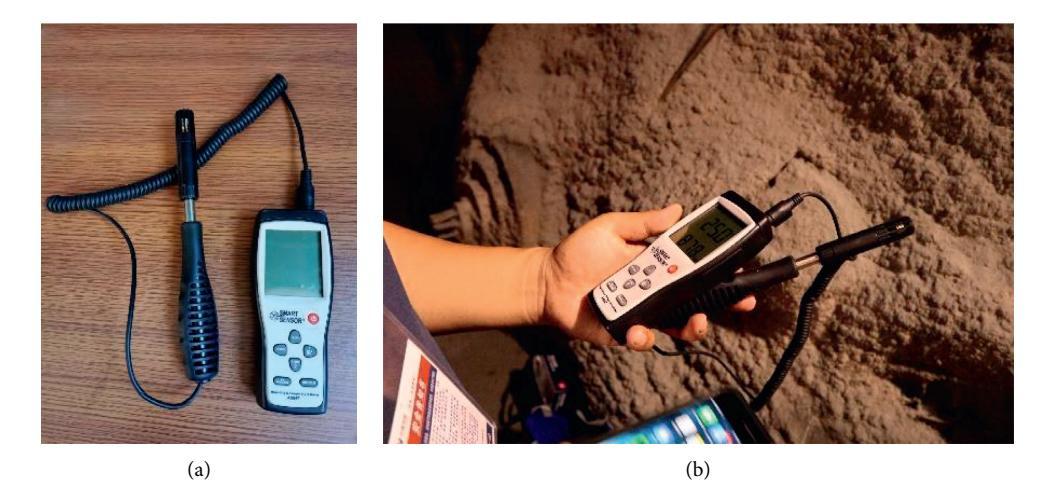
As shown in Table 3, the humidity in the tailrace surge chamber is 87% to 89%, and the temperature is 24°C to 25°C. In the atmosphere, the corrosion rate of metals generally increases with increasing humidity. For many metals, there is a critical humidity for corrosion, while the critical humidity for steel is around 65% [22]. The highest relative humidity of the tailrace surge chamber is about 25% higher than the critical humidity, indicating that the relative humidity in the chamber has a great influence on corrosion. Thus, the tailrace surge chamber can be considered a severely corrosive environment.

FIGURE 7: The Temperature and Humidity Measurement in the Tailrace Surge Chamber. (a) Humidity & temperature meter. (b) Field measurement.

Test site	Humidity (%)	Temperature (°C)
1	87.2	24.7
2	87.8	24.1
3	88.3	24.1
4	87.8	25.0

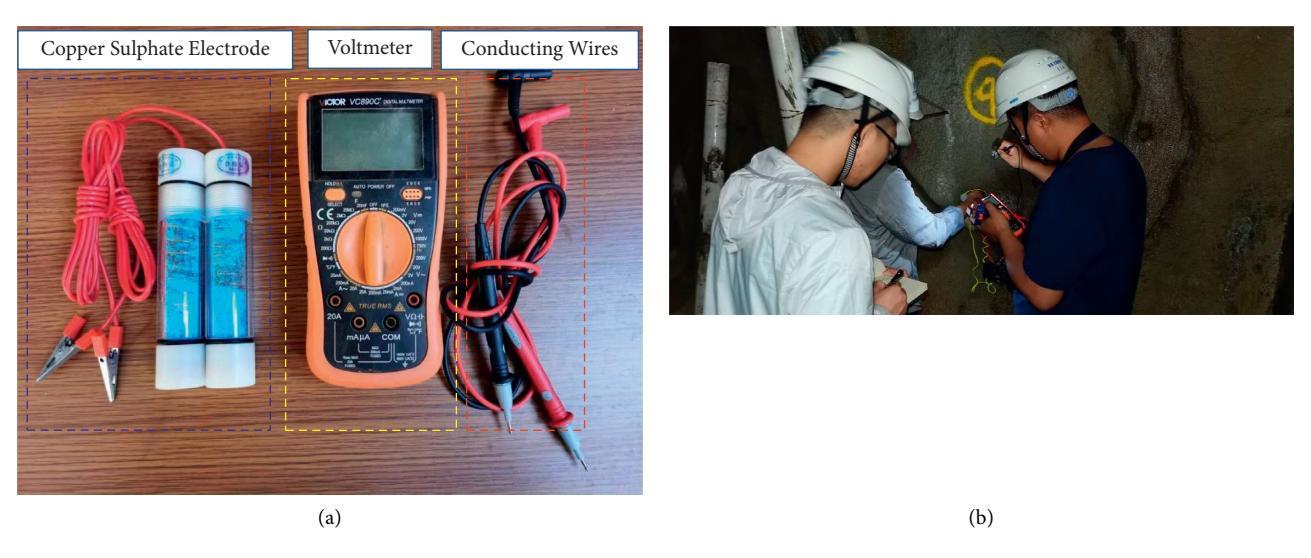
3.3. Underground Stray Current. Stray current, which exists widely in rock and soil mass media, is another influencing factor of anchor corrosion. The action mechanism of the stray current is mainly based on the electrolysis of electrochemical corrosion [2]. High-tensile steel used in tendons is more sensitive to stray current corrosion than normal steel, and certain precautions are necessary in these structures where this type of corrosion may take place [23]. Because of the complexity of the anchor cable structure, it is difficult to accurately measure the potential. To determine whether there is a stray current in the surrounding rock of the tailrace surge chamber, the potential of the bolt installed in the rock was measured. The stray current test was conducted with a copper sulfate electrode, voltmeter, and wires (Figure 8). The stray current measurement results are shown in Figure 9.

metal is in a natural corrosion state. When the measured potential is greater than -400 mV, there is stray current corrosion in the metal. As shown in Figure 7, Bolt7 and Bolt 10 have high potentials, however, they are still in the natural corrosion potential region. In general, half of the bolt potential is in the protected range, indicating that there should

be no stray current in the rock near the tailrace surge chamber. In conclusion, the influence of the stray current on the anchor cable corrosion can be ignored in the chamber.

FIGURE 8: The stray current measurement. (a) The stray current measure device. (b) Field test.

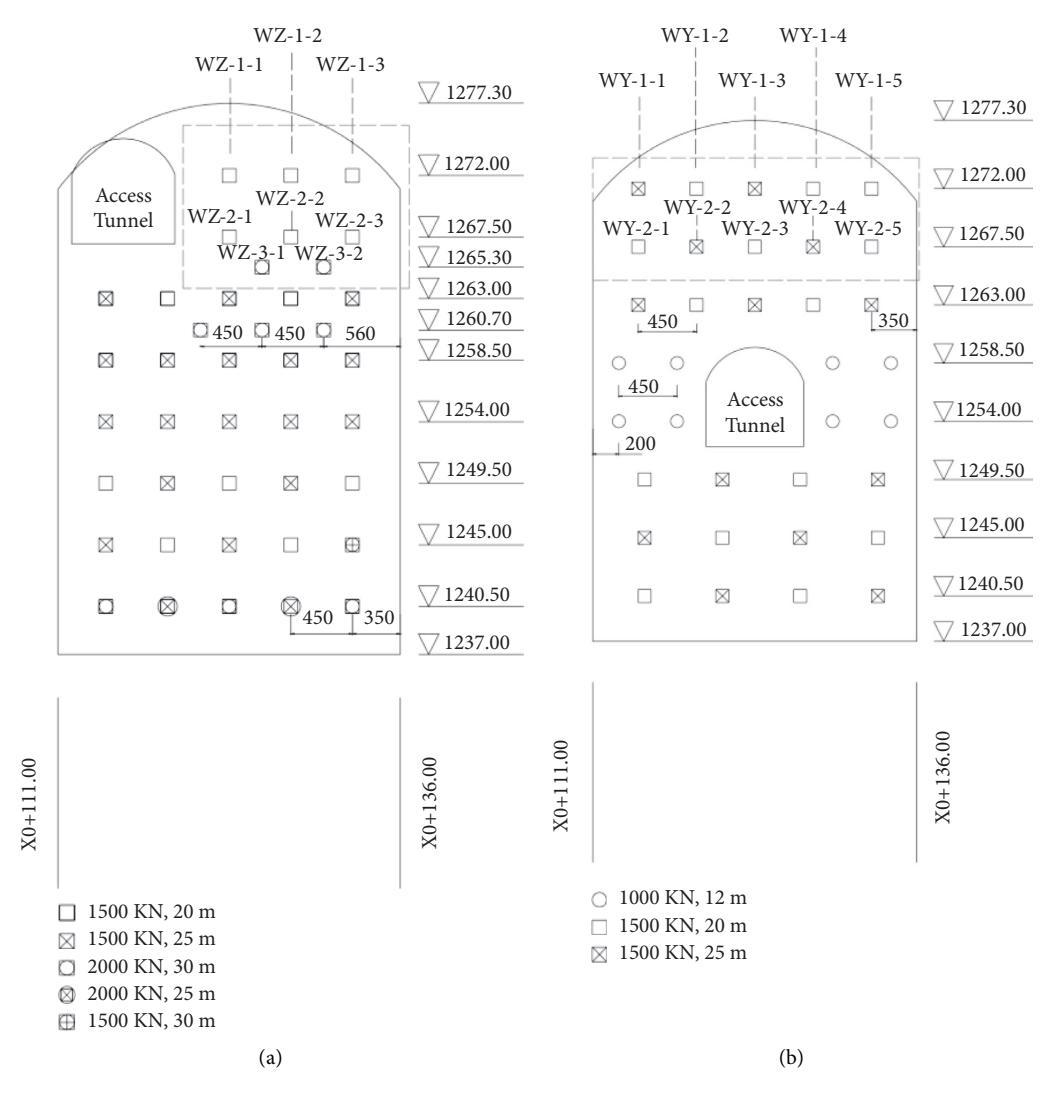
To fully acquire the corrosion status of the anchor cable in the tailrace surge chamber, a set of new inspection procedure and evaluation system were proposed as described below. 4.1. Numbering and Investigation of Anchor Cables. The layout of anchor cables in the tailrace surge chamber was redrawn. The visible anchor heads were numbered to facilitate further record and description. The distribution of anchor cables on the left-end wall and the right-end wall is shown in Figure 11.

FIGURE 11: Distribution and numbers of anchor cables on the left-end wall and the right-end wall of the tailrace surge chamber. (a) Left-end wall. (b) Right-end wall.
