# Damage Characteristics and Mechanism of a Strong Water Inrush Disaster at the Wangjialing Coal Mine, Shanxi Province, China

A serious groundwater inrush occurred at the Wangjialing coal mine on March 28, 2010. Great effort from all over the country was taken during the postaccident rescue. However, triggered by accumulated water in the upper abandoned tunnels and goafs of a nearby closed individually owned coal mine, it caused great damage, including 38 deaths and direct economic losses of over 49 million yuan. The inrush water was from the abandoned tunnels and goafs, which were filled subsequently by groundwater from the sandstone aquifer in the roof of the coal seam. The passage formed in the west roof of the heading face of the air return tunnel in the 20101 first mining face. Unidentified distribution and water-filled degree of the abandoned tunnels and goafs are critical bases for the accident. That important regulations for abundant groundwater exploration and release were not carried out thoroughly was another fatal cause leading to the accident. The poor awareness of water hazard controlling also contributed to the accident to a large extent.

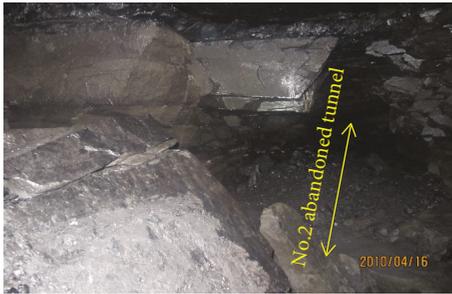
FIGURE 12: No.2 abandoned tunnel.

of the No.1 abandoned tunnel decreased to 0.8 m, the thin wall, where it had been damaged by the accumulated goaf water before the accident and its effective waterproof thickness was less than 0.8 m, was eventually broken by the high-pressure inrush water accumulated previously in the abandoned tunnels and goafs of the individually closed coal mine. In the following time, a great amount of the accumulated water flooded the tunnels of the Wangjialing coal mine to 583 m a.s.l. and caused great damage.
