Deformation Process and Mechanism Analyses of a Rock Slope Based on Long-Term Monitoring at the Pubugou Hydropower Station, China

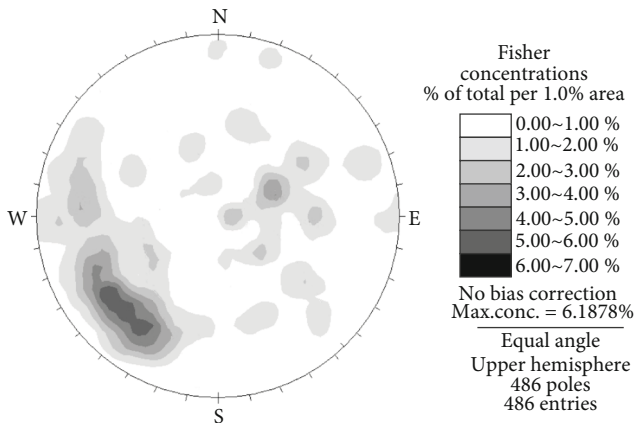
FIGURE 6: Contour plots of basal joints in the horizontal adit.

The basal joints are composed of various primary and tectonic fissure types at the most basic level and randomly developed in the rock mass [47, 48]. In this study, we investigated the distribution of approximately 486 basal joints in the adits (Figure 6). The results showed that the discontinuities on the PBRGS are abundant; no persistent and dominating discontinuity trends were identified. The most basal joints account for only 5.1% of the total number of cracks, i.e., 25 basal joints.
