Failure Analysis of a Highway Cut Slope with Anti-Slide Piles

Landslides induced by engineering construction are very common in reality; it is necessary to clarify the causes of landslide failure to avoid similar accidents. A landslide induced by highway construction is taken as a case. Field observations, data collection, and analyses were used to investigate the deformation and causes of the landslide. The failed slope is mostly comprised of gravel soil, there were some shear cracks on both sides of the slope before sliding, and most tensile cracks were connected with shear cracks after sliding. The cut slope of this highway was designed to be protected by prestressed anchor sheet piles. However, in the construction process, the slope in front of the antipiles was removed when the piles were constructed without any anchor cables, which led to the shear damage of a row of anti-slide piles with a 15-meter-long cantilever. Moreover, continuous rainfall over several days aggravated the landslide damage because of increase of the self-weight and degradation of the mechanical parameters of the slope materials. The mechanical and simulation analyses both show that the resistance provid

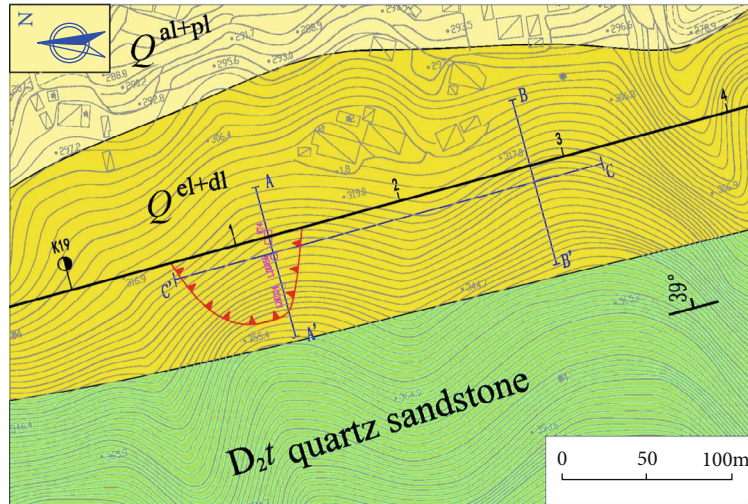
FIGURE 1: Geological engineering plane.

The slope is composed of residual silty clay, Quaternary and siltstone gravel soil, and quartz sandstone of the Majian group in the Middle Devonian (D_2t) (shown in Figure 1). The soil and rock mass is as follows.

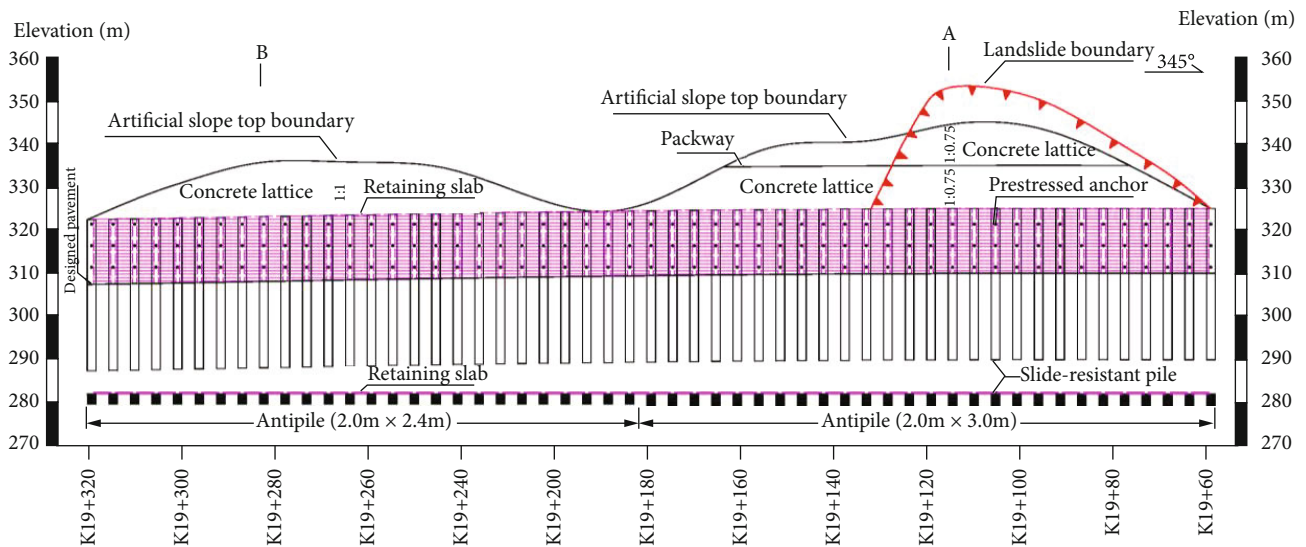
FIGURE 2: The elevation layout of the reinforcement engineering.

According to the highway design, the highway pavement is about 24.5 m wide, and the subgrade on this section is designed to form by excavation, and then there will be a cut slope in both sides of the highway, especially the cut slope on the right, where the landslide happened. The slope on the right side is divided into a vertical part and an incline part. In order to meet the slope stability demand, the prestressed anchored sheet piles are designed in the vertical slope; the piles are 35 m long with the space of 5 m along the highway. Three rows of anchors are designed on each pile; their length are 35 m, 30 m, and 25 m from top to toe with the prestress of 15 tons. The diameter of the anchor is 120 mm and each anchor cable has 5 strands with the diameter of 15.2 mm; its elastic module is 1.95×10^8 kPa and the tensile strength is 1.86×10^6 kPa. The inclined slope surface above the pile top is protected with lattice frame construction. The maximal height difference above the pile top is 20 m in the K19+120 profile. Figure 2 shows the reinforcement design layout in the elevation.

As shown in Figure 2, the whole slope can be divided into two parts along the highway mileage. The first section slope is from K19+060 to K19+200, and the second section slope is from K19+200 to K19+320. Figures 3 and 4 represent their typical engineering geology cross-section profile with reinforcement work. The cut slope above the pile top of the first section was excavated into two stages with the ratio of 1.0:0.75, and the cross-sectional size of anti-slide piles was 2.0 m × 3.0 m. The slope above the pile top of the second section was excavated in one stage with the ratio of 1.0:1.0. The cross-sectional size of anti-slide piles was 2.0 m × 2.4 m. The

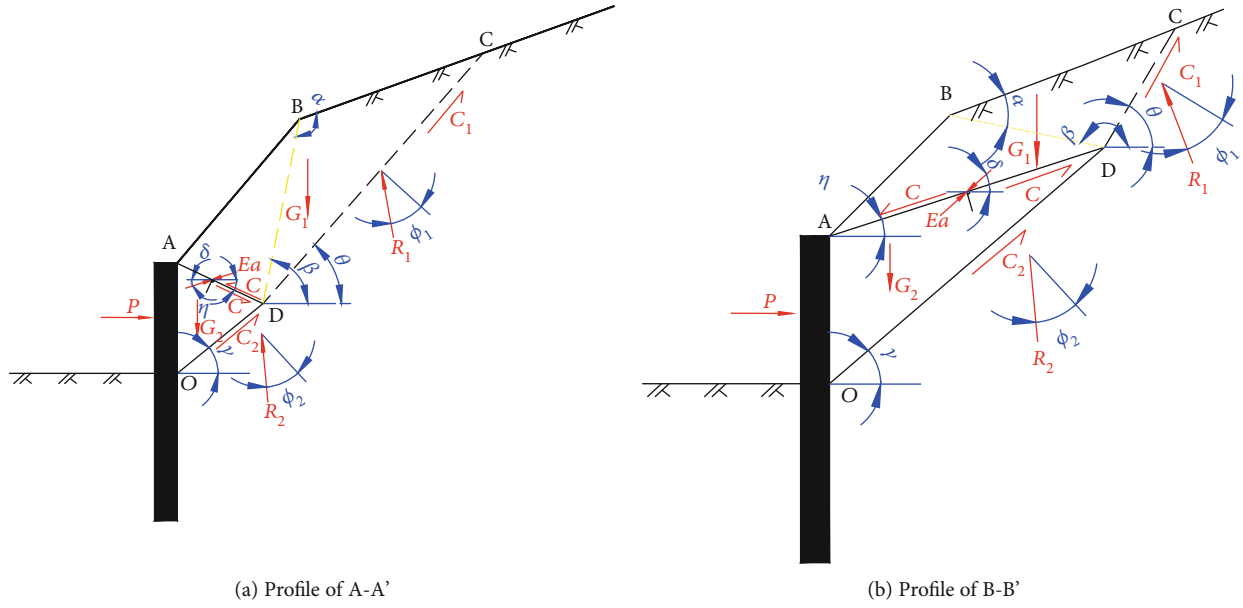
FIGURE 9: Mechanical analysis of rock mass and soil behind antipiles.

The slope failure attributes to the irrational construction process and continuous rainfall, their effects can be quantitatively analyzed with static equilibrium functions. Based on Coulomb earth pressure theory, the active earth pressure of this slope can be simplified as shown in Figure 9. Zone ADO represents the siltstone, and zone ABCD represents the gravel soil. The earth pressure acts in the interface AD of gravel soil and siltstone. To simplify calculations, the shear strength of the interface is assumed to be two-thirds as strong as that of gravel soil, and the interface of the anti-slide pile and siltstone is smooth. The lengths of BC and CD would vary with the change of the angle θ .

where G_1 and G_2 are the weights of parts ABCD and ADO, respectively, kN; C_1 , C_2 , and C denote the tangential forces caused by the interface cohesion as shown in Figure 9, kN; and R_1 and R_2 denote the forces on the interface contributed by the friction angle, kN. E_a is the active earth pressure on the interface of parts ABCD and ADO, kN. P is the force between pile and soil, kN. ϕ_1 and ϕ_2 are the cohesive of the rupture surface on parts ABCD and ADO, respectively, °. θ , γ , and η are the tilt angles of rupture surfaces CD, DO, and AD, °.

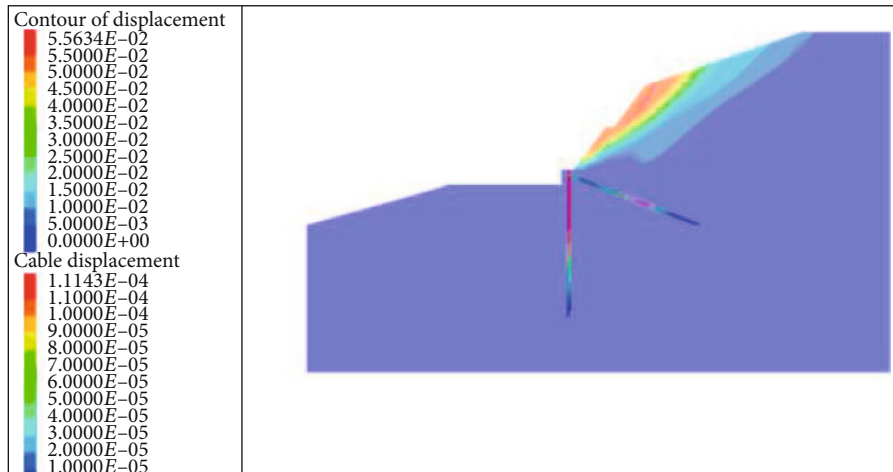
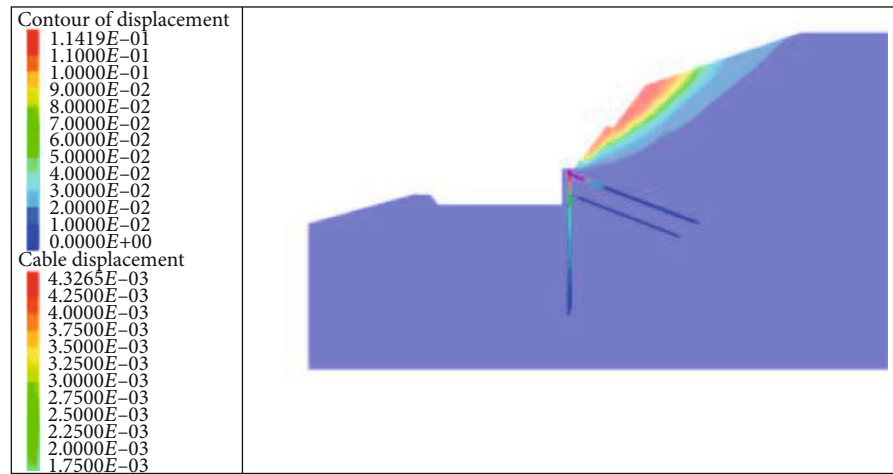
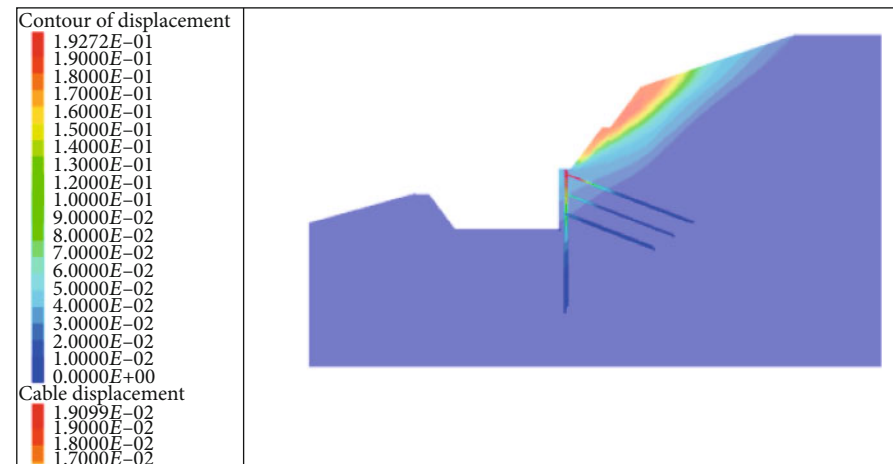
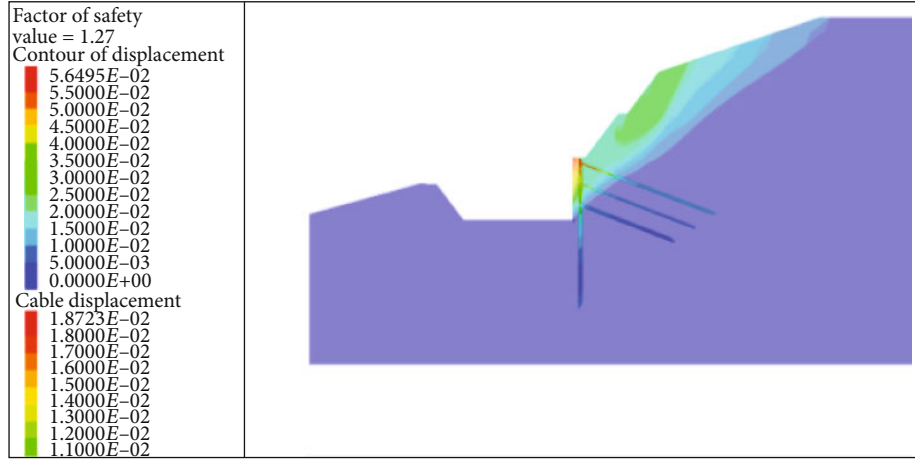
FIGURE 12: Numerical simulation of suggested rational construction process.

FLAC^{3D} is used to simulate the deformation and stability of the cut slope. The calculation results of the actual and rational construction processes are shown in Figures 11 and 12, respectively. Here, it should be pointed out that the first two steps of the two construction processes are the same; the difference just begins from the third step. Therefore, only the first two steps are given in Figures 11 and 12 which show just the following construction processes. According to the numerical simulation, the slope stability coefficient is 1.02 under the actual construction process and 1.27 under the rational construction process. Under the rational construction process, the anchor cables restrain effectively the deformation of rock and soil behind the piles, reducing the overall displacement of the slope. Therefore, rational construction process can effectively enhance the stability of the slope.

The irrational construction process is the key factor causing the slope failure. The actual construction process led to anchor late cable implementation. Here, each anti-slide pile without the anchor turned into a 15-meter-long cantilever pile when the rock mass and soil in front of the piles were excavated. The greatest disadvantage of a cantilever pile is that its displacement is generally bigger than that of an embedded pile. Moreover, retaining plates between the piles had not yet been implemented. All of these would promote the rock and soil behind the piles moving towards the free face, and then the stress condition of the slope adjusted, which is a disadvantage to the stability of the slope. If anchor cables had been implemented in time, the displacement and the stress adjustment of the slope above the top of the anti-slide piles would have been well controlled, and the slope failure would not have happened.
