Research Article

Deformation and Failure Process of Slope Caused by Underground Mining: A Case Study of Pusa Collapse in Nayong County, Guizhou Province, China

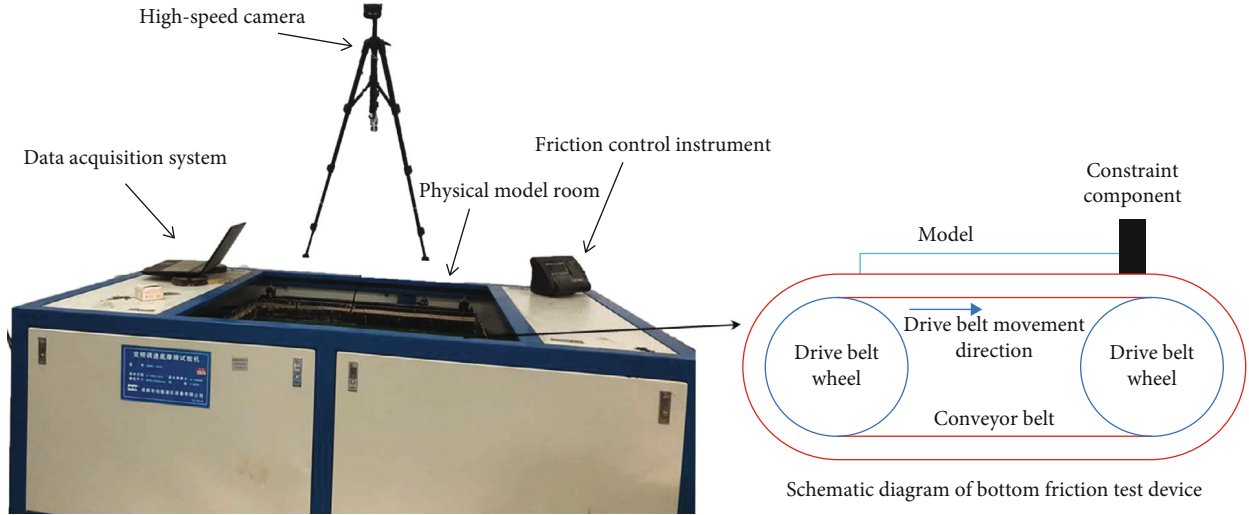
FIGURE 7: Bottom friction-based physical model test setup.

4.1.1. Bottom Friction Test. The bottom friction model test simulates the gravitational force on the model by the friction between the model and the bottom surface. The basic principle is the model is flattened on the horizontal conveyor belt so that the original section depth direction is consistent with the direction of the conveyor belt movement (see Figure 7),

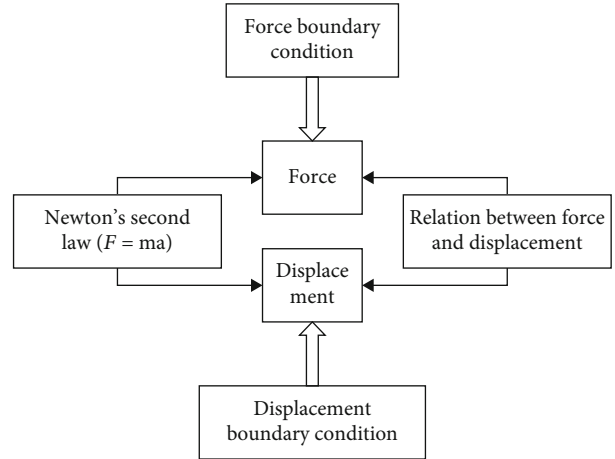
FIGURE 8: Process diagram of particle flow cycle calculation.

cally recalculate according to the theory of the force-displacement relationship. Contact forces and particle motion are updated until the system reaches a new equilibrium (see Figure 8). The law of particles follows Newton's second law of motion, which describes the rigid motion of individual particles by acting on the combined forces and force moment vectors acting on each particle. As a result, the rock mass model constructed by PFC can simulate the dynamic behavior of rock bodies in nature.

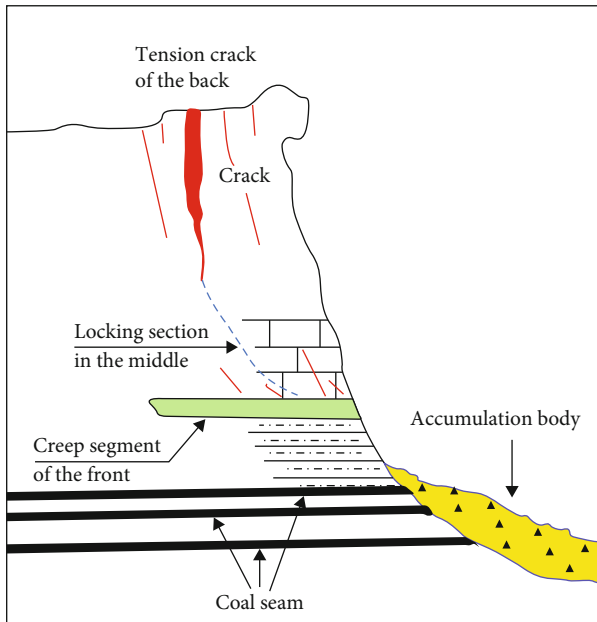
FIGURE 9: The three-section mechanism of a landslide [40].

- (1) During slope formation, unloading/rebound deformations are caused by postgenesis along the gentle structural surface at the bottom of the slope. After the coal seam is mined, the overlying rock mass is deformed. This results in tensile stress zones and tensile cracks at the top of the landslide, especially in high-stress zones (Figure 9)

- (2) Subsequently, with the mining of multiple coal seams, the deformation intensifies. Under the long-term action of gravity, the slope is continuously crawling along the gentle structural surface, resulting in a deepening of the head crack (Figure 9)

- (3) When the rear crack reaches a certain depth, the accumulated stress in the “locking section” causes the slope to break gradually. Finally, the “locking segment” will be destroyed by shear forces, and brittle damage will occur on the slope. Since such slopes often have considerable potential energy, the sliding velocity can be exceptionally high when disruption occurs

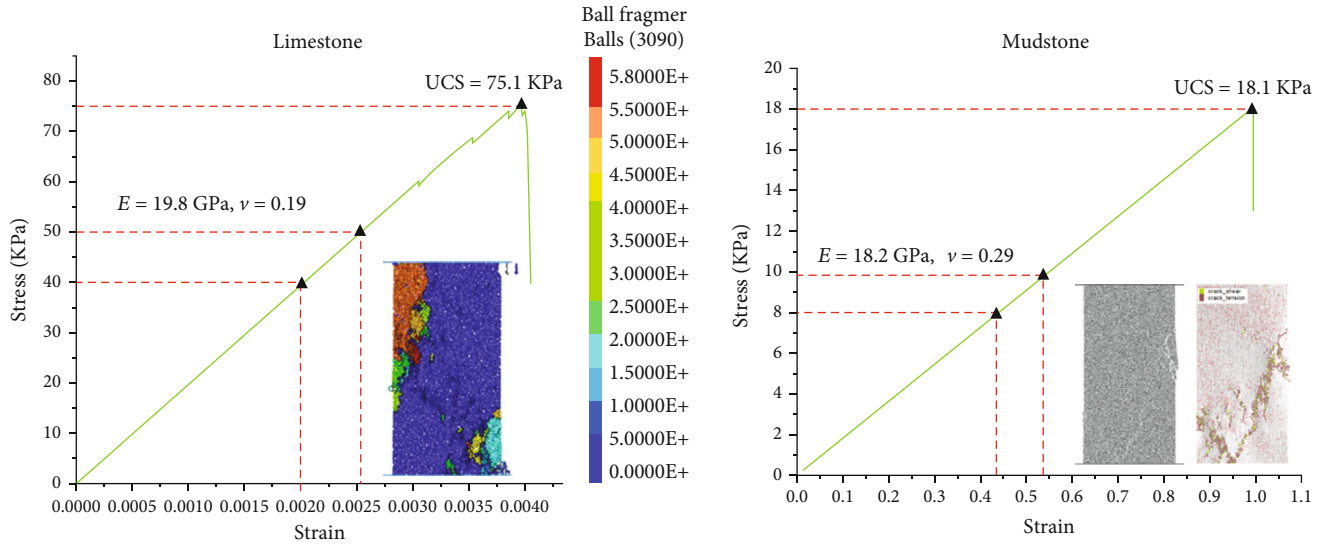
FIGURE 11: Calibration curve of limestone and mudstone parameters.

According to the size of the simulation model and the calculation efficiency of the computer, it is comprehensively determined that the particle size is 0.3–0.49 m, the porosity is 12%, the model sample is 50 m \times 100 m, and the number of sample particles generated is 8846. Since the simulation test is a reproduction of the indoor test, the purpose is to reflect the macroparameters into the microparameters and then calibrate the macroparameters through the simulation test with the microparameters. The uniaxial compression test is also designed in the model test to obtain the stress-strain curves of limestone and mudstone (Figure 11), and then, the microscopic parameters of limestone and mudstone are calculated. The results of parameter calibration are shown in Table 2.

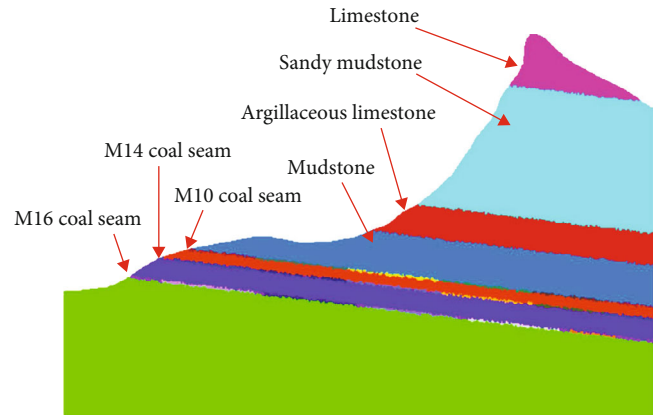
FIGURE 12: Schematic profile of numerical model.

6.2. Numerical Model. The deformation process of the Pusa slope was simulated using the PFC 2D model. The results were further analyzed to verify the failure mechanism. Based on the terrain before the collapse and the nearby landform, this paper reconstructs the two-dimensional discrete element model based on the best main section of the slope. The model, 350 m in height and 800 m in length, consisted of 50,000 particles. Figure 12 shows a numerical model constructed based on the longitudinal section in Figure 2(c). Several straight lines were used to build the slope surface in the model. To better reflect the deformation and failure process of the slope, the geological conditions were simplified. For example, the faults were not considered, and the rock mass only has four types: limestone layer, argillaceous limestone layer, sandy mudstone layer, and coal layer. The coal seam was composed of strata represented by M16, M14, and M10. In this study, PFC built-in model was adopted for the numerical model with required physical
