Study on Deformation Mechanism and Control Measures of Tanziyan Landslide

Studying the deformation and failure mechanism of the Tanziyan landslide in Yesanguan Town, Badong County, and designing the controlling measures are of great significance to ensure the sustainable development of urban planning and construction. In this paper, stability of Tanziyan landslide is analyzed using the calculation method of complex plane slip surface. After consideration of the essential characteristics of the disaster body, the deformation and failure mechanism of the landslide is studied, and the corresponding landslide treatment measures are presented. Results show stability state of the landslide is understable to unstable as a whole, and the development process can be roughly divided into three stages: sliding, bending and the cracks are connected. Finally, it is proposed to cut and reshape the slope from the crack groove on the slope top to the national highway, and then lattice beams and anchor cables are presented to protect the reshaped slope surface. Ecological bags are used to stack and regreen between the lattice structures. A retaining wall is built on the inner side of the national h

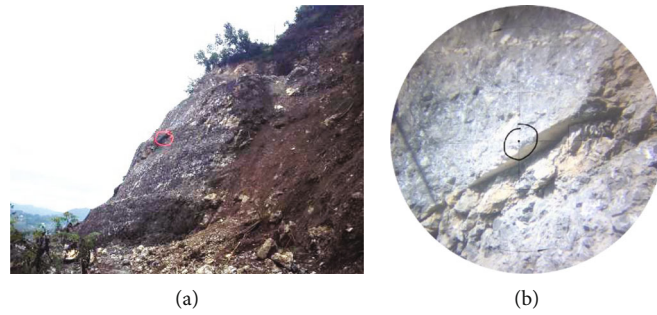
FIGURE 6: Drawing and operation drawing of slide monitoring point.

3.1.1. Sliding. The slide deformation occurs at the inner slope of G318 at the front edge of collapse, with a total of 3 places developed, namely, TH1, TH2, and TH3 (Figure 5), which are closely arranged from east to west. After the occurrence of slide TH1 and slide TH2, the professional monitoring of slide TH3 was focused. According to the professional deformation monitoring records, the displacement of collapse body was 0.3 m from June 30, 2018, to July 5, 2018 (Figure 6). In addition, from June 25, 2018, to June 30, 2018, the monitoring results of the high-pressure electrode slope on the upper part of the collapse TH3 were cracks, and the mountain displacement was 3.8 cm.
