Fire-Side Corrosion: A Case Study of Failed Tubes of a Fossil Fuel Boiler

The failures of superheater and reheater boiler tubes operating in a power plant utilizing natural gas or mazut as a fuel have been analysed and the fire-side corrosion has been suggested as the main reason for the failure in boiler tubes. The tubes have been provided by a fossil fuel power plant in Iran and optical and electron microscopy investigations have been performed on the tubes as well as the corrosion products on their surfaces. The results showed that the thickness of the failed tubes is not uniform which suggests that fire-side corrosion has happened on the tubes. Fire-side corrosion is caused by the reaction of combustion products with oxide layers on the tube surface resulting in metal loss and consequently tubes fracture. However, the tubes corrosion behaviour did not follow the conventional models of the fire-side corrosion. Given that, using the corrosion monitoring techniques for these boiler tubes seems essential. As a result, the thickness of the boiler tubes in different parts of the boiler has been recorded and critical points are selected accordingly. Such critical points are selected

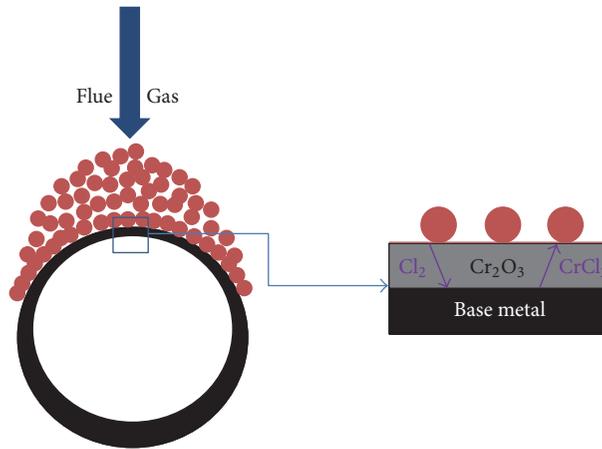
FIGURE 9: Schematic of the fire-side corrosion in the presence of chlorine.

Alloying with sufficient amount of chromium to form a chromium-rich oxide may thus increase the resistance to chlorination [9]. However, corrosion under deposits is highly complex, with a number of competing reactions taking place, and the stability of metal oxides contra metal chlorides is not sufficient to accurately predict alloy performance.

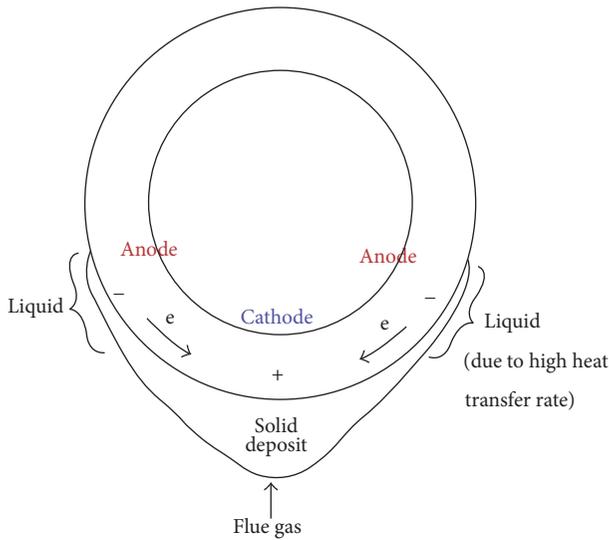
FIGURE 10: Schematic of corrosion under deposits on the tubes [7].

The areas on the tube surfaces which are covered by molten sulphates are generally anode. We expect to see such behaviour on the side of tubes which are exposed to fire. Therefore, as Figure 8 illustrates, the areas with thick deposits are locally cathode while the areas with thinner and molten deposit layers are locally anodes and expose highest corrosion rate by molten salts. In other words, there are 4 sites in a tube cross section: a safe area on the opposite side of the fire, a cathodic area with thick deposits, and two anodic sites with molten corrosion products as shown in Figures 10 and 11. From the electrochemistry points of view, (4) occurs at anodic part leading to metal loss:
