Research Article Failure Analysis of Tubing Collapse in a Gas Well

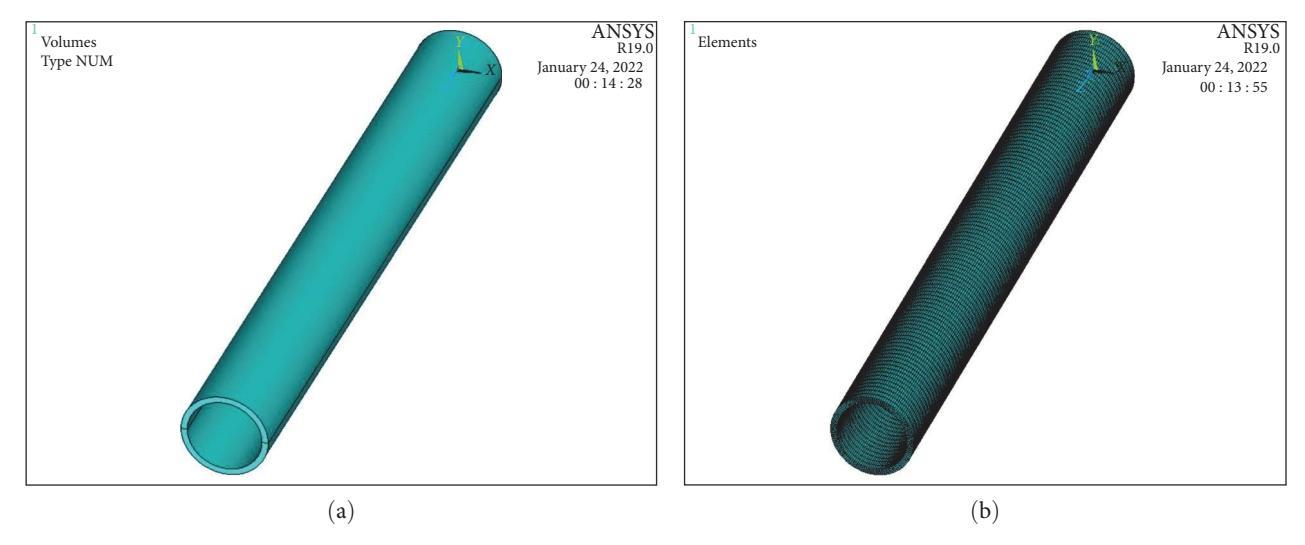
FIGURE 8: Tubing FEA model (a) and the modeling of the tubing (b).

In order to verify the influence of abnormal axial load on collapse behavior, the FEA model of the failed pipeline was established according to the actual outer diameter, wall thickness, and other geometric dimensions of tubing (see data in Figure 8). The axial loads under different working conditions during service were simulated and analyzed to study the stress state of failed tubing under different working conditions. The modeling of tubing was based on the actual geometric dimension measurement results of tubing, and the finite element model was established according to the axial load. The mesh of the established model is divided, as shown in Figure 9.

Apply frictionless symmetrical constraints on both ends of the tubing model, and then apply an axial load of 0-1,146.3 kN on the inner wall of the tubing to simulate

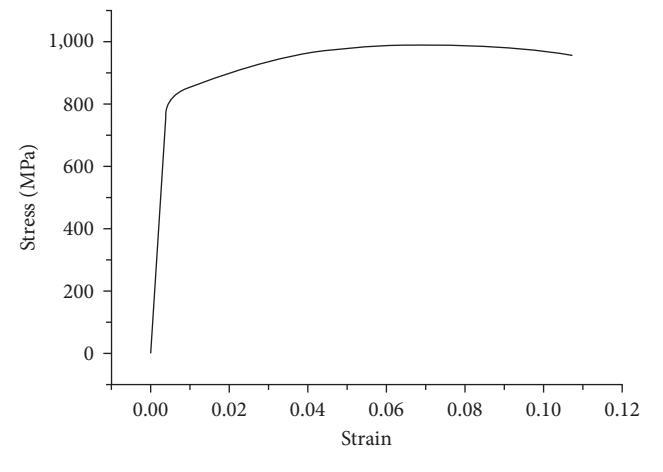
FIGURE 11: Tensile stress-strain curve of the tubing in the same batch.

The analysis type of FEA was static. The nature of the solving approach adopted implicit calculation. The selected material properties were elastoplastic. The nature of the hardening approach adopted isotropic and isotropic hardening. The elastic moduli used for the simulation was 210 GPa, and Figure 11 shows the results of tensile stress–strain curve of the tubing in the same batch. The number of elements and nodes used to perform the final simulation were 127,000 and
