Research on Deformation and Failure Evolution of Deep Rock Burst Drivage Roadway Surrounding Rock under Dynamic Disturbance

Based on the existing research results, this paper takes the No. 3 connection roadway of drainage roadway at panel 1303 in the “10.20” Rock Burst Accident of Longyun Coal Industry as the engineering background. By using the finite difference numerical simulation method of engineering scale, the deformation and failure evolution of surrounding rock under the superposition of mining disturbance and external dynamic load, and the mechanism of instability causing the disaster are deeply studied through the detailed simulation of the process of roadway formation in the accident roadway and the application of dynamic load. The research methods and results can provide an important basis for research in related fields.

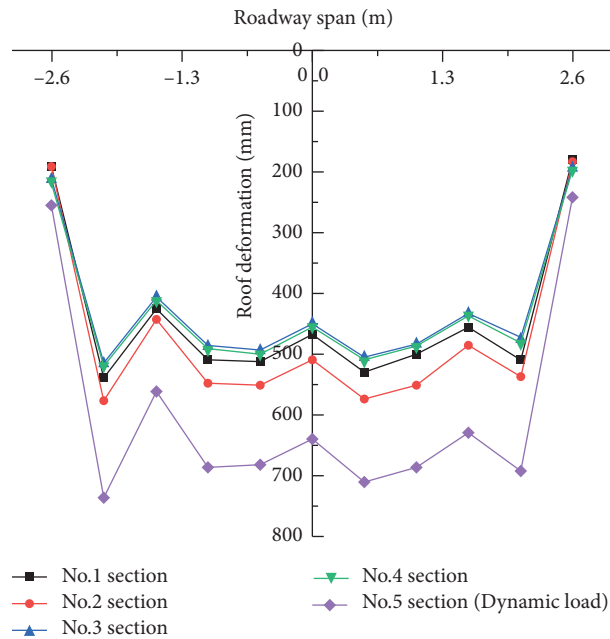
FIGURE 7: Evolution of roof displacement pattern.

Under normal circumstances, the roof of a deep coal roadway under high stress will expand, slide along the surface, and gradually bulge into the roadway, forming a "V-shaped" extrusion type deformation failure, but in this

simulation experiment, the distribution of roof sag shows discontinuous sag, which is due to the large roof span of the roadway and the large distance between the bolts and cables, which results in the larger roof sag at the place where the ability of the cable bolts and rebar bolts to protect the surface is weak. It can be seen that the anchoring force, row spacing, and bolt surface protecting component are the factors that must be considered in the optimization of supporting design. In addition, the maximum horizontal displacement of the two ribs occurred in the upper middle of the coal rib, indicating that the coal mass at this location was severely broken due to the decompression of the roof separation, which in turn reduced its strong support for the roof coal seam.

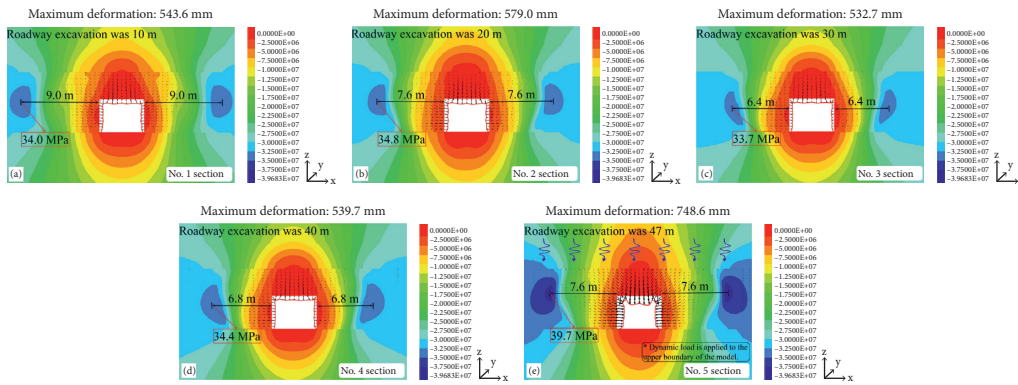
FIGURE 9: Distribution of surrounding rock stress and displacement during roadway excavation. Roadway excavation was (a) 10 m, (b) 20 m, (c) 30 m, (d) 40 m, and (e) 47 m.

In order to more clearly see the characteristics of the displacement distribution of the roadway surrounding rock, combined with the analysis of the vertical stress cloud diagram and the displacement vector diagram of the surrounding rock on the monitoring section (as shown in Figure 9), it can be seen that the amount of roof sag is more

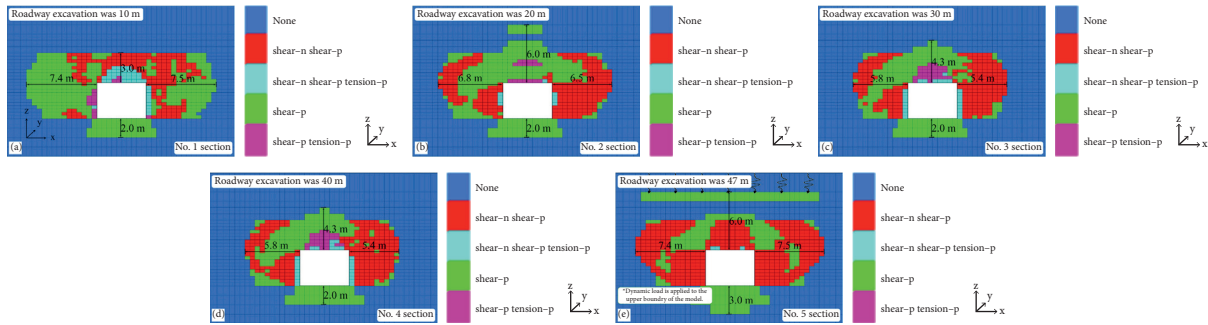
FIGURE 10: Distribution of surrounding rock plastic zone during roadway excavation. Roadway excavation was (a) 10 m, (b) 20 m, (c) 30 m, (d) 40 m, and (e) 47 m.

From the distribution of plastic zone in surrounding rock during roadway advancing (as shown in Figure 10), it can be visually seen that due to the superposition of deep high in situ stress static load and dynamic load disturbance, the instability and plastic failure of the roadway top-coal are caused by the large deformation of the roof surrounding rock directly. When the heading face advances to 10 m from

the roadway connection, the width of the plastic zone of the coal seam is reduced from 7.4 m to 5.8 m under the support of the roadway surrounding rock, and the plastic failure in the roof and ribs is controlled. During the period, the support plan played a certain role in supporting the surrounding rock. When the heading face advances to 3 m away from the roadway connection, the plastic zone of the surrounding rock increases significantly, and the plastic failure zone of the roof coal expands most obviously, from 5.8 m to 7.5 m, and the hard roof plastic failure zone of the roadway development and expand again. As shown in Figure 11(a), when the roadway is 10 m away from the roadway connection, it can be seen that the plastic zone at the two heading faces of the roadway has advanced connection, and the width of the plastic zone reaches 9.5 m. As shown in Figure 11(b), when there is still 3 m from the roadway connection, it can be seen that the 3 m coal pillar between the two heading faces has been destroyed, and the width of the two ribs of the plastic failure range has reached 16.9 m,

which is close to the plastic zone range of the excavated and supported roadway. Overall, the plastic failure of the roadway roof mainly occurs within the 3 m range of the roof coal below the coal rock seam interface. With the connection of the roadway, the plastic zone of the roadway surrounding rock expands to the deep part of the two ribs as a whole. When there is a coal pillar of 3 m, the support completely fails under the dynamic load disturbance.

The whole process of excavation and support of deep rock burst drive roadway shows that the plastic failure is mainly distributed in the roof coal and rock mass and the two ribs coal mass, and the floor rock mass has less plastic failure. Therefore, attention should be paid to strengthening the support strength of the roof and the two ribs when carrying out the support design. In addition, since the evolution of the roof sag pattern (as shown in Figure 7) shows a significant influence of the support scheme on the roof sag, it can be concluded that the “10.20” rock burst accident occurred because of the short length of the cable bolts that the top-coal cannot be effectively anchored in the stable key strata, and an effective bearing structure cannot be formed in the rock strata. The anchoring force and surface protection ability of the cable bolts alone cannot resist the disturbance of dynamic load in the high stress environment so as to ensure the stability of surrounding rock structure.

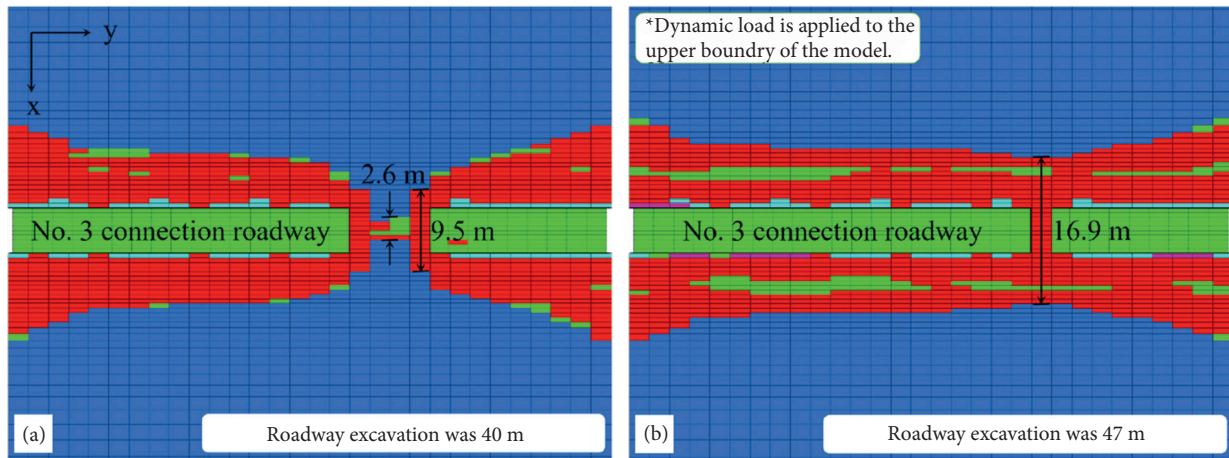
FIGURE 11: Distribution of surrounding rock plastic zone along the direction of excavation. Roadway excavation was (a) 40 m and (b) 47 m.

In order to explore the distribution characteristics and evolution law of plastic zone in surrounding rock during the connection period of deep rock burst drivage roadway under dynamic disturbance, the distribution of plastic zone on each monitoring section is shown in Figure 10. The distribution of the plastic zone on the horizontal section of the two ribs of coal and rock mass when the roadway is close to the connection is shown in Figure 11.

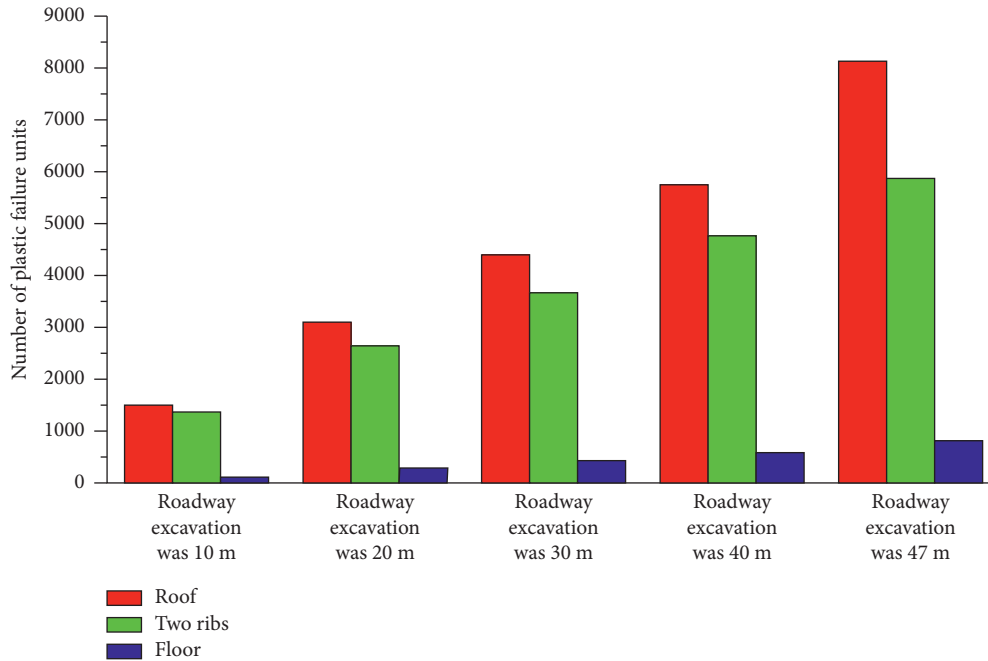
FIGURE 12: Evolution of surrounding rock plastic zone during roadway excavation.

In addition, to quantitatively analyze the temporal and spatial evolution law of the plastic zone of the overall roadway surrounding rock under dynamic disturbance, the numbers of failure zones on the roof, floor, and the two ribs of the roadway are respectively counted, as shown in Figure 12. It can be seen that the degree of plastic failure of the roadway floor is relatively light. As the roadway advances, the proportion of failure is slowly increasing, which is 3.7%, 4.6%, 4.9%, 5.0%, and 5.5%, respectively. The degree of the two ribs failure is the second, and under the support of the ribs, the proportion of their failure has shown a more obvious decline as the roadway advances, followed by 46.2%, 43.9%, 43.2%, 43.0%, and 39.6%. The degree of the roof is the most serious. As the roadway advances, its failure accounts for an increasing proportion, which is 50.1%, 51.5%, 51.9%, 52.0%, and 54.9%, respectively. And within the last 7 m of advancing, the growth rate of the number of failure zones in

the two ribs is 23.2%, and the growth rate of the roof is as high as 41.4%.

The analysis shows that the impact of dynamic load disturbance on the plastic deformation of the roof is greater than that on the two ribs and floor, and the plastic failure of the roof coal seam plays a leading role in the overall surrounding rock deformation of the roadway.

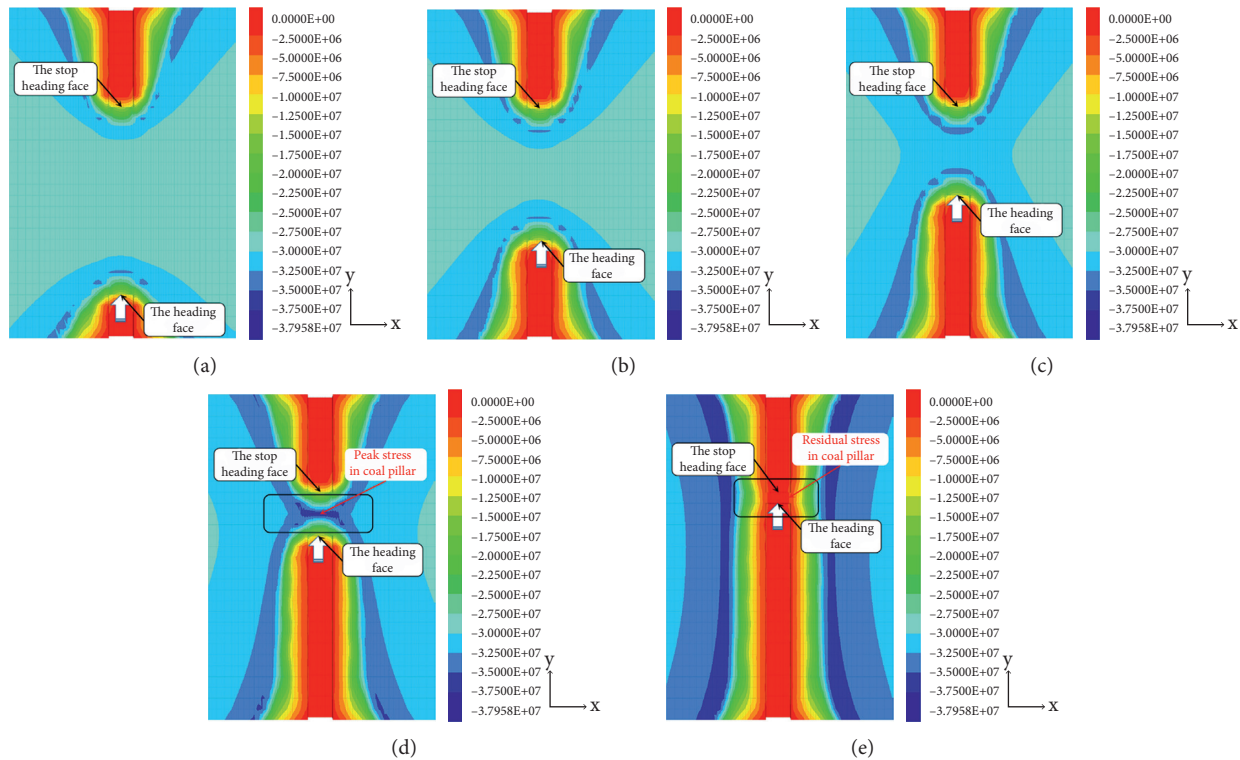
FIGURE 13: Distribution of surrounding rock stress along the direction of excavation. Roadway excavation was (a) 10 m, (b) 20 m, (c) 30 m, (d) 40 m, and (e) 47 m.

Figure 13 shows the stress distribution of surrounding rock along the direction of connection after the excavation of roadway. It can be seen from Figures 13(a)~13(d) that the stress area in the coal and rock mass between the heading face and the stop heading face presents a “low-high-low” distribution law before the roadway advances 10 m away, and the surrounding rock on the inner side of the high stress area and the heading face are in a low stress area. When it is 40 m away from roadway connection, the high stress area in front of the heading face is completely above 30 MPa, and therefore a small range of discontinuous stress peak area of 32.5~35 MPa appears. When the distance of roadway connection is 30 m, the high stress area of 30~32.5 MPa in the coal and rock mass in front of it gradually expands along the advancing direction, and the 32.5~35 MPa stress peak area continues to extend forward and appear continuous trend with the advancement of the heading face. When the distance of roadway connection is 20 m, the range of the stress area of 30~32.5 MPa expands and superimposes rapidly, and the stress zone of 32.5~35 MPa has become a continuous envelope and continues to extend along with the advancement of the heading face. When the distance of roadway connection is 10 m, as shown in Figure 13(d), the peak stress

area in front of the two heading face fronts is completely superimposed, during which the coal pillar reaches the peak strength, and the peak stress reaches 37.9 MPa. Finally, when the distance of roadway connection is 3 m, dynamic load is applied to the upper boundary of the model, as shown in Figure 13(e), the high stress area of the 3 m coal pillar between the two heading faces completely disappears, and the coal pillar is destroyed. During this period, the stress value rapidly decreased to below 5 MPa, that is, the residual strength of the coal and rock mass after the peak. At the same time, the coal and rock mass in a certain range around the heading face and the roadway is also completely in the stress reduction zone, and it is very easy to lose stability under the disturbance. As a result, the plastic zone of the coal pillar and its surrounding rock rapidly develops and expands, and the overall bearing capacity of the surrounding rock decreases, which eventually induces rock burst accident. It can be judged from this that the support scheme does not have a significant support effect in terms of the results of the control of the roadway surrounding rock, especially the ability to resist dynamic disasters is poor.
