Research Article

Deformation and Failure Evolution Law and Support Optimization of Gob-Side Entry in Weakly Cemented Soft Rock under the Influence of Fault

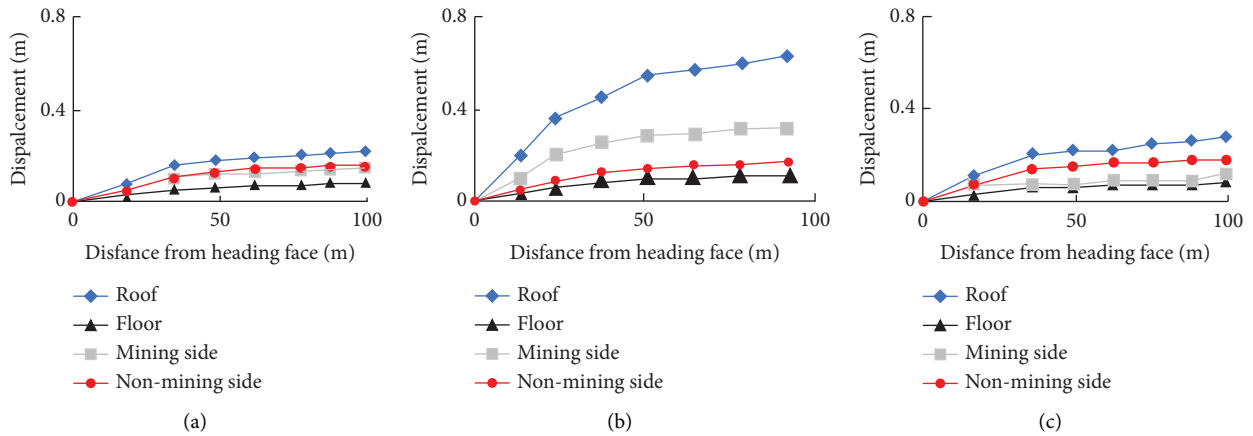
3.2.1. Surface Displacement Monitoring. The change of roadway surface displacement in the three monitoring areas is shown in Figure 5.

FIGURE 5: Monitoring results of roadway surface displacement. (a) 1# survey area. (b) 2# survey area. (c) 3# survey area.

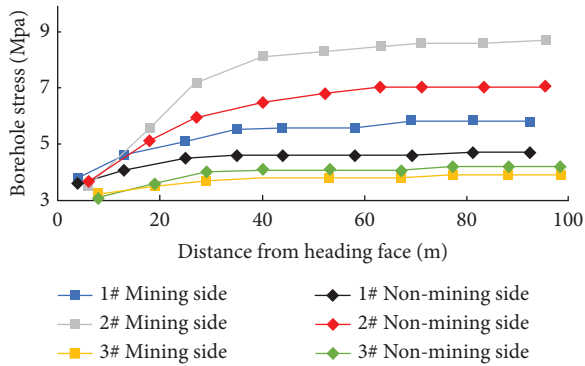
3.2.3. Drilling Stress Monitoring. Representative borehole stress data are selected at the locations of 1 #, 2 #, and 3 # measuring points, and the stress distribution near the roadway is shown in Figure 6.

3.3. Stress Evolution Law of Gob-Side Entry. The stress in the normal area and the area affected by the fault after tunneling along the goaf presents a stress change trend of “surge stage-stable stage.” The stress in the normal area tends to be stable after 30–35 m of tunneling, and the loose range of the surrounding rock of the roadway is basically less than 3 m. At this time, the cable can play a better supporting role, and the overall deformation of the roadway is controllable.

In the roadway in the fault-affected area, the stress of the roadway increases sharply within 50 m from the heading face. Compared with the normal area, the range of the stress surge stage and the vertical stress value increase by 43% and 63%, respectively. The fracture range of the roadway surrounding rock increases from 3 m to 5 m, and the fractures and separation layers increase. It is more difficult to control roadway deformation.

FIGURE 6: Surface displacement monitoring results.

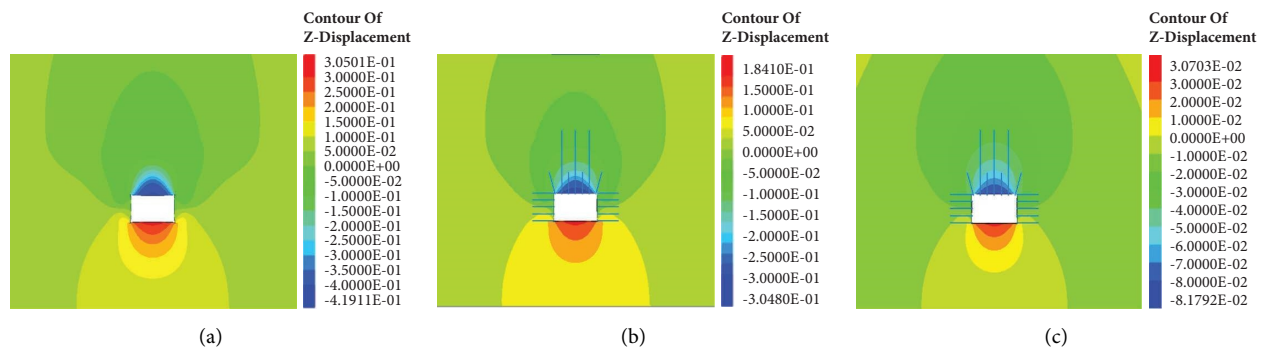
4.2.2. Analysis of Simulation Results. The cloud diagram of displacement distribution along the channel is shown in Figures 8 and 9, and the displacement change curve is shown in Figure 10. From the displacement distribution program, it can be seen that the vertical displacement is mainly concentrated on the roof, which is shown as the roof subsidence, and the horizontal displacement is mainly concentrated on the two sides, which is shown as the inner extrusion of the side. In Scheme 1, the maximum roof subsidence is 398 mm, and the displacement of two sides is 198 mm. In Scheme 2, the maximum subsidence of the roof is 296 mm, and the displacement of two sides is 116 mm. In Scheme 3, the

maximum subsidence of roof is 79 mm, and the displacement of two sides is 55 mm. In Scheme 4, the maximum roof subsidence is 62 mm, and the displacement of two sides is 48 mm.

FIGURE 8: Cloud chart of vertical displacement distribution. (a) Scheme 1. (b) Scheme 2. (c) Scheme 3.

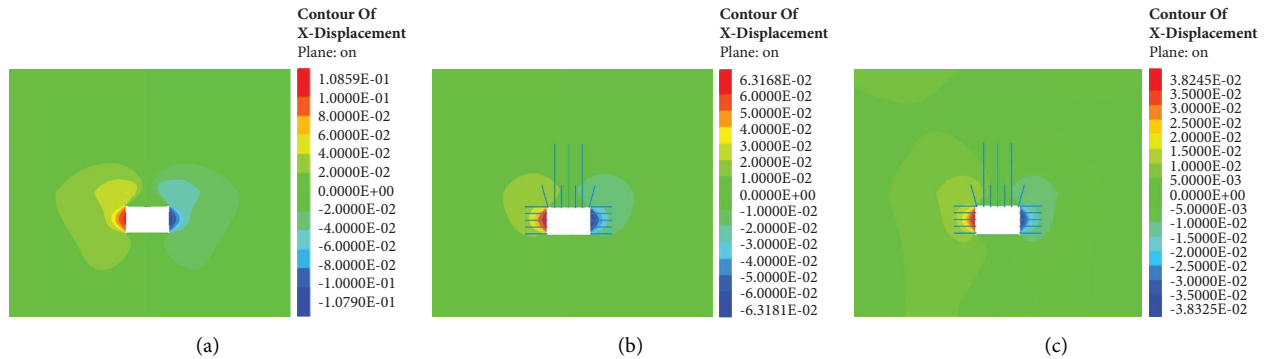
FIGURE 9: Cloud chart of horizontal displacement distribution. (a) Scheme 1. (b) Scheme 2. (c) Scheme 3.

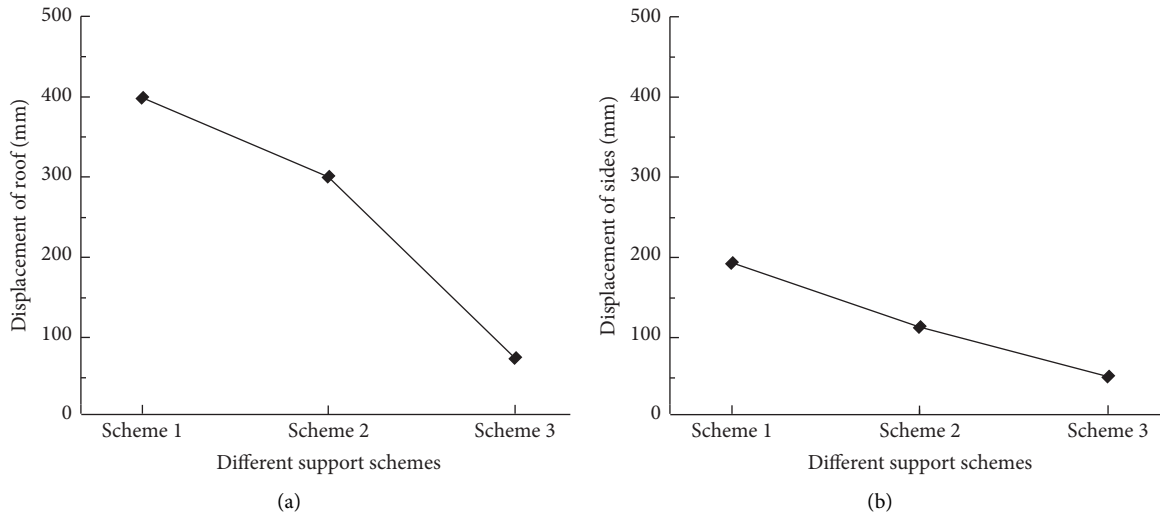
FIGURE 10: Displacement curve of surrounding rock surface. (a) Roof-floor. (b) Sides.
