Failure Behaviour of Sandstone with a Preexisting Joint under Stepped Excavation

Much geotechnical construction needs to be carried out under the condition of stepped excavation. However, there is still a lack of research on crack coalescence and failure modes of jointed rock mass under stepped excavation conditions. In order to simulate the stepped excavation test of the real project, the polylactic acid (PLA) material is selected as the filler for the excavation area. The stepped excavation tests are performed on sandstone specimens containing a preexisting joint under different normal load conditions. The dynamic stepped excavation of simulating excavate rock engineering is realised. The constant normal loads during the excavation process are determined to be 80 kN and 100 kN. The influence of the joint inclination on the failure characteristics of the excavation process is analysed. Four typical failure modes are summarised: (a) Mode I: crack coalescence of tensile failure; (b) Mode II: crack coalescence of mixed failure; (c) Mode III: without crack coalescence of mixed failure; (d) Mode IV: without crack coalescence of shear failure. Furthermore, the failure characteristics o

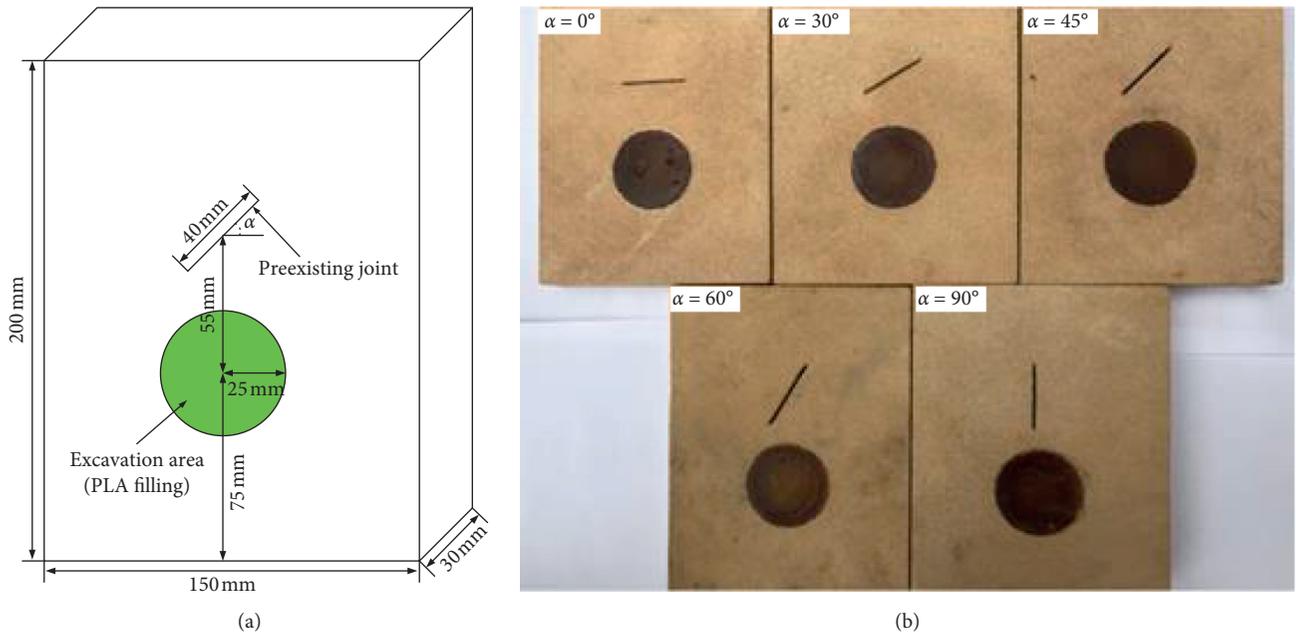
FIGURE 1: (a) Schematic diagram of the geometric parameters of preexisting joint and excavation area. (b) Experimental samples.

2.1. Sample Preparation. To avoid the dispersion of the test results, the sandstone samples are collected from the same rock block. The water-jet cutting is used in producing sandstone samples with different joint inclinations and the same geometric parameter of the hole. The geometric distribution of the sample is shown in Figure 1(a). The sample size is 200 mm (height) \times 150 mm (length) \times 30 mm (width). The joint inclination α between the preexisting joint and the horizontal direction is selected as five angles, which are 0° , 30° , 45° , 60° , and 90° , as shown in Figure 1(b). The width and length of the preexisting joint are 2.5 mm and 40 mm, respectively. The circular hole radius is 25 mm and is located 55 mm directly below the preexisting joint. The distance between the hole and the end of the sample is 75 mm. The polylactic acid (PLA) is selected as a filling material to fill the excavation area. The PLA material is granular in shape at room temperature and needs to be converted into liquid

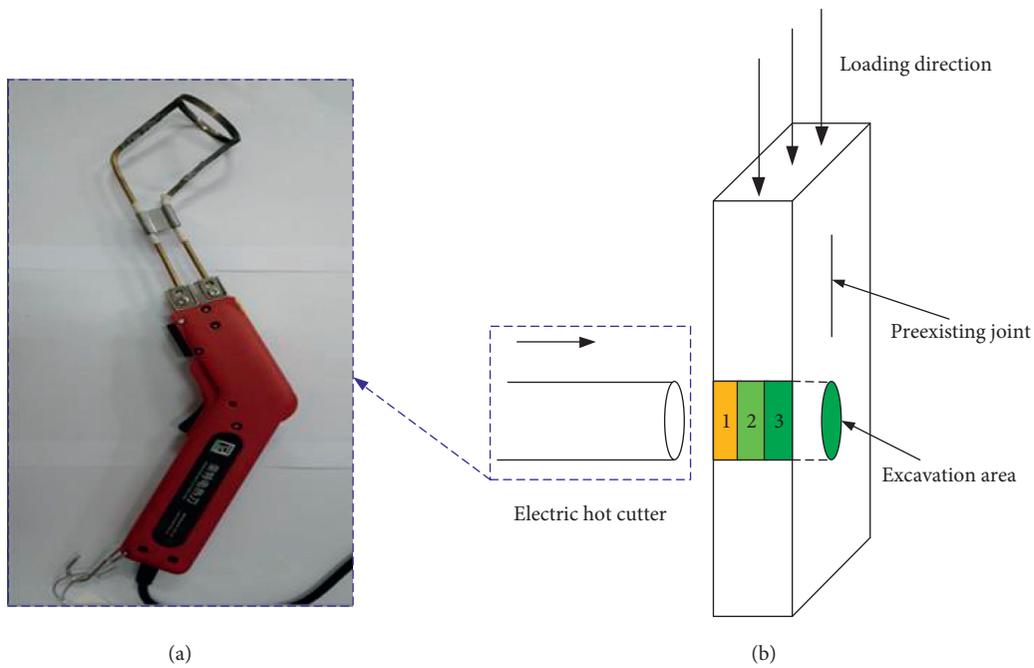
FIGURE 2: (a) Electric hot cutter. (b) Schematic diagram of the stepped excavation test.

2.2. Experimental Design. The test is performed on the electrohydraulic servo testing machine. The loading method adopted is force-controlled loading, and the loading rate is 200 N/S. It can be seen from Table 1 that the uniaxial compressive strength of sandstone is 25.96 MPa. After many pretests, it was found that when the following two stress values were used, the requirements of the stepped excavation test could be met. That is, the lower value is 17.78 MPa (80 kN), which is 68.49% of the uniaxial compressive strength; the higher value is 22.22 MPa (100 kN), which is 85.59% of the uniaxial compressive strength. After the normal load reached the set load and remained stable, the stepped excavation test is started. The excavation method is the hot melt method, and the specific operation is to use a special electric hot cutter to melt the excavation area in the test sample at equal distances, as shown in Figure 2. It is divided into three excavation steps, and each excavation is 10 mm. After each excavation operation, wait for 1 minute for the specimen to reach the equilibrium of the stress state again, and then proceed to the next excavation operation. The samples are numbered in the form of S-A-B, where A represents the inclination of the preexisting joint and B represents the set load, as shown in Table 2. For example, S-30-80 represents a sample with a preexisting joint inclination of 30° and under the condition of normal load of 80 kN.

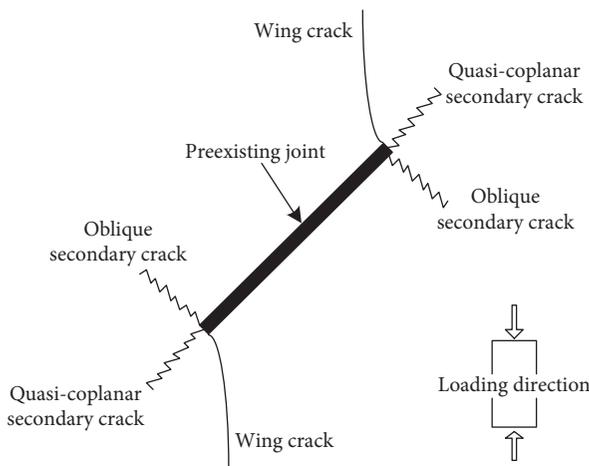
FIGURE 3: Crack types observed in the preexisting joint specimen under uniaxial loading [38, 39].

3.1. Crack Evolution Process. Previous studies [38, 39] indicated that there are two types of cracks at the tip of the joint under uniaxial loading: wing crack and secondary crack, as displayed in Figure 3. The wing crack is usually a tensile crack, which first occurs in the specimen. Its propagation direction is generally parallel to the loading direction. During the wing crack propagation process, secondary crack is gradually generated and usually is shear crack. Because of its propagation and coalescence, it is easier to cause the overall damage of the specimen.

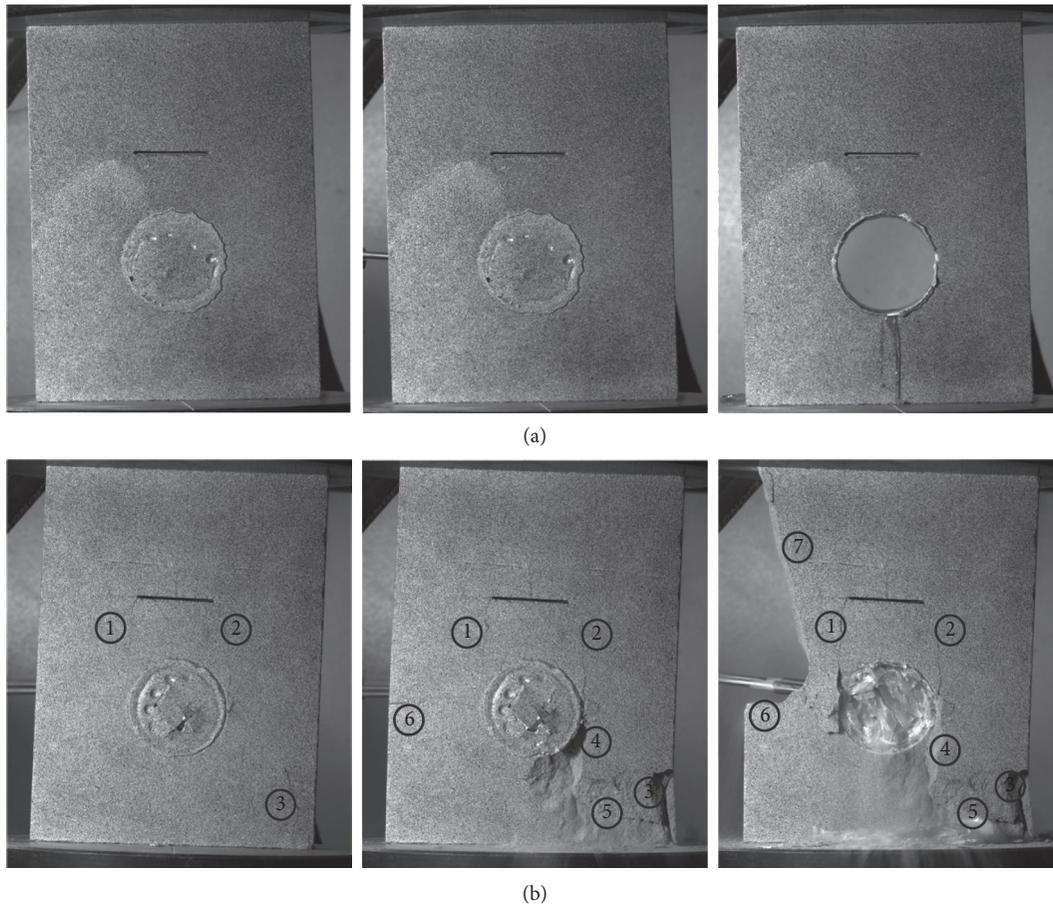
FIGURE 4: Crack evolution process of $\alpha = 0^\circ$: (a) S-0-80; (b) S-0-100.

Figure 4(a) shows the crack propagation process of S-0-80 during the stepped excavation. It can be found that S-0-80 has no visible crack propagation phenomenon in the three-

step excavation test. Until the end of the test, there is no overall damage to the specimen. When the normal load is increased to 100 kN, after the first step of excavation and

unloading is completed, two tensile cracks 1 and 2 can be seen at both ends of the preexisting joint, as shown in Figure 4(b). In the subsequent crack propagation process, it only extends to both sides of the hole. Until the second excavation is completed, the tensile cracks 1 and 2 coalesce on both sides of the hole. Subsequently, crack 4 that originated on the right side of the excavation area coalesces with crack 5. Crack 6 coalesces with the tensile crack 7 that occurs on the upper-left corner, and the specimen is finally destroyed.

corner of the sample and continue to propagate. Then, tensile cracks occur at the left and right tips of the joint, which coalesces with the hole. Finally, the sample undergoes tensile failure. Mode II mainly appears in S-0-100 and S-45-100. As shown in Figure 9(b), the cracks that cause the joint to coalesce with the excavation area are all tensile cracks. The shear cracks that appear during the test all occur in the lower-left or right corner of the specimen, and there is a visible shear friction area. Figure 6(b) shows that the failure process of S-45-100 is very rapid. From the initiation of the crack to the overall failure of the specimen, the time is extremely short. The crack coalescence is that wing cracks are generated at both ends of the preexisting joint; one extends downward to coalesce with the excavation area, and the other extends upward to penetrate the specimen. Stress concentration occurred in the area around the excavation hole, which caused a shear crack in the lower-left corner of the specimen, resulting in tensile-shear mixed failure. However, S-0-100 has a longer failure process. The crack coalescence mode is that the tensile cracks initiate at both ends of the preexisting joint, which propagate downward to coalesce with the excavation hole. The shear crack appears in the lower-right corner of the specimen, and the tensile crack appears at the left end of the specimen. Finally, the tensile and shear mixed failure of the specimen occurs, as shown in Figure 4(b). Mode III occurs in S-60-100. The preexisting

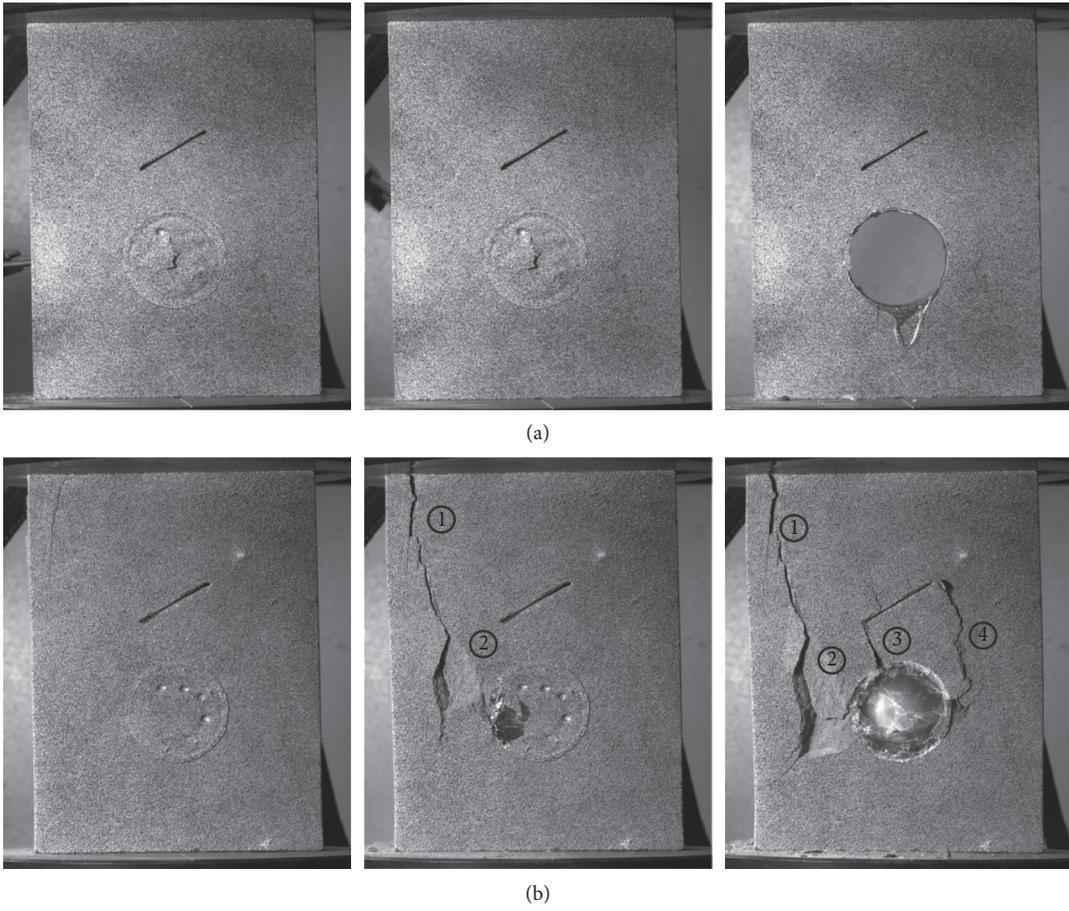
FIGURE 5: Crack evolution process of $\alpha = 30^\circ$: (a) S-30-80; (b) S-30-100.

As shown in Figure 5(a), the crack propagation process of S-30-80 is similar to that of S-0-80. During the excavation process, the specimen does not undergo overall damage. Figure 5(b) shows the crack evolution process of S-30-100. After the first step of excavation, no apparent cracks appear on the surface of the sample. After the completion of the second step of excavation, it is found that crack 1 appears on the upper-left corner, which is a tensile crack. The crack propagation direction is parallel to the loading direction and continues to expand downward. Crack 1 coalesces with crack 2 on the left side of the hole, and the surface of the sample is partially collapsed. When the third step of excavation is completed, a tensile crack 3 appears at the tip of the joint, which coalesces with the crack above the hole. At the same time, a tensile crack 4 appears at the right end of the joint and continues to expand until it coalesces to the right of

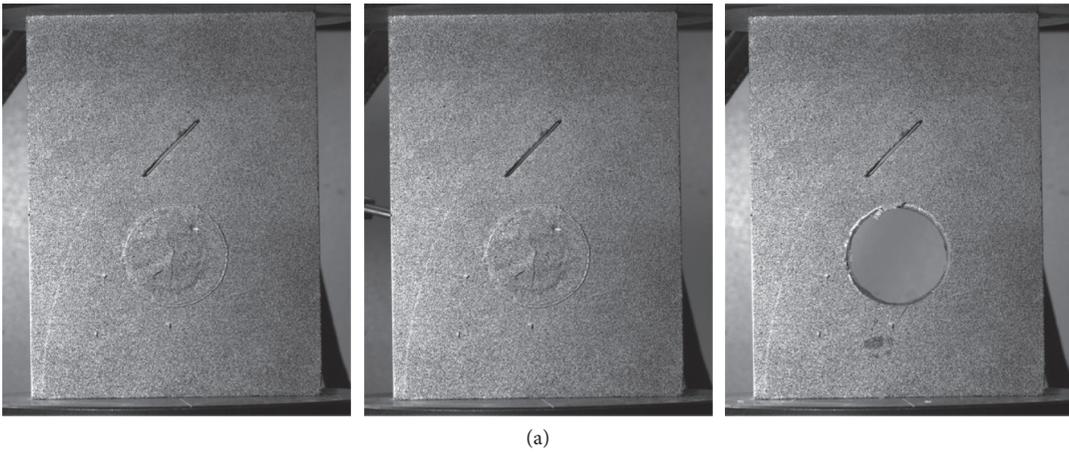
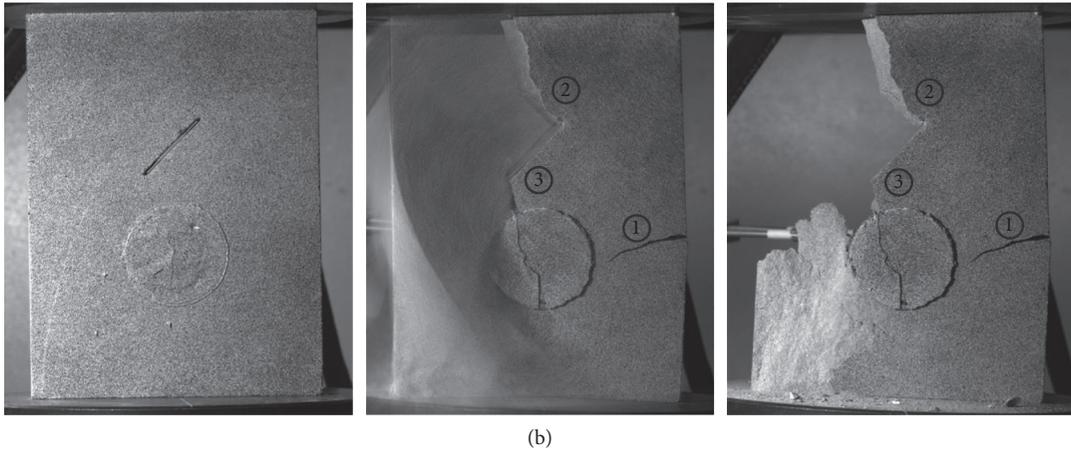
FIGURE 6: Crack evolution process of $\alpha = 45^\circ$: (a) S-45-80; (b) S-45-100.

As shown in Figure 6(a), during the three-step excavation process, there is no visible crack initiation and propagation appears in S-45-80. As shown in Figure 6(b), after the first step of excavation of S-45-100, no apparent crack initiation appears on the surface of the specimen. After the second step of excavation and unloading operation is completed, the test specimen is severely damaged, and crack 1 appears on the right end of the specimen, coalescing with the excavation hole. A wing crack 2 appears at the right tip of the joint, which expands upward to the boundary of the specimen. At the same time, a wing crack 3 appears at the left tip of the joint, which expands downward until it coalesces with the crack above the hole. In the area on the left side of the specimen, a lot of damage occurs. The cracks appear on the left side of the hole and quickly propagate to the boundary of the specimen, resulting in the overall failure of the specimen.

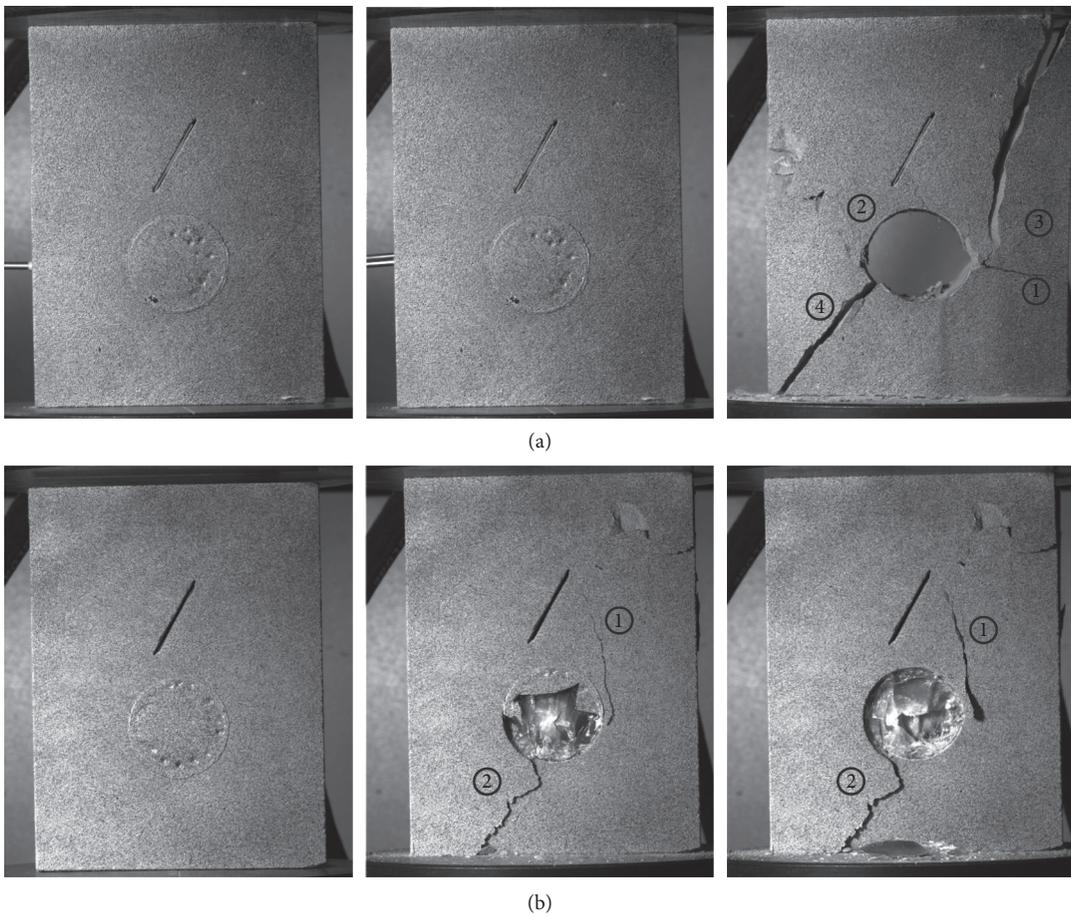
FIGURE 7: Crack evolution process of $\alpha = 60^\circ$: (a) S-60-80; (b) S-60-100.

As shown in Figure 7(a), when the joint inclination is 60°, the failure of the specimen is different from other joint inclinations. The first and the second excavations do not have a significant influence on the specimen, and no apparent crack initiation occurs on the surface of the specimen. However, after the completion of the third step of excavation, a large number of shear cracks appear on both sides of the excavated hole. Cracks 3 and 4 on both sides of the excavation hole expand rapidly, penetrating the lower-left and upper-right corners of the specimen, and form two macroscopic shear failure zones on the surface of the specimen. As shown in Figure 7(b), when the normal load is increased to 100 kN, when the second step of excavation is completed, a tensile crack 1 is formed on the right side of the hole, which expands parallel to the loading direction. Subsequently, a shear crack 2 appears in the lower-left corner of the excavated hole and propagates to the bottom of the specimen. When the third step of excavation is completed, cracks 1 and 2 continue to expand, eventually leading to damage to the specimen.

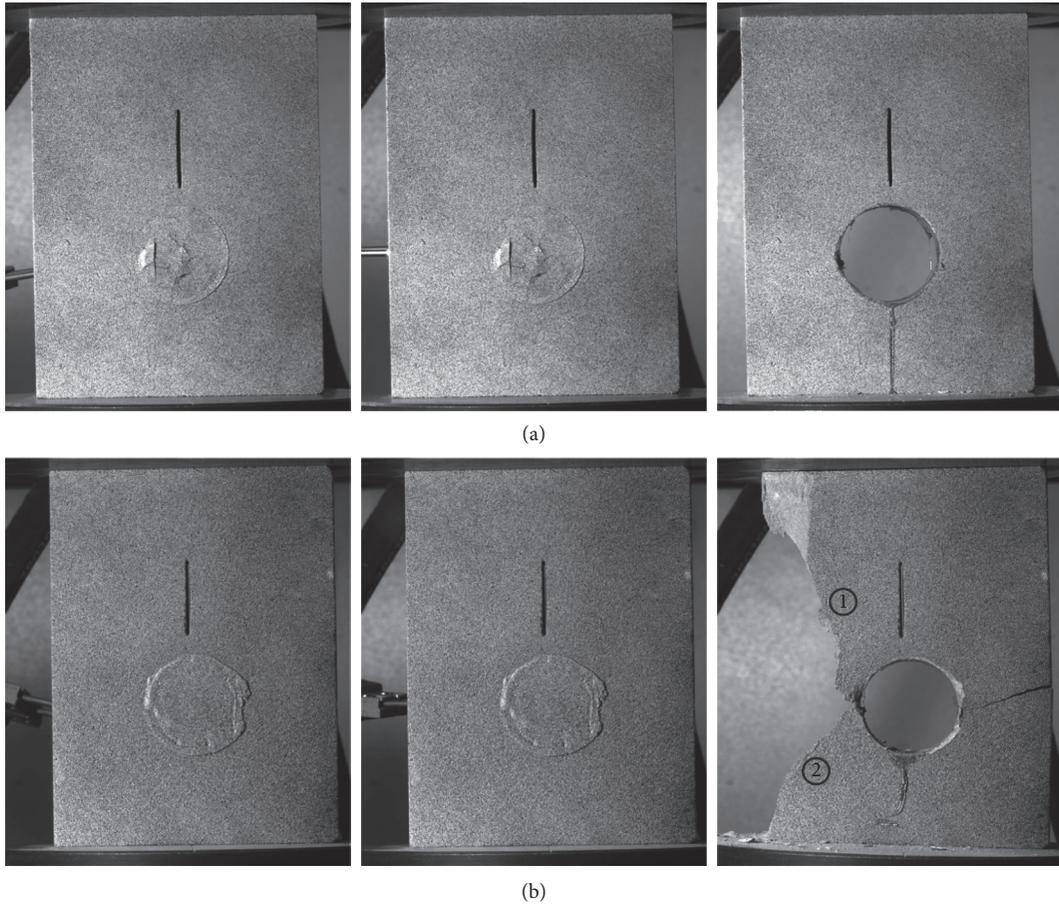
FIGURE 8: Crack evolution process of $\alpha = 90^\circ$: (a) S-90-80; (b) S-90-100.

As shown in Figure 8(a), S-90-80 does not undergo overall damage during the excavation process. As shown in Figure 8(b), after S-90-100 completes the first two steps of excavation, there is no obvious crack initiation on the surface of the test specimen. Until the third step of excavation is completed, cracks 1 and 2 appear on the left side of the excavated hole and extend to the boundary of the specimen, resulting in the overall failure of the specimen.

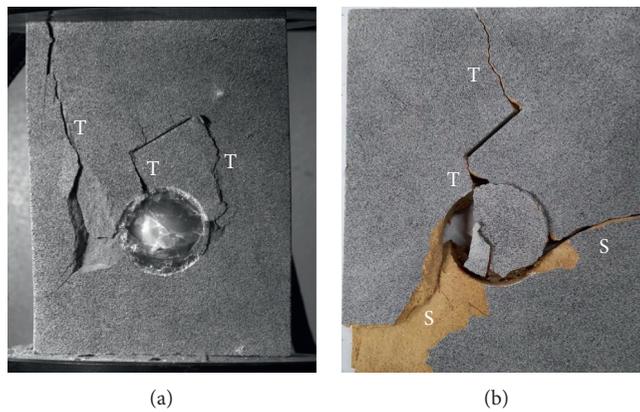
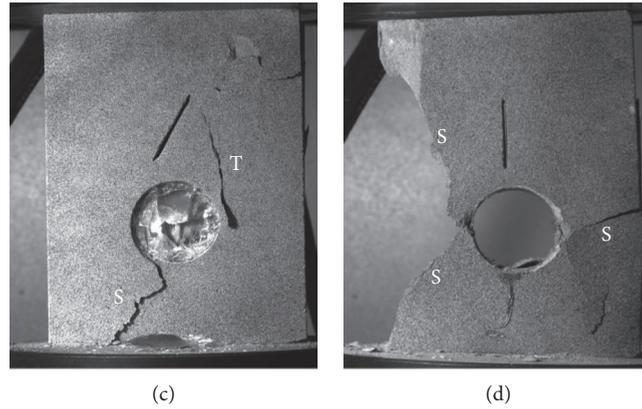
FIGURE 9: Typical failure mode observed in the present experiment (T: tensile crack; S: shear crack). (a) Mode I, (b) Mode II, (c) Mode III, and (d) Mode IV.

3.2. Failure Characteristics. According to the final failure characteristics of the specimen and whether the hole is coalesced to the preexisting joint, the failure modes of the specimen are divided into the following four categories: (a) Mode I: crack coalescence of tensile failure; (b) Mode II: crack coalescence of mixed failure; (c) Mode III: without crack coalescence of mixed failure; (d) Mode IV: without crack coalescence of shear failure, as shown in Figure 9.

Mode I occurs in S-30-100, as shown in Figure 9(a). It can be noticed that tensile cracks appear in the upper-left

joint without crack coalescence of mixed failure with the holes can be noticed, as displayed in Figure 9(c). The shear crack initiates at the lower-left corner of the excavation hole and spreads to the lower-left corner of the specimen. The stress concentration around the excavated hole causes this failure mode. A large number of cracks appear around the excavation hole and expand to the edge of the specimen, resulting in the final failure of the specimen. The cracks initiate on both sides of the hole and finally divide the specimen into two parts. Mode IV appears in S-90-100. As shown in Figure 9(d), two shear cracks are generated at the left end of the specimen, which coalesces with the upper-left corner and the lower-left corner of the specimen and subsequently causes the overall damage of the specimen.

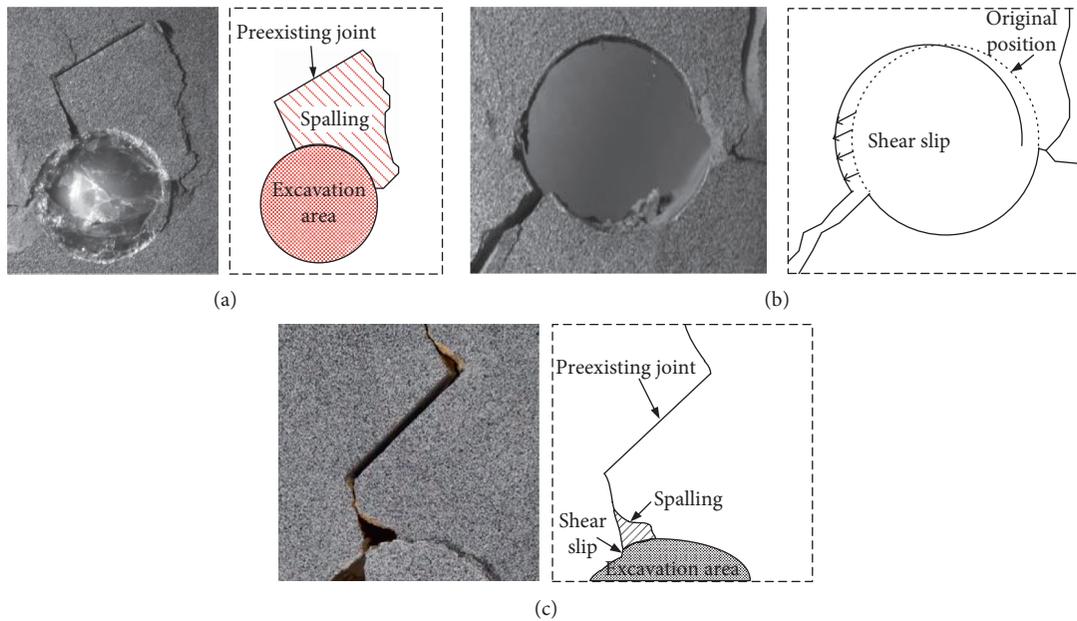
FIGURE 10: Failure modes between the hole and joint. (a) Type I, (b) Type II, and (c) Type III.

significant influence on the stress field distribution, causing stress concentration and damage around the excavation area. Through analysing the crack coalescence around the excavation hole, three main failure modes are summarised: (a) Type I: spalling failure; (b) Type II: shear slip failure; (c) Type III: shear slip and spalling mixed failure.

Type I mainly appeared in S-0-100 and S-30-100. As shown in Figure 10(a), taking S-30-110 as an example, the area above the excavation has a typical spalling failure. During the failure process, a tensile crack appears in the tip of the joint and propagates downward parallel to the loading direction. The crack coalesces with the excavation hole. This

type of failure mode generally appears in specimens with small joint inclinations, such as 0° and 30° . Type II mainly appeared in S-60-80. As shown in Figure 10(b), two shear cracks on both sides of the hole caused the shear failure surface to move up and down. A relatively apparent displacement also appears on the failure surface on the right side of the excavated hole. Compared with the original excavation hole, it can be seen that there is a shear displacement on the right side of the excavation area. This is because the specimen produces two shear cracks during the failure process. Under the action of normal stress, the failure surface of the specimen receives a component force. The upper and lower parts of the fracture surface slide relatively. The failure mode requires the specimen to produce shear cracks that coalesce with the end of the specimen and the

excavation area. It can provide large shear stress on the crack surface, which causes a large sliding dislocation of the specimen. Eventually, the excavation area undergoes the shear slip failure and damages downward. This type of failure mode mainly occurs in the specimens with large joint inclination. When the shear slip failure mode in the excavation zone appears, the overall failure of the specimen is mainly shear failure. Type III mainly appears in the failure process of S-45-100. As shown in Figure 10(c), there is a shear slip failure and part of the spalling failure in the area above the excavation hole. The overall failure mode is a mixed failure of shear slip and spalling. The failure surfaces have both shear and tensile cracks. It can be observed that the top of the excavation hole has a vertical displacement due to the shear slip in the lower-left corner.

Another crack at the left tip of the joint coalesces with the excavation hole. The shear slip phenomenon also appears in the excavation hole. This indicates that this failure mode is a mixed failure.
