Research Article

The Performance of Calcium Silicate Board Partition Fireproof Drywall Assembly with Junction Box under Fire

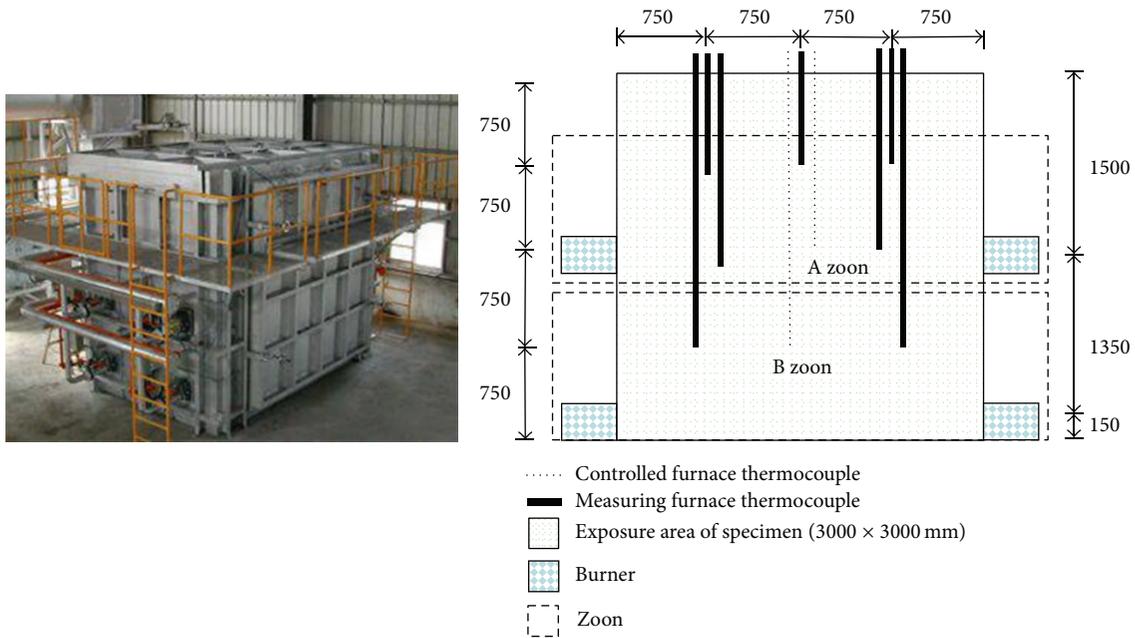
FIGURE 1: Full-size high-temperature furnace (inner size: 300 cm in width, 300 cm in height, and 240 cm in depth).

2.1. Fire Test Furnaces. This study uses two sets of test equipment that both can conduct material testing horizontally or vertically. The first furnace measures 300 cm in width, 300 cm in height, and 240 cm in depth. The second one measures 120 cm in width, 120 cm in height, and 120 cm in depth.

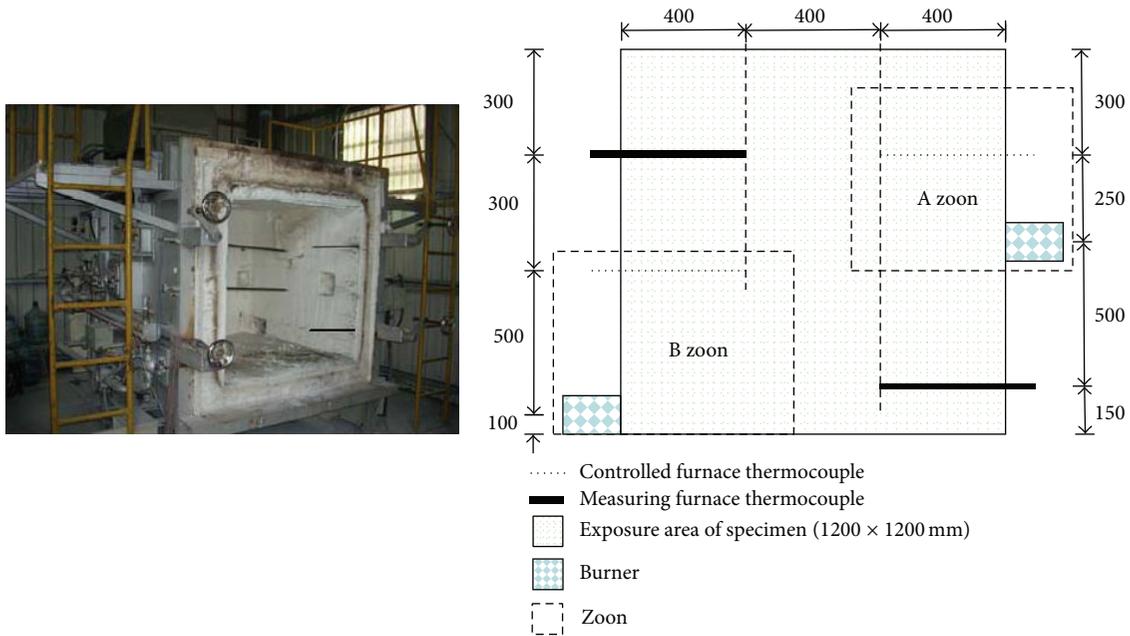
FIGURE 2: Small-size high-temperature furnace (inner size: 120 cm in width, 120 cm in height, and 120 cm in depth).

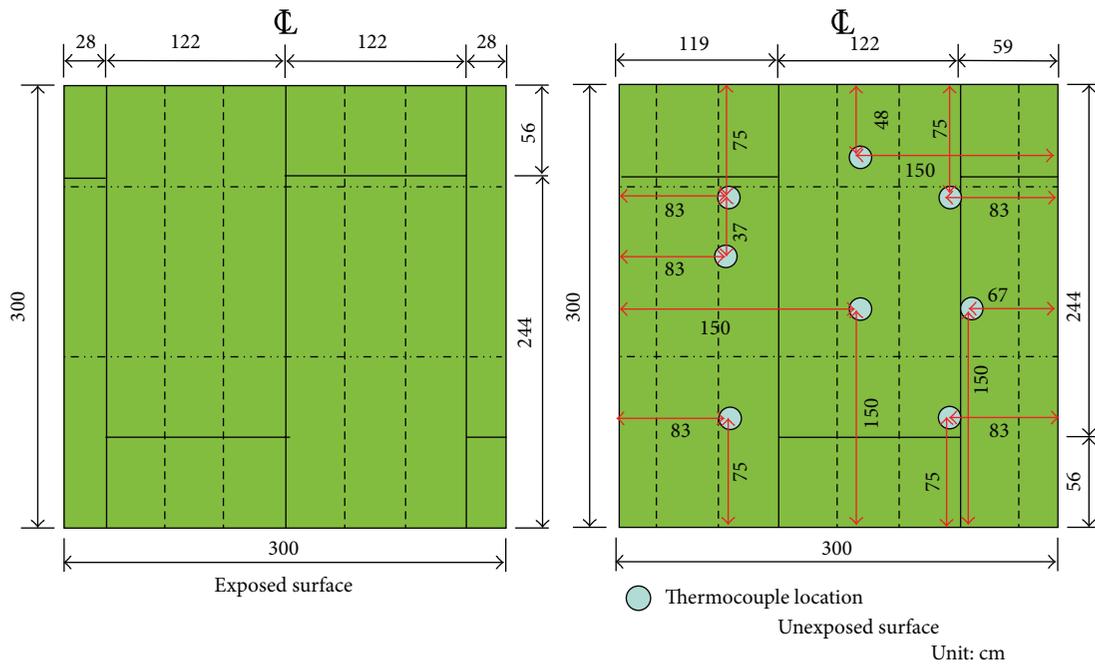
FIGURE 3: Test 1: the exposed surface and unexposed surface of specimen and geometry of the thermocouple (the arrangement of boards and measuring points of specimen).

ISO 834-1 [9] specifies that the weak spot of the test specimen should be right in the center, so that we make the joining seam in the middle as shown in Figure 3. Six standardized 60-minute heating tests were performed as shown in Table 1. Test 1 is a full-size 3 m × 3 m furnace standard test. The test specimen is the board material provided by the supplier, not purchased. The density of the fireproof cotton is 60 kg/m³. Test 2 is in the 1.2 m × 1.2 m small high-temperature furnace. The calcium silicate board is purchased, with the density of the fireproof cotton at 60 kg/m³. Test 3 is in the 1.2 m × 1.2 m small high-temperature furnace, with the socket and junction box embedded in the backside of the test specimen, and that the density of the fireproof cotton is 60 kg/m³. Test 4 is in the 1.2 m × 1.2 m small high-temperature furnace, with the socket and junction box embedded in the backside of the test specimen, and the density of the fireproof cotton is 100 kg/m³. Test 5 is in the 1.2 m × 1.2 m small high-temperature furnace, with the socket and junction box installed externally in the backside of the test specimen, and the density of the fireproof cotton is 60 kg/m³. Test 6 is in the 1.2 m × 1.2 m small high-temperature furnace, with the socket and junction box embedded in the front of the test specimen facing the fire, and the density of the fireproof cotton is 60 kg/m³. As there is no law enforcing the placement height of socket and junction box on the firewall, this study hopes to observe the most basic damage. The socket and junction box are placed 60 cm above

2.4. Test Measurements. In Test 1, 8 thermocouples are placed on the surface of the test specimen away from the fire as shown in Figure 3. All are done following the requirements of ISO 834-1 [9] to observe the temperature distribution of the surface away from the fire. Place the thermocouples on

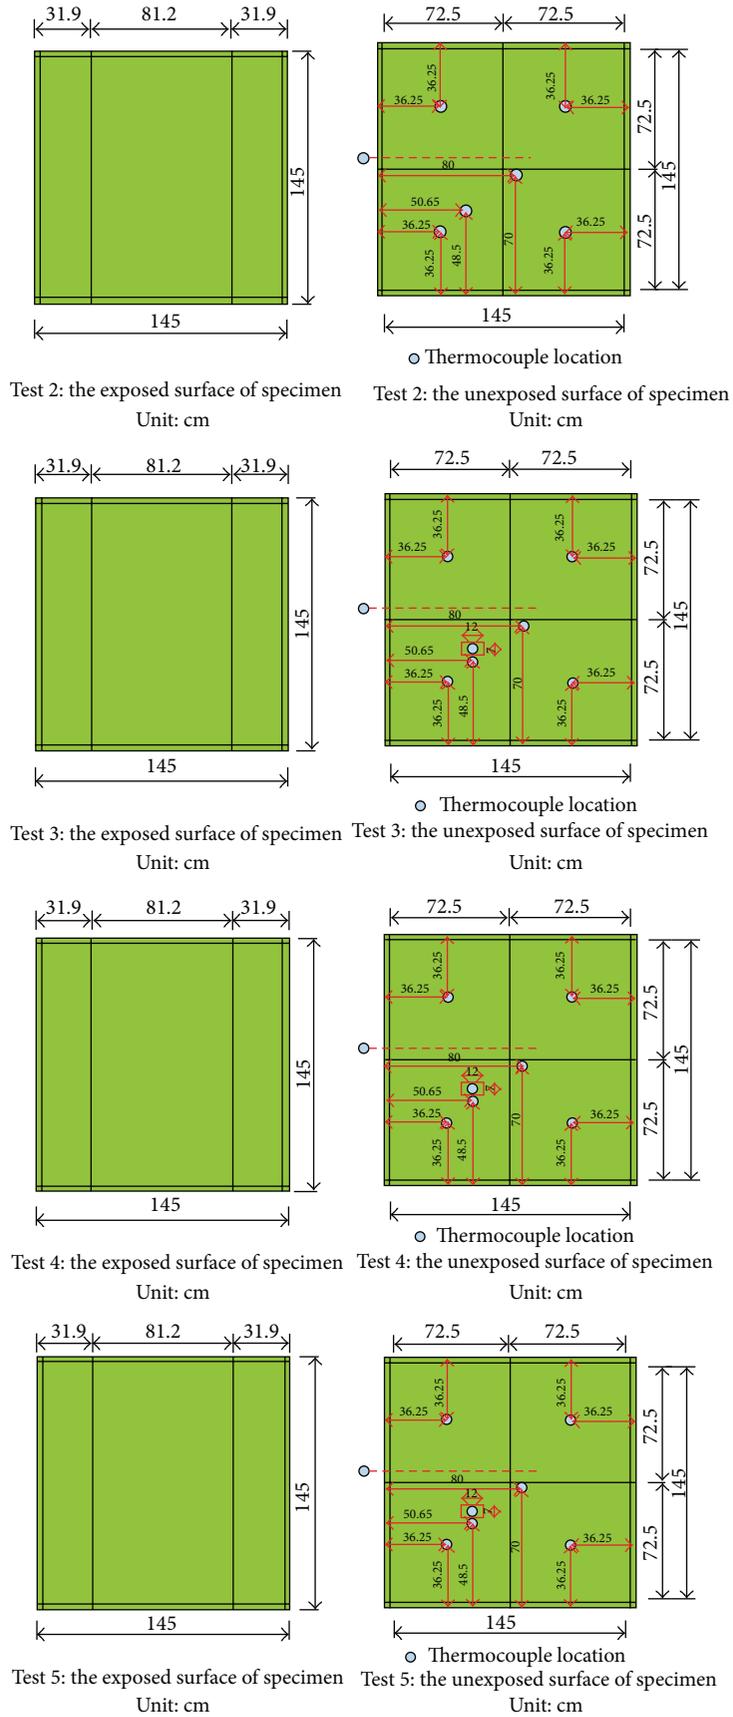
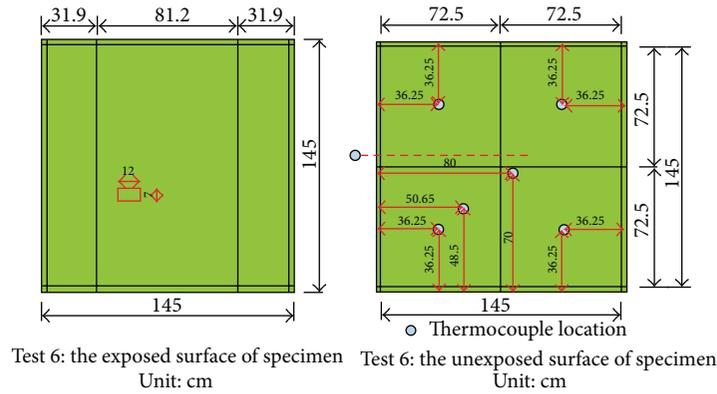
FIGURE 4: Continued.

FIGURE 4: Test 2~Test 6: exposed surface and unexposed surface of specimen and geometry of the thermocouple (the arrangement of boards and measuring points of specimens for Test 2~Test 6).

the surface of the test specimen for Tests 2 to 6 as shown in Figure 4. Four are placed near the centers of the four edges of the specimen, one is located in the center of the wall, one is near the junction box panel, one is above the junction box panel, and the other is in the center of the rock wool. The temperature measurement is recorded by the computer every 6 seconds, and photos are taken during the experiment process.

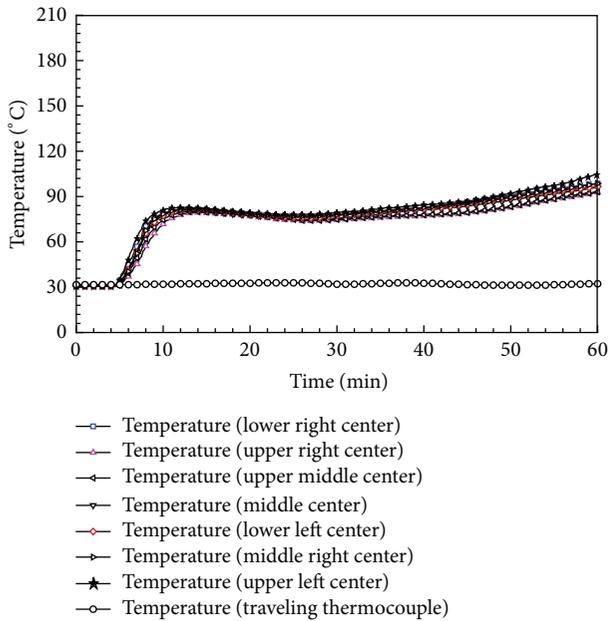
FIGURE 5: Time-temperature chart for the specimen in Test 1.

3.1. Experiment Results. The time for Test 1 lasts 60 minutes. Seven minutes after the test started, the gap between top right corners of the unexposed surface away from the right frame starts showing a bit odorous white smoke. The temperature at all the detection points also shows a significant uptrend and keeps rising till the 11th minute when it shows a downtrend till the 27th minute and then goes up again all the way till the test ends. At the 27th minute, the highest temperature is at the upper left center at 73.9°C. At this point, a horizontal crack appears on the surface not facing the fire on the left panel and the center. At the 37th minute, the horizontal crack on the left keeps extending toward the center. At the 60th minute when the test ends, the highest temperature at the upper left center is 97.6°C and the highest average temperature is at 89.5°C (see Figure 5). It never goes over the requirements for ISO 834-1 [9] and therefore meets the demand of the fire ratings of 60 minutes.

the fire resistance meets the requirements of ISO 834-1 [9] and the 60 min of fire ratings. From the 11th to the 27th minute, the temperature shows a steady decrease, indicating that there is some moisture inside the board and the rock wool to absorb the heat. The temperature at the surface on the backside then starts going up only after the material itself is totally dried. This often occurs in firewall tests when the material is more consistent. For example, the metal sandwich wall in Chuang et al. [1] shows such phenomenon. The metal surface does not get burned, and the insulation layer (rock wool) in between can consistently absorb heat for a while. Only when the heat reaches saturation will the temperature on the surface not facing the fire continue to go up. Therefore, when using material's thermal conductivity [3] and the numerical simulation of partitioning material combination [7, 8] to predict whether it meets certain fire

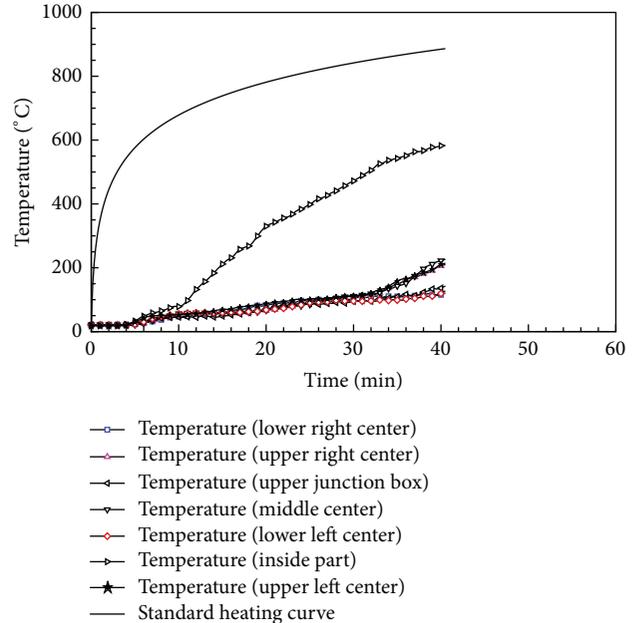
FIGURE 6: Time-temperature chart for the specimen in Test 2.

Test 2 lasts 40.5 minutes. Six minutes into the test there seems to be an explosion. The temperature inside the rock wool center also shows a clear uptrend at this time, indicating that the calcium silicate board facing the fire is damaged due to the rising temperature. At the 8th minute, the cross-shaped gap not facing the fire starts generating smoke. At the 12th minute, the temperature inside the rock wool center continues going up, indicating that the rock wool continues touching the higher temperature. At the 39th minute, the temperature in the middle heats up to 180°C (see Figure 6). According to the fire ratings requirements in ISO 834-1 [9], the fire performance is determined to be damaged if the highest temperature by the back side is more than 180°C and therefore the test specimen does not meet the fire ratings requirements of 60 minutes.

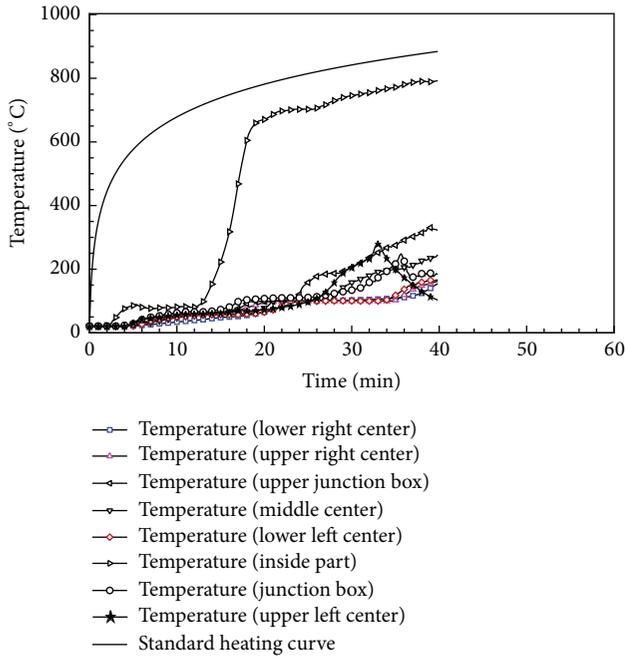
FIGURE 7: Time-temperature chart for the specimen in Test 3.

Test 3 lasts 40 minutes. Six minutes into the test there seems to be an explosion. The temperature inside the rock wool center also shows a clear uptrend, indicating that the calcium silicate board facing the fire is damaged due to the rising furnace temperature. At the 15th minute when the furnace temperature is at 750°C, the temperature at the detection point is already above 180°C and afterward it quickly approaches the furnace temperature, indicating that the rock wool center is totally on fire. The calcium silicate board facing the fire and part of the rock wool are also burned, resulting in the continuously higher temperature measured from the surface not facing the fire. At the 19th minute, the junction box panel has begun to melt and the heated gas begins to spring from the gap between the box and the board, leading to the significant increase in the temperature of the upper junction box measured by the thermocouple.

At the 31st minute, the detection point goes over 180°C (see Figure 7), failing to meet the fire ratings requirements of ISO 834-1 [9].

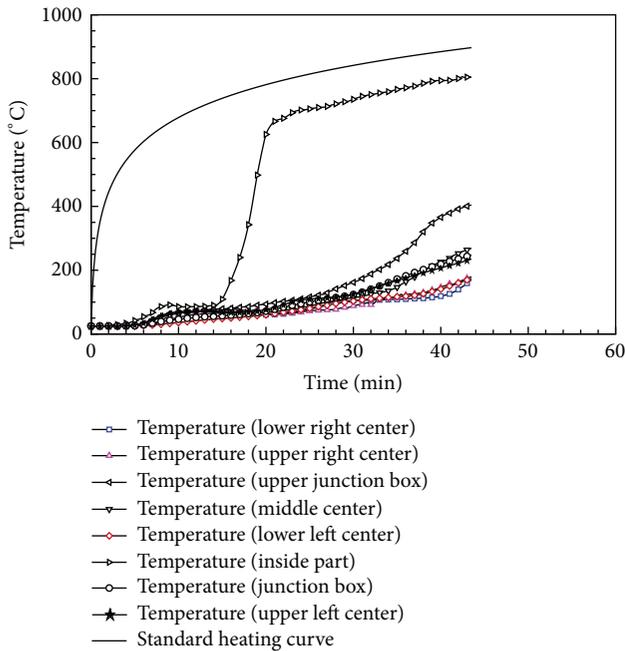
FIGURE 8: Time-temperature chart for the specimen in Test 4.

Test 4 lasts 43.8 minutes. Six minutes after the test started there seems to be an explosion. The temperature inside the fireproof cotton center also shows a clear uptrend, indicating that the calcium silicate board facing the fire may have been damaged due to the rising furnace temperature. At the 17th minute, the temperature inside the rock wool center is already more than 180°C and at 20th minute it quickly approaches the furnace temperature, indicating that the rock wool center is totally on fire. The calcium silicate board facing the fire and part of the rock wool are also burned. At the 25th minute, the junction box panel has begun to melt. At the 34th minute, the temperature at the upper junction box goes over 180°C (see Figure 8), failing to meet the fire ratings requirements of ISO 834-1 [9].

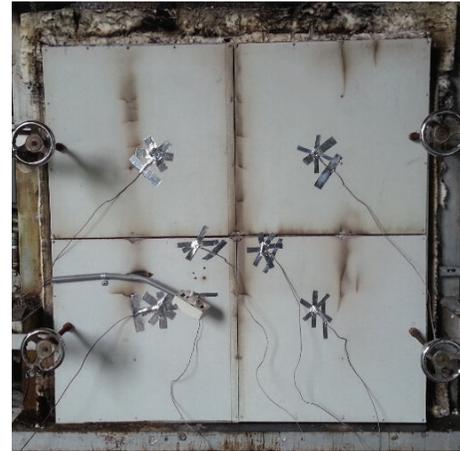
FIGURE 9: The result of the unexposed surface of the sample in Test 5.

Test 5 lasts 39 minutes. Six minutes into the test there seems to be an explosion. The temperature inside the rock wool center also shows a clear uptrend after the 7th minute, indicating that the calcium silicate board facing the fire is damaged due to the rising temperature. After the 7th minute, the cross-shaped gap not facing the fire starts generating smoke. At the 25th minute, the junction box has begun to melt due to heat. At the 29th minute, the part connected to the screw is totally melted and then falls off. At this point, the temperature at the junction box is 53.9°C because the box has already fallen off and away from the furnace (see Figure 9). The temperature gradually goes up to 62.6°C and then gradually goes down. Although this seems to stay within the requirements of ISO 834-1 [9], the screws protrude and are exposed in the surface not facing the fire after the junction box is melted, so that the thermocouples are not too far away from the screws as they should. The temperature of the screws taken at the 31st minute is 236.9°C. At this point, all the detection points on the surface not facing the fire have not exceeded 180°C, but the exposed screws have indeed exceeded 180°C (see Figure 10) after the external junction box melts. At the 37th minute, the temperature in the middle center is more than 180°C, failing to meet the 60 minutes of fire ratings requirements of ISO 834-1 [9].

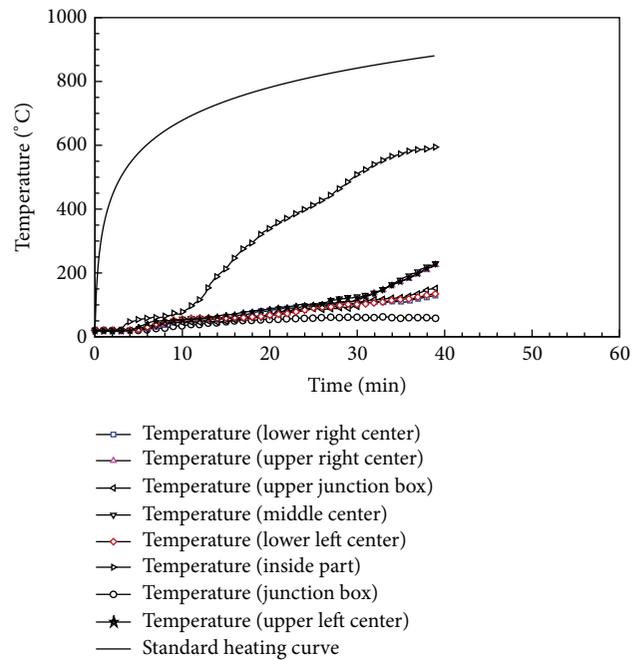
FIGURE 10: Time-temperature chart for the specimen in Test 5.

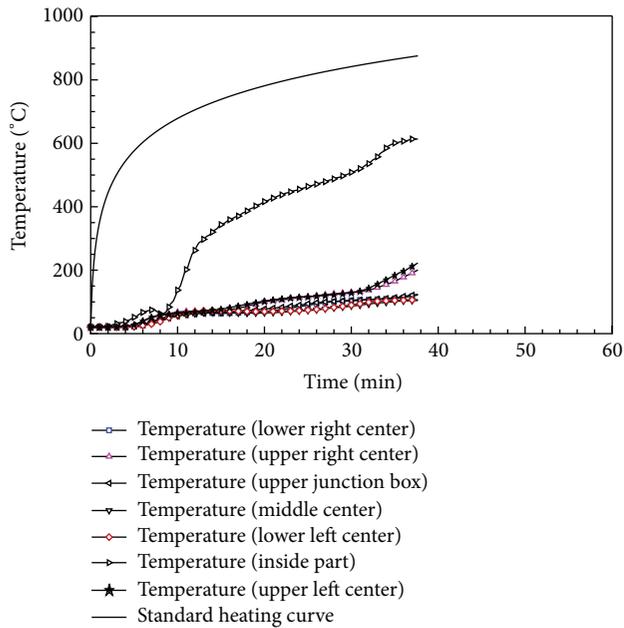
FIGURE 11: Time-temperature chart for the specimen in Test 6.

Test 6 lasts 37.6 minutes. Six minutes into the test there seems to be an explosion. The temperature inside the rock wool center also shows a clear uptrend, indicating that the calcium silicate board facing the fire is damaged due to the rising temperature. At the 9th minute, the cross-shaped gap not facing the fire starts generating smoke. At the 12th minute, the temperature inside the rock wool center continues going up, indicating that the rock wool continues touching higher temperature. At the 36.8th minute, the temperature in the middle heats up to 180°C (see Figure 11), failing to meet the 60 minutes of fire ratings requirements of ISO 834-1 [9].

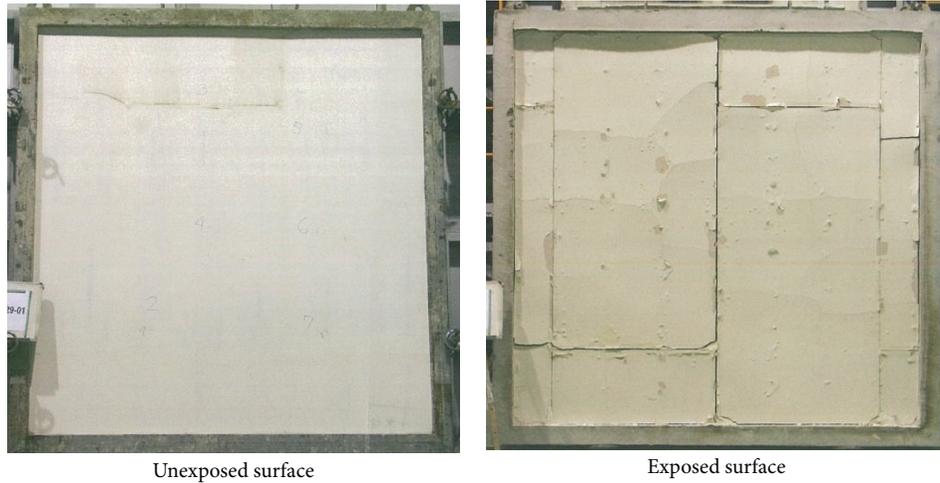
FIGURE 12: The result of the specimen after 60 min standard fire test in Test 1.

3.2. Comprehensive Discussion. The board used in Test 1 is provided by the supplier. These board materials are known as the laboratory grade. Although there are some cracks on the surface facing the fire during the experiment, the surface does not explode, and the integrity is good by visual inspection (see Figure 12). After testing it for 60 minutes,

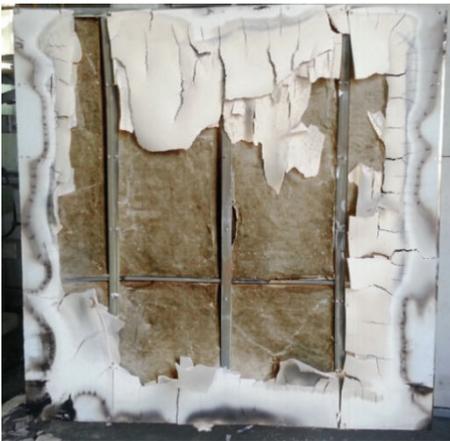
FIGURE 13: The result of the exposed surface of the specimen in Test 5.

contraction in some parts (see Figure 13), and the fire can go through the unfilled part to reach the calcium silicate board not facing the fire, resulting in the test specimen not meeting the 60 minutes of fire ratings. The calcium silicate boards from Tests 2 to 6 all explode at the 6th minute. First, it means that these materials are of the same production process and formula. Second, it means that the temperature of the furnace rises at a normal rate, making the surface facing the fire in

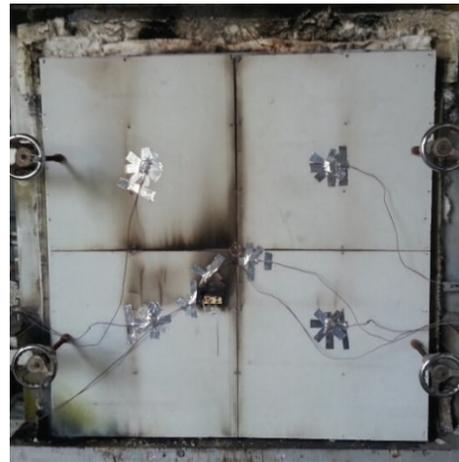
FIGURE 15: The result of the unexposed surface of the specimen after 43.8 min standard fire test in Test 4.

on the fire performance of the wall body. Fire performance is determined together by the calcium silicate boards on the two sides and the fireproof cotton in between. When the calcium silicate board on the side not facing the fire is damaged, a weak spot is produced. Hot air can come out from this spot. The metal junction box (fastened to the frame through screws and metal bars) is installed in after cutting a hole on the board not facing the fire, and there should be some gaps in between the metal box and the calcium silicate board. The frame can also deform after being heated, making the gap even bigger, and the surrounding edges and the place above can be affected by the heat. Although panels and sockets may be installed outside of the junction box, they are not noncombustible materials and therefore will still be melted by the hot air or burned (see Figures 14 and 15).

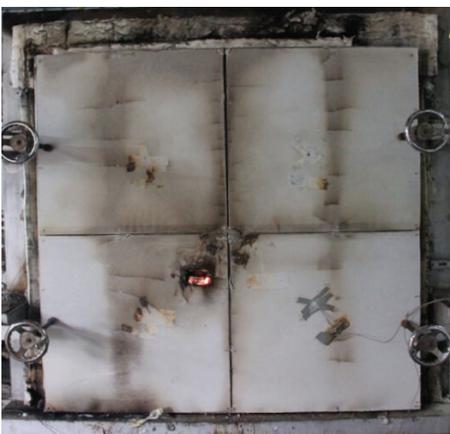
FIGURE 14: The result of the unexposed surface of the specimen after 40 min standard fire test in Test 3.

The junction box panel in Test 3 starts to smoke at the 8th minute, and it starts to melt at the 19th minute and totally melts to make the panel fall to the ground at the 27th minute, and at the 31st minute the surface temperature not facing the fire exceeds the limitation in ISO 834-1 [9]. The fire ratings of Test 2 manage to be maintained at 39 minutes, but Test 3 only has 31 minutes. The two have a difference about 8 minutes; so it shows that installing socket and junction box on the surface facing away from the fire can raise the regional temperature of the socket and junction box and the space above them. Test 4 attempts to increase the rock wool density (from 60 kg/m^3 to 100 kg/m^3) to improve the fire ratings while keeping other conditions constant. The junction box panel starts to smoke at the 10th minute, starts to melt at the 25th minute, and totally melts at the 32nd minute. Eventually at the 34th minute, the surface away from the fire exceeds the maximum temperature allowed in ISO 834-1 [9]. The areas with higher temperature in Tests 3 and 4 are all nearby the socket and junction box and the space above them, so it is somewhat risky when the calcium silicate board away from the fire is damaged. This also explains that adding the rock wool density may not greatly improve the fire ratings. This study attempts to add in even more rock wool density; however, in this type of drywall system, rock wool with even higher density cannot be added in anymore. As 5 cm in thickness and 100 kg/m^3 in density are considered to be the limits, there are no tests with even higher density of rock wool. Test 5 is to understand the impact of external box on the firewall. As the calcium silicate board away from the fire is penetrated by two screws, the overall temperature distribution is more even. However, the commercially available board materials have poor quality so they do not meet the 60 minutes of fire ratings requirements. At the 37th minute of the test, the side away from the fire has already exceeded the maximum temperature allowed in ISO 834-1 [9]. Overall, the fire performance is better than in Tests 3 and 4 but about the same with Test 2. Test 6 is for the box embedded on the side facing the fire of the calcium silicate board. As the commercially available boards have poor quality, the whole side explodes at the 6th minute; therefore, the impact of embedding the junction box into the fire side is not so obvious. The temperature distribution of the side not facing fire is similar to Tests 5 and 2, without sudden changes in extremely high temperature. As the board
