# Fractographic Analysis of Brinar 400 and Brinar 500 Steels in Impact Testing

Properties of low-alloy boron-containing steels Brinar 400 and Brinar 500 in as-delivered and normalized conditions are considered. Charpy tests carried out within temperature ranges of ductile-to-brittle transition were followed by fractographic analysis. The tests were carried out on specimens with their axes parallel and perpendicular to hot-working direction, at  $-40^{\circ}\text{C}$ ,  $-20^{\circ}\text{C}$ ,  $0^{\circ}\text{C}$ , and  $+20^{\circ}\text{C}$ . The determined impact properties of Brinar steels were complemented with fractographic analysis performed with use of a scanning electron microscope. It was found that temperatures of ductile-brittle transition were significantly different for the materials in as-delivered and normalized conditions. In addition the tensile tests were carried out, determining basic strength properties of the analyzed materials.

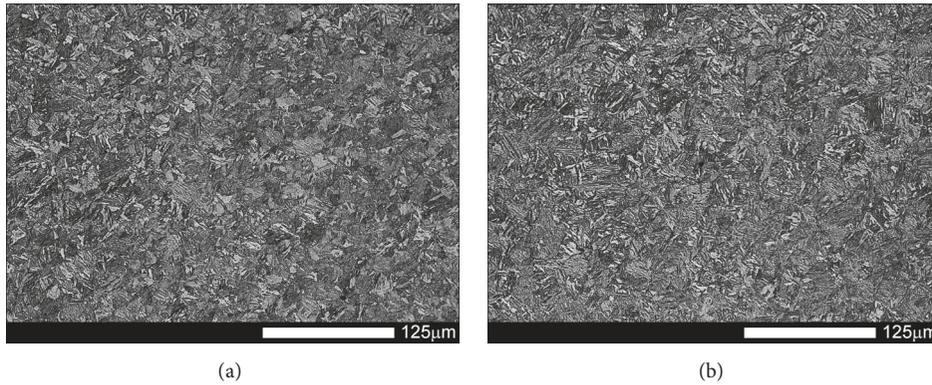
FIGURE 1: Microstructures of the examined steels in as-delivered condition: (a) Brinar 400 and (b) Brinar 500. Etched with 3-%  $\text{HNO}_3$ ; light microscopy.

**3.1. Microstructural Analysis.** Figures 1 and 2 show microstructures of the examined steels in as-delivered condition. In this condition, the steels have structures of low-carbon, homogeneous martensite with its morphology similar to that of tempered martensite. Moreover, a three-level structure typical for martensite occurring in low-carbon steels can be observed, composed of laths, blocks, and packages. Martensite laths creating a block show identical crystallographic orientation and thus represent the same variant of the created martensite structure.

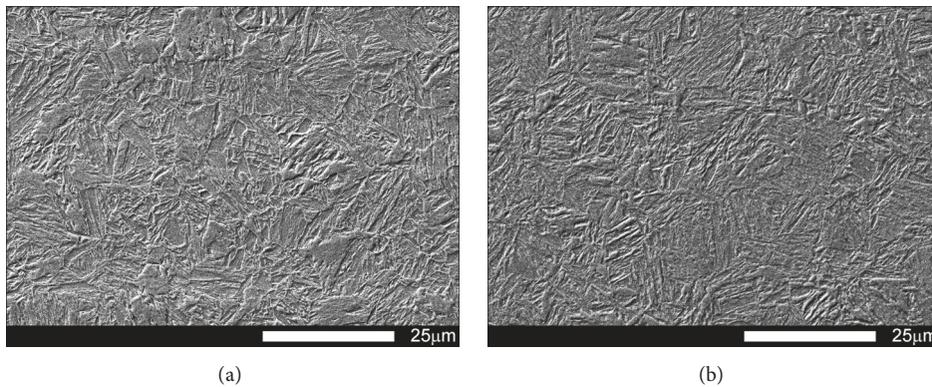
FIGURE 2: Magnified view of microstructures shown in Figure 1: (a) Brinar 400 and (b) Brinar 500. Etched with 3-%  $\text{HNO}_3$ ; SEM.

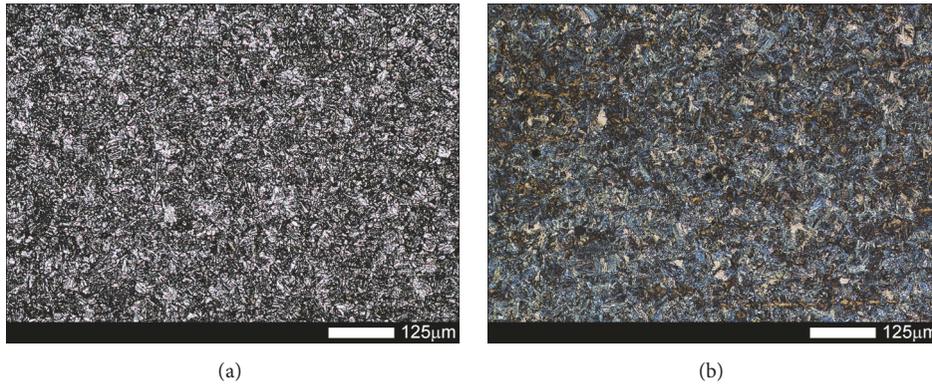
FIGURE 3: Microstructures of the examined steels in normalized condition: (a) Brinar 400 and (b) Brinar 500. Etched with 3-%  $\text{HNO}_3$ ; light microscopy.

In the examined steels, normalization caused variable structural changes. Microstructure of Brinar 400 (Figure 3(a)) was composed mostly of granular and, locally, acicular ferrite. Moreover, sparse precipitates of carbide phases (mostly cementite) were observed; see Figure 4(a). Such a microstructure made it possible to reach hardness of 209 HBW. In the case of Brinar 500, normalization caused extensive structural changes (Figure 3(b)). Its microstructure was composed mostly of acicular martensite (with precipitates of carbide phases) and martensite. Moreover, small amounts of granular ferrite and upper bainite were observed; see Figure 4(b). Irrespective of diversification of Brinar 500 microstructure, normalization led to precipitation of large numbers of carbide phases in the whole material

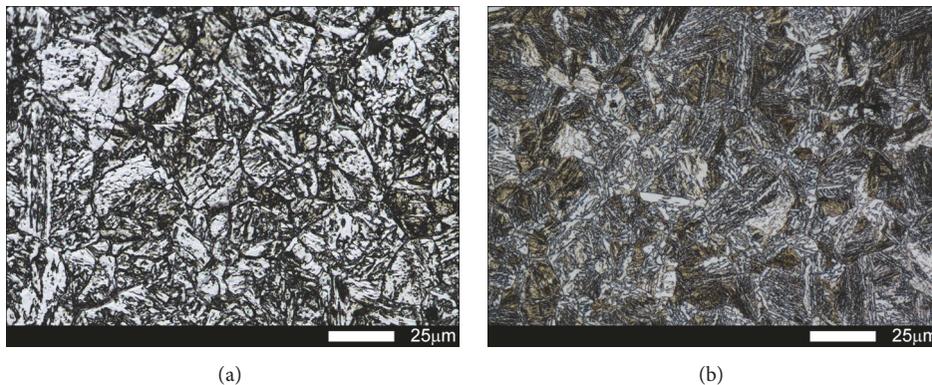
FIGURE 4: Magnified view of microstructures shown in Figure 3: (a) Brinar 400 and (b) Brinar 500. Etched with 3-%  $\text{HNO}_3$ ; light microscopy.

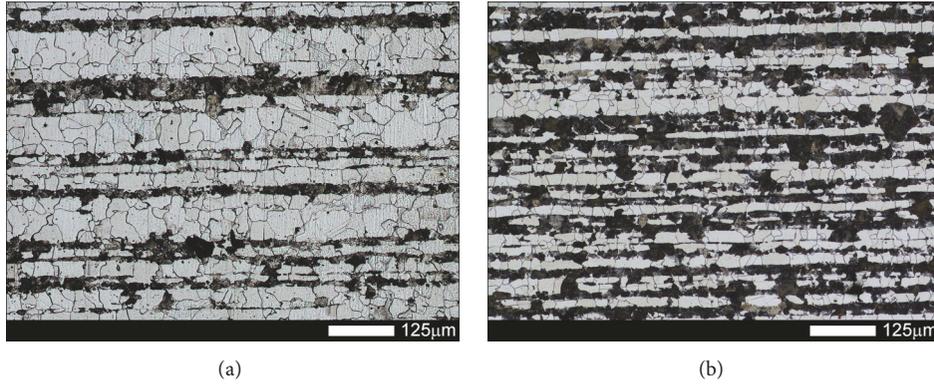
FIGURE 5: Microstructures of the examined steels in fully annealed condition: (a) Brinar 400 and (b) Brinar 500. Etched with 3-% HNO<sub>3</sub>; light microscopy.

Because of high hardenability of both Brinar grades, normalizing of these steels leads to nonequilibrium structures, which significantly hinders identification of their initial condition before any heat-treatment operations. In order to recognise their structural properties, full annealing of both Brinar steels was carried out. Structure of Brinar 400 (Figure 5(a)) after full annealing followed by cooling at  $0.1^\circ\text{C/s}$  is composed of banded arrangement of equilibrium ferrite grains with fine-lamellar pearlite. On ferrite grain boundaries, precipitates of tertiary cementite can be clearly observed; see Figure 6(a). Microstructure of Brinar 500 after the same heat treatment (Figure 5(b)) is composed of strongly banded areas of ferrite with fine-lamellar pearlite and sparse colonies of degraded pearlite; see Figure 6(b). Volume percentages of these phases are adequate to carbon concentration in this steel. No precipitates of cementite are observed on ferrite grain boundaries, which suggests that it is completely bounded in the pearlitic mixture.

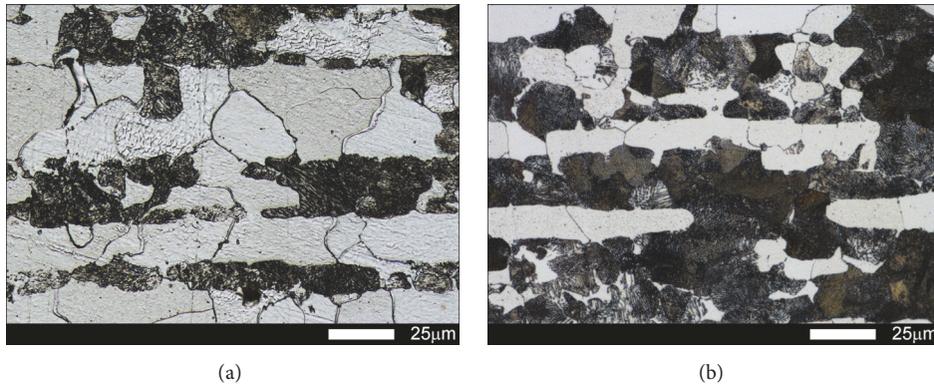
FIGURE 6: Magnified view of microstructures shown in Figure 5: (a) Brinar 400 and (b) Brinar 500. Etched with 3-% HNO<sub>3</sub>; light microscopy.

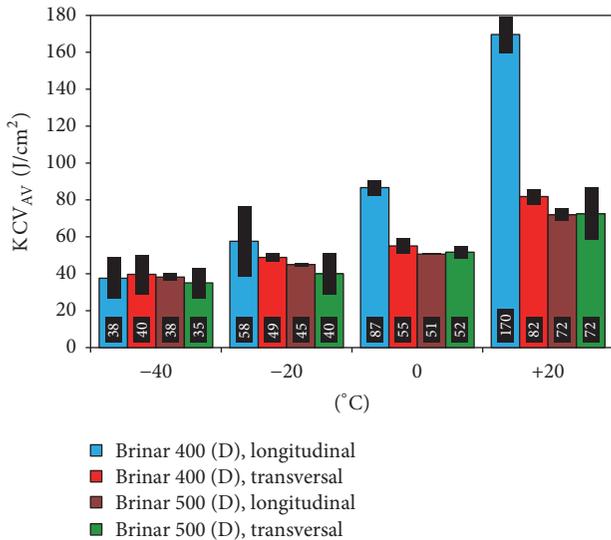
FIGURE 7: Impact strength of steels Brinar 400 and Brinar 500 in as-delivered condition.

**3.2. Results of Impact Testing and Discussion.** Results of impact testing of Brinar 400 and Brinar 500 in as-delivered and normalized conditions are shown in Figures 7 and 8. When  $35 \text{ J/cm}^2$  is accepted as the brittleness criterion corresponding to 50-% occurrence of plastic and brittle fractures, it can be said that both analyzed steels meet this criterion in the entire range of testing temperatures; see Figure 7. At all test temperatures (except  $-40^\circ\text{C}$ ), steel Brinar 400 in longitudinal direction showed the highest impact strength. Moreover, important differences between impact strength values in longitudinal and transverse directions were found for this steel. At  $+20^\circ\text{C}$ , impact strength in longitudinal direction was over 107% higher than that in transverse direction. Smaller differences could be found at 0 and  $-20^\circ\text{C}$ , when impact strength in longitudinal direction was, respectively, over 57%

and 17% higher. At  $-40^\circ\text{C}$ , impact strength values for all the specimens were similar, while the lowest value equal to the brittleness criterion was found for Brinar 500 in transverse direction.

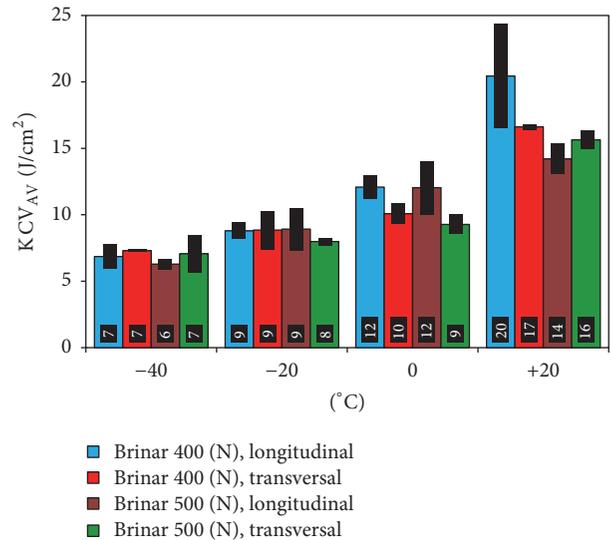
FIGURE 8: Impact strength of steels Brinar 400 and Brinar 500 in normalized condition.

In normalized condition, impact strength of both Brinar 400 and Brinar 500 at each test temperature was lower than  $35\text{ J/cm}^2$ . Therefore, it could be acknowledged that, in both analyzed steels, mechanical properties were degraded as a result of normalization in comparison to the as-delivered condition. So, it should be considered that high-temperature thermal effects—for example, during welding operations—could lead to brittleness of Brinar 400 and Brinar 500, even at temperatures above  $0^\circ\text{C}$ .

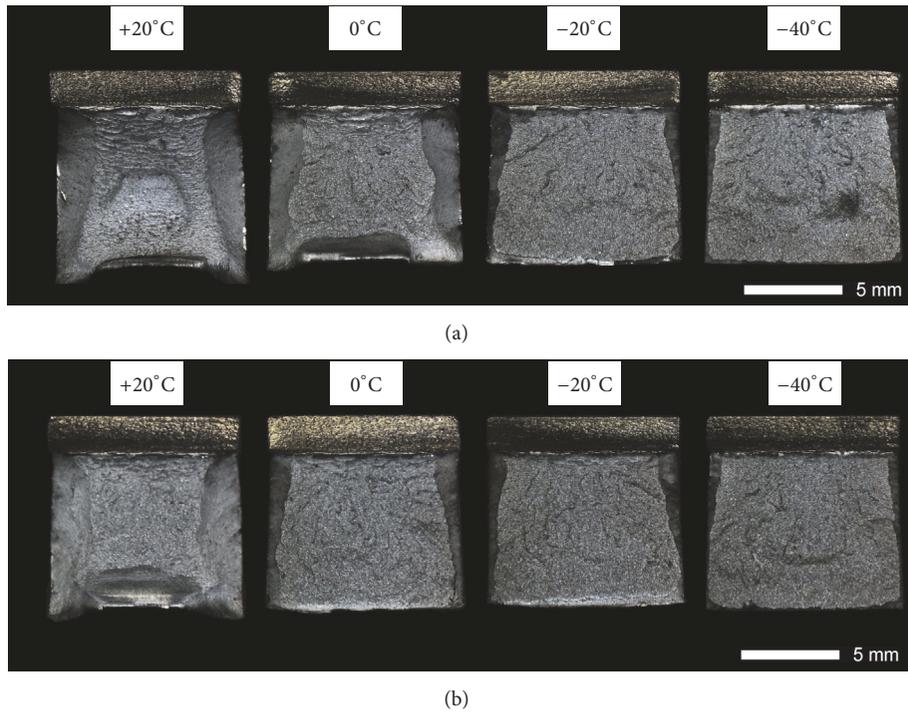
FIGURE 9: Fracture surfaces of Brinar 400 specimens in as-delivered condition: (a) longitudinal and (b) transverse. Unetched; stereoscopic microscopy.

In specimens of as-delivered Brinar 400 (Figure 9) after impact test at  $+20^\circ\text{C}$ , percentages of plastic zones on fracture surfaces are significant for both directions: 56% for longitudinal direction and 40% for transverse direction. This

made it possible to maintain high impact strength, especially in longitudinal direction. Moreover, large areas of plastic deformations are macroscopically visible on fracture surfaces showing developed topography. Portions of side plastic zones are also significant. After testing at  $0^\circ\text{C}$ , percentages of these zones for longitudinal and transverse directions are, respectively, 44% and 18%. After testing at  $-20^\circ\text{C}$  and  $-40^\circ\text{C}$ , these percentages for both directions range between 13% and 18%. Nevertheless, even at these negative temperatures, steel Brinar 400 in as-delivered condition maintains high impact strength. This suggests that impact strength level at lower testing temperatures must be affected by nature of cracking in central zone of the fracture surface. Therefore, this zone is the subject of detailed fractographic analysis with use of electron microscopy.

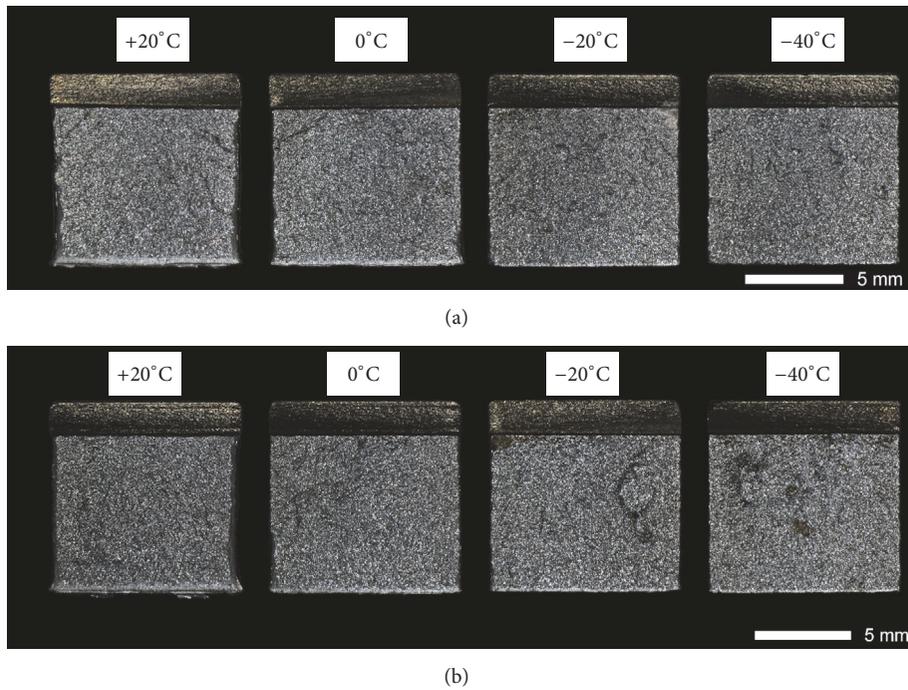
FIGURE 10: Fracture surfaces of Brinar 400 specimens in normalized condition: (a) longitudinal and (b) transverse. Unetched; stereoscopic microscopy.

After normalizing, almost 100-% cleavage zones are observed on all fracture surfaces of Brinar 400 specimens (Figure 10), although, after testing at  $+20^\circ\text{C}$  (especially on surfaces of longitudinal specimens), narrow plastic zones making ca. 10% of the surface can be observed. In comparison to the as-delivered condition, central surface areas of the specimens are more rough and since cracking proceeds through cleavage planes cutting grains, they reflect actual grain size of the broken material. Moreover, no plastic deformation was found by macroscopic observations. Therefore, low impact strength of normalized Brinar 400 is related

to missing plastic zones on fractured surfaces and also to structure of the cleavage zone, whose details were revealed by SEM testing.

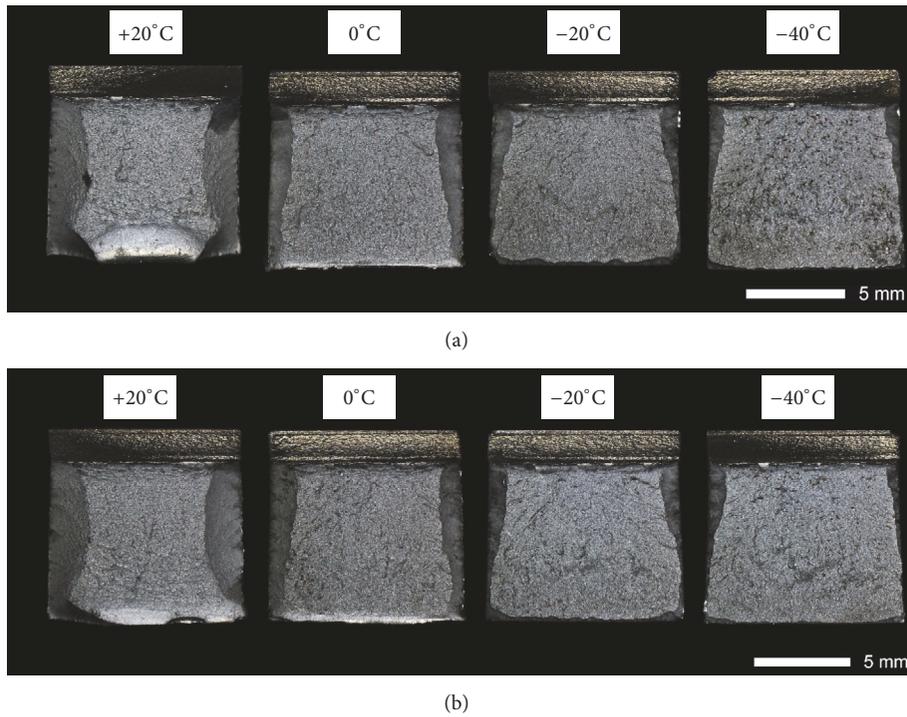
FIGURE 11: Fracture surfaces of Brinar 500 specimens in as-delivered condition: (a) longitudinal and (b) transverse. Unetched; stereoscopic microscopy.

In as-delivered condition, plastic zones on fracture surfaces of Brinar 500 (Figure 11) after impact testing at ambient temperature make 48% for longitudinal and 35% for transverse direction. Moreover, macroscopic plastic deformation of the fracture is observed. After testing at  $0^\circ\text{C}$ , side plastic zones become narrower and make 23% and 21% of fracture surface area, respectively. After impact tests carried out at negative temperatures, plastic zones become even narrower and central cleavage zone constitutes ca. 90% of fracture surface area. Nevertheless, both Brinar 500 and Brinar 400, even at the lowest temperature, show satisfactory impact strength for which, to a large extent, structure of the central zone is responsible.

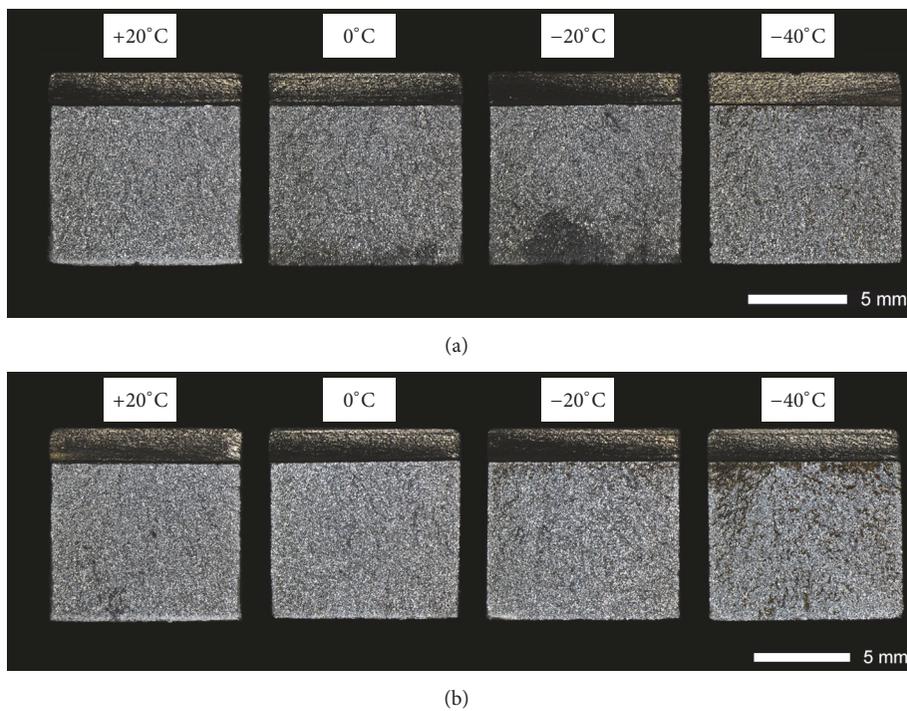
FIGURE 12: Fracture surfaces of Brinar 400 specimens in normalized condition: (a) longitudinal and (b) transverse. Unetched; stereoscopic microscopy.

Fracture surfaces of normalized Brinar 500 (Figure 12) are similar to those of normalized Brinar 400 and, in each case, show absence of macroscopic plastic deformation, as well as absence of plastic zones on sides and under the mechanical notch. Such arrangement is correlated with reduced impact strength in the entire range of testing temperatures.

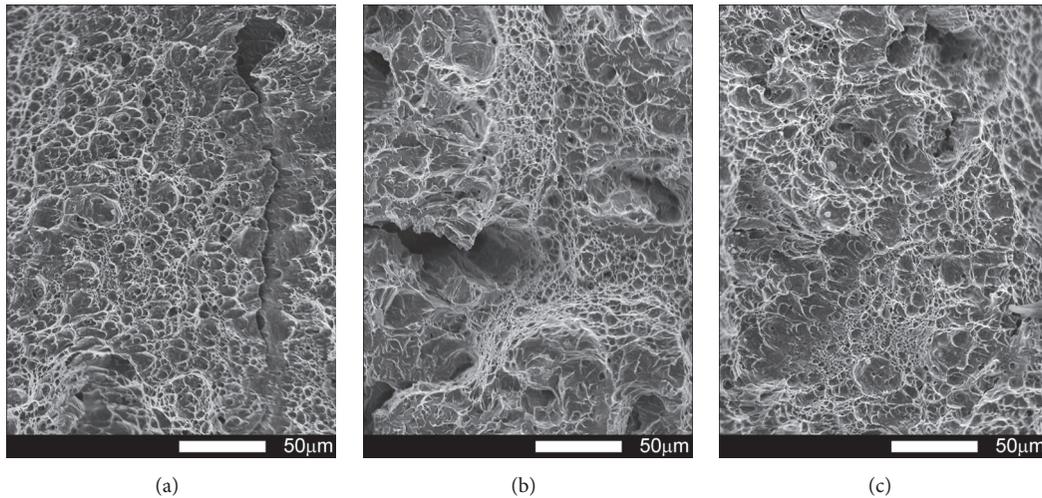
FIGURE 13: Fracture surfaces of longitudinal Brinar 400 specimens in as-delivered condition after testing at +20°C: (a) under-notch zone; (b) central zone; (c) final-fracture zone. Unetched; SEM.

**3.3.1. Brinar 400: as Delivered.** Fracture surfaces of Brinar 400 specimens in as-delivered condition, cut out in parallel to plastic working direction, are shown in Figures 13 and 14. Macroscopic analysis of fractures after impact tests at  $+20^\circ\text{C}$  and  $0^\circ\text{C}$  showed relatively big parts of plastic zones under mechanical notches and plastic side zones. Microscopic analysis of under-notch plastic zones (Figure 13(a)) revealed that they are ductile fractures with voids of various diameters, partially showing “scaly” structure. It is believed that such a fracture is created as a result of slips followed by decohesion and appearance of microcracks in the planes  $\{100\}$ . Microcracks join each other by shearing their separating walls giving the fracture characteristic appearance of overlapping scales. This indicates that the fracture is initiated by plastic deformation (slip), but cracking itself proceeds basically along determined crystallographic planes [6]. Dimples have parabolic shapes, which proves action of tangent forces in creation of the fracture. Smooth areas with no typical dimpled relief can be also distinguished.

Central zones of fracture surfaces in all the specimens (Figures 13(b) and 14(b)), even those subjected to impact testing at the lowest temperatures, are classified as quasi-cleavage fractures with developed topography and numerous transverse cracks. Such a fracture is typical for steels with martensitic or bainitic structure [2, 6]. This kind of fracture is created by cleavage cracking in small, local areas and

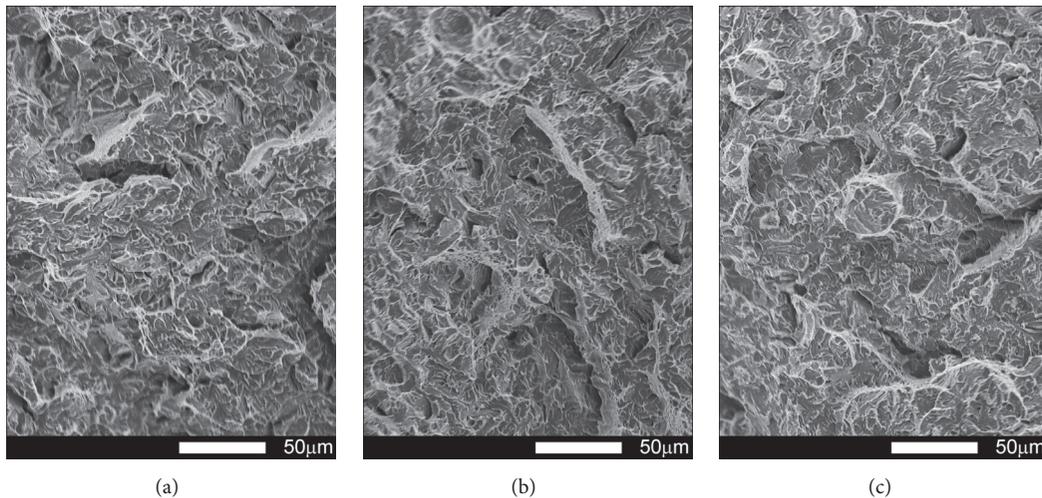
FIGURE 14: Fracture surfaces of longitudinal Brinar 400 specimens in as-delivered condition after testing at -40°C: (a) under-notch zone; (b) central zone; (c) final-fracture zone. Unetched; SEM.

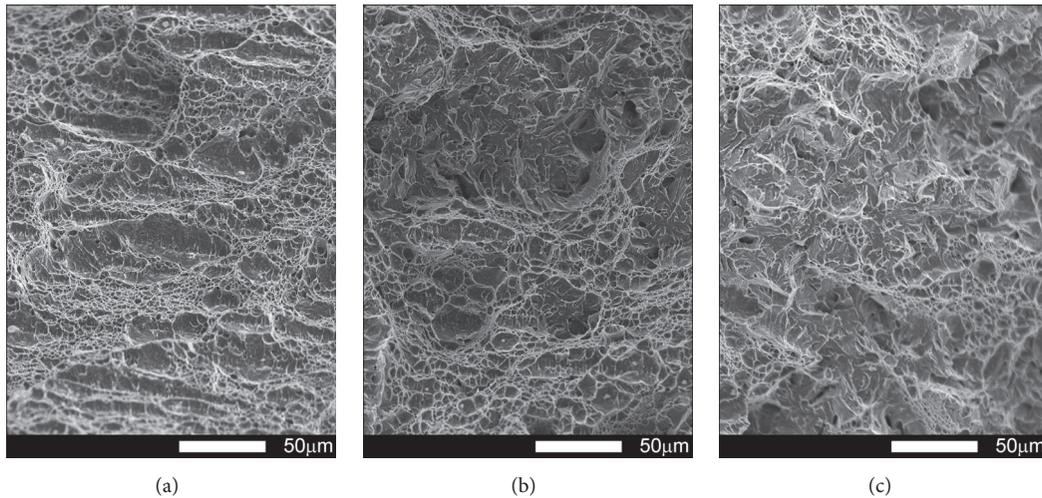
FIGURE 15: Fracture surfaces of transverse Brinar 400 specimens in as-delivered condition after testing at +20°C: (a) under-notch zone; (b) central zone; (c) final-fracture zone. Unetched; SEM.

Fracture surfaces of Brinar 400 specimens in as-delivered condition, cut out transversely to plastic working direction, are shown in Figures 15 and 16. The performed fractographic analysis showed that fracture surface of a transverse specimen tested at ambient temperature (Figure 15) does not significantly differ from that of a longitudinal specimen. Thus, differences in impact strength values could result mostly from differences in microscopic structures of the specimens. Under the mechanical notch (Figure 15(a)), a plastic zone is visible, with dimples of parabolic shape.

However, central zone (Figure 15(b)) presents a mixed fracture, that is, plastic and quasi-cleavage with developed topography formed in a system of elevations and cavities, showing traces of plastic deformation. Precipitates of

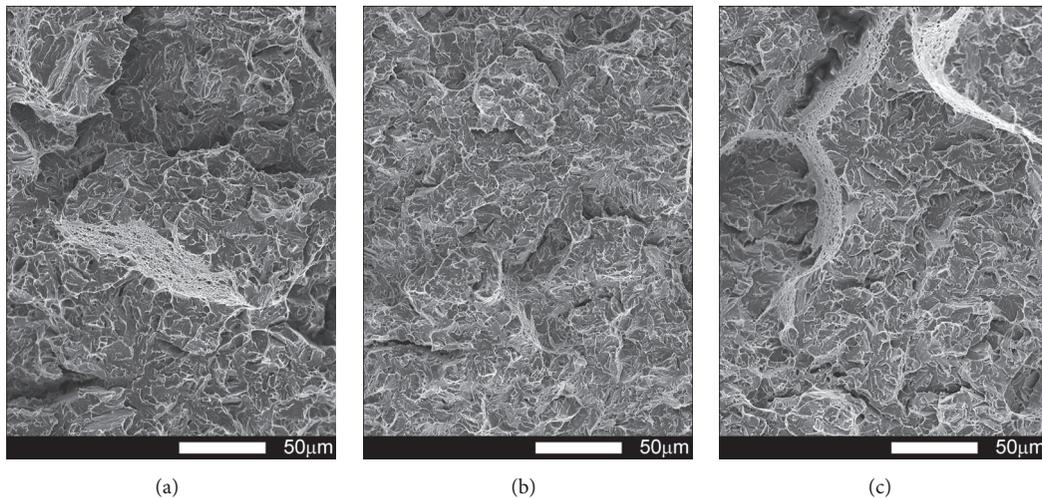
FIGURE 16: Fracture surfaces of transverse Brinar 400 specimens in as-delivered condition after testing at -40°C: (a) under-notch zone; (b) central zone; (c) final-fracture zone. Unetched; SEM.

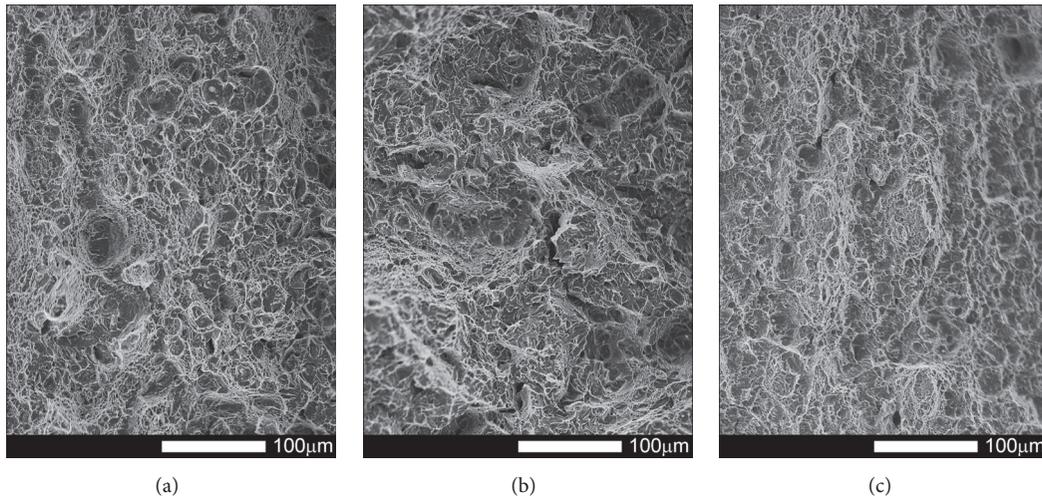
FIGURE 17: Fracture surfaces of longitudinal Brinar 500 specimens in as-delivered condition after testing at  $+20^{\circ}\text{C}$ : (a) under-notch zone; (b) central zone; (c) final-fracture zone. Unetched; SEM.

**3.3.2. Brinar 500: as Delivered.** Figures 17–20 show microscopic images of individual zones of fracture surfaces of representative Brinar 500 specimens in as-delivered condition. After testing at +20, plastic under-notch zones in longitudinal specimens have dimpled structure; see Figure 17(a). In larger dimples, nonmetallic inclusions or traces after inclusions in form of transverse cracks are visible. Structure of under-notch zone in transverse specimens tested at ambient temperature is similar; see Figure 19(a). Under-notch fracture zones in longitudinal specimens tested at negative temperatures (Figure 18(a)) and in transverse specimens tested at 0°C are developed quasi-cleavage fractures typical for martensitic steels, containing also bands of plastic fractures.

within the whole temperature range (Figures 17(b)–20(b)). Topography of the fracture, like in the case of Brinar 400, is still well developed. Occurrence of such topography means that cracking proceeded not in one crystallographic plane, but it jumped from one plane to another by shearing or creating secondary cracks in their separating walls. It was demonstrated that this effect occurs after encountering a screw dislocation, while a jog height is dependent on magnitude of Burgers' vector [6]. Creation of jogs is related to increased energy absorbed during cracking, which is equivalent to reduced brittleness. The jogs change direction of crack propagation. As a result, on some lengths, cracking speed is delayed, which results in bending its front and merging its neighbouring jogs to a “river-like” system. Ridges of these jogs and slopes around transverse cracks make areas of typical plastic fractures that, like in the case of Brinar 400, become smaller at lower test temperature.

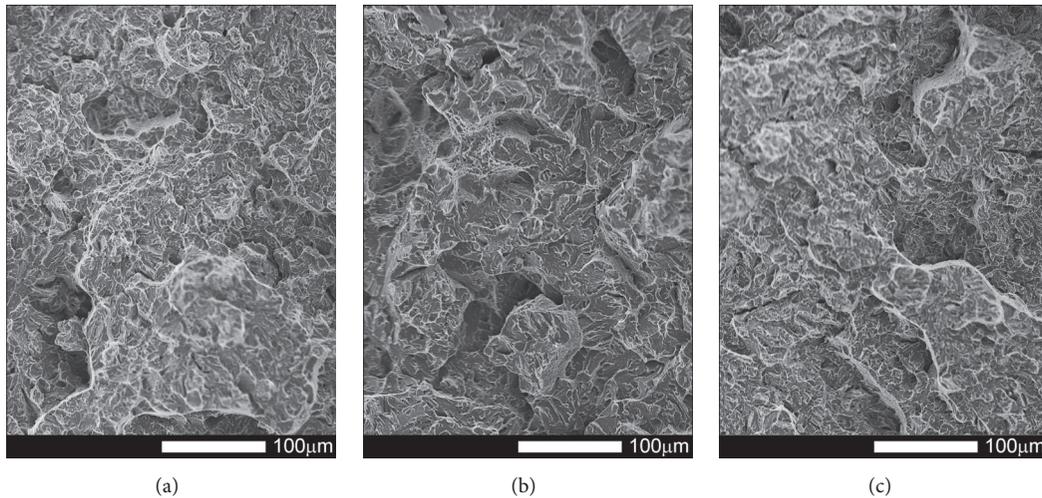
FIGURE 18: Fracture surfaces of longitudinal Brinar 500 specimens in as-delivered condition after testing at  $-40^{\circ}\text{C}$ : (a) under-notch zone; (b) central zone; (c) final-fracture zone. Unetched; SEM.

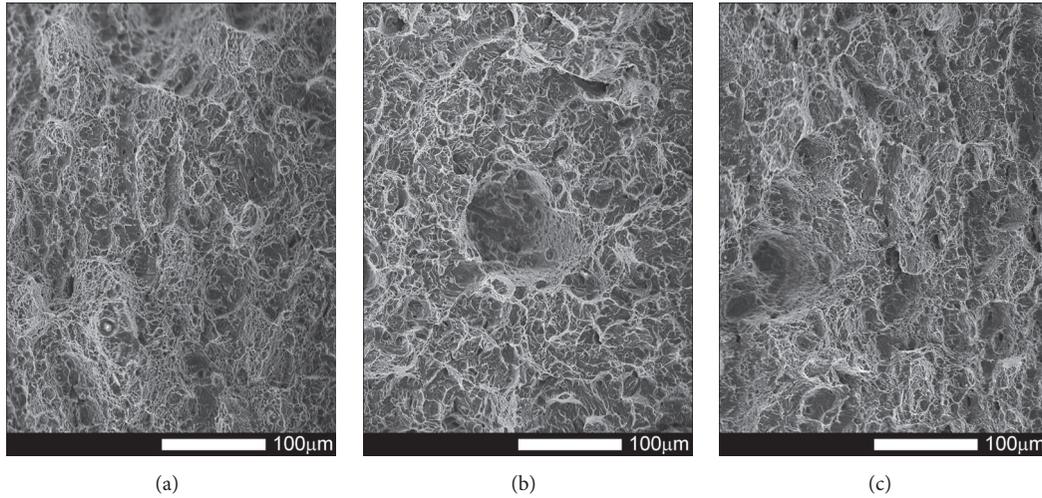
FIGURE 19: Fracture surfaces of transverse Brinar 500 specimens in as-delivered condition after testing at +20°C: (a) under-notch zone; (b) central zone; (c) final-fracture zone. Unetched; SEM.

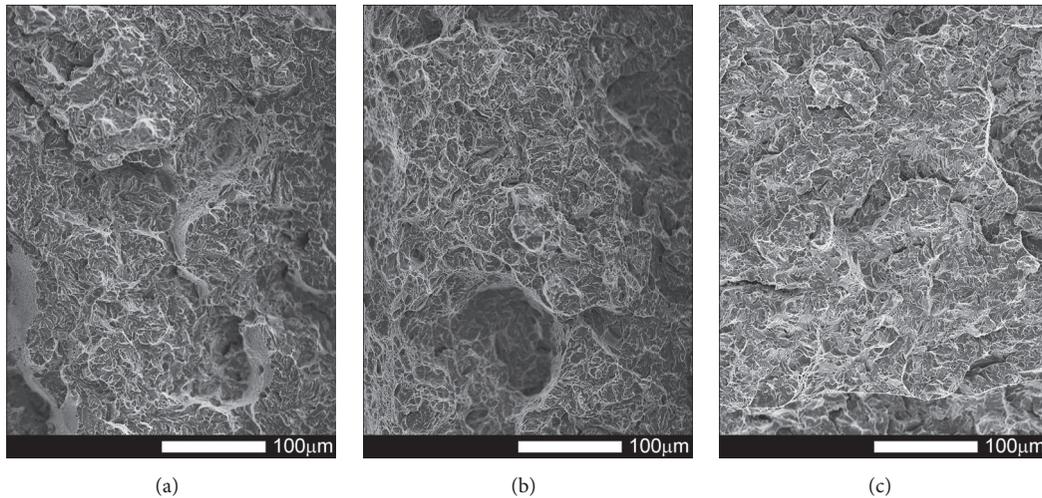
FIGURE 20: Fracture surfaces of transverse Brinar 500 specimens in as-delivered condition after testing at -40°C: (a) under-notch zone; (b) central zone; (c) final-fracture zone. Unetched; SEM.

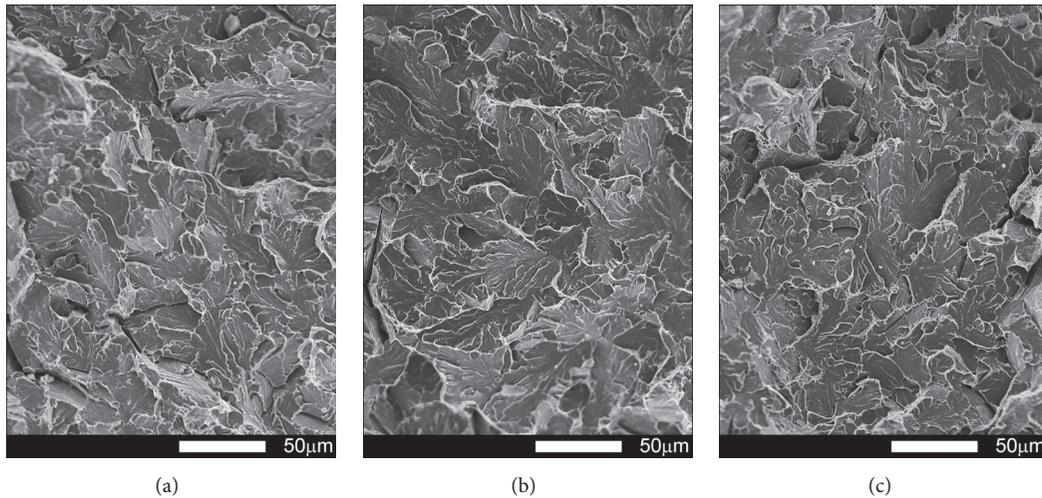
FIGURE 21: Fracture surfaces of longitudinal Brinar 400 specimens in normalized condition after testing at +20°C: (a) under-notch zone; (b) central zone; (c) final-fracture zone. Unetched; SEM.

**3.3.3. Brinar 400: Normalized.** Figures 21–24 show SEM images of representative fracture surfaces of Brinar 400 specimens in normalized condition. Earlier macroscopic examinations of Brinar 400 fractures after normalizing in both longitudinal and transverse specimens tested at  $+20^{\circ}\text{C}$  did not reveal any plastic side and under-notch zones. That was correlated with lower impact strength values in normalized condition at ambient temperature and above.

Irrespective of the direction in which a specimen was cut out, central fracture zone is of cleavage nature with characteristic river-like relief; see Figures 21(b) and 23(b).

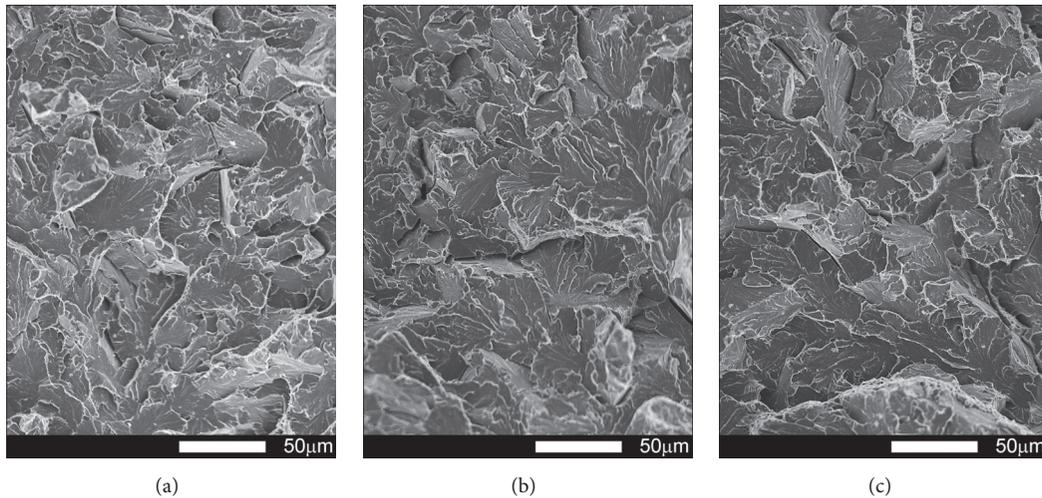
FIGURE 22: Fracture surfaces of longitudinal Brinar 400 specimens in normalized condition after testing at -40°C: (a) under-notch zone; (b) central zone; (c) final-fracture zone. Unetched; SEM.

Fractures of Brinar 400 specimens tested at lower temperatures are also typical cleavage fractures created by cracking along specific crystallographic planes; see Figures 22(b) and 24(b). Fracture surfaces show jogs with characteristic river-like relief and their presence means that cracking did not proceed in one crystallographic plane but jumped from one plane to another. As Maciejny [6] reports, this effect occurs when the cracking front encounters a screw dislocation and size of the jog is dependent on magnitude of Burgers' vector. Moreover, the jogs influence direction of crack propagation. As a result, the crack is delayed on some lengths and contributes to merging adjacent jogs in a river-like system

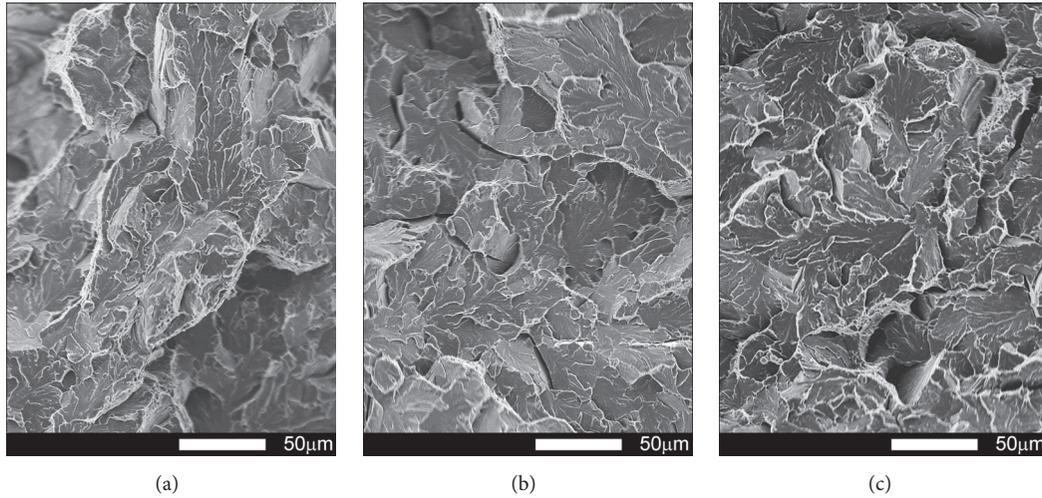
FIGURE 23: Fracture surfaces of transverse Brinar 400 specimens in normalized condition after testing at +20°C: (a) under-notch zone; (b) central zone; (c) final-fracture zone. Unetched; SEM.

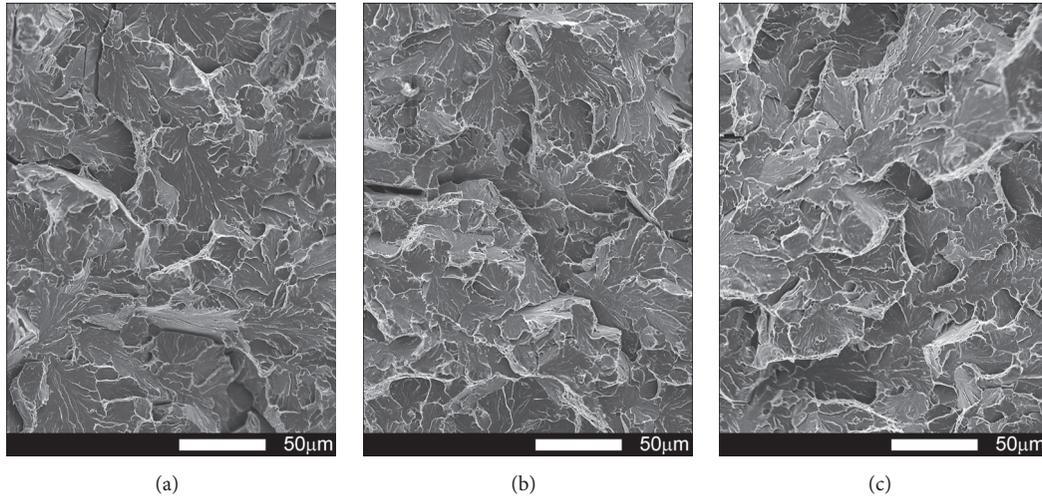
FIGURE 24: Fracture surfaces of transverse Brinar 400 specimens in normalized condition after testing at -40°C: (a) under-notch zone; (b) central zone; (c) final-fracture zone. Unetched; SEM.

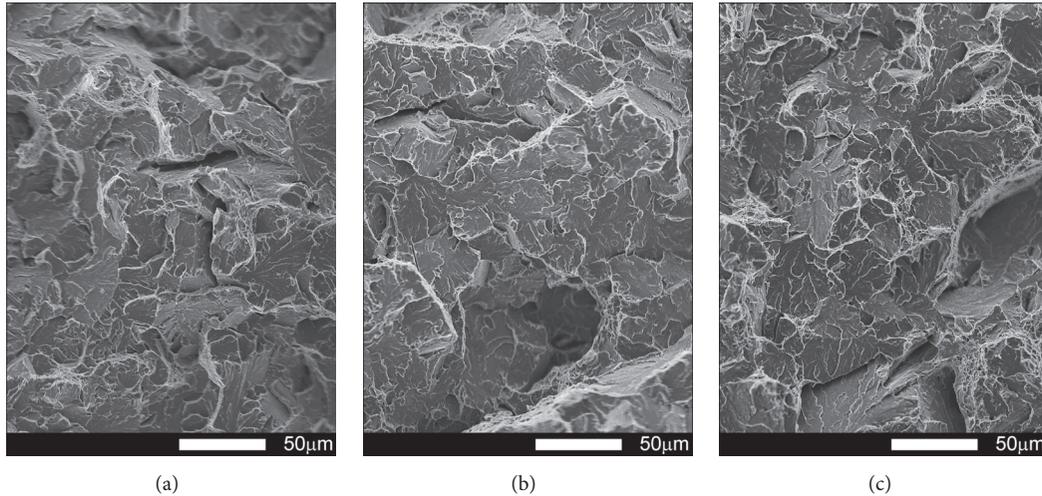
FIGURE 25: Fracture surfaces of longitudinal Brinar 500 specimens in normalized condition after testing at +20°C: (a) under-notch zone; (b) central zone; (c) final-fracture zone. Unetched; SEM.

**3.3.4. Brinar 500: Normalized.** Figures 25–28 show representative fracture surfaces of Brinar 500 specimens in normalized condition. A fracture of normalized Brinar 500, even after testing at +20°C, is a typical cleavage fracture (Figures 25(b) and 27(b)) with characteristic system of “rivers” that combine in “drainage areas” towards expansion direction of the main crack. Presence of the river-like relief indicates additional expenditure of energy during creation of a fracture

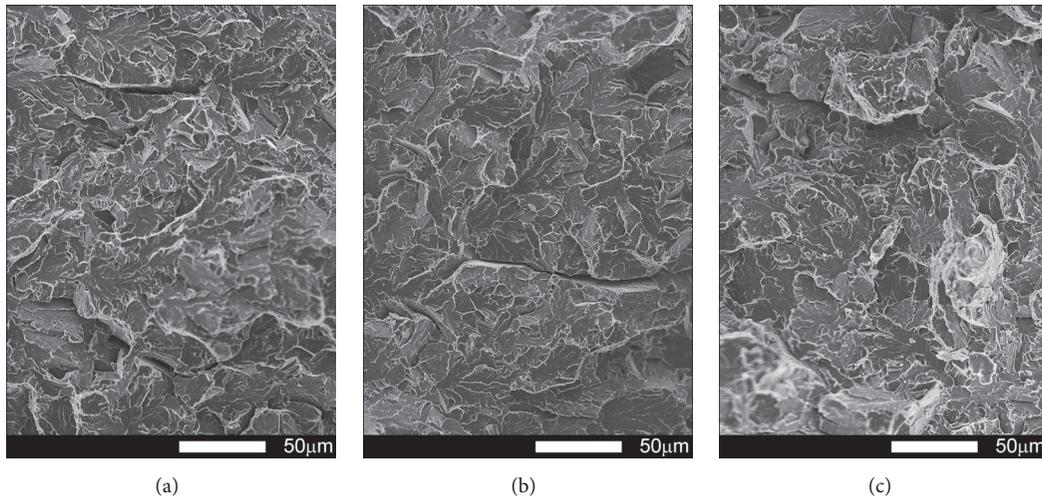
FIGURE 26: Fracture surfaces of longitudinal Brinar 500 specimens in normalized condition after testing at -40°C: (a) under-notch zone; (b) central zone; (c) final-fracture zone. Unetched; SEM.

Moreover, traces of secondary cracks can be seen on surfaces of facets. Apart from cleavage facets, bands of plastic fracture running along cleavage rigs occur on the fracture surface. After impact testing of normalized steel Brinar 500 at lower temperatures (Figures 26(b) and 28(b)), central, quite developed parts of fracture surfaces are cleavage fractures in that plastic areas are smaller than those in normalized Brinar 400. Structure of the observed facets is typical, with “drainage areas” and traces of intercrystalline secondary cracks.

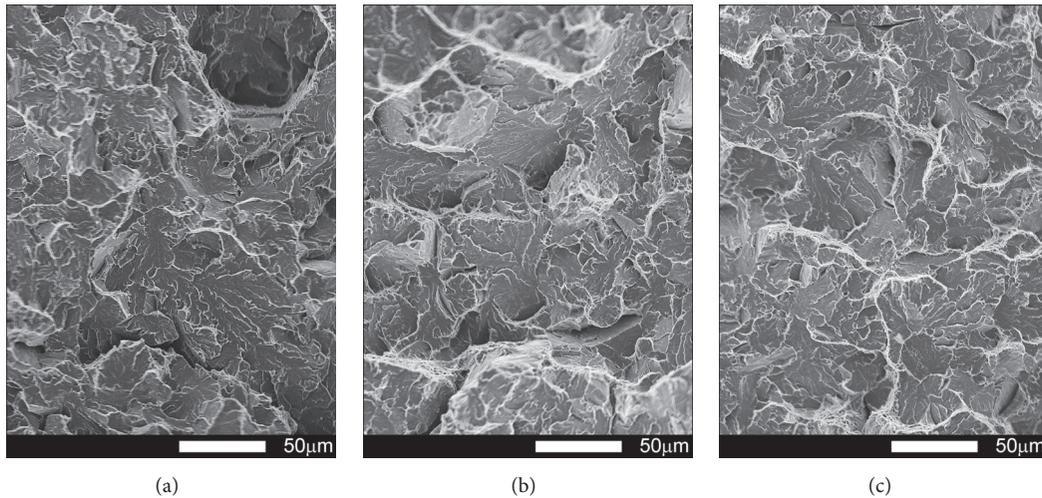
FIGURE 27: Fracture surfaces of transverse Brinar 500 specimens in normalized condition after testing at +20°C: (a) under-notch zone; (b) central zone; (c) final-fracture zone. Unetched; SEM.

Microscopic observations of the analyzed steels in normalized condition showed typically cleavage fractures with characteristic “river-like” relief, containing small portions of plastic dimpled zones.

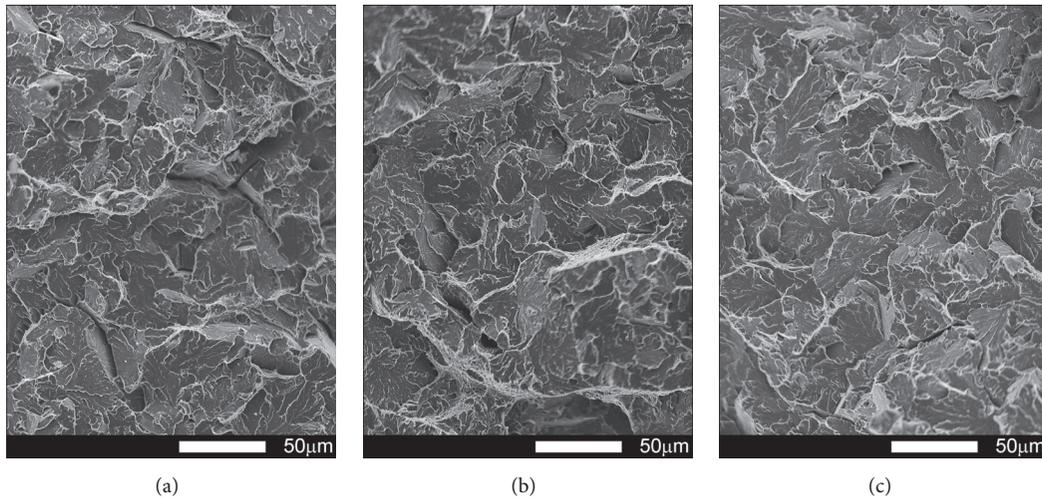
FIGURE 28: Fracture surfaces of transverse Brinar 500 specimens in normalized condition after testing at -40°C: (a) under-notch zone; (b) central zone; (c) final-fracture zone. Unetched; SEM.
