Research Article

Damage Identification of Wind Turbine Blades Using Piezoelectric Transducers

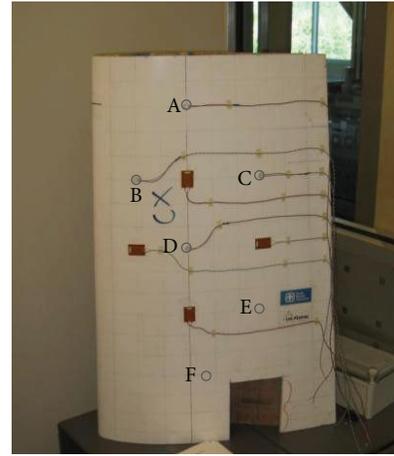
FIGURE 1: Turbine blade section.

The experimental setup under a laboratory setting consisted of a 1 m long \times 0.55 m wide section of a CX-100 wind turbine blade with a thickness that varies from 0.3 cm (trailing edge) to 10 cm (spar cap) instrumented with six piezoelectric patches, labeled A–F, as shown in Figure 1. Figure 1 also shows 4 rectangular macrofiber composite (MFC) sensors attached to the turbine blade; these sensors were not used in this study. The patches E and F are bonded inside the blade. The CX-100 is a carbon reinforced composite 9 m turbine blade designed by Sandia National Laboratory (SNL) [15]. The piezoelectric patches are 13 mm in diameter and are attached to the surface of the turbine blade using cyanoacrylate adhesive. The use of 6 piezoelectric patches results in 15 possible wave propagation paths, labeled with the actuator patch first and the sensor patch second. The length of AF is measured at 600 mm as the longest path, and EF is the shortest distance at 220 mm. The vertical paths (AD and AE) are located directly on the center support spar of the blade, as seen in the cross section picture in Figure 2. The patches were connected to a National Instruments (NI) PXI data acquisition system for data acquisition.

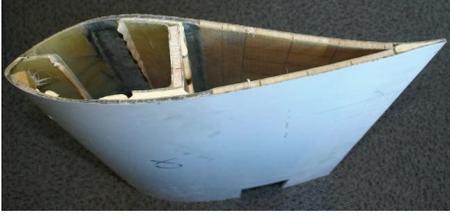
FIGURE 2: Cross section view of CX-100.

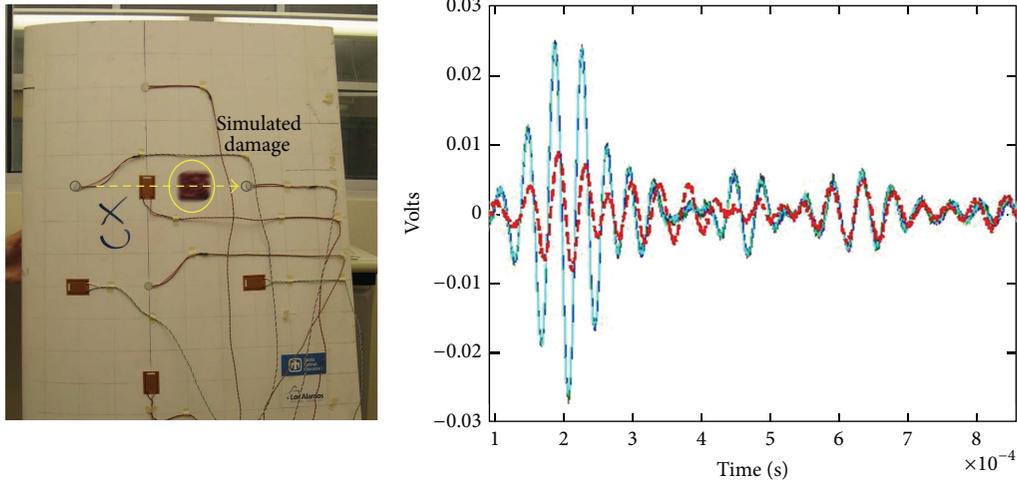
FIGURE 3: Turbine blade section with simulated damage and ten recorded baseline signals and damaged signal for path BC.

After the excitation frequency has been determined, multiple baselines for the undamaged structure were recorded. These baselines contain variations in the boundary conditions to attempt to simulate potential real world variability, including mass loading and manually induced vibrations to the structure. Damage was then introduced by applying a piece of industrial putty to the surface of the turbine blade in the path of propagation of the Lamb waves. The putty serves to change the damping properties of the structure in a localized area, similar to the effects of a delamination. The putty was approximately 5 cm × 5 cm, with 0.5 cm thickness. An example of recorded signal is shown in Figure 3. The responses (path BC) are recorded in the direct path before and after the simulate damage was applied. One can clearly see the attenuation of the first arrival wave caused by the simulated damage.

of the other recorded values. To incorporate all of the baseline readings into a single value, all of the damage indices for the baseline cases were averaged and then compared with the correlation coefficient for the damaged case. The result of the induced damage (shown in Figure 3) is illustrated in Figure 4. Ten baselines were first measured to construct the baseline database under different boundary conditions. The average of all the baselines is taken as an undamaged value and compared against the damage index for the damaged case.

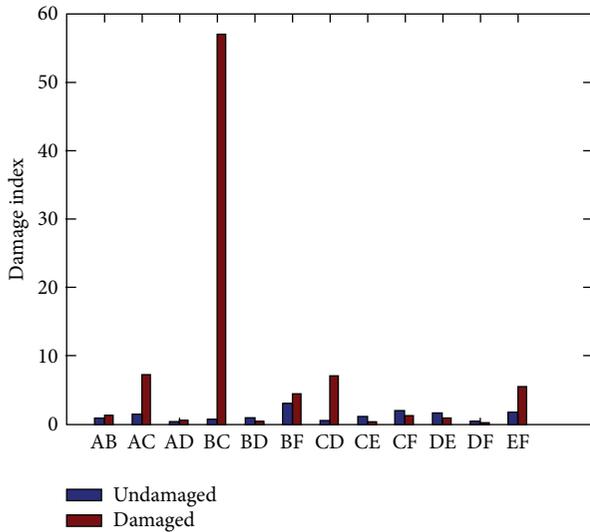
FIGURE 4: Damage index values for undamaged and damaged blade.

The result shows that path BC indicates very clear signs of damage. In addition, paths AC and CE is also affected by this damage. Therefore, it is possible to get the approximate location of damage based on the paths. AC and CD both have very similar magnitude damage indices which would suggest that the damage is located about the same distance from those 2 paths, which also agrees with the indication that the damage was on or near the BC path. Based on the fact that the AB and BD paths are not indicating damage, it is likely that the damage is closer to the C piezoelectric patch. This process could approximately locate induced structural damage.

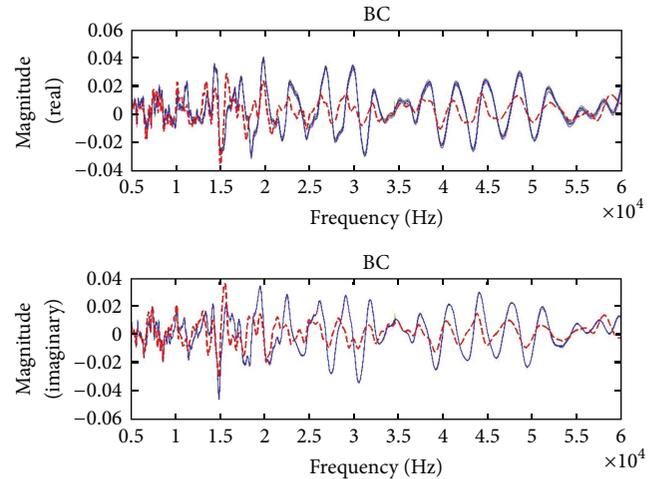
FIGURE 5: 15 recorded baseline signals and damaged signal for path BC.

4.2. High-Frequency FRF. Initially, the testing was conducted using an input frequency bandwidth of 30–80 kHz on each sensor-actuator combination. The experimental results, where the same damage as in the previous section in Figure 4 was introduced, are shown in Figure 5. The high-frequency response displays the changes in shape due to the simulated damage condition. The top portion of the figure is the real part, while the bottom portion is the imaginary part of FRF. As can be seen in the figure, the real portion of the response shows more variability due to baseline changes, while the imaginary portion is very stable, which is the ideal behavior. Changes due to boundary conditions are slight shifts in the magnitude of the FRF at the resonance and antiresonance peaks. The changes caused by damage result in a complete change in the frequency response function.

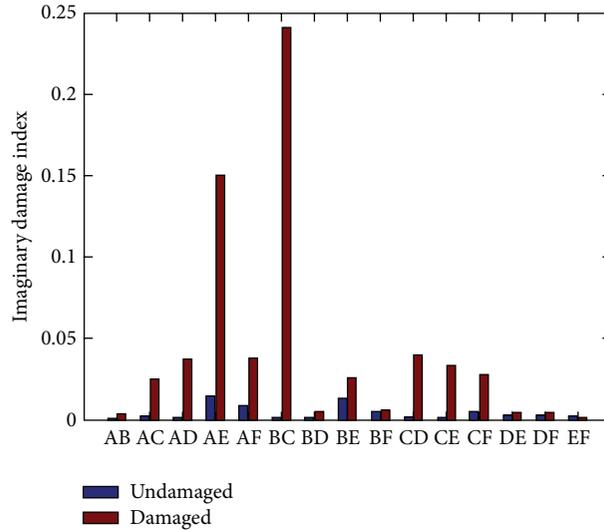
FIGURE 6: Damage index values using FRFs.

A correlation-based damage metric chart is illustrated in Figure 6. The figure shows that almost every path is indicating the presence of damage on the structure. The only exception is the EF path, which is the farthest path from the damage location. Paths BC and AE have the largest damage indices

(as a reminder the AE path did not provide an acceptable response for the Lamb wave method). This indicates that the damage is located on or very near to both of these paths.

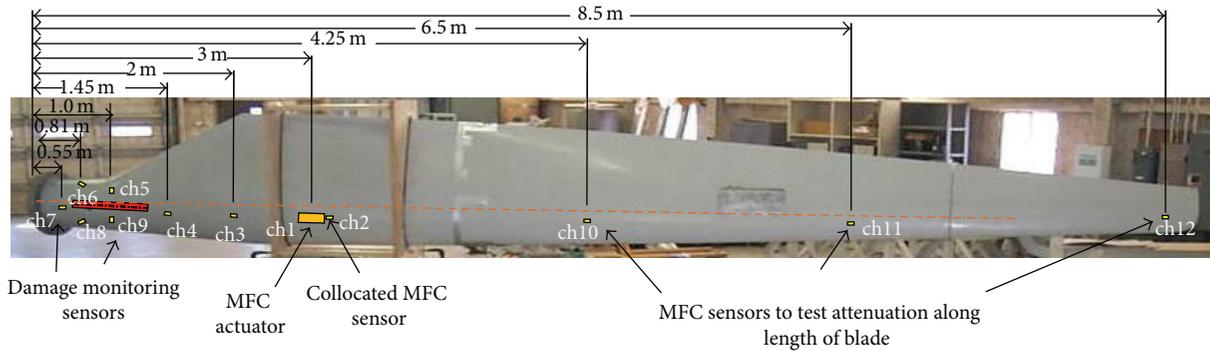
FIGURE 7: Overview of the fatigue test setup. A single MFC actuator in Ch1 is used to excite the blade, and 11 MFC sensors are used to measure the signal.

test setup is shown in Figure 7. The 9 meter blade was instrumented with eleven 2.5×3.75 cm MFC sensors and one 5×10 cm MFC actuator. The location of the sensors and the actuator in relation to the blade geometry is also shown in Figure 7. The blade underwent fatigue excitation at 2 Hz for defined intervals, and active-sensing data were collected between sessions while the fatigue excitation source was shut down. These data were collected from the eleven sensing channels at a sampling rate of 60 kHz, producing 32768 time points for each channel. A 7.5 RMS random excitation signal amplified by a factor of 30 was provided to the actuator. During the test, the fatigue damage was visually identified in the root area after 2.3 million cycles.

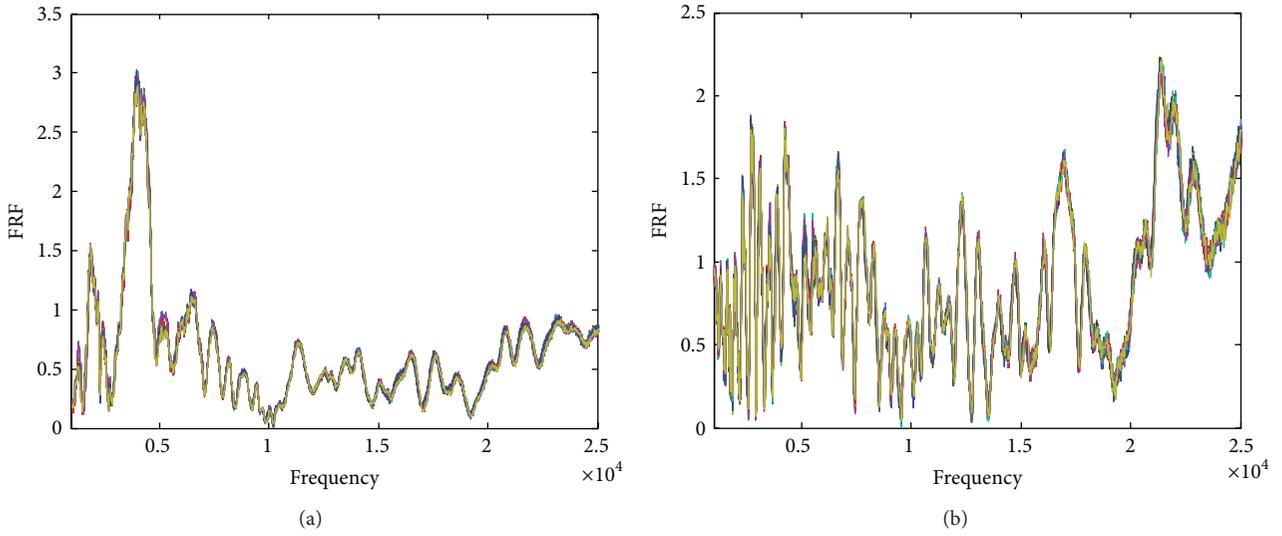
FIGURE 8: Identified FRFs. (a) Ch3, (b) Ch4. 20 measurements (from 260 k to 506 k cycles) are overlapped in the figure.

The collected data were converted to the frequency domain using FFT for the start of the fatigue cycling and at each cessation thereafter. The FRF obtained from the blade in the pristine condition was used to predict the system response from data collected at testing interval. FRF measurements of channels 3 and 4 are shown in Figure 8, for the frequency range of 1–25 kHz. Although extensive

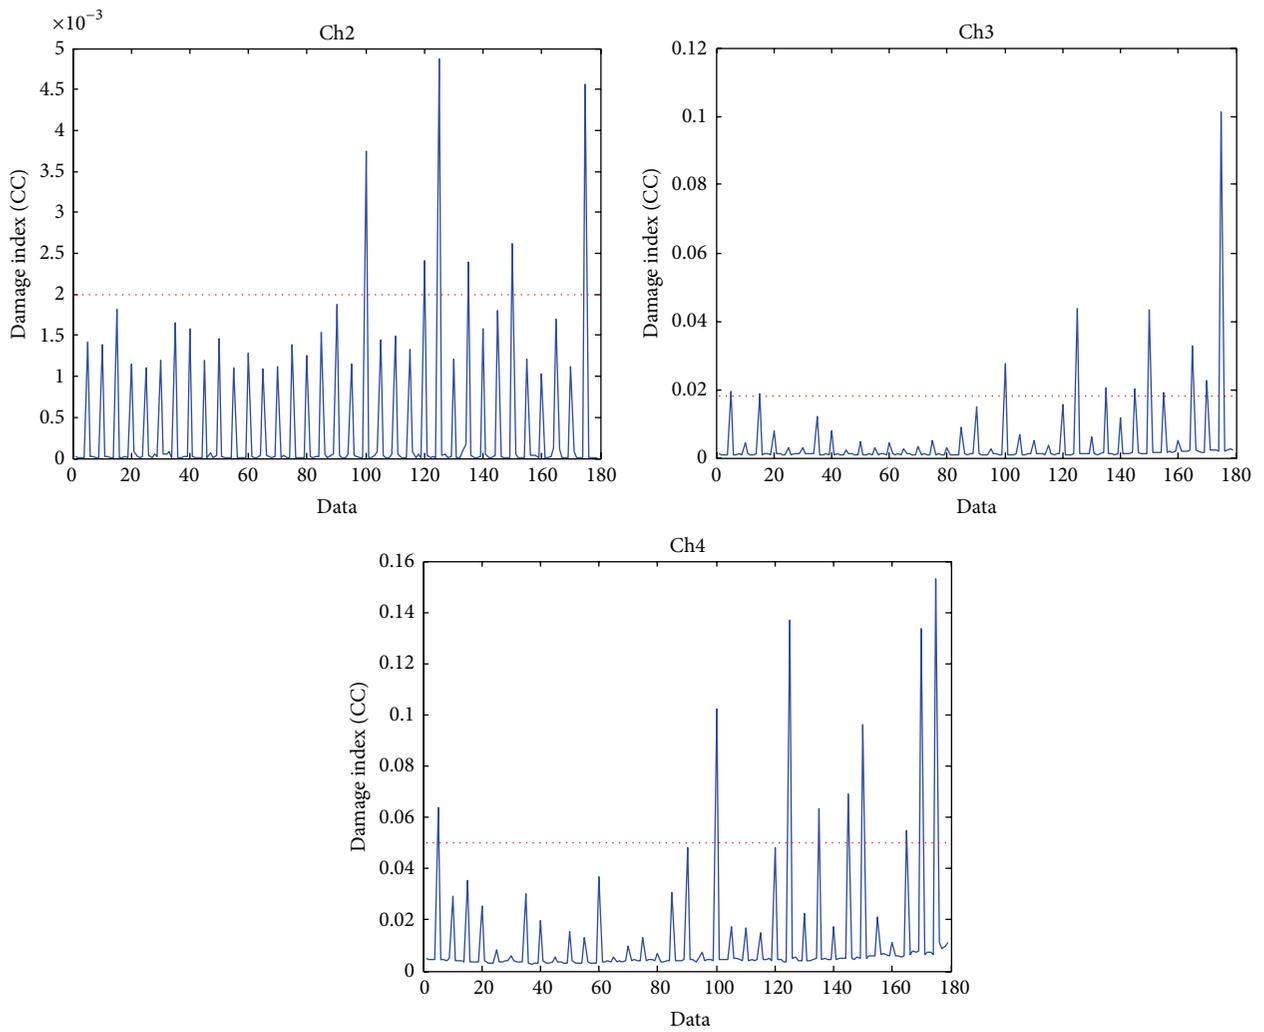
FIGURE 9: FRF-based DI values for Ch2–4. DI is measured between the current measurement and the previous reading.

The correlation coefficient between the current measurement and the previous reading was used as a feature to track the progression of structural change over the course of the fatigue test. In this way, the effect of fatigue loading given within the measurement interval could be estimated. The values of the correlation coefficients calculated at periodic intervals throughout the course of the test are shown in Figure 9. Note that plots are not in the same scale.

which was made after 1.8 million cycles. Another change was observed in the data 150, which was measured at 2.11 million cycles. Finally, the measurements taken on the final day (175 at 2.53 million cycles), all three measurements showed a large increase in the damage metrics, which indicates the on-set of structural damage on the blade. It is also interesting to note that the Ch4 (close to the damaged area) already showed certain increase in the DI value (170 : 2.38 million cycles) just before the final test, which may indicate the imminent damage.

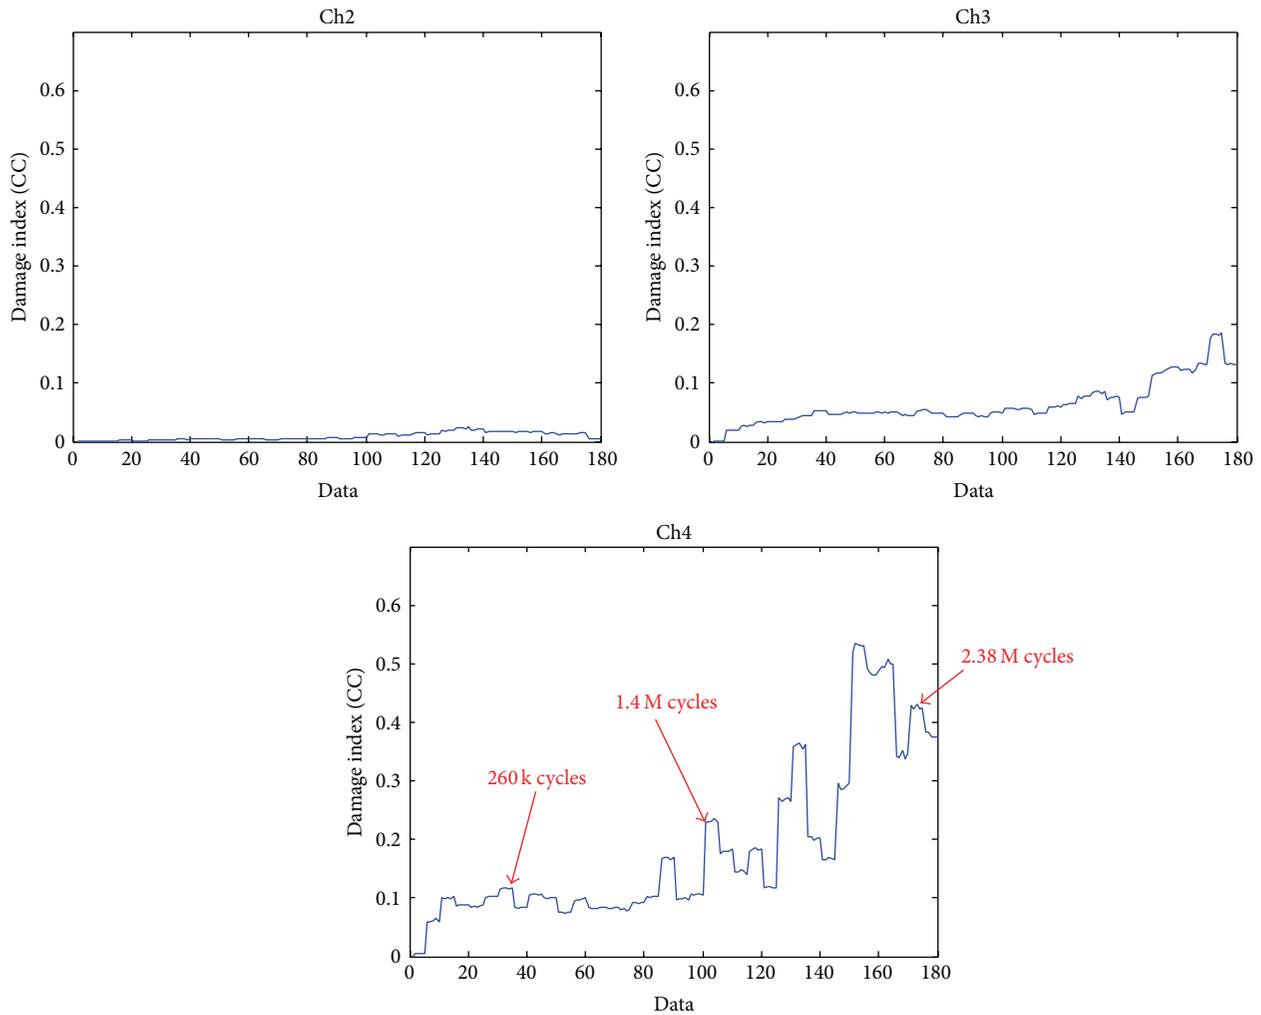
FIGURE 10: FRF-based DI values which are compared to a baseline for Ch2–4. DI is obtained between the current measurement and the baselines.

Figure 10 depicts another FRF-based DI value. In this case, the measurements were compared to the baseline, which was measured on the first day of the test. The changes in FRF indicate changes in the structural parameters, which in turn indicate the presence of damage. By comparing the measurements made on the first day, these figures give relative changes in structural integrity. It can be seen that the values in Ch4 are substantially higher than Ch3 and Ch2, which indicates the damage is located close to this sensor.
