## Research Article

# Seismic Performance of Multistorey Masonry Structure with Openings Repaired with CFRP Grid

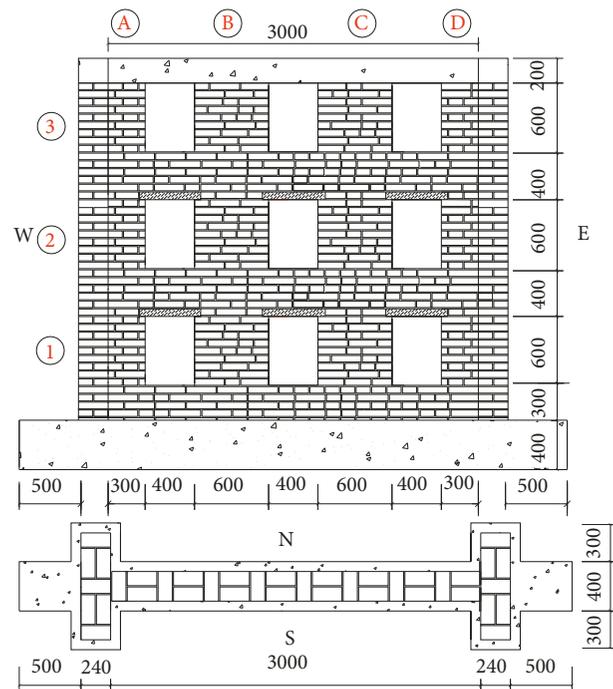
FIGURE 1: Description and Segmentation of multistorey masonry wall (mm) (number-XX represents spandrels and number-X represents piers).

**2.1. Model Wall Design.** The experiment protocol included the quasistatic testing of the URM wall, repairing the damaged URM wall with CFRP grid, as well as the quasistatic test of the CFRP grids repaired masonry (CRM) wall. A 1/3-scale three-storey masonry wall with openings was constructed. RC beams were set at the top and the bottom of the model wall, to support and apply the uniform vertical load. Three identical openings existed in each floor. RC lintels were set at the top of each opening at the first and second floors, whereas the lintels of third floor overlapped with the top RC loading beam. Both ends of the wall were set with short cross walls, to provide the lateral restriction and accurately model the real multi-storey masonry structures. The dimensions of the model wall are illustrated in Figure 1. The repairing scheme was completed by adhesively bonding CFRP grids in the certain areas where the cracks intensively

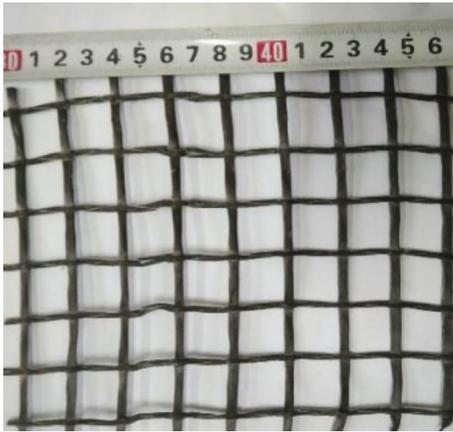
FIGURE 2: CFRP grid.

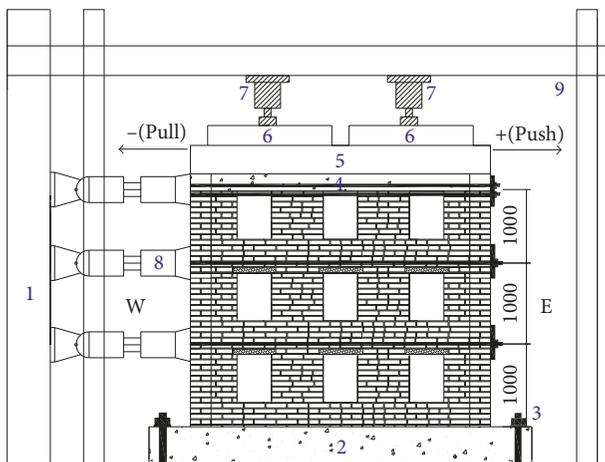
FIGURE 3: Test setup: (1) reaction wall, (2) RC bottom beam, (3) threaded rods, (4) RC head beam, (5) loading beam, (6) distribution beam, (7) load jacks, (8) MTS actuators, and (9) loading frame.

**2.3. Test Setup.** The test setup is presented in Figure 3. The bottom RC beam was fixed to the strong floor by four threaded rods. Two vertical hydraulic jacks were placed on the top of the distribution beams to apply the vertical load. The top RC beam uniformly distributed the vertical load that was kept constant as 0.75 MPa during the test. The lateral load was applied to the height of every floor by three MTS

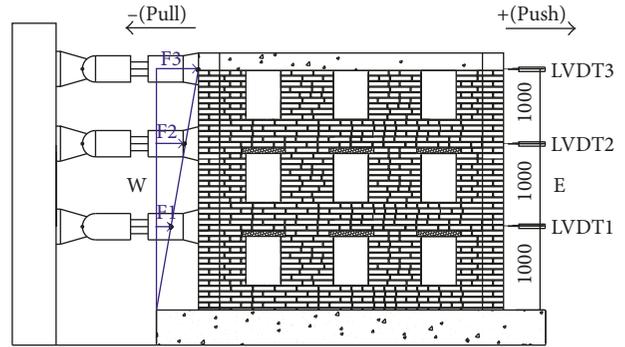
FIGURE 4: Loading scheme and instrumentations.

electrohydraulic servo actuators. The top actuator was set as the master unit, and the rest two actuators were the slave units. In order to achieve a triangular load distribution, the master unit was under displacement control and the slave units were coded to be load-controlled in accordance with the load of master unit. It means that each actuator pushed the wall with the same proportional loads at each floor as shown in Figure 4.

Three linear variable differential transformers (LVDTs) were installed to measure the lateral displacement at height of every floor. The loading scheme and instrumentation are illustrated in Figure 4.

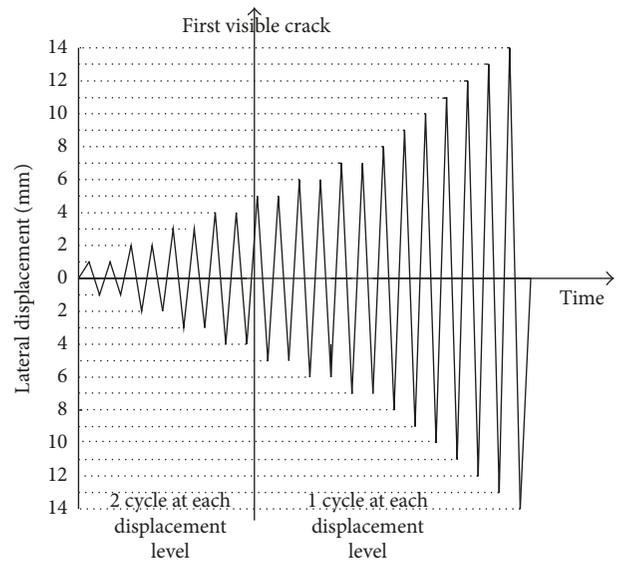
FIGURE 5: Loading history.

A typical quasistatic loading history was adopted to simulate the seismic action by a displacement-controlled loading. For the URM wall, two cycles were adopted at each displacement level prior to the appearance of first visible crack and one cycle thereafter, in which the displacement increment was 1 mm. When the seismic shear bearing capacity of the wall decreased to 85% of the maximum load, or the wall displayed severe damages, the test was terminated. For the CRM wall, the same loading history as the URM wall was applied. The loading history is presented in Figure 5.

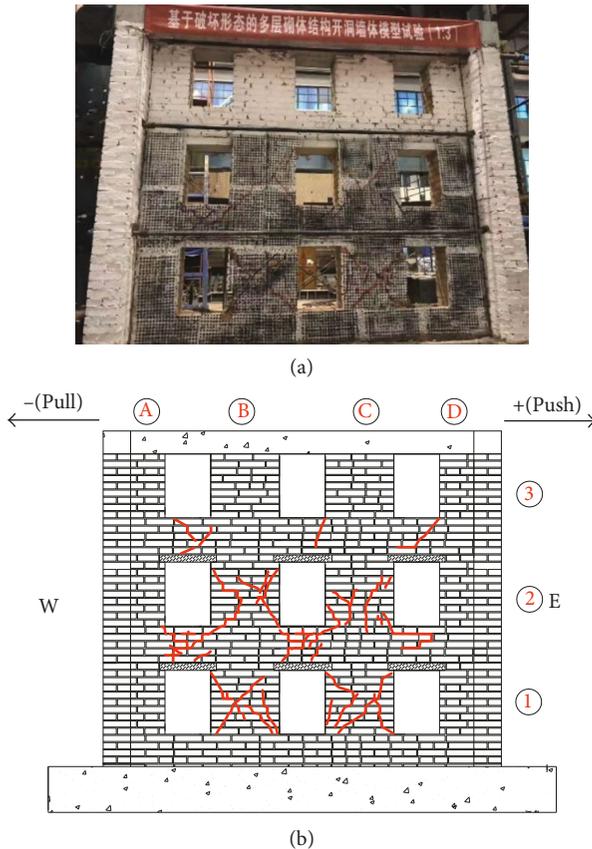
FIGURE 6: Final failure and crack pattern of the URM wall. (a) Final failure of the URM wall from the south side. (b) Crack schematic diagram of URM wall.

The final failure mode and cracking schematic diagram of the URM wall are presented in Figure 6. The cracks in the spandrels of the second floor firstly occurred, the piers of the first floor cracked thereafter, and the piers of the second floor then cracked, the spandrels of the third floor finally cracked. The failure mechanism of the URM wall was thus the weak spandrel failure corresponding to the sequence of cracking [1]. The URM wall failed due to shear failure in accordance with the cross diagonal cracks.

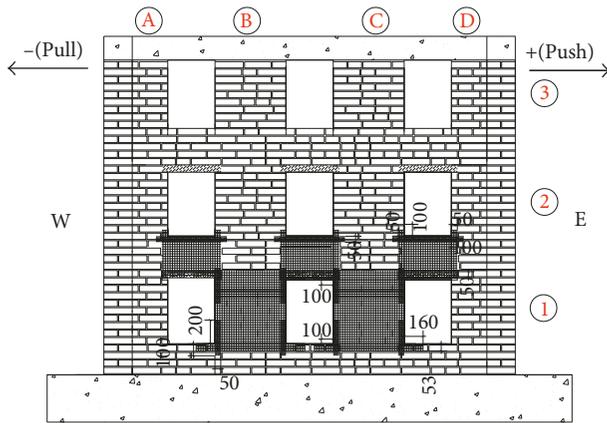
FIGURE 7: Repair scheme of the damaged URM wall.

The repair procedure of the earthquake-damaged masonry wall could be summarized as follows: the broken bricks and mortar were firstly remedied using same strength mortar, but the completely broken bricks need to be replaced using same bricks. The surface of the repair areas were then cleaned to remove the irregularities and dust after the repaired mortar being hardened. In order to secure the performance of the CFRP grid repair scheme and prevent the premature cutting fracture of the CFRP grids, CFRP sheets were bonded at the edges of openings before bonding CFRP grids as presented in Figure 7. The CFRP sheet width was 100 mm, and the fiber direction was across the edges. The epoxy resin was only applied to the repaired area, and the CFRP grids were then bonded. The CFRP grid repairing system was cured for 24 hours before testing. The repaired masonry wall is schematically presented in Figure 7.

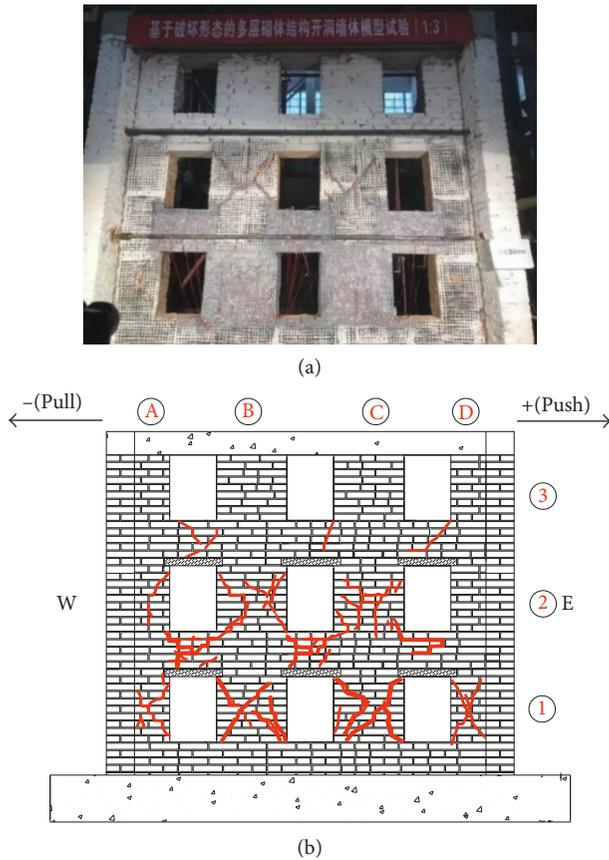
FIGURE 8: Final failure and crack pattern of CRM wall. (a) Failure of the CRM wall from the south side. (b) Crack schematic diagram of CRM wall.

The final failure and cracking schematic diagram of the CRM wall are presented in Figure 8. The details of failure were shown in Figure 9. The debonding failure mostly initiated from the center of repaired regions and propagated to the edges. It was noticed that the CFRP grid was not fully debonded from the masonry because the additional CFRP sheets bonded at the edges of openings which can effectively prevent the propagation of debonding failure. It may be concluded that the failures of the CRM wall developed from the lower floor to the higher floor according to the sequence of failure. Furthermore, the unrepaired areas cracked before the occurrence of debonding failure of the same floor.

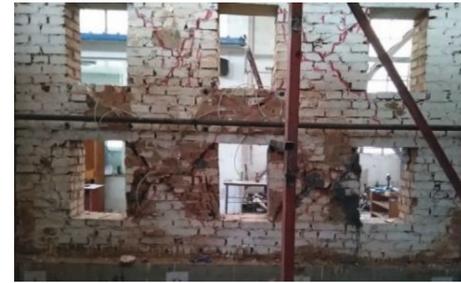
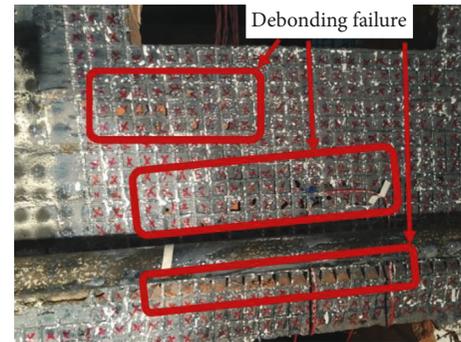
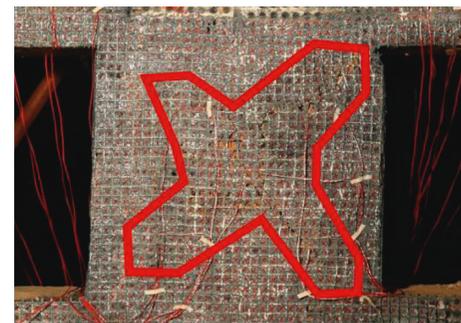
FIGURE 9: Failure details of CRM wall. (a) Failure of the CRM wall from the north side. (b) Debonding failure in 2-CD region. (c) Debonding failure in 1-B region.

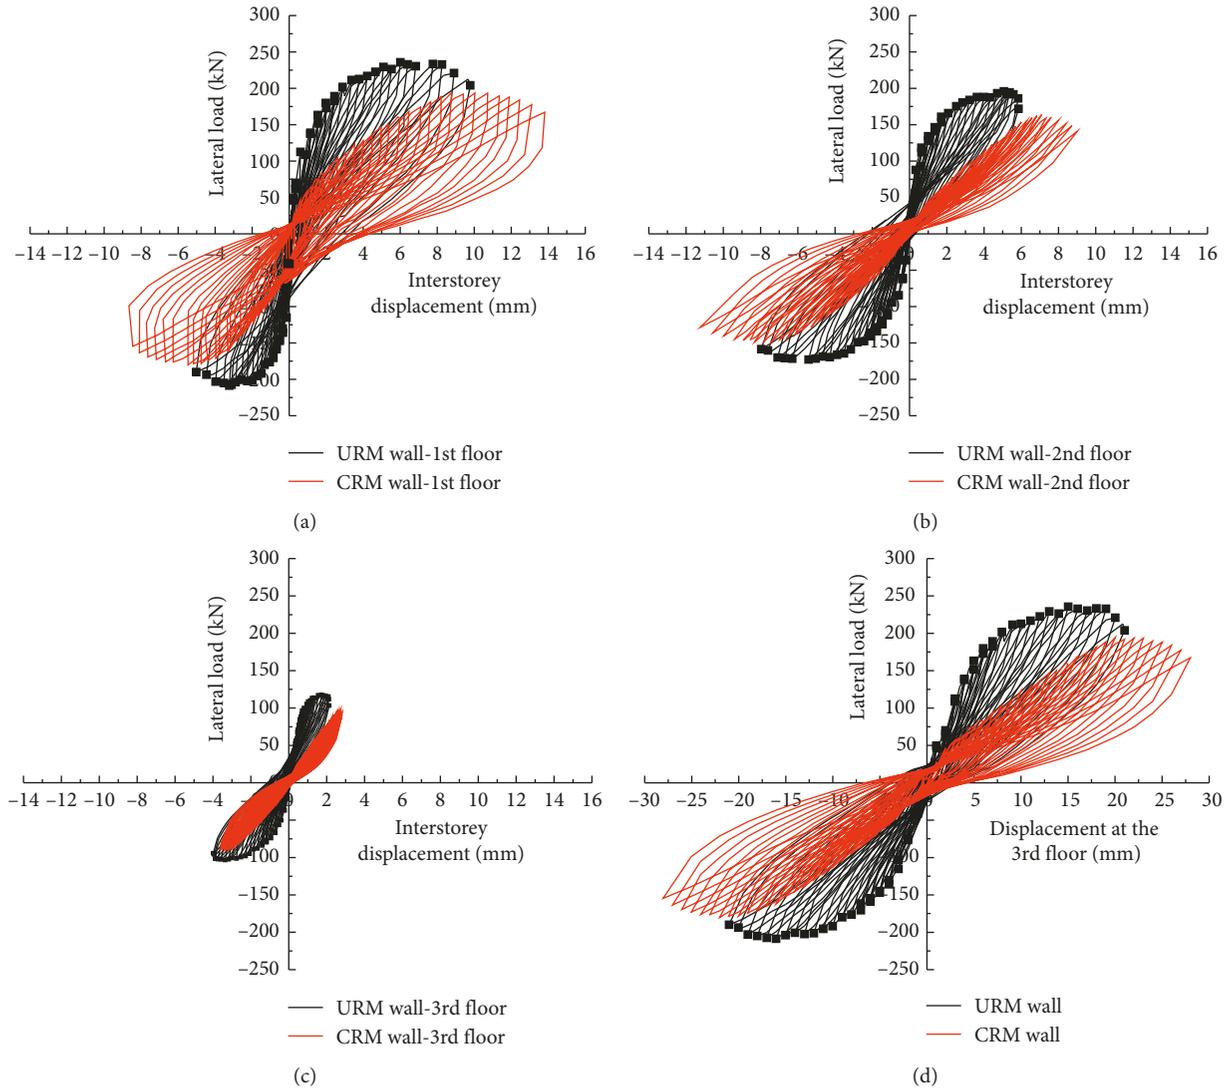
FIGURE 10: Hysteresis curves of the URM and CRM walls. (a) Hysteresis curves of 1st the floor. (b) Hysteresis curves of the 2nd floor. (c) Hysteresis curves of the 3rd floor. (d) Hysteresis curves of the entire wall.

**4.2. Hysteretic Response and Skeleton Curve.** The hysteretic response represents the detailed relationship of lateral displacement and the corresponding load. It demonstrates the deformation characteristics, the stiffness degradation, and the energy dissipation of the structures during cyclic load. The hysteretic and skeleton curves of each floor of the model wall prior to and after repairing are presented in Figures 10 and 11.

From the comparison of the hysteretic and skeleton curves of the model wall at each floor, it can be found that the seismic shear bearing capacity of the URM wall was 235.7 kN. It was effectively restored to 194.3 kN after CFRP grids repairing. The shear bearing capacity of was restored to

82.4%, 84.7%, and 83.0% for the first, second, and third floor, respectively. The hysteretic curves of the URM wall displayed a certain pinching phenomenon, whereas the CRM wall curves exhibited fatter envelope curve, demonstrating an improved energy dissipation capacity. Due to the heavy damage of the URM wall and the limited repair areas, the secant stiffness of the CRM wall did not recover to the undamaged state as shown in Figure 11(b).

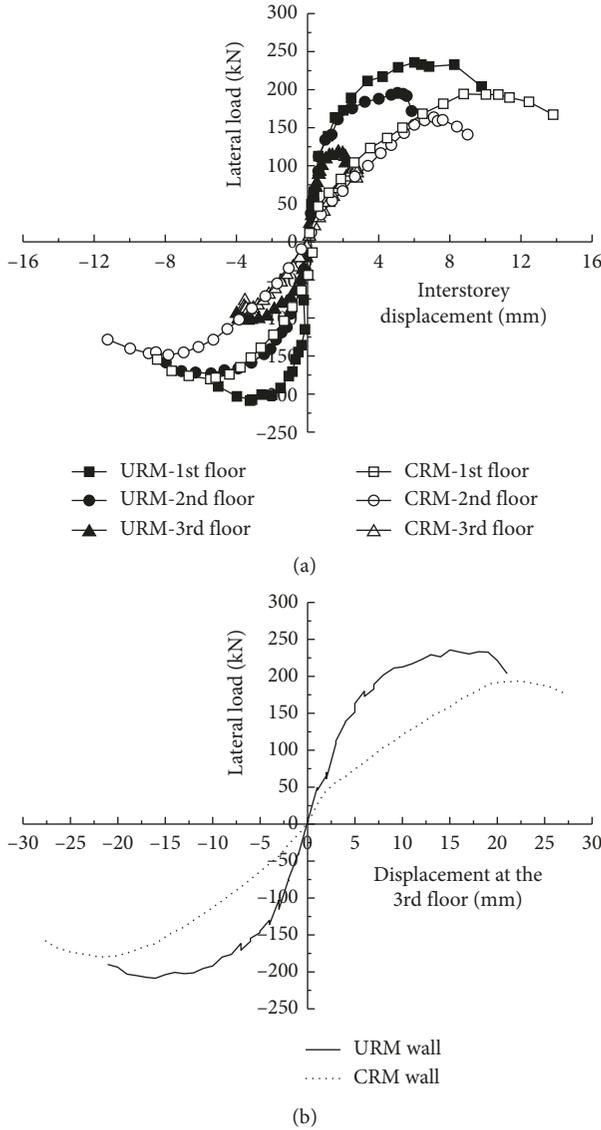
FIGURE 11: Envelope curves of URM and CRM wall. (a) Envelope curves of each floor. (b) Envelop curves of the entire wall.

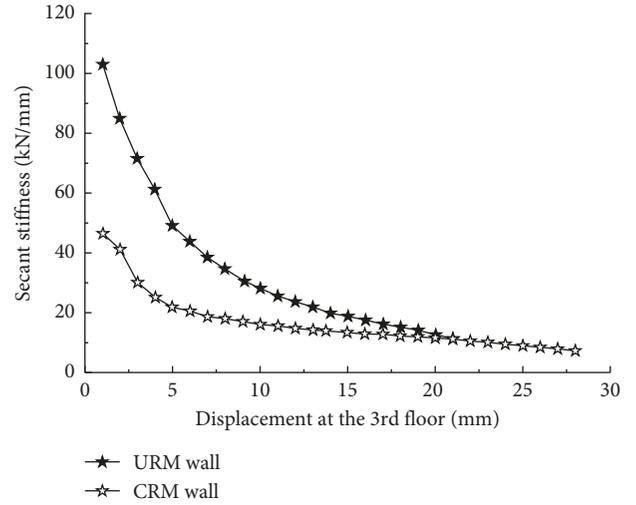
FIGURE 12: Secant stiffness degradation of URM and CRM wall.

positive and negative peak lateral loads of the  $i$ th cycle. In the case of two cycles prior to cracking, the stiffness was calculated by the first cycle. The stiffness degradation curves presented in Figure 12 showed that the initial secant stiffness of the CRM wall was lower than that of the URM wall. This moderate stiffness recovery can be attributed to the severe damage of URM wall and the limited repairing scheme.

For the URM wall, the stiffness degradation of the elastic stage was significantly greater than the deformation development stage. In terms of the CRM wall, prior to the first new crack occurrence ( $\pm 6$  mm), the stiffness degradation of this stage was apparently greater compared to the new damage development stage. Compared to the URM wall, since the CFRP grid restricted the occurrence and development of cracks, the stiffness degradation of the CRM wall was milder than the URM wall.

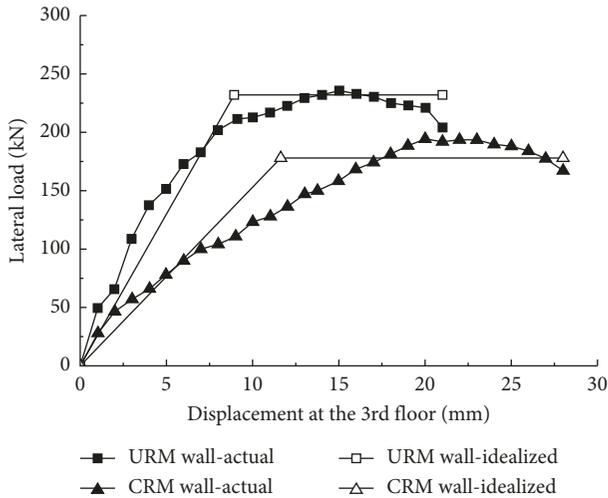
FIGURE 13: Actual and idealized envelop curves.

The obtained idealized envelope load-displacement curves are presented in Figure 13. Consequently, the ductility coefficient of the URM wall was 2.35, and it increased to 2.41 for the CRM wall. This promotion was because CFRP grids effectively postponed or even prevented the appearance and development of the cracks.

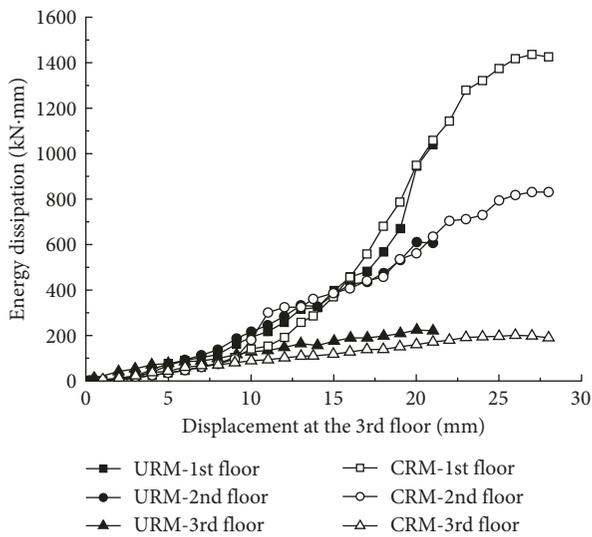
FIGURE 14: Energy dissipation of both URM and CRM wall.

**4.5. Energy Dissipation Capacity.** The hysteretic loop area of each displacement level represented the energy dissipation of the corresponding state. Figure 14 presents the energy dissipation of each floor at every displacement level of the wall prior to and after repairing. It can be found that the energy dissipations of the walls prior to and after repairing were approximately identical before the first new crack appearance in the CRM wall when the top displacement reached to  $\pm 6$  mm. The energy dissipation of the walls prior to and after repairing was mainly attributed to the first and second floors, leading to these two floors severely damaged. For the URM wall, after reaching to the peak load ( $\pm 15$  mm), the energy dissipation of the first floor significantly increased compared to the second floor. For the CRM wall, when the top displacement of the CRM wall reached to  $\pm 15$  mm, as all CFRP grids exhibited debonding failure, the energy dissipation of the first floor significantly increased compared to the second floor. The energy dissipations of both first and second floors of CRM wall were almost equivalent to those of the URM wall at the same displacement level, indicating that the energy dissipation capacity was successfully restored due to the CFRP grid

repairing. However, due to the fact that the third floor was unrepaired, the corresponding energy dissipation was not restored. When the top lateral displacement of the CRM wall reached to  $\pm 26$  mm, the energy dissipation of each floor started to decrease, indicating that the CFRP grid displayed severe debonding failure and the wall severely damaged.

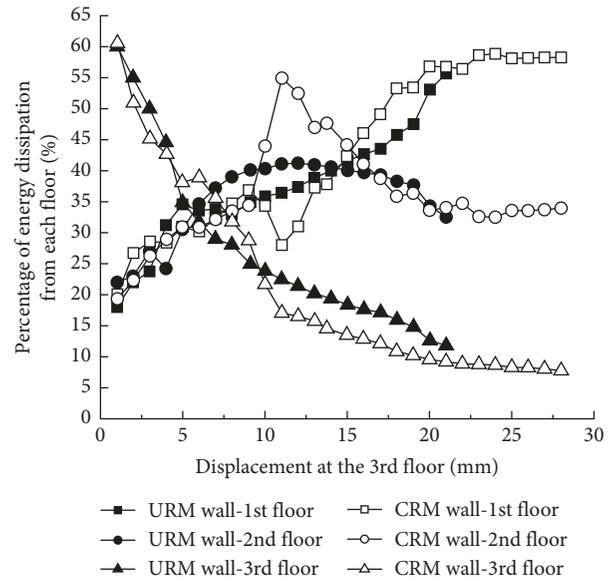
FIGURE 15: Percentage of energy dissipation from each floor.

Figure 15 shows the percentage of energy dissipation of the entire wall contributed from each floor. The development trends of the percentage of energy dissipation contributed from each floor of both URM and CRM walls were almost similar. It can be found that the percentage of energy dissipation contributed from the third floor continuously decreased. On the contrary, the percentages of energy dissipation contributed from both first and second floors constantly increased.

the third floor because the damages intensively concentrated in the lower two floors. In the deformation development stage of the URM wall ( $\pm 8$  mm to  $\pm 15$  mm), the percentage of energy dissipation contributed from the second floor was greater than that from the first floor because heavy damages occurred in the spandrels of the second floor. After the peak load of the URM wall, the energy dissipation capacity of the entire wall mostly contributed from the first floor because the heavy damages shifted to the piers of the first floor.

For the CRM wall, after all repaired piers of the first floor, 1-C, and 1-B regions starting to debond ( $\pm 9$  mm), the energy dissipation capacity of entire wall mostly shifted to the second floor due to the initiation and development of debonding in the spandrels of second floor. After the top lateral deformation reaching to  $\pm 15$  mm, where all repaired spandrels of second floor exhibited debonding failure, the major contributions on the energy dissipation of entire wall shifted back the first floor. After the peak load ( $\pm 22$  mm), the percentages of energy dissipation contributed from each floor approximately were constant.

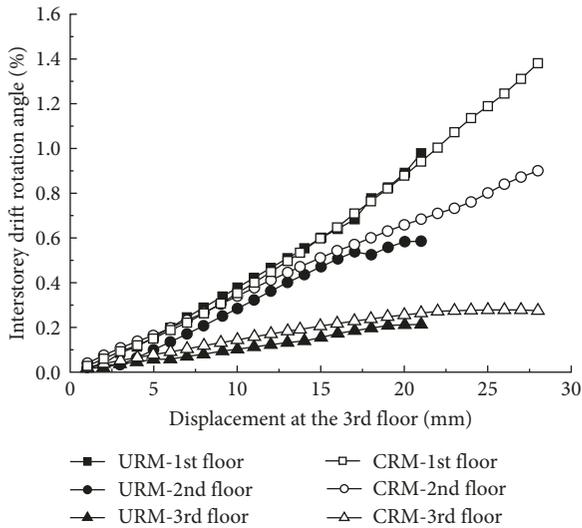
FIGURE 16: Interstorey drift rotation angle of URM and CRM wall.

**4.6. Interstorey Drift Rotation Angle.** Interstorey drift rotation angle is another important factor to evaluate the ductility and seismic resistance of structures. Figure 16 presents the interstorey drift rotation angle of each floor of the wall prior to and after repairing. It is indicated that the interstorey drift ratio angles of the first and second floors were greater because the damages mainly occurred at these two floors. The interstorey drift rotation angles of the first and second floors of the CRM wall were almost identical as the URM wall. It is because the CFRP grid repair effectively prevented the occurrence and development of the cracks. On the contrary, the interstorey drift rotation angle of the third floor of the CRM wall was higher compared to the URM wall. Moreover, the interstorey drift rotation angle decreased

from the first floor to the third floor, which implied that the CRM and URM walls were in the shear type deformation.
