# Dynamic Property Analysis of Orthotropic Bridge Deck with Local Fatigue Crack

With the increase in traffic volume and overweight vehicles, fatigue problems are highlighted. Especially for the orthotropic steel deck, the premature cracks seriously affect the service performance, operation, and service quality of the bridge. In this paper, the steel box-girder segment model and deck substructure model considering several typical fatigue cracks were established to reveal the variation law of fatigue cracks on vibration frequency and deflection under vehicle traveling load. A natural frequency analysis was performed to evaluate the change in the vibration characteristics due to localized damage, together with a dynamic analysis that considered a vehicle traveling on the bridge. The results show that the initiation and propagation of several typical cracks have little influence on the lower modes of the overall structure and great influence on the high-order modes of the substructure. The dynamic deflection response of the bridge changed under vehicle load as damage progressed. Therefore, it was possible to identify cracks of the orthotropic steel bridge deck and to provide guidance

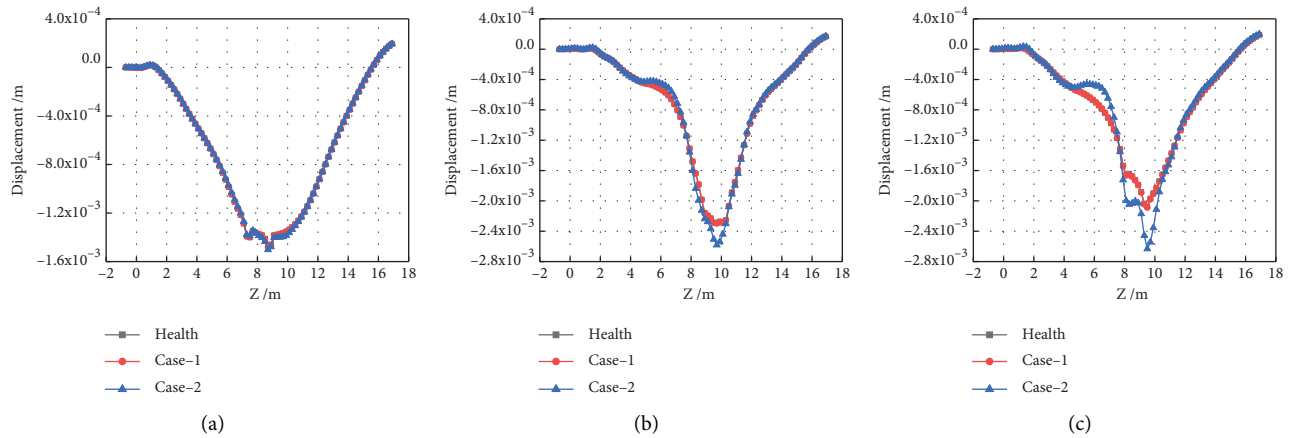
FIGURE 16: Displacement of the observation point (Type 3 damage). (a) Observation point 1. (b) Observation point 2. (c) Observation point 3.

Figure 16 shows the displacement with Type 3 damage change of three observation points under the traveling vehicle load. For Case 1, the crack at the U-rib butt weld hardly affected the displacement of the three observation points. However, once the crack propagated along the butt weld (Case 2), the displacement will increase greatly. The

displacement change recorded at observation point 3 was the largest, with an increase of 0.555 mm. The reason for this phenomenon was the sudden change of the stiffness at the weld due to the failure of the U-rib butt weld. When the center of the double axle just reached the weld failure position, the displacement increased obviously. Therefore, it is possible to identify crack damage Type 3 according to the displacement changes recorded at observation point 3.
