Research Article

Low-Cycle Fatigue Properties of the X70 High-Frequency Electric-Resistant Welded Pipes

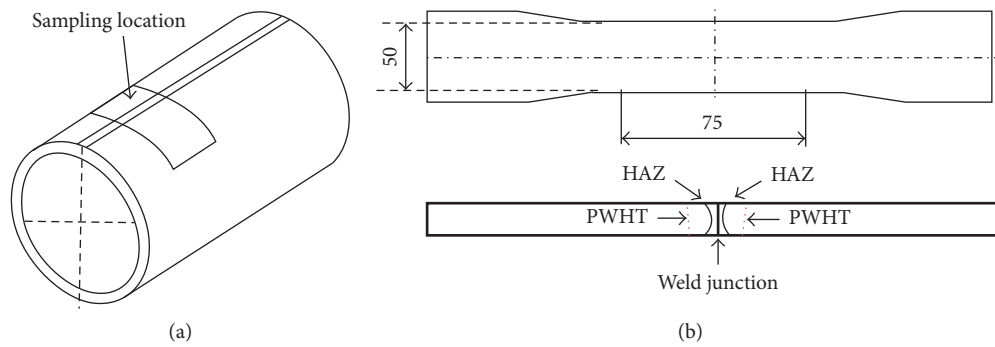
FIGURE 1: (a) Schematic illustration of the locations of cut and preparation of the test specimens. (b) The critical dimensions of the fatigue test specimens (all dimensions are in millimeter).

The weld seam and pipe body specimens were cut from the weld seam and prepared from 180° along the circumference of the pipe in accordance with the API specifications for fabricating pipelines as schematically shown in Figure 1. Then, the plate fatigue specimens were machined. The size of the fatigue specimens is also shown in Figure 1. To assess the integrity of the X70 line pipe, two typical full-thickness plate fatigue specimens were used, that is, with or without surface finishing (the surface means as-rolled surface of the steel plate). This process was performed to reflect the actual fatigue life of the pipe and demonstrate the effect of the weld and PWHT, as well as the surface defects, on the fatigue life of the X70 HFW pipe.

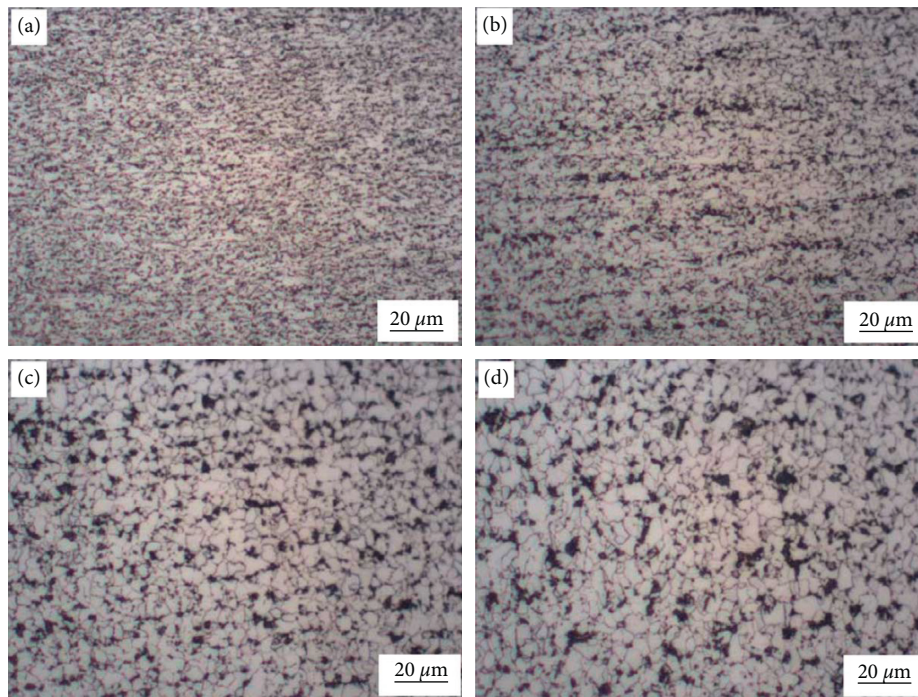
FIGURE 2: Optical microstructure of the weld joint: (a) base metal, (b) heat-affected zone (HAZ) close to the base metal, (c) HAZ close to the weld junction, and (d) weld junction.

3.1. Microstructure and Mechanical Properties of the X70 HFW Pipe. The microstructure of the X70 pipeline steel is a typical acicular ferrite obtained by advanced thermal-mechanical control process (Figure 2(a)). Thus, high strength and toughness were obtained (Table 2). The yield and tensile strengths of the pipe body (i.e., steel plate) were 525 MPa and 620 MPa, respectively, and the average Charpy impact energy was approximately 192 J. However, the acicular ferrite microstructure in the weld seam was disturbed by the HFW and PWHT. The microstructures of the weld junction and heat-affected zone (HAZ) changed to a mixture of ferrite and pearlite (Figures 2(c) and 2(d)). The ferrite grain size gradually coarsened from the base metal to the weld junction (Figures 2(b)–2(d)), and the coarsest microstructure appeared at the weld junction (Figure 2(d)). The coarse microstructure resulted in reduced mechanical properties of weld seam (Table 2). The tensile strength of the weld seam approximately decreased by over 10 MPa than that of the pipe body, and the Charpy impact energy was reduced to 130 J. Nevertheless, the values of the mechanical properties for the X70 HFW pipe remained superior to the specified value of the API specifications for the X70 line pipe.

reliefs were observed in the facets and at the side of secondary cracks. The specific different rupture characteristics presented between the pipe body and the weld joint may be related to the variation in the microstructure at the fracture zone. The microstructure of the pipe body was refined acicular ferrite, whereas the microstructure of weld joint was coarsened polygonal ferrite (Figure 2).

The X70 HFW pipe had high strength, impact toughness (Table 2), and fatigue resistance (Figure 3). Lower mechanical properties appeared in the weld joint. The tensile strength of the weld joint decreased by approximately 15 MPa than that of the pipe body, and the impact energy was reduced from 209 J for the pipe body to 130 J for the weld seam. Meanwhile, fatigue resistance also decreased. The microstructural results showed that the coarsened polygonal ferrite and pearlite were obtained in the weld seam, whereas no obvious oxide and other inclusions were observed (Figure 2). The fatigue fractography shows that the fatigue

that fatigue resistance was largely determined by the yield strength or arguably by the tensile strength. Meanwhile, no oxide inclusions were observed in the microstructure (Figure 2) and fracture surface (Figure 4). Thus, X70 HFW pipe exhibited improved weld quality.

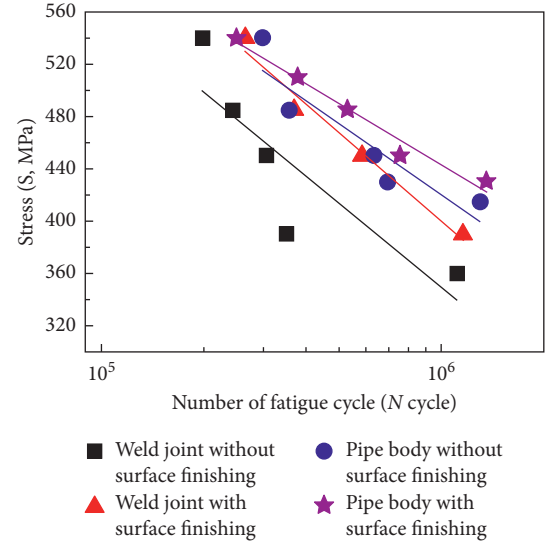
FIGURE 3: Stress-number of fatigue cycle curves evaluated at $R = 0.1$, 10 Hz, and room temperature for the pipe body and the welded joint with and without surface finishing.

3.2. Stress-Number of Fatigue Cycle (S-N) Curves of the X70 HFW Pipe. The pipeline pipes, except the surface coating, do not require any other surface finishing, when they are applied in transmission pipelines. Hence, the fatigue test specimens without surface finishing could better reflect the fatigue properties of a pipeline. The stress (S)-number of fatigue cycle (N) curves obtained from the load control fatigue tests for the pipe body and weld joint without surface finishing were first determined (Figure 3). A considerable decrease (by over 50 MPa) in the resistance to S-N fatigue of the welded joint was observed than that of the pipe body. Kim et al. [23] suggested that the resistance to S-N fatigue was largely determined by the yield strength or arguably by the tensile strength of metals. However, the tensile strength of the welded joint was lower by approximately 10 MPa than that of the pipe body. This result indicates the presence of other factors that affect the resistance to S-N fatigue.

Athanasios et al. [24] reported that fatigue cracks generally originated on the surface of the sample, and this phenomenon greatly affected the fatigue life. To estimate the effect of surface breaking irregularities, the $S-N$ curves of the pipe body and weld joint with surface finishing were also measured (Figure 3). The results show that the surface finishing strongly improved the fatigue performance of the HFW pipe. The resistance to $S-N$ fatigue of the welded joint and pipe body was higher than that of the specimens without surface finishing. The resistance to $S-N$ fatigue of the welded joints was still lower than that of the pipe bodies, with an approximate reduction of 20 MPa. Nevertheless, the resistance to $S-N$ fatigue of the welded joints was higher than that of the pipe bodies without surface finishing.

of the resistance to S - N fatigue for the weld joint were higher than those of the pipe body (Figure 3). Fatigue is always generated on the surface [23–26, 31, 32], which implies that fatigue crack initiation is more sensitive to the surface defects [32]. Thus, fatigue cracks of all specimens were generated on the surface, and more nuclei of fatigue cracks appeared on the surface of the pipe body specimens without surface finishing (Figure 4). Moreover, several small oxidized pit defects on the as-rolled plate surface facilitated the fatigue crack initiation (Figure 5), which resulted in a small reduction in the resistance to S - N fatigue for pipe body without surface finishing (Figure 3). Conversely, a bigger reduction in the resistance to S - N fatigue occurred in the weld joint specimens without surface finishing (Figure 3). Meanwhile, the fatigue crack nucleus became line-like along the weld seam (Figures 4 and 5). Figure 8(b) shows that a raised upset of melted metal formed at the weld seam by squeezing. This formation was named “burr,” and the burr should be removed online by deburring machines. In this case, line-like defects possibly formed along the side of the burr. The orientation for the long surface defect has a great effect on the fatigue crack initiation and propagation [33, 34]. Given that the long surface defect is perpendicular to the principal stress direction, the fatigue cracks will be easily generated at the sharp corners of the long surface defect and quickly propagated in the depth direction [34]. The results of the microstructural observation of the fracture section verified that the fatigue crack of the weld joint specimens without surface finishing was generated at the HAZ (Figure 6). This result was consistent with the burring in Figure 7. Hence, the trails and defects caused by deburring in HAZ were the main reasons for the reduced resistance to S - N fatigue of the weld joint without surface finishing. Nevertheless, compared with our previous work on the X80 submerged-arc welded pipe [22], the decreasing degrees of resistance to S - N fatigue between the weld joint and pipe body were comparable, which were approximately 80 MPa for the X70 HFW pipe and 100 MPa for the X80 submerged-arc welded pipe [22]. The results indicate that the HFW pipes and submerged-arc welded pipe had similar weld qualities.

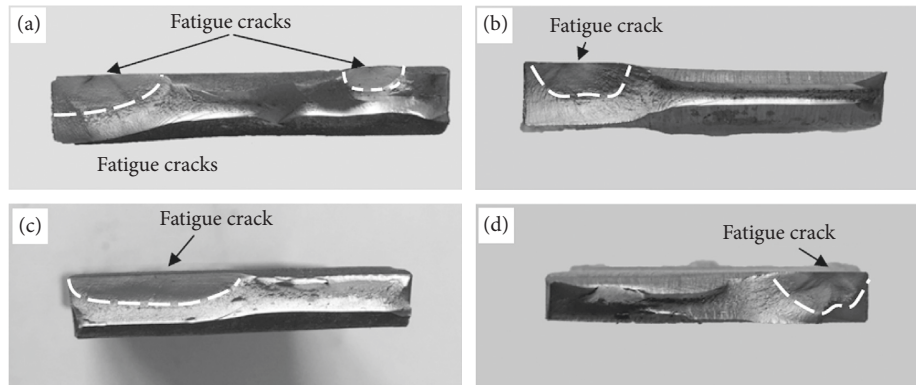
FIGURE 4: Typical macrofractures of the pipe body (a) without surface finishing and (b) with surface finishing and those of the weld joint (c) without surface finishing and (d) with surface finishing.

3.3. Macrofracture Analysis. The typical macrofractography of the specimens after fatigue fracture at same stress is shown in Figure 4. In all cases, the fracture surface contained two

“The flat rupture section” corresponds to the typical of fatigue failure. Within this section, the accumulation of microstructure defects and mechanical property defects in materials may have been caused by cyclic loading [23–25]. Nucleation and propagation of microdefects occurred; that is, a fatigue microcrack was initiated at the accumulated defects. Then, microcracks propagated perpendicular to the cyclic loading and left crack-like tear on the surface of fatigue damage [26]. Nucleation of fatigue failure processes always begin from the surface [27]. Therefore, fatigue crack initiation is sensitive to the micro- and/or macrodefects of the microstructure and mechanical properties near the surface of specimens [26, 27]. Only one of the fatigue cracks was initiated on the fracture surface of the pipe body specimens with surface finishing (Figure 4(a)). By contrast, more than

one fatigue crack was initiated on the surface of the pipe body specimens without surface finishing (Figure 4(b)) because more surface defects may have existed on the surface of the hot-rolled steel plate. The weld joint apparently followed similar rules. Only one of the fatigue cracks initiated at the weld seam was observed on the fracture surface of the weld joint with surface finishing (Figure 4(c)). However, for the weld joint without surface finishing, fatigue crack was apparently generated along the weld seam (Figure 5(d)). The appearance of the fatigue crack initiation may be related to the effect of deburring on the cross-sectional geometry and surface of the weld joint.

3.4. Microfracture Analysis. The macrofractography shows that the fatigue failure processes included fatigue crack initiation, propagation, and final rupture (Figure 4). In these processes, the fatigue crack initiation and propagation are the most important processes that determine fatigue endurance [20]. Therefore, the microfractures caused by crack initiation and propagation were analyzed in detail by SEM (Figures 5 and 6).

crack was initiated at a line defect on the surface of weld joint without surface finishing, which resulted in reduced fatigue resistance (Figure 4). However, the fatigue crack initiation side in the HAZ was confirmed by the microstructural observation of fracture cross section (Figure 7). All results suggest that the weld seam as the weakest location for the X70 HFW pipe was not caused by oxide and other inclusions, which were assumed to be the primary reason for reduced mechanical properties of the weld seam [6]. The law of cause and effect should be considered in searching for a cause to improve the mechanical properties of HFW pipes.

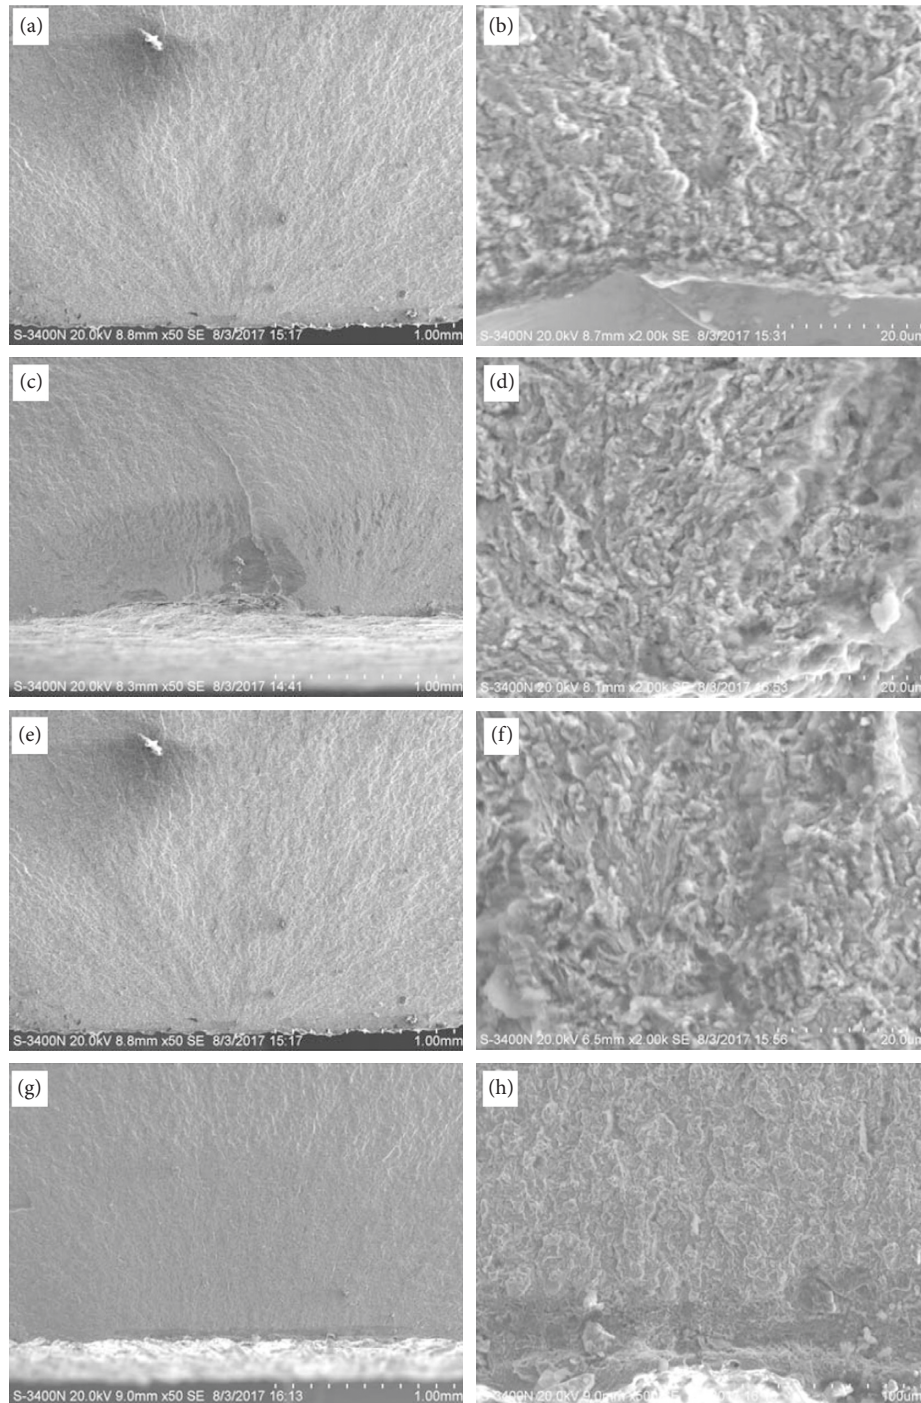
FIGURE 5: Typical fractures at the crack initiation zone of (a–d) the pipe bodies and (e–h) weld joints (a, b, e, f) with and (c, d, g, h) without surface finishing.

3.4.1. Fatigue Crack Initial States. Figure 5 shows the fractography of the initial crack side of all specimens. In the pipe body or weld joint specimens with surface finishing, the fatigue cracks were generated at a small dot scope on the surface and grew inward in radial directions, which were clearly displayed by the river pattern (Figures 5(a) and 5(c)). At the initial crack zone, fine transgranular tear facets were observed on the fracture surface of each specimen in the pipe body or weld joint with surface finishing. No notable difference was observed in the morphology of the fracture mode (Figures 5(b) and 5(d)). The change in failure mechanism from ductile tear manner was responsible for the increased fatigue resistance of pipe body to the weld joint [25].

more than one fatigue crack nuclei were generated at a surface defect of the pipe body specimen without surface finishing and grew to a large fatigue crack (Figure 5(e)). The microfractography showed the fine transgranular tear facets on the fracture surface (Figure 5(f)). This result is similar to the pipe body specimen with surface finishing (Figure 5(b)).

In addition, the fatigue crack of specimens of weld joint was generated with a long line-like crack along the weld seam (Figures 5(g) and 5(h)), and a linear defect was observed on the surface along weld seam (Figure 5(h)). Meanwhile, coarse transgranular cleavage facets compared with the other specimens were observed on the fracture surface (Figure 5(h)). The notable variations in the brittle fracture mechanism may be relative to the “burring” surface defects and coarsening microstructure of the weld seam.

The fractographic results show that the change in fracture manner between the pipe body and the weld joint may be related to the difference in microstructures (Figures 5 and 6). Thus, the fatigue fracture of the weld joint should be the weld seam and HAZ. Figure 7 shows the microstructure near the fracture surface of weld joints with and without surface finishing, as well as the microstructure of the weld seam and HAZ. Figure 7(a) shows that the microstructure near the fracture of weld joint with surface finishing was coarsened polygonal ferrite and pearlite. By contrast, the microstructure near the fracture of weld joint without surface finishing was polygonal ferrite and pearlite with a banded microstructural characteristic (Figure 7(b)). Figure 2 shows that the zone with coarse microstructure of polygonal ferrite and pearlite corresponded to the weld junction, whereas the zone with banded polygonal ferrite and pearlite corresponded to the HAZ. The results were further confirmed by the scanning electron micrographs in Figures 7(c) and 7(d).

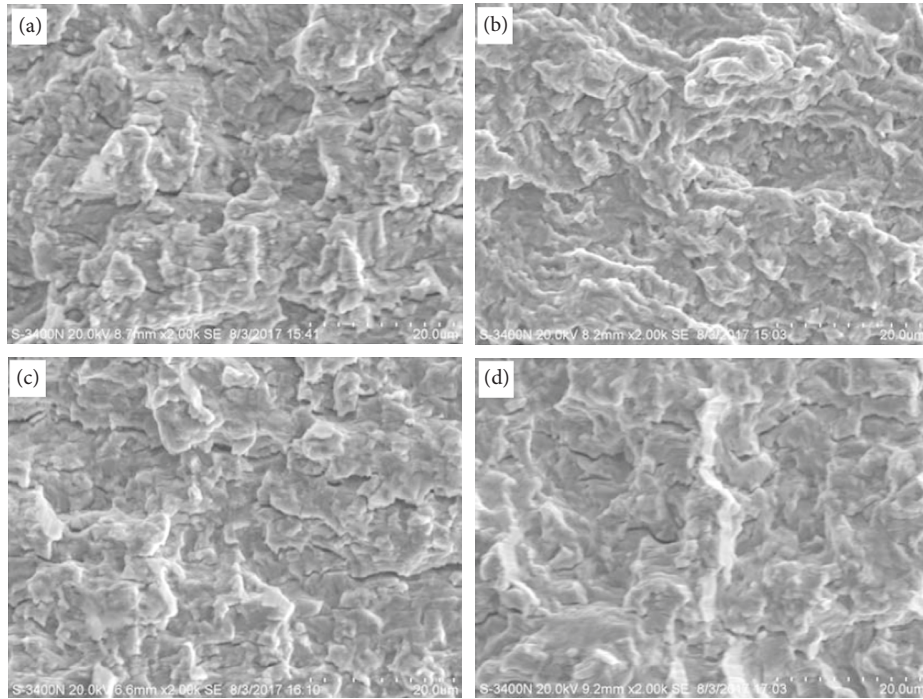
FIGURE 6: Typical fractures at the crack propagation zone of (a, b) the pipe bodies and (c, d) weld joints (a, c) with and (b, d) without surface finishing.

3.4.2. Fatigue Crack Propagation States. Figure 6 shows the microfracture surface at the crack propagation section of the pipe body and weld joint specimens with and without surface finishing. The microfracture surfaces were uniform and contained transgranular cleavage facets and rough relief [26]. Simultaneously, fatigue striations were found on several transgranular cleavage facets and/or on the steps of the roughness reliefs. In addition, certain secondary cracks caused by microtear appeared were found on the surface. However, the facet size on the fracture surface of the pipe body was smaller than the pipe body, and several dot-like

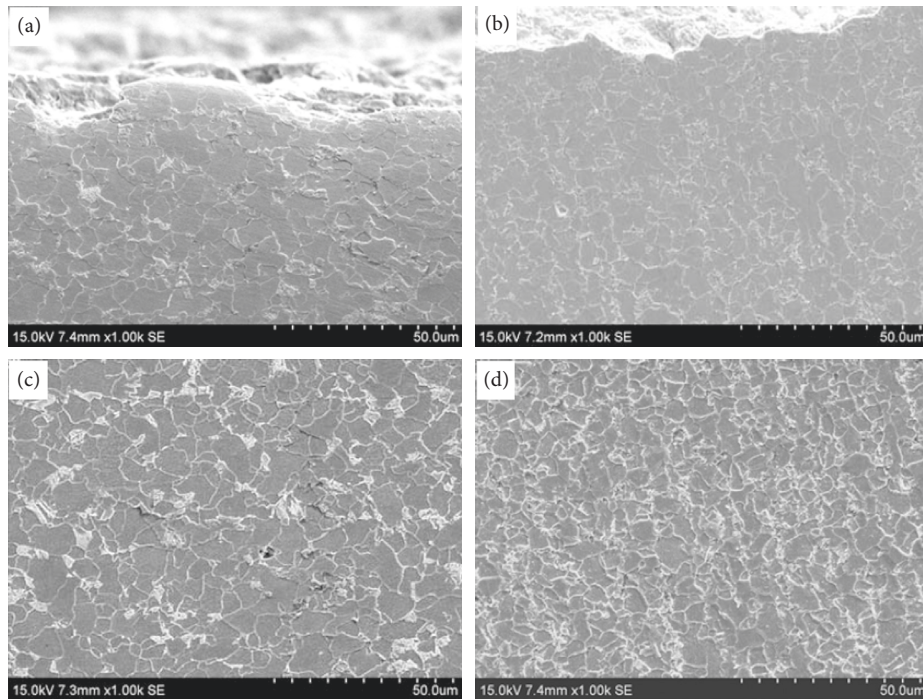
FIGURE 7: Microstructures of the fracture section of the weld joint specimens (a) with and (b) without surface finishing, and the microstructures of (c) weld junction and (d) HAZ.
