Research Article

Effect of High Temperature Sodium Hydroxide Immersion on Fusion Bond Epoxy Coating

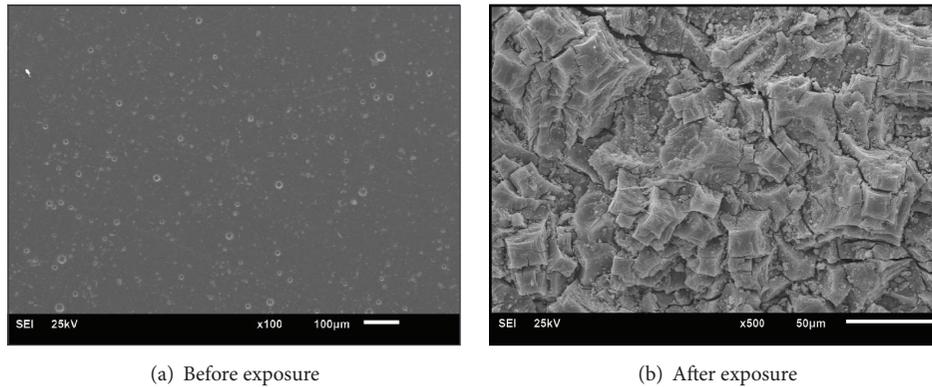
FIGURE 1: SEM surface morphology of Fusion Bond Epoxy coating: (a) before and (b) after exposure to 5% NaOH solution for 30 days at 93°C/200°F.

3.1. SEM/EDAX Analysis. Figure 1 shows the SEM micrographs of FBE coated sample before and after 30 days of exposure to 5% NaOH solution at 93°C. Before exposure, the coating was uniform and consists of surface micropores that might have resulted from coating application (Figure 1(a)). After chemical exposure a marked change in morphology of the exposed sample was observed (Figure 1(b)). The distinctive crystalline features evident on the surface were attributed to the low molecular weight salt deposits and pigments/fillers, indicating coating degradation. The deposit layer formed was dense and well adhered but contains a network of interconnected microcracks. This indicates that the deposit layer was not protective against electrolyte diffusion and instead retards the diffusion of the electrolyte through the coating.

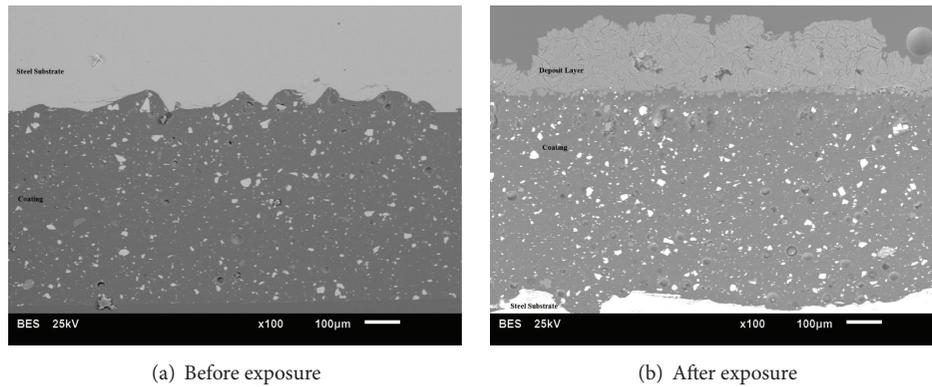
FIGURE 2: SEM cross section analysis of Fusion Bond Epoxy coating: (a) before and (b) after exposure to 5% NaOH solution for 30 days at 93°C/200°F.

To determine the extent of coating degradation along the coating front, a cross section analysis of before exposure and exposed coating was carried out as shown in Figure 2. Comparison of cross section analysis of the before exposure coating with the exposed coating showed extent of coating degradation and unaffected coating zone. Cross section analysis of the exposed coating revealed that the coating thickness has changed from initial average thickness

of 23.0 mils to 30.0 mils due to formation of adhering deposit on the surface, indicating chemical degradation of the coating [2]. The thickness of deposit was about 3.0–4.0 mils, that of discolored zone was 4.0–5.0 mils, and the unaffected zone was 18.0–22.0 mils as determined by SEM. Interaction of alkali with coating was investigated by mapping the distribution of sodium (Na) element from the solution into the coating as shown in Figure 3. Elemental mapping of the exposed coating showed variation in the distribution of Na element at the degraded area and unaffected zone. A high concentration of Na element from the solution was detected in a deposit layer and a uniform distribution in a discolored zone was observed. The unaffected zone detected relatively low distribution of Na element.

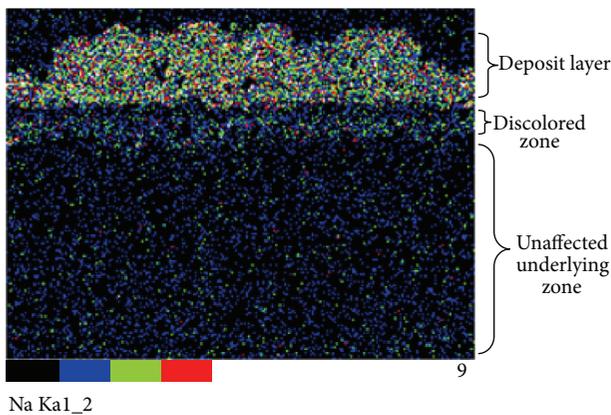
FIGURE 3: EDAX (Na element mapping) analysis of Fusion bond Epoxy coating exposed to 5% NaOH solution for 30 days at 93°C/200°F.

SEM/EDAX analysis showing a formation of adhering deposit layer and a uniform discolored zone underneath is evidence of diffusion of electrolyte through the coating and the degradation of the FBE. It indicates that the coating exposed to hot caustic environment degrade forming a deposit layer as a result of hydrolysis reaction of polymers and leaching of pigments [2, 14–16]. This type of chemical degradation phenomenon is supported by ATR-FTIR analysis.

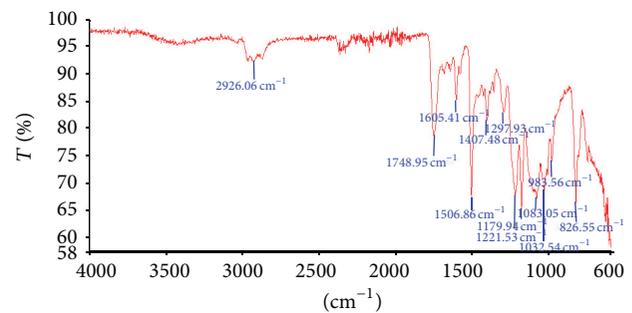
FIGURE 4: ATR-FTIR spectrum of the coating system before exposure.

3.2. ATR-FTIR Analysis. Figures 4–6 show the ATR-FTIR spectrum of the FBE coating system, before exposure, discolored zone, and underlying unaffected zone. Before exposure, the ATR-FTIR spectrum of the FBE coating system showed strong narrow peak at 827 cm⁻¹ was attributed to C-H absorption of para-disubstituted benzene rings. The medium strong and broad absorption bands in the range of 1033–1083 cm⁻¹ were assigned to the stretch vibrations of the aliphatic functional groups C-O. Absorptions observed at 1181 cm⁻¹ and 1221 cm⁻¹ were caused by the stretching vibration of aromatic ether C-O, in-plane deformation of C-O of

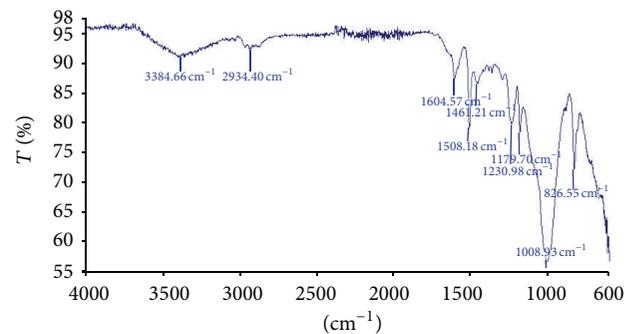
FIGURE 5: ATR-FTIR spectrum of the discolored zone of the coating system after exposure.

After exposure to sodium hydroxide solution several distinctive changes were observed as indicated by appearance of a new peak at 3385 cm^{-1} associated with hydroxy group (-OH) indicating diffusion of electrolyte through the coating [17]. Also, the peak at 1749 cm^{-1} completely disappears and the peak at 1508 cm^{-1} decreases and at 1460 cm^{-1} increases in intensity. Similar changes in the chemical structure of epoxy resin cured with acid anhydride type curing agent after immersion in NaOH solution at high temperature are reported by Hojo et al. [2, 18]. According to the study, these changes are due to the hydrolysis of the ester groups and the subsequent leaching of the low molecular mass in the caustic environment. The hydrolysis of epoxy coating under chemical attack by alkali results into scission of polymeric chain. The hydrolytic reaction by alkali is expressed as follows [15, 19].

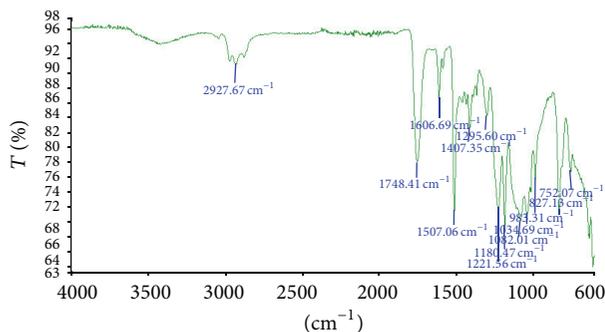
FIGURE 6: ATR-FTIR spectrum of the underlying layer of the unaffected zone.

No appreciable changes in ATR-FTIR characteristic of underlying un-affected zone were observed, except for increase in the intensity of peak at 1456 cm^{-1} , when compared with the spectra of the coating before exposure. However, no sign of hydrolysis or formation of carboxylate salt (Figure 8) was observed, as evident by absence of Na element evaluated by EDAX analysis.

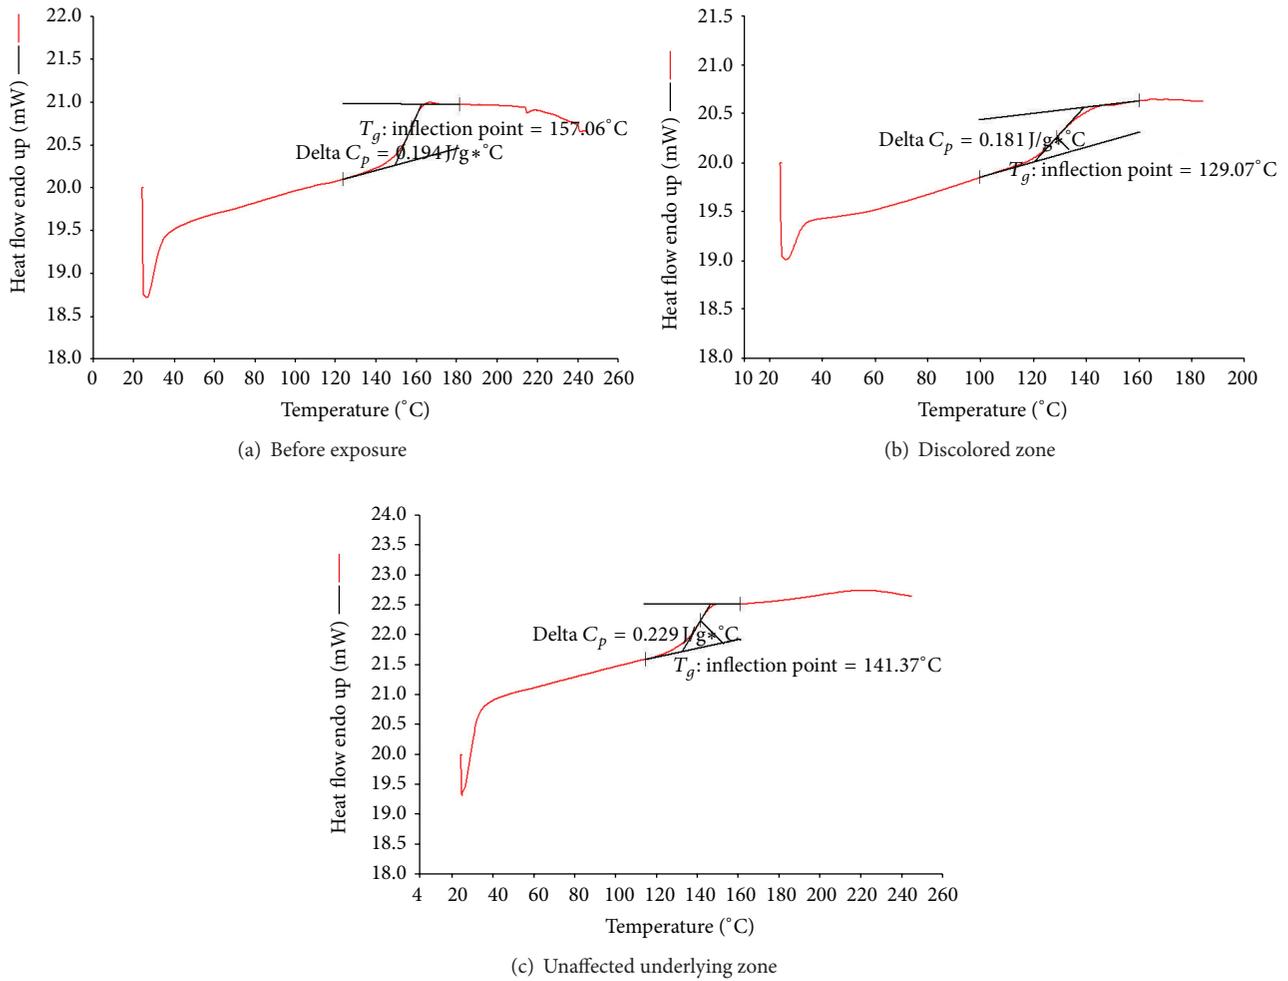
FIGURE 9: DSC scans of FBE coating system: (a) before exposure and after exposure to 5% NaOH solution for 30 days at 93°C/200°F (b) discolored zone, and (c) unaffected underlying zone.

3.3. DSC Analysis. Figure 9 shows the DSC scans of the FBE coating system, before exposure, discolored zone, and underlying unaffected zone. The glass transition temperature (T_g) of the coating before exposure was 157°C (Figure 9(a)). After exposure, T_g of the discolored zone decreased substantially to 129°C (Figure 9(b)), indicating that at high temperature

T_g of underlying unaffected zone of the coating after the immersion test referred to as a “wet T_g ” was about 141°C (Figure 9(c)), a relatively small change when compared with T_g of 157°C for the untested one. This reduction in T_g of 16°C of underlying unaffected zone was due to absorption of water molecule in a polymer matrix as a result of capillary uptake by existing pores in the coating system [21, 22]. This observation was supported by similar change in T_g value of 141°C after saturation of the FBE coating in distilled water for 30 days at $93^\circ\text{C}/200^\circ\text{F}$ as shown in Figure 10.

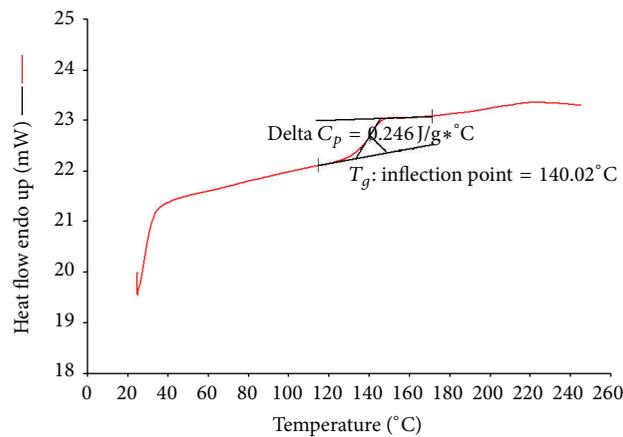
FIGURE 10: DSC scan of FBE coating system after immersion in distilled water for 30 days at 93°C/200°F.

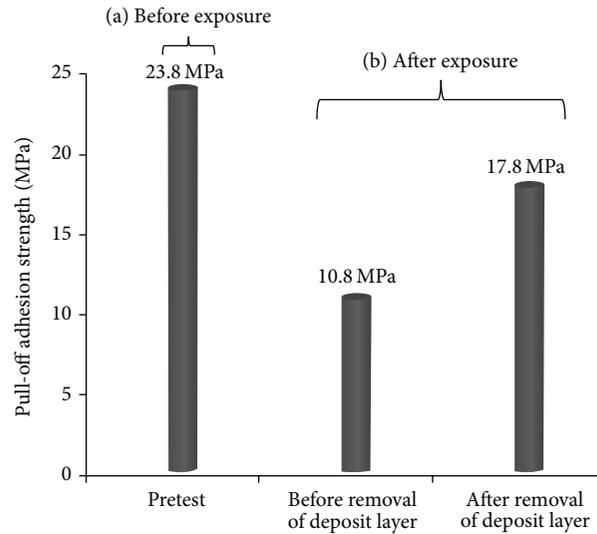
FIGURE 11: Pull-off adhesion strength of Fusion Bond Epoxy coating: (a) before and (b) after exposure to 5% NaOH solution for 30 days at 93°C/200°F.

3.4. Pull-Off Adhesion Strength. Figure 11 shows the average pull-off adhesion strength of the FBE coating before and after exposure to 5% NaOH for 30 days at $93^\circ\text{C}/200^\circ\text{F}$ determined on triplicate samples. Before exposure, the coating showed the adhesion strength of 23.8 MPa and did not fracture within itself or disbond from the substrate indicating that the coating possesses good adhesion strength. After exposure, the pull-off adhesion strength of the coating without removal of the deposit layer was 10.8 MPa and fractured cohesively within the deposit layer. The pull-off adhesion strength after removal of the deposit layer was 17.8 MPa and did not fracture within itself or from the substrate. The result indicated that the bulk adhesion strength of the coating was not affected after exposure to the alkaline environment [23].

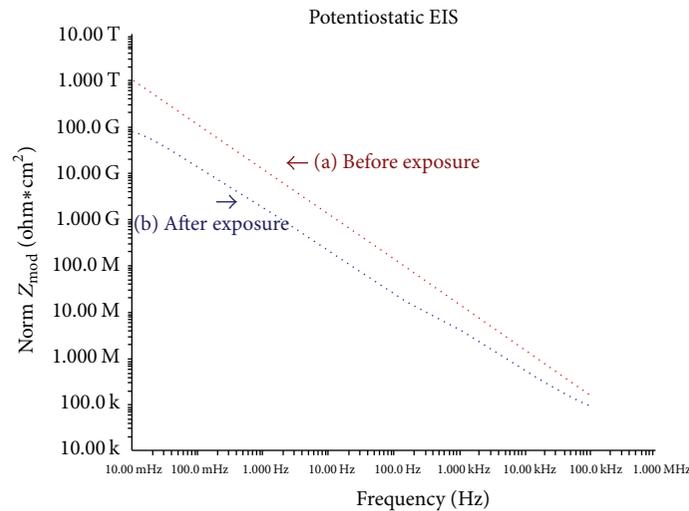
FIGURE 12: EIS Bode magnitude plots of the Fusion Bond Epoxy coating: (a) before and (b) after exposure to 5% NaOH solution for 30 days at 93°C/200°F.

3.5. Electrochemical Impedance Spectroscopy (EIS). Figure 12 shows the Bode plot of the coating before and after exposure to 5% NaOH for 30 days at $93^\circ\text{C}/200^\circ\text{F}$, determined using EIS. The high frequency region of the Bode plot provides information about coating characteristics; the low frequency region provides information about processes occurring near the metal surfaces. Generally, the coatings with resistance over $10^8\ \Omega\text{cm}^2$ provide good corrosion protection, while those with resistance under $10^6\ \Omega\text{cm}^2$ provide poor corrosion protection [24, 25]. Analysis of the low frequency region at 0.1 Hz of the Bode plot indicates that the coating system has effective barrier properties. Initially before exposure, the Bode plot of the coating shows a straight line of slope -1 with high impedance value of $1.21 \times 10^{11}\ \text{ohm}\cdot\text{cm}^2$ at low frequency, indicating that the coating system behaved like a pure capacitor. After 30 days of exposure to NaOH solution, the coating maintained high impedance characteristics and showed the impedance value of $1.49 \times 10^{10}\ \text{ohm}\cdot\text{cm}^2$, indicating retention of the barrier property. The high impedance

value of the coating on exposure to 5% NaOH solution at high temperature may be attributed to the formation of the deposit layer that retards the diffusion of electrolyte through the coating.
