Figure S1: An overview of the effects of water management in GDLs on carbon corrosion rate in the catalyst layer.

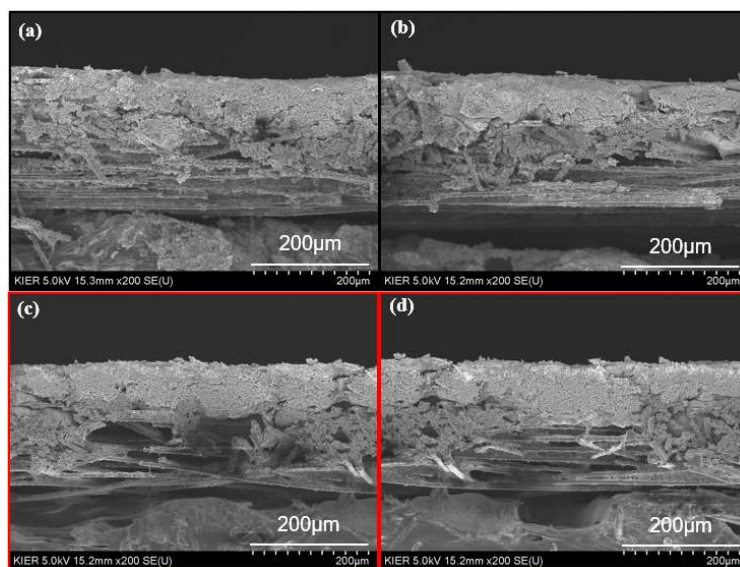
Figure S2: SEM images of fresh GDLs measured twice (a) GDL A 1st, (b) GDL A 2nd, (c) GDL B 1st, and (d) GDL B 2nd.

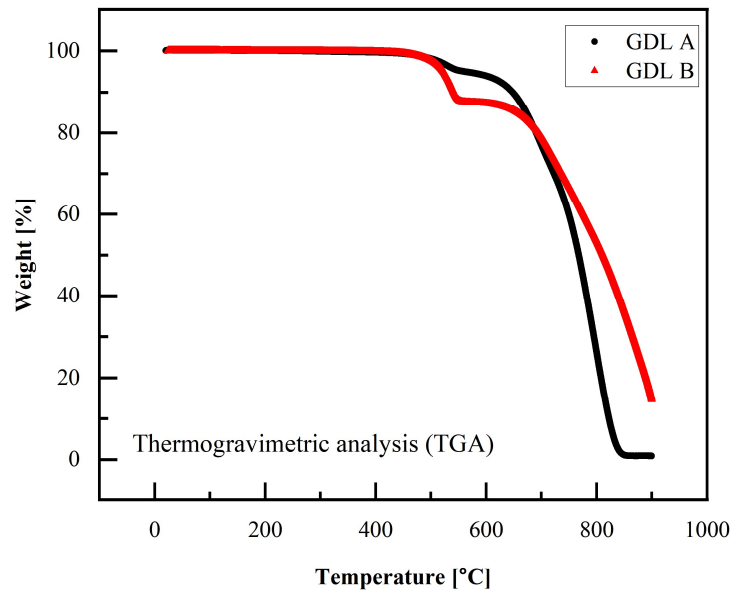
Figure S3: TGA curves of GDL A and GDL B in nitrogen for a heating rate of $10\text{ }^{\circ}\text{C min}^{-1}$.

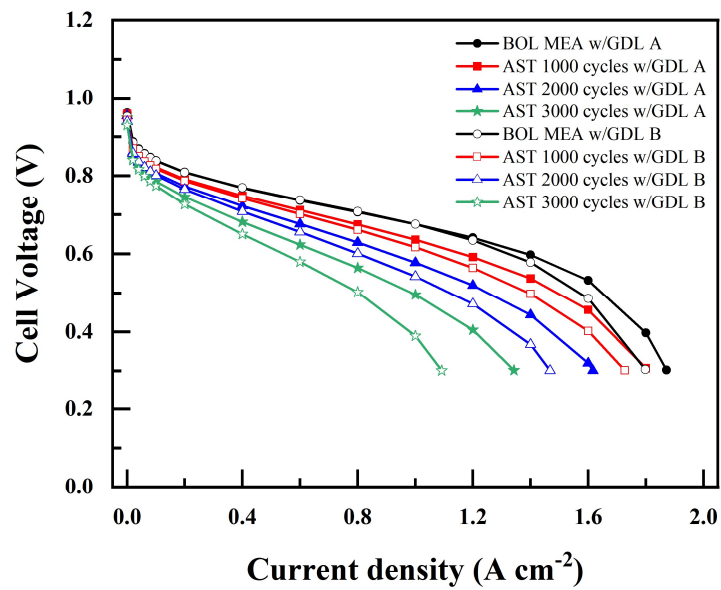
Figure S4: Polarization curves obtained over 3,000 cycles using the modified AST.
