Terahertz Spectroscopy and Imaging Detection of Defects in Civil Aircraft Composites

In this work, terahertz time-domain spectroscopy and imaging technology were used to nondestructively detect low-velocity impact damage defects in CFRP composite laminates. The terahertz spectra of defects were extracted, and their characteristics were systematically analyzed. The time- and frequency-domain imaging displays of defects were obtained, and the detection of these defects was discriminated and analyzed.

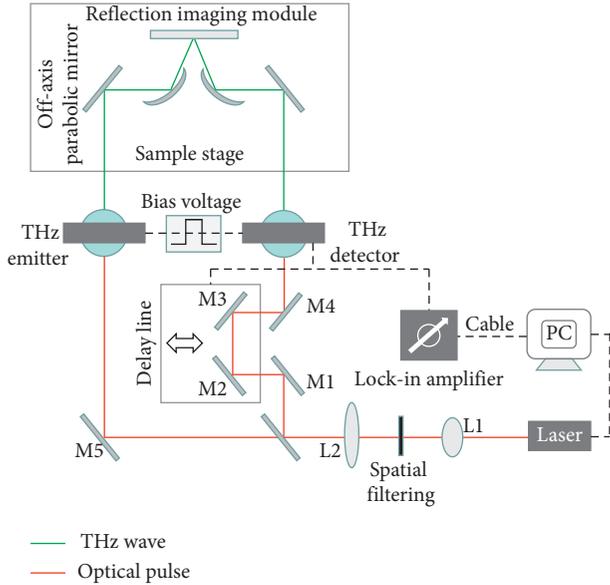
FIGURE 1: Schematic of the THz-TDS imaging system in reflection mode.

2.2. Experimental Apparatus. A CCT-1800 series terahertz time-domain spectroscopy (THz-TDS) imaging system (China Communication Technology (CCT) Co., China) was used, in addition to a terahertz time-domain spectral analyzer, reflection imaging module and data-acquisition system, and analysis software. A schematic of the THz-TDS imaging system in reflection mode is shown in Figure 1. A 780 nm fiber femtosecond laser (Menlo Systems, Germany) was used as excitation source in the system. Via the beam splitting mirror, the system was divided into pump and probe beams, which were transformed to terahertz waves with a stable excitation and reception spectrum ranging from 0.06 to 4 THz, respectively. The optical delay was 54 ps, and the spectral resolution and dynamic range were up to 20 GHz and 80 dB, respectively. The THz-TDS reflection imaging mode was used to scan the specimens on a two-dimensional platform. The sampling rate of waveforms was 15 Hz, the minimum scanning step was 0.08 mm, and the maximum scanning range was 50 mm × 50 mm.

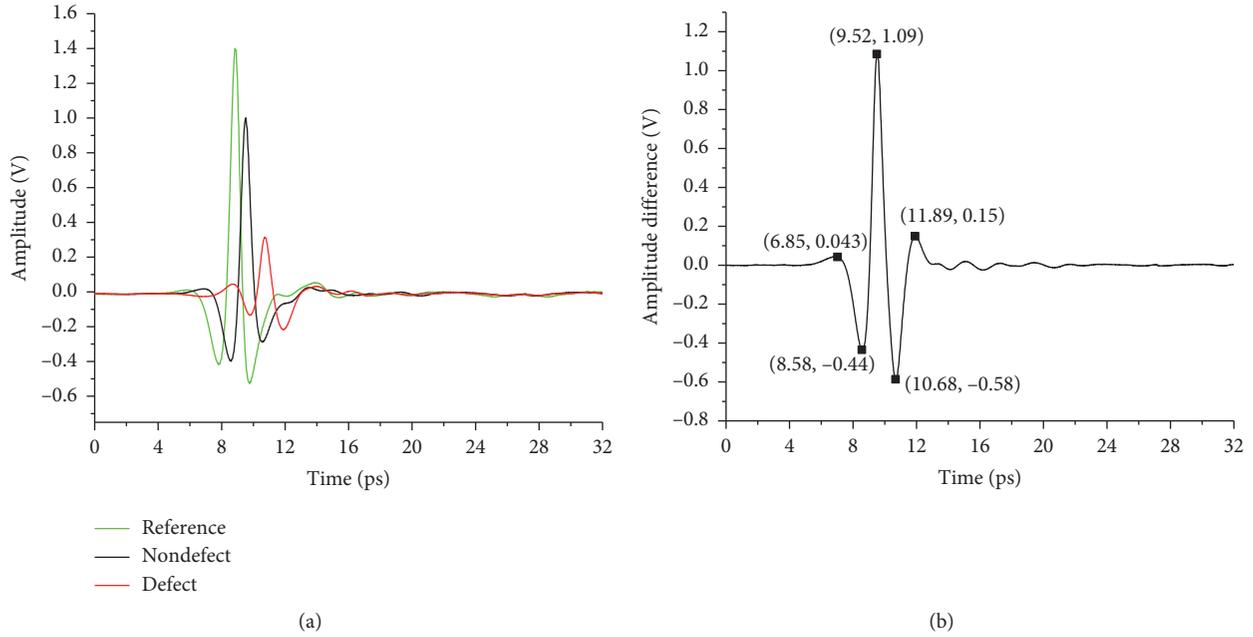
FIGURE 2: Terahertz waveforms of the experimental specimen: (a) time-domain waveform; (b) time-domain signal amplitude difference between the defect and nondefect sites.

3.1. Time-Domain Waveform and Imaging. Figure 2 shows the terahertz time-domain signal waveforms of the defect and nondefect specimens. It can be seen from Figure 2(a) that the sample signal exhibits an amplitude attenuation and a time delay relative to the reference signal. In addition, the amplitude signal intensity at the defect site also has greater attenuation and time delay than those at the nondefect sites. The maximum amplitude of the defect site is approximately 32% of the nondefect sites, and the time delay is 1.19 ps. Because of the different reflection, transmission, and loss of the signal in the discontinuous interface composed of air or resin between composite layers, the amplitudes of the reflected signal that was detected are therefore different. The time delay in the reflection signals of the defective and nondefective parts is due to the different refractive indexes of air and resin. Figure 2(b) shows the difference in signal amplitude between the defect and nondefect sites in the time domain. On the time axis, the difference between the defect and nondefect sites at different times is quite different, and the imaging can be performed according to local eigenvalues.

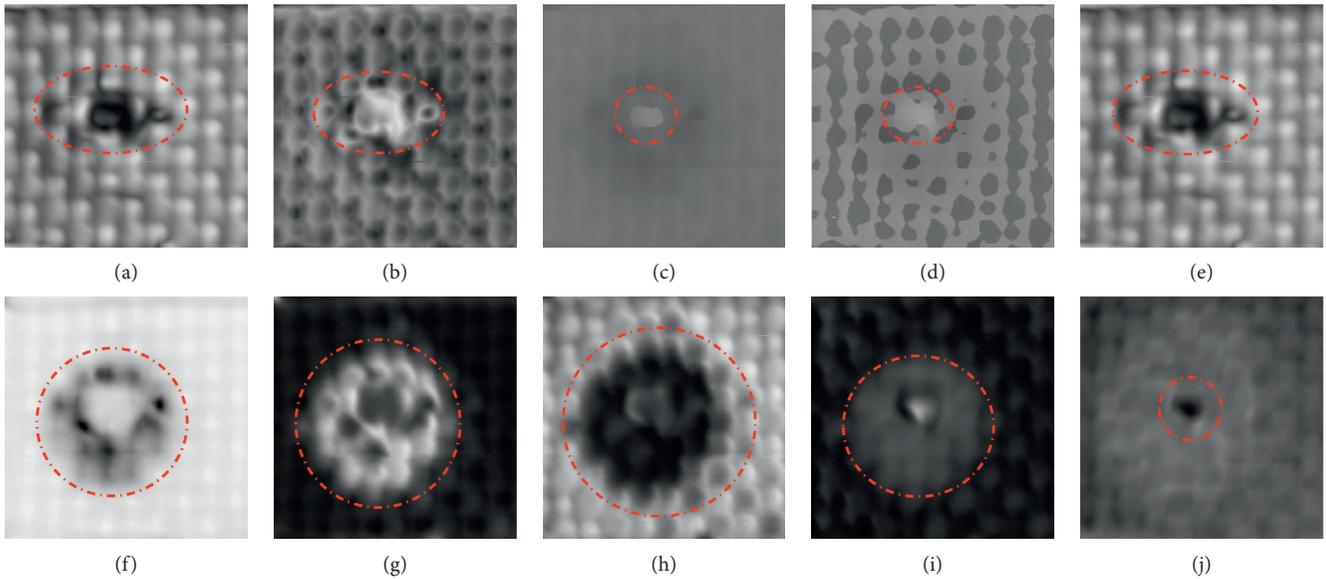
FIGURE 3: Time-domain signal imaging at defect of specimen: (a) time-domain maximum peak; (b) time-domain minimum peak; (c) maximum flight time; (d) minimum flight time; (e) peak-to-peak; (f) $t = 6.85$ ps; (g) $t = 8.58$ ps; (h) $t = 9.52$ ps; (i) $t = 10.68$ ps; (j) $t = 11.89$ ps.

Figure 3 shows the time-domain signal imaging results of the defect in the tested specimens. Figures 3(a)–3(e) present the imaging results based on the maximum peak, minimum peak, maximum flight time, minimum flight time, and peak value in the time domain, respectively. It is clear that these imaging results are obviously weaker than those obtained by

choosing the characteristic time of the difference between the amplitudes of the defect and nondefect sites. As seen from Figures 3(f)–3(j), the former imaging only shows a small number of severely damaged structural areas, but does not fully show the impact damage defects in the specimen. Additionally, it has the shortcomings of low resolution and blurred edges. The result of amplitude difference imaging is due to the amplitude difference between $t = 6.85$ ps and $t = 11.89$ ps being small, the contrast between the defect and nondefect in corresponding images being weak, and the edge being blurred, which makes it difficult to completely distinguish the impact damage defect. However, the image contrast between the defect and the nondefect is obvious, and the edge is clear at $t = 8.58$, 9.52 , and 10.68 ps, where the defect expands from the impact center to an approximately circular area. It is helpful to distinguish the impact damage in the specimen completely, so the defect can be detected quantitatively.

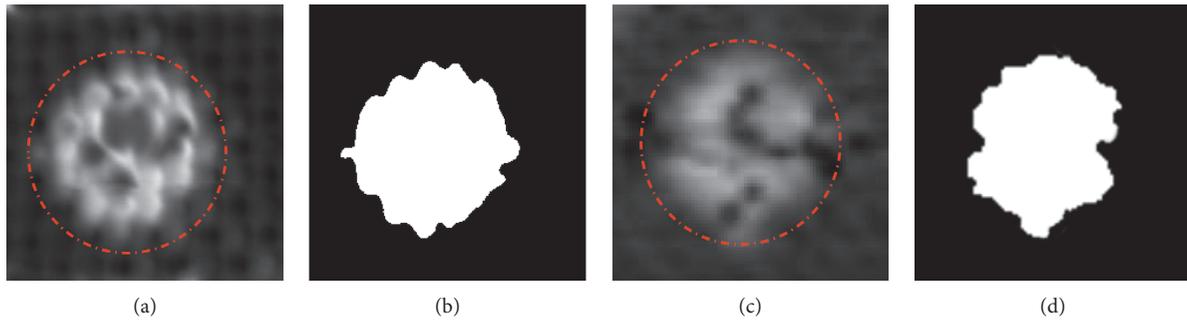
FIGURE 4: Detection images and extraction results at defect of specimen: (a) time-domain signal imaging; (b) defect extraction result of time-domain signal imaging; (c) infrared imaging; (d) defect extraction result of infrared imaging.

Because the amplitude difference was the largest when $t = 9.52$ ps, the image was used to segment and extract the defect, as shown in Figures 4(a) and 4(b), and the defect area was 210.125 mm^2 . We have used thermal imaging technology to detect the defect and obtained that the defect area is 202.742 mm^2 , which is shown in Figures 4(c) and 4(d), respectively. It can be found that the resolution of terahertz imaging is obviously higher than that of infrared imaging, and the edge is not fuzzy, which is beneficial to the extraction of defects. By comparing the results of the two technologies, the relative error is 3.6%, which is satisfied with the damage detection requirements of CFRP composite in in-service aircraft. It is shown that terahertz time-domain spectroscopy and imaging technology has a higher accuracy in detecting such defects.

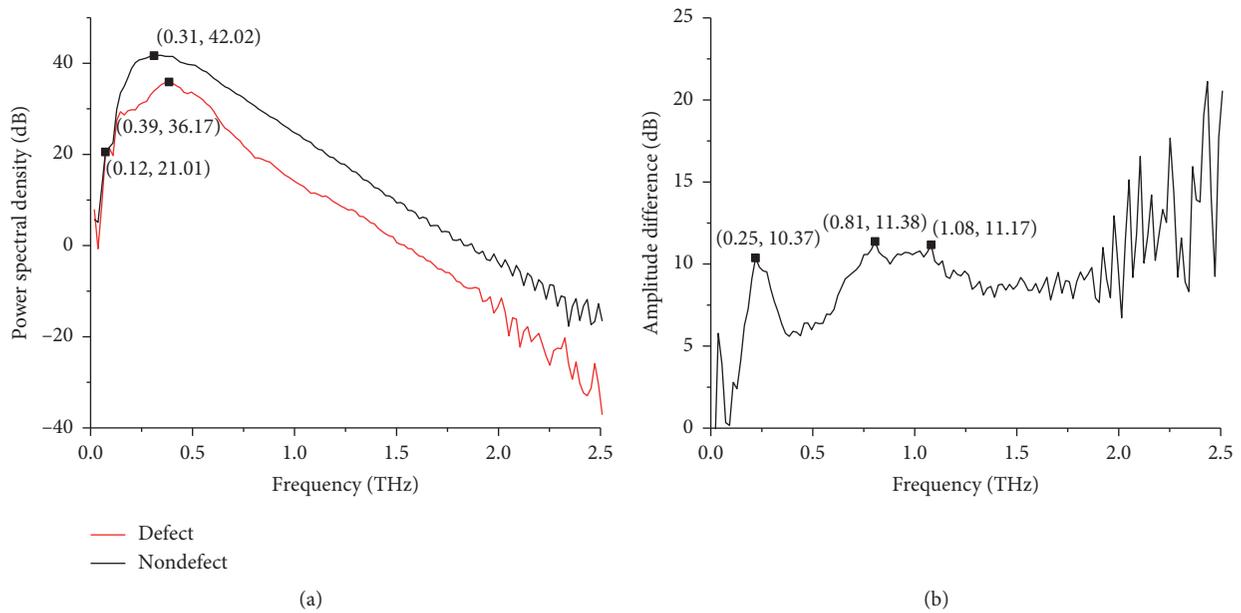
FIGURE 5: (a) Power spectral density waveform. (b) Power spectral density amplitude difference.

3.2. Power Spectral Density Waveform and Imaging. Figure 5 shows the power spectral density waveform and its amplitude difference between the defect and the nondefect sites in the specimen. It is clearly seen from Figure 5(a) that the general trend of reflection signals at the defect and nondefect in the frequency domain is to first increase and then decrease with increasing frequency. It is reported that the absorption and dissipation of polymer resin in terahertz band are low, mainly due to dipole polarization and relaxation dissipation [21]. The frequency-domain signal at the defect reaches its peak at 0.31 THz, and the frequency-domain signal at the nondefect reaches its peak at 0.39 THz, and the amplitude at the defect is relative to that at the nondefect. The attenuation of the defect contributes to the different absorption spectra of the interlayer resin and air in the terahertz frequency range, as well as to the light dispersion and absorption of the specimen structure itself and the defect. When the frequency is less than 0.12 THz, the frequency-domain signals are basically the same, and the two signals attenuate seriously after becoming larger than 2.0 THz, which contains a significant amount of interference noise. Therefore, the effective detection band for this defect is 0.12–2.0 THz. It can be seen in Figure 5(b) that the

amplitude difference waveform between the defect and nondefect is not uniform, and there are local eigenvalues. The corresponding frequency points of $f = 0.25, 0.81,$ and 1.08 THz at the peak of the amplitude difference are selected for imaging, and the corresponding detection results are illustrated in Figure 6.

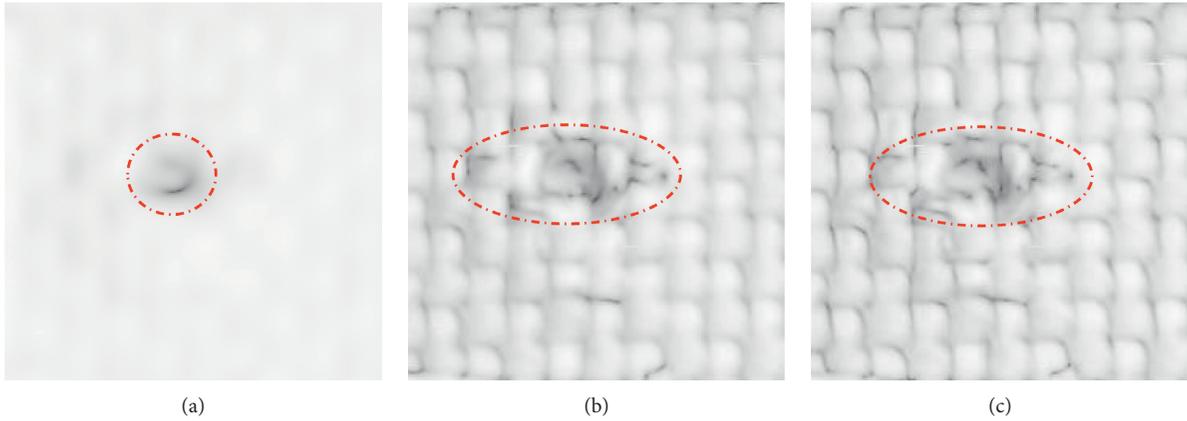
FIGURE 6: Imaging of power spectral density at defect of specimen: (a) $f=0.25$ THz; (b) $f=0.81$ THz; (c) $f=1.08$ THz.

Comparing the results of Figures 6 and 8, it is concluded that the image with a larger amplitude difference between 0.81 and 1.08 THz is better than that with a smaller amplitude difference at $f = 0.22$ (or $f = 0.25$ THz). Moreover, the aforementioned images only show a small number of severely damaged areas in the impact center, and the

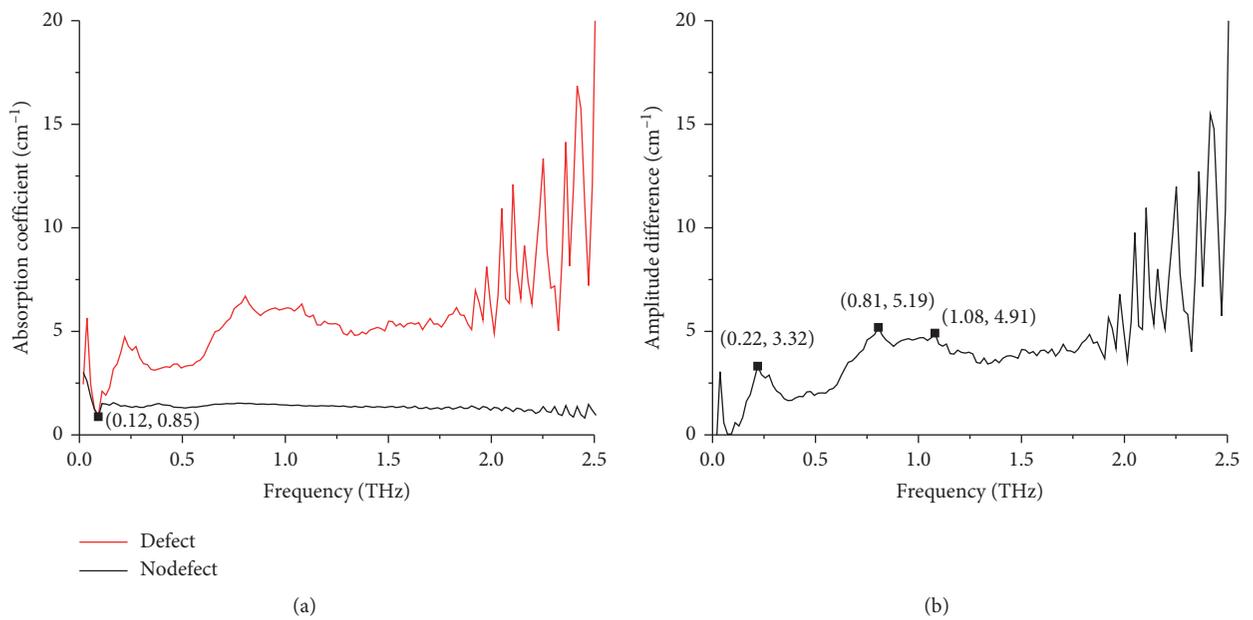
FIGURE 7: (a) Absorption coefficient waveform. (b) Absorption coefficient amplitude difference.

3.3. Absorption Coefficient and Imaging. Figure 7 shows the waveform of the absorption coefficient and its amplitude

difference between the defect and nondefect in the specimen. Figure 7(a) clearly shows that the absorption coefficient of the nondefect site remains relatively stable. The overall trend of the absorption coefficient of the defect site increases slowly with increasing frequency, and its value is significantly higher than that of the nondefect site. The increase of absorption coefficient is mainly caused by the structural destruction at the defect of CFRP, which is related to the composite material's complex refractive index to terahertz light. In addition, it is clearly found that the difference of

absorption coefficient is small when the frequency is less than 0.12 THz, and the noise region appears at 2.0 THz. Comparing Figure 7(a) with Figure 5(a), the absorption coefficient of the defect is inversely related to its power spectral density. In Figure 7(b), obvious characteristic peaks exist at 0.22, 0.81, and 1.08 THz that correspond to the characteristic points of the power spectral density amplitude difference in Figure 5(b). The aforementioned characteristic peaks are considered to be caused by the fiber structure, epoxy resin, and defects in the specimens [16, 23]. The corresponding frequency points $f = 0.22$, 0.81, and 1.08 THz corresponding to the peak value difference of the absorption coefficient between the defect and nondefect are selected for imaging, and the corresponding detection results are shown in Figure 8.

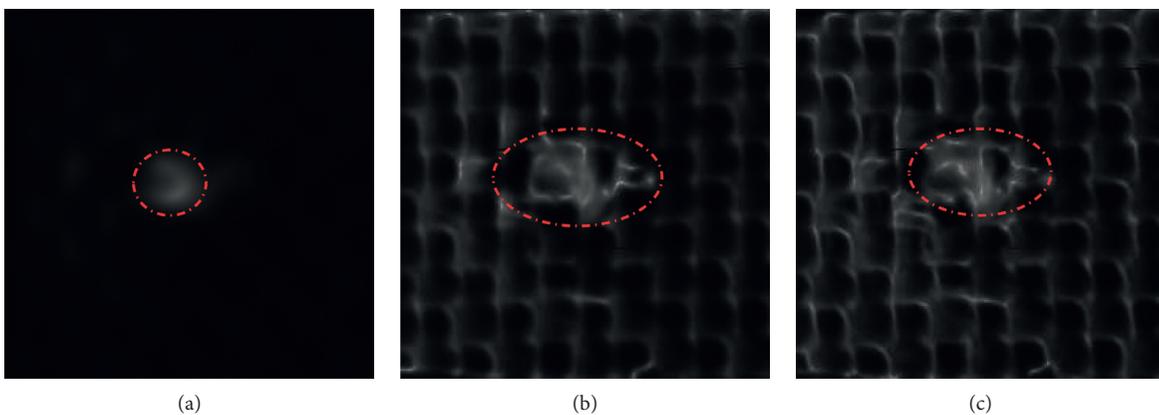
FIGURE 8: Imaging of absorption coefficient at defect of specimen: (a) $f=0.22$ THz; (b) $f=0.81$ THz; (c) $f=1.08$ THz.
