## Research Article

# In Vivo Corrosion Behavior of Biodegradable Magnesium Alloy by MAF Treatment

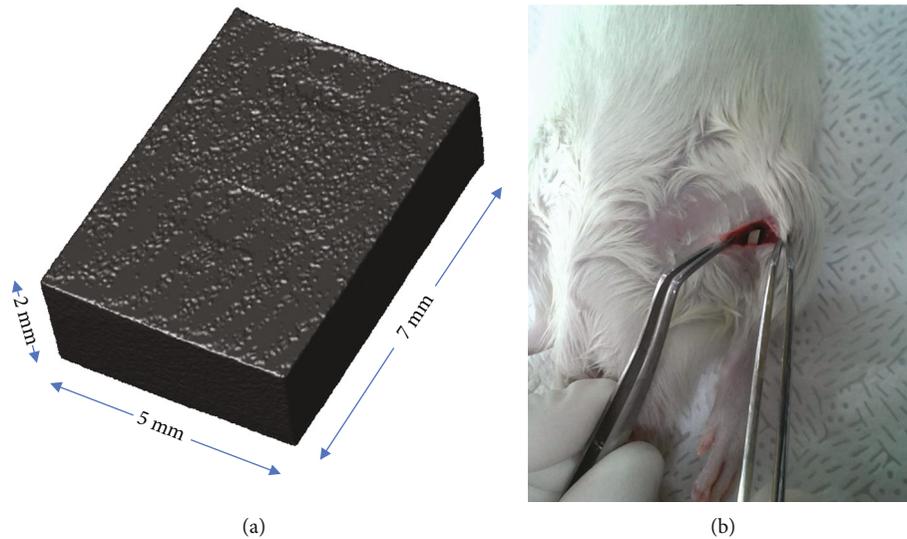
FIGURE 1: In vivo corrosion control samples and intraoperative diagrams in rats. (a) Stereoscopic imaging of the sample and annotation of the sampling size. (b) Preparation of an in vivo corrosion model in rats and surgical burial of the sample.

**2.4.2. Surgical Procedures.** Firstly, the rats were anesthetized with isoflurane (Isolurane inhalation anesthetic solution; Pizer Japan Inc., Tokyo, Japan). Peel off the skin, fascia to expose the anterior tibial muscle. A sample was buried between the right tibial muscle and periosteum by dental round-bar and a nontaper tissue bar. Then, press the implant and flushed with saline, which can be seen in Figure 1. The wound was closed by suture needle (Nylon suture 5-0; Natsume seisakusho Co., Ltd.). After suturing the incision, put the rat on the pad until they recovered from the anesthetic state. For postoperative analgesia, 0.5 mL of transaminopurine hydrate (sulpyrine injection 250 mg NP; Nipro Pharma Corporation, Osaka, Japan) was added to in rats’ drinking water as anti-inflammatory and analgesic for two weeks. At the end of the experiments, the rats were anesthetized with

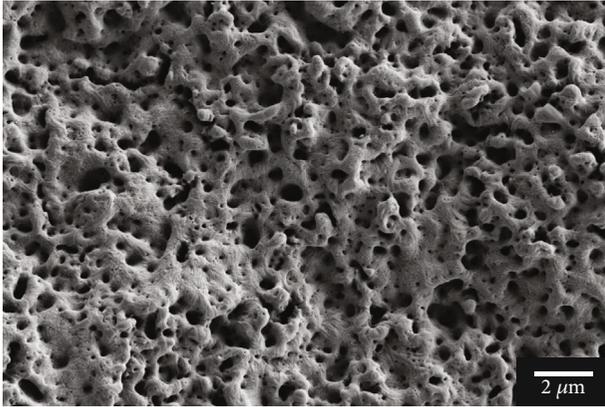
FIGURE 2: FE-SEM observing surface morphology after MAF coated.

**3.1. Specimen Surface Morphology.** Figure 2 illustrates the surface morphology of the MAF group under scanning electron microscopy before it was placed in the body. The surface of  $\text{MgF}_2$  coating was uneven and porous, coral-like.

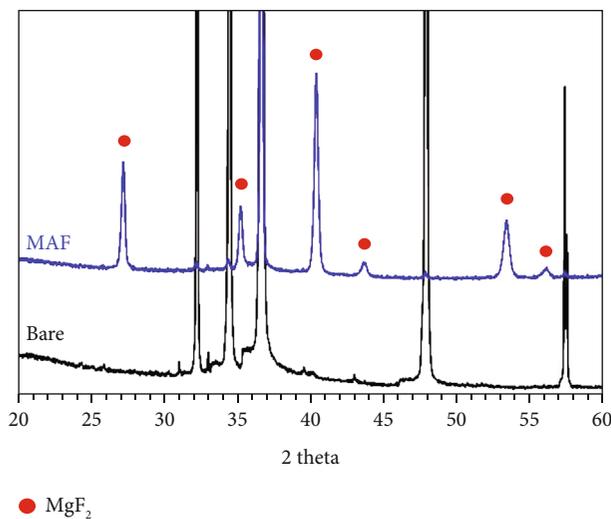
FIGURE 3: XRD patterns of the Bare and the MAF.

Figure 3 presents the XRD curves of the Bare and the MAF sampling groups. Comparison of the untreated with the JCPDS standard card indicates that the coating of the treated sample consists of quadrilateral  $\text{MgF}_2$  (JCPDS No. 41-1443) mainly. EDS analysis showed that the coating surface was dominated by F and Mg elements, which accounted for 61.04% and 38.41%, respectively, as shown in Figure 4.

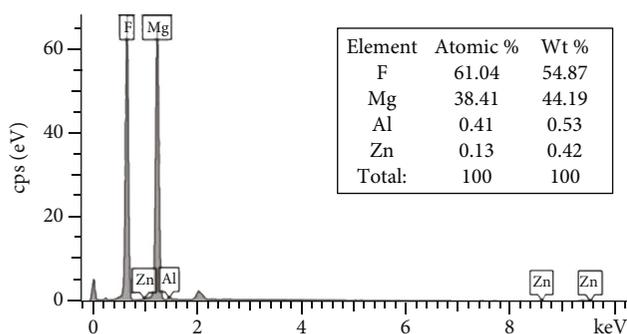
FIGURE 4: EDS spectra of the MAF coating and percentage of element composition.

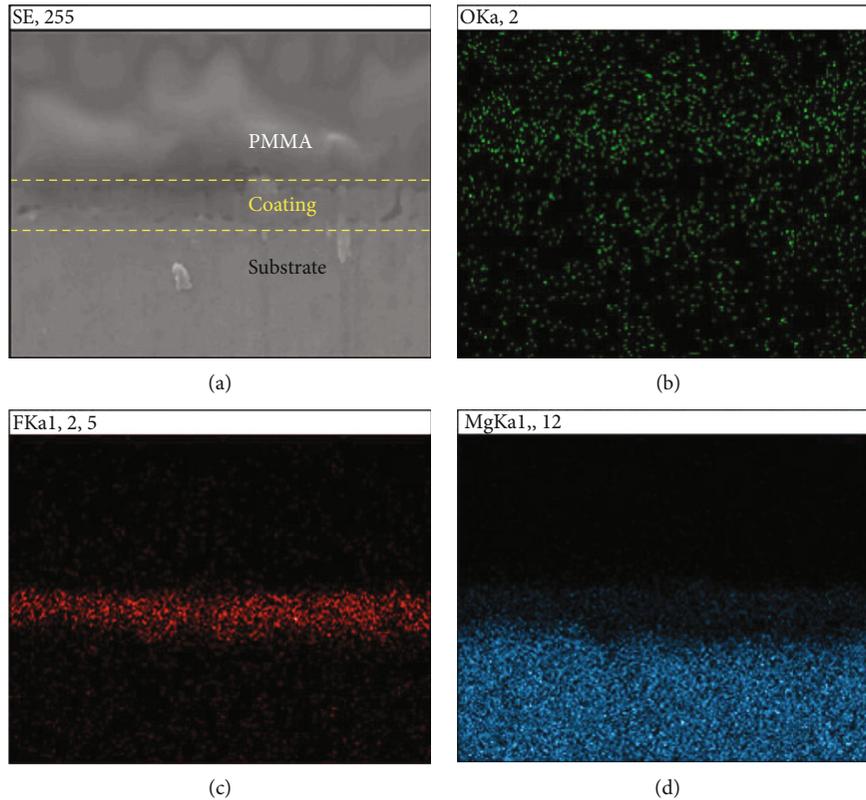
FIGURE 5: Cross-sectional electron microscopy images and energy diffraction spectra of the MAF coating. (a) Cross-sectional morphology observed under the SEM. Cross-sectional elemental mapping assay of the coating by EDS. (b–d) The results of the distribution of the three elements, oxygen, fluorine, and magnesium, respectively.

Figure 5 gives the SEM scan of the cross-section of the MAF group. From Figure 5(a), it can be seen that a layer

appeared between the Mg alloy substrate and PMMA, i.e., on the surface of the base. According to the EDS mapping analysis, F elements were only distributed in the upper layer of the samples (Figure 5(c)), averaging 4.26  $\mu\text{m}$  thick. The middle part of the coating was more evenly spaced. The density of fluorine elements decreased as closer to the substrate, and the Mg elements in this depth were relatively sparsely distributed compared to the deeper part (Figure 5(d)). A combination of Figures 5(c) and 5(d) reveals a simultaneous distribution of Mg and F in this domain.

The corrosion tests in the *in vivo* environment were performed in combination with existing *in vitro* experiments on the MAF coating treatment. The composition, surface morphology, and electrochemistry of MAF-coated magnesium alloys have been evaluated to some extent by *in vitro* experiments in previous studies, with more satisfactory results [15–17]. In this experiment, the processed AZ31 samples were processed at 190 V constant voltage mode. Figure 2 shows the rough coral-like surface morphology of the microarc fluoride treated magnesium alloy, similar to previous MAF coatings at high voltages [15, 16, 30]. Figure 5(a) shows that the fluoride coating with a thickness of 4.26 μm is evenly distributed on top of the magnesium substrate. The distribution of oxygen elements throughout the section in Figure 5(b) is,

we speculated, due to the internal magnesium exposure caused by the casting and grinding. Oxidation reactions with the air will form a thin oxide film. Because of the short reaction time, there is not much oxygen content. By the infiltrative distribution of fluorine elements in Figure 5(c), it can

be assumed that the surface of the substrate is transformed into a fluorinated layer during the electrochemical process. As the fluoride layer grows inward and outward simultaneously, the geometry of the magnesium alloy slightly changes [5]. This also leads to a relative decrease in the distribution density of magnesium in the part of the coating in contact with the substrate. The chemical reaction leads to the combination of magnesium and fluorine atoms, which changes the original distribution of the elements. In addition, the corrosion current density and corrosion potential of the postcoated samples are analyzed by PDP experiments. A significant enhancement of the corrosion resistance can be observed.

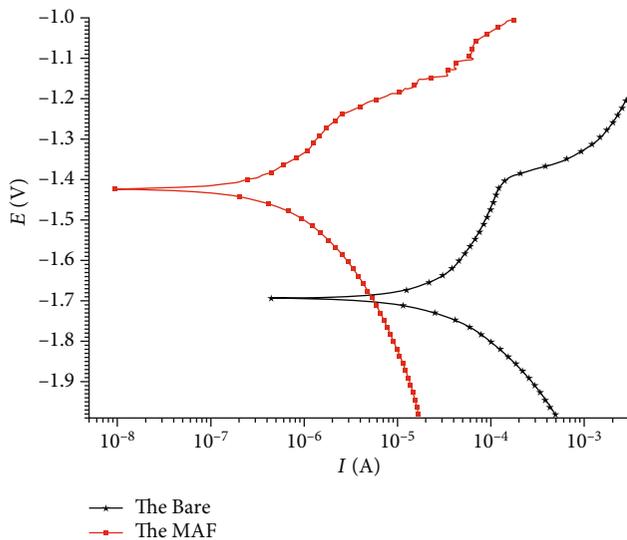
FIGURE 6: Potentiodynamic polarization curves of the Bare and the MAF samples.

**3.2. Corrosion Experiments.** Figure 6 is the empirical result of the dynamic potential polarization (PDP) experiment. Resistance properties can be reflected by the corrosion potential of the samples ( $E_{\text{corr}}$ ) and the current density ( $I_d$ ). The Bare group showed a corrosion current density of approximately  $4.0 \times 10^{-5}$  A. The  $I_d$  of the MAF group was about  $2.1 \times 10^{-6}$  A, which was about 20 times lower than the former. Significantly better corrosion resistance of the treated specimens can be interpreted.

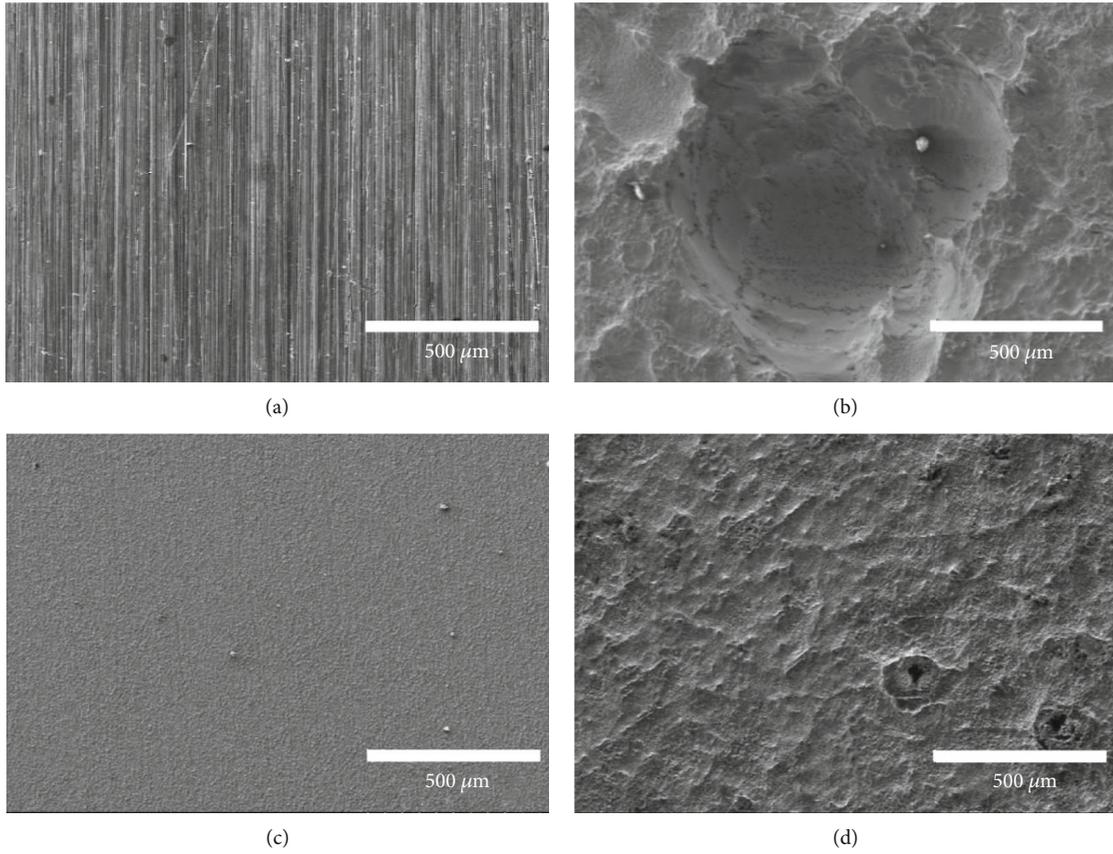
FIGURE 7: Observations of in vivo experimental samples before and after corrosion using FE-SEM. Surface morphology of (a) Bare, 0 week; (b) Bare, 16 weeks; (c) MAF, 0 week; and (d) MAF, 16 weeks.

The surface images obtained by SEM (Figure 7) reveal that the Bare before implantation (Figure 7(a)) was a line shape produced by grinding, whereas the MAF (Figure 7(c)) had a smoother surface view. After removal at week 16, significant pitting was observed on the Bare surface (Figure 7(b)). Scan results displayed a corrosion range of approximately 0.94 mm in diameter. The MAF surface only appeared to be water-washed soil with a few occasional pitting holes, which can be read from Figure 7(d). The surfaces of the Bare were more uneven due to more localized corrosion in comparison.

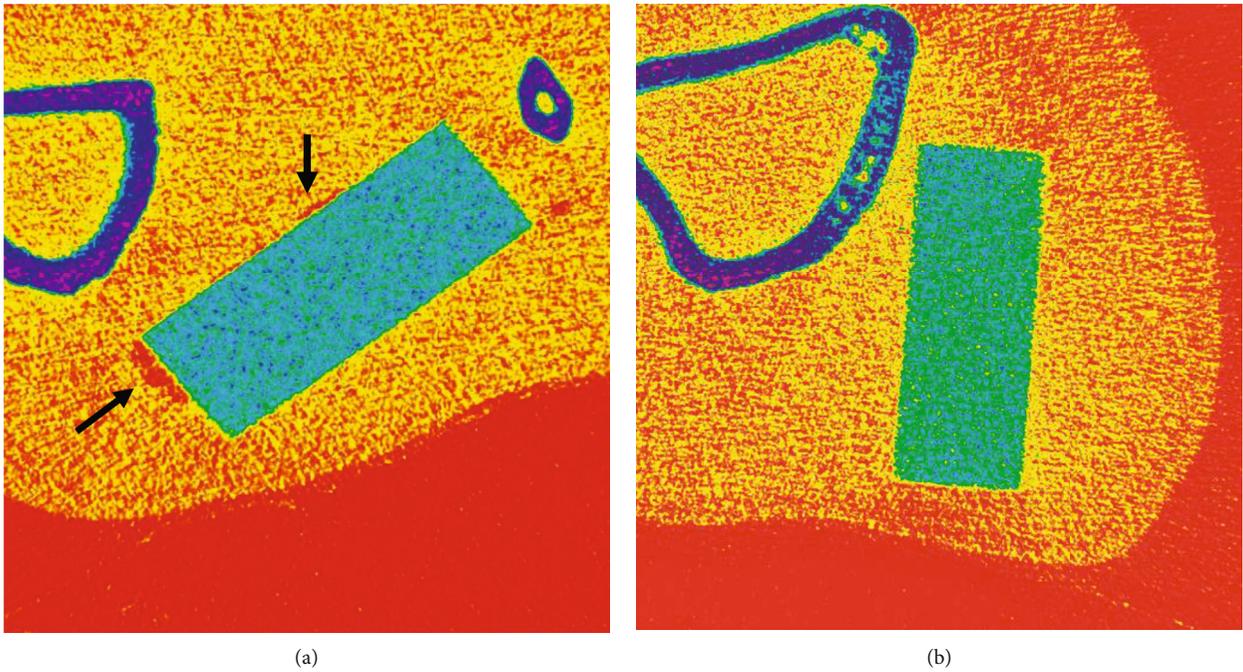
FIGURE 8: 2D results of the micro-CT scan of the sample (a) Bare and (b) MAF burial site at week four.

**3.3. Micro-CT Scanning.** Figure 8 depicts the imaging of two groups of samples *in vivo* at week 4 using micro-CT. The large gas cavity was clearly visible in the Bare group at the location indicated (Figure 8(a)), and there were more small gas cavities around the sample, so that the color spots were

sparse. The MAF group, on the other hand, had denser imaging around the sample, proving that the gas production was pretty slow.

the micro-CT imaging results (Figure 8(a)), it is evident that gas density belts appear around the untreated specimen. The presence of air cavities on the sample contact surface with body fluids represents the occurrence and product accumulation of the anodic dissolution process. This partly reflects the inappropriate degradation rate of magnesium alloys and the difficulty of wound healing due to bubbles. Although bubbles can adversely affect the implant, no further damage to the bone and surrounding tissues was observed, the same as in the subcutaneous magnesium implantation experiments of Kuhlmann et al. [35]. It has been shown that the hydrogen produced during the corrosion of magnesium-based materials can be removed and excreted to some extent [32, 36]. In a sense, the negative effects of corrosion behavior and bubbles can be minimized if the corrosion rate is kept within a safe range [25].

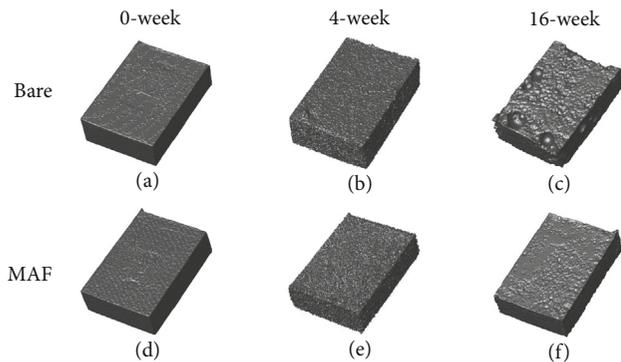
FIGURE 9: Micro-CT scans of samples from in vivo experimental procedures at selected time points, 3D images.

Figure 9 contains the results of micro-CT imaging of the specimens at weeks 0, 4, and 16, respectively. At week 4, a corrosion pit appeared in the lower left corner of the Bare samples and tended to enlarge. At 16 weeks, the sampling

from the Bare group had other corrosion pits in addition to the one in the lower left corner, the largest of which was nearly 1 mm in diameter. In addition to this, it can be noted that the rectangular form becomes incomplete. Nevertheless, the MAF group had only a few pitting-like indentations on the surface of the sample. Judging from the results of week 4 and week 16, the MAF group would be less corrosive than the Bare group no matter what.

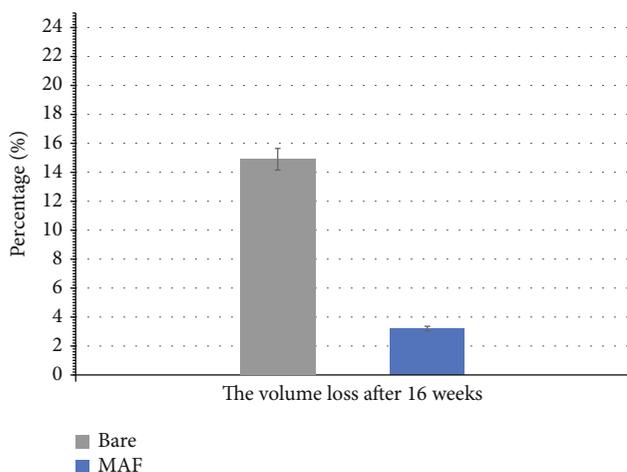
FIGURE 10: Volume change of in vivo experiments.

Figure 10 is a histogram produced from the volume loss after sample removal. The volume loss in the Bare group was 14.9% compared to 3.2% in the MAF group. The Bare group was approximately 4.67 times more likely to be in the MAF group.
