Seismic Vulnerability Assessment of Site-Vicinity Infrastructure for Supporting the Accident Management of a Nuclear Power Plant

T. J. Katona^{1,2} and A. Vilimi³

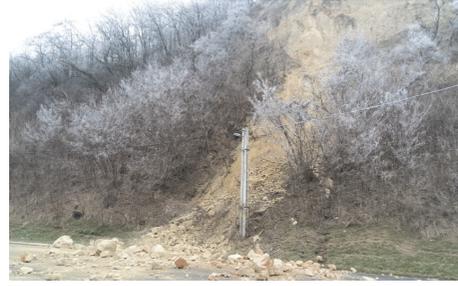
FIGURE 3: Sliding of the loess bluff to the road No. 6 (photo made by the authors).

4.4. Transportation Facilities. The road network in the region is well developed. The settlements as well as the plant site are connected to the main road No. 6 and highway by redundant connections. Although local road failures can be expected at flood-plain due to liquefaction, the villages and cities in region can be accessed. Part of the main road No. 6 is passing beside the rectilinear loess bluff North of the city of Paks susceptible to cracking-sliding failure. The loess bluff is unstable and can slide as it happened in 1976, 1977, 1993, and 2008 [22, 43] and very recently (see Figure 3). These events have been triggered by weather conditions.
