Damage analysis of CFRP under impact fatigue

Abstract. In recent years carbon fibre reinforced polymers (CFRPs) have become some of the most important structural materials in the aerospace industry due to their excellent stiffness and strength to weight ratios. The real-life loading histories of aerospace composite components and structures involve the generation of transient loads that can propagate as cyclic impacts. This phenomenon is known as impact fatigue (IF). Such loads can cause various types of damage in composites, including fibre breakage, transverse matrix cracking, de-bonding between fibres and matrix and delamination, resulting in a reduction of residual stiffness and a loss of functionality.

Keywords: Impact fatigue, micro CT, CFRP, cracks

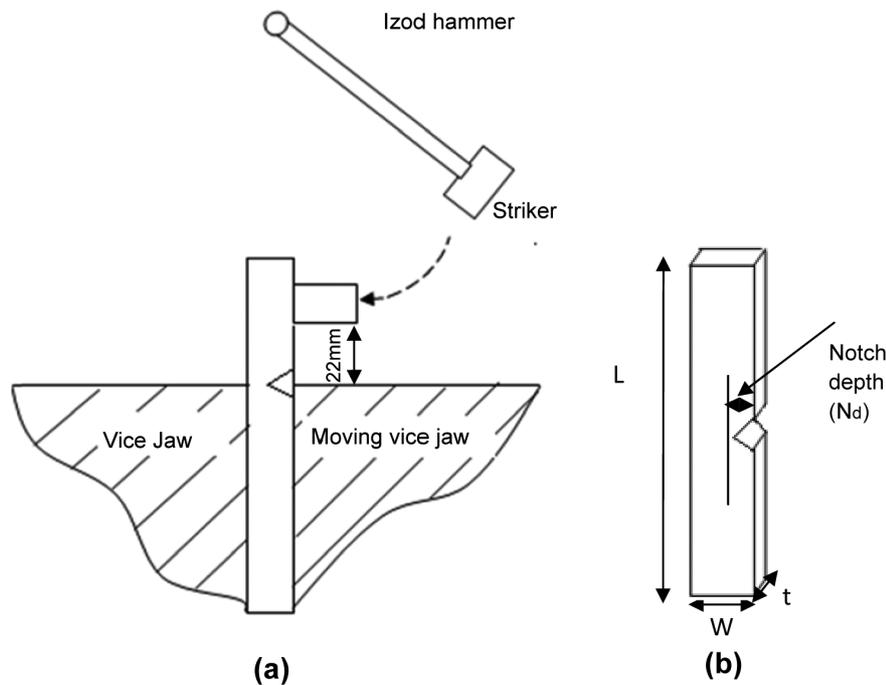
Fig. 1. (a) Impact test set-up indicating the position of the specimen in the vice, the motion of the Izod hammer and the impact point. (b) Schematic of the specimen used in Izod tests where L is the length, W is the width and t is the thickness.

Izod specimens were cut from the UD CFRP material described above using a milling machine. The specimen configuration is displayed in Fig. 1 (b) where length, L, was 80 mm, width, W, was 10 mm and thickness t was 1 mm or 4 mm. The samples were notched using a single-tooth carbide cutter. Notches of 2 and 6 mm depth were cut into the 1 mm thick specimens (8 in total) and 4 mm thick (16 in total) specimens respectively. The two sets of samples were termed Group A and B, as detailed in Table 3. According to British standard (BS EN ISO 180:1996) composite samples must have a 45 degree V notch in the middle of the sample length and the hammer must strike 22 mm above the notch, as shown in Fig. 1(a). The samples made for this test were notched with a slow cutter speed, fast feed rate and the use of coolant in order to avoid thermal damage i.e raising the temperature of the matrix above its glass transition temperature.

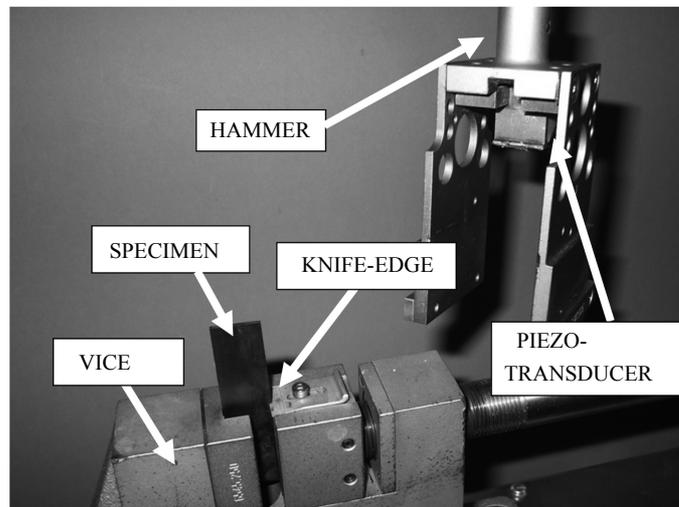
Fig. 2. Izod test configuration during testing.

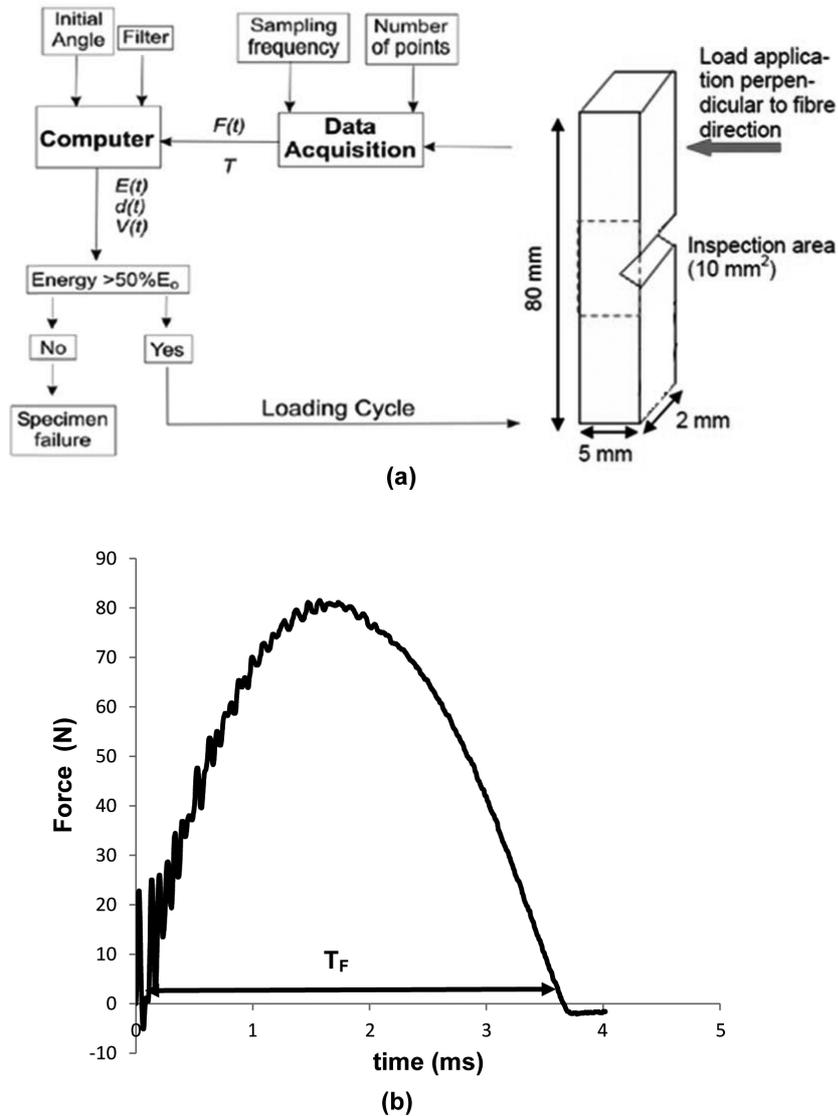
Fig. 3. (a) Izod test specimen during testing at energy of 0.02J and (b) force data acquisition indicating the loading time T_F .

cause complete failure in a single impact test must be used. In this work a calibrated impact hammer with mass of 0.334 kg and nominal length of 0.3268 m was used. The pendulum hammer was released from a pre-selected initial angle in the range of 0–150° which corresponds to a potential energy in the range of 0–2J and velocity between 0–3.46 m/s. The impact-fatigue tests were carried out using a modified CEAST Resil impactor, which is shown in Fig. 2. The specimen is supported at one end by an instrumented vice and its opposite end is struck repeatedly by a controlled pendulum hammer, with the hammer being caught and returned to the same starting position after each impact. The impact of the pendulum hammer produces a tensile load in the specimen over a period of 6–7 ms and the period between the impacts is approximately 15 s. The evolution of force, displacement and the energy during each impact can be monitored at 5 μ s intervals and up to 8000 points can be stored for each impact. In order to decrease the data noise a 1 KHz filter can be used. The amplified and filtered data is downloaded to a computer as magnitudes of force and time and this data is then used to calculate velocity, V , displacement, d , and absorbed energy, E , for each impact, as indicated in Fig. 3(a). Figure 3(b) shows a typical force time plot indicating the loading time, T_F , which is defined as the time interval between the initial loading point and the moment that the applied force diminishes to zero.

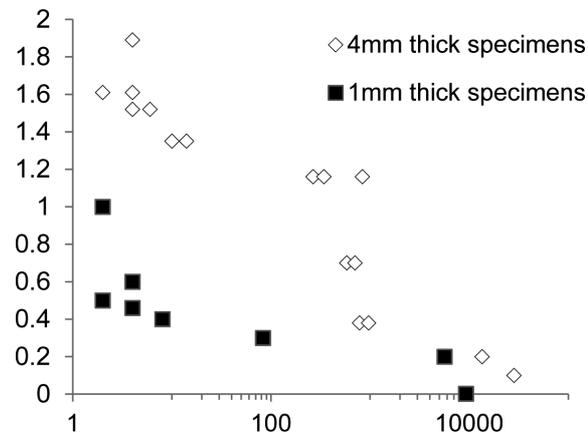
Fig. 4. Impact energy (E) vs number of impacts to failure (Nf) during IF in semi-logarithmic coordinates.

Impact tests were conducted in energy control which means that the applied force is not a directly controllable variable. Impact damage can be characterised by a decrease in impact energy (E) with number of cycles required to failure (N_f) [2]. An E vs N_f plot for both 4 mm and 1 mm thick samples is presented in Fig. 4. The figure demonstrates a similar trend in the data for the first and second groups of specimens in that there is an approximately linear relationship between E and $\log(N_f)$. As explained, the impact energy associated with a given N_f is significantly lower for the 1 mm thick samples than for the 4 mm thick samples, the ratio in impact energy being approximately the same as the thickness ratio. A level of scatter is apparent in Fig. 4, however, this is inevitable as fatigue is a probabilistic phenomenon.

The results in this section have shown that CFRP's are susceptible to rapid degradation and failure when subject to IF. It is also seen that IF can be studied E- N_f graphs. These graphs show that as the impact energy decreases,

the number of cycles to failure will increase in a quasi-linear fashion. From the data that had been tested it is seen that in cases of IF a fatigue limit is not clearly observable, making this a potential problem in designing against IF. Analysis of damaged surfaces during the subjection to IF is required to reveal the phenomenon in the micro-level. This will take place in the following section.

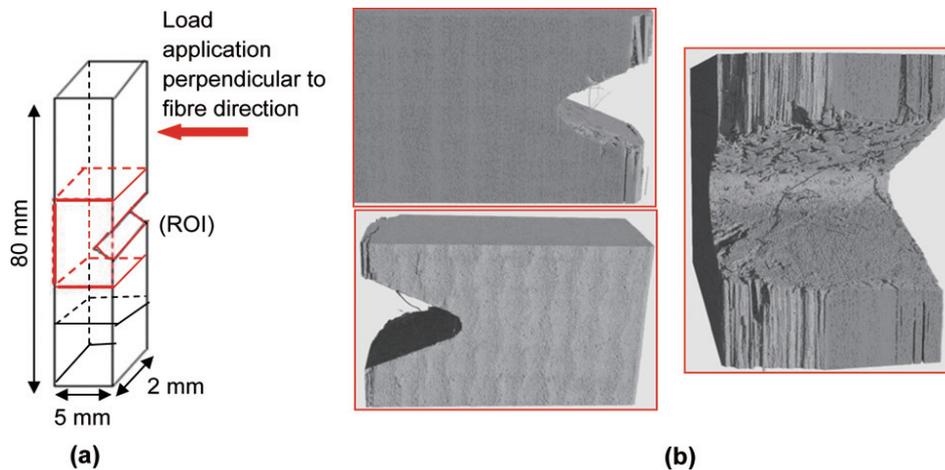
Fig. 5. (a) Specimen schematic highlighting the region of interest (ROI), (b) Side views and front view of the ROI.

Damage in the UD IM7/8552 composites generated in the IF Izod tests was studied. The findings illustrate the capabilities of the micro-CT system and the evolution of the damage with IF cycles. The main CT scanning and reconstruction parameters were the pixel size, which was 3.5 μm and the exposure time that was kept at 1 s. Figure 5a presents the dimensions of the specimen as well as the region of interest (ROI) selected for analysis. In Fig. 5b

the side and front views of the undamaged specimen are presented. Signs of matrix cracking and fibre pullout are visible at the edges due to formation of the notch (front view Fig. 5); the cutting plane was perpendicular to the fibre direction. After 250 impacts the specimen was removed from the IF machine and was re-examined. A through thickness can be seen Fig. 6. In order to observe the full extent of the damage shown in Fig. 6, the view is inverted to the orientation illustrated in Fig. 7.

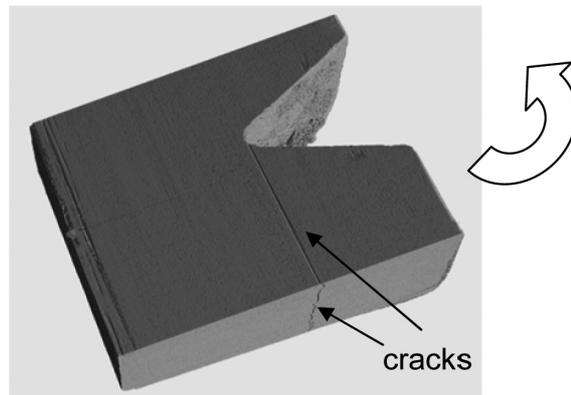
Fig. 6. Damaged bottom area or region of interest and arrow indicating how the view was rotated in order to emphasise at the whole crack distribution.

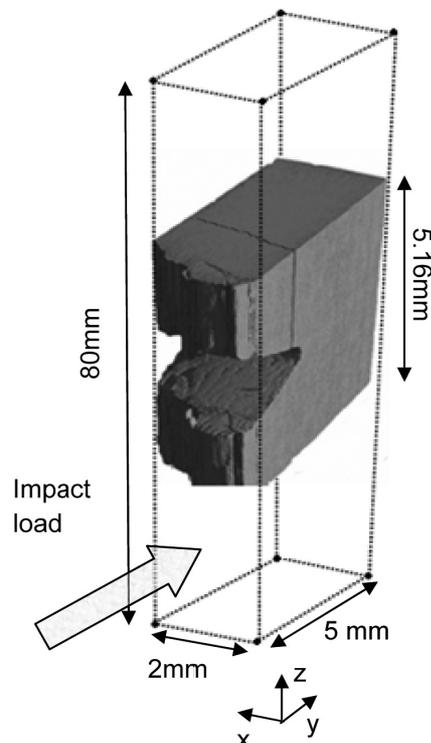
Fig. 7. Inverted view of the region of interest and schematic of the volume of the examined area in comparison with the actual specimen volume.

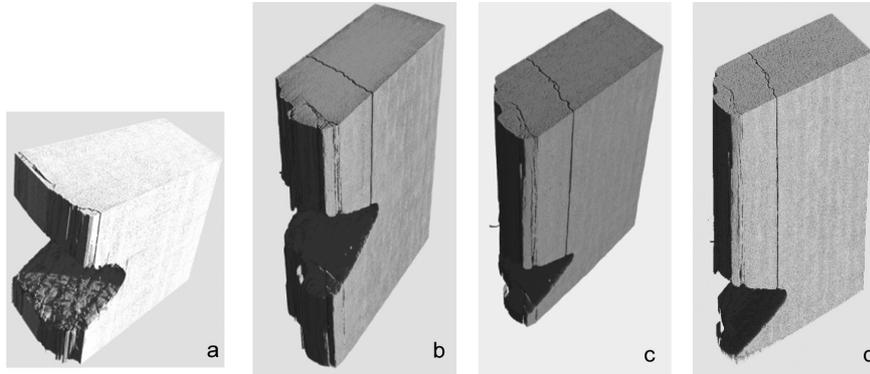
Fig. 8. Right-side view before testing (a); after 250 impacts (b); after 400 impacts and after 600 impacts (d)

Figures 8 to 12 shows the comparison between undamaged and damaged states of the tested specimen. A crack can be seen to be growing substantially in the fibre direction and across the sample width. The transition from one side of the specimen to the other can be seen more clearly in Figs 10, 12. In Fig. 11 it can be observed that the crack initially as the root of the notch at one side grows almost parallel to the notch tip in the x direction whilst also

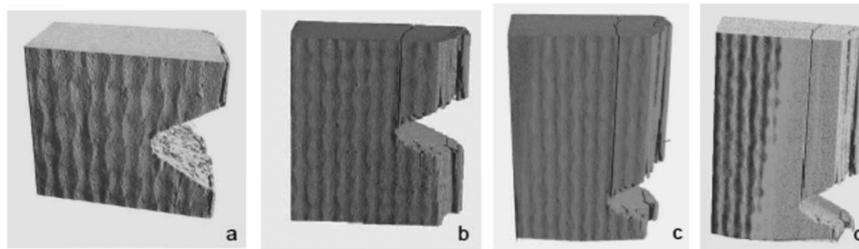
Fig. 9. Left-side view before testing (a); after 250 impacts (b); after 400 impacts and after 600 impacts (d).

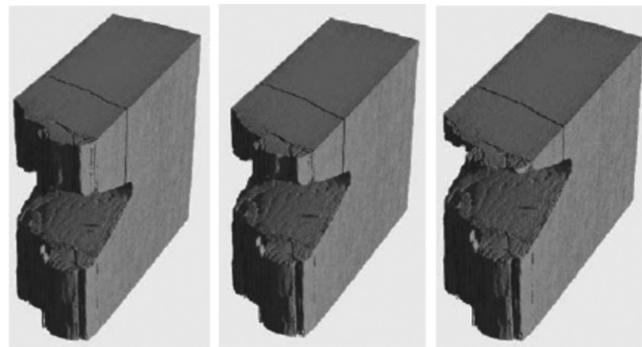
Fig. 10. Views for successive sectioning along the z axis at 3 intervals of 0.5 mm (after 250 impacts).

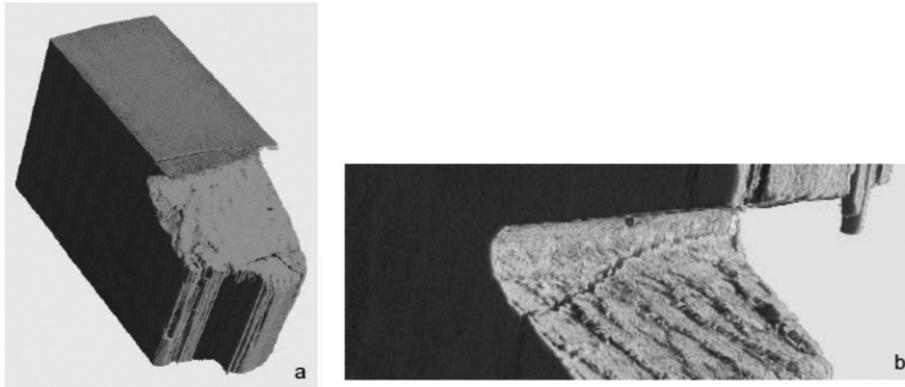
Fig. 11. Side view indicating the relative positioning of crack (a) and notch and crack intersection with the notch (b).

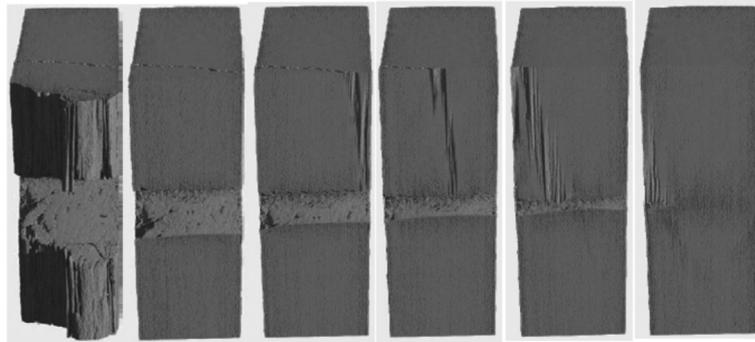
Fig. 12. Views of successive sectioning at 5 intervals of 0.2 mm along the y axis after 250 impacts (Note that the notch depth is 1 mm).

grows in the z-direction. The damage in the y-direction is illustrated in Fig. 12 that shows successive sections along this axis. The most important failure mechanism in composites that is responsible for strength deterioration of a laminate are matrix cracks and delamination. While fibre failure is the ultimate failure mechanism, matrix cracks and delaminations can occur much earlier.

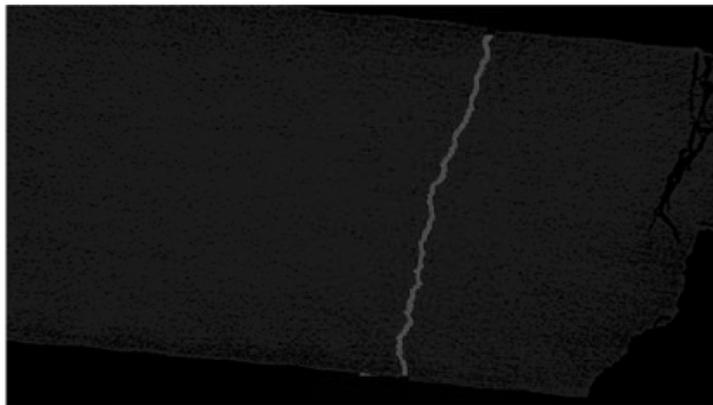
Fig. 13. Specimen top view highlighting the capabilities of the region growing algorithm to isolate the crack area.

cracks using a region growing algorithm. This enables quantification of delamination area or the crack distribution. Figures 13 to 15 present this procedure. Initially a region of interest is selected in each direction (Figs 13 and 14). Then the whole 3-D profile is constructed as shown in Fig. 15 and is ‘filled’ with the region growing algorithm (grey area). After ‘filling’ the region of interest, information about the volume/area of the cracks can be obtained by the histogram of the region based on the grey level distribution. In our case the total area measured was $3 \mu\text{m}^2$.

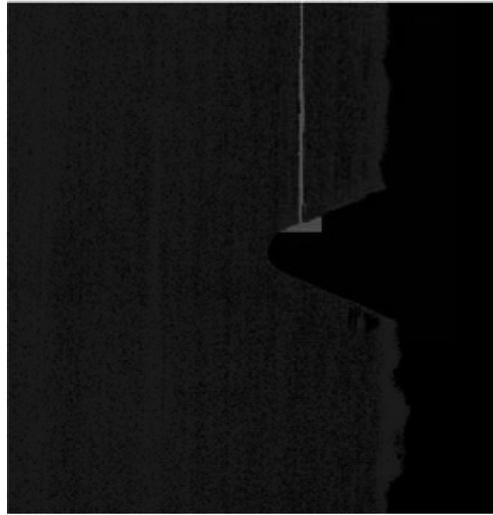
Fig. 14. Specimen side view highlighting the capabilities of the region growing algorithm to isolate the crack area.

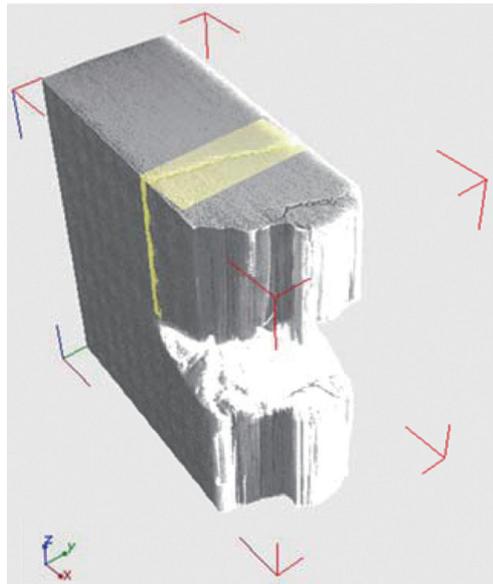
Fig. 15. Specimen 3-D view highlighting the capabilities of the region growing algorithm to isolate the crack volume.
