Research Article

Investigation of the Optimal Layout of the Roadway in Closely Spaced Ultra-Thick Coal Seams Mining with Remaining Coal Pillars

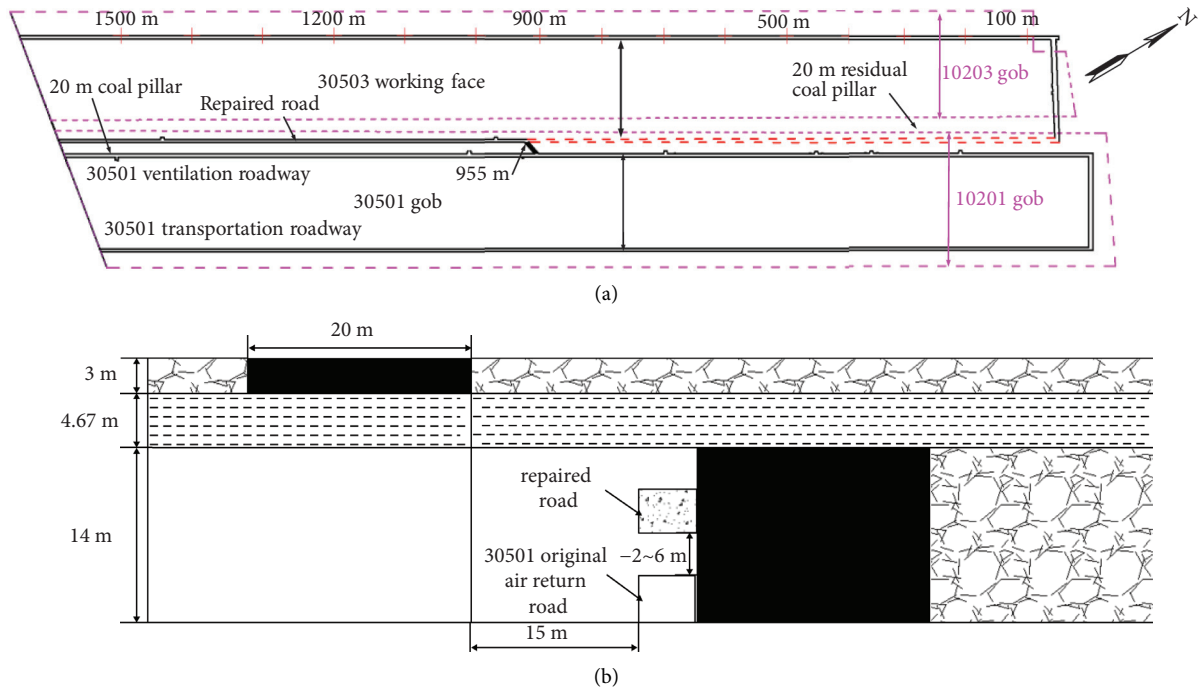
FIGURE 1: The layout of the 30503 working face. (a) Plan. (b) Elevation.

thickness of 14 m and a distance of 4.6 m from the overlying 2# coal seam. The overlying 10201 and 10203 working faces have been mined, leaving a 20 m coal pillar in the middle (Figure 1). The 30503 working face is on the east side of the 30501 gob, and the west side is solid coal. The initial design of 30501 working face adopts the 30501 original return air roadway (the repaired roadway). The horizontal distance between this roadway and the remaining coal pillar of 2# coal seam is 15 m. When the roadway is driven to 955 m, the plan is changed and 30501 return air roadway is adopted. In the design of the 30503 working face, it is planned to reuse the original return air roadway of 30501 as the return air roadway. However, during the restoration of the original return air roadway to 955 m, due to the damage to the original roadway structure, roof-falling is severe, which readily leads to roof leakage. The level of the roadway is adjusted to ensure the safety of roadway repair and driving; there is a large distance between the roadway floor and the original roadway roof so the original roadway has been partially filled with coal, and the roof of the roadway repair section is prone to caving.

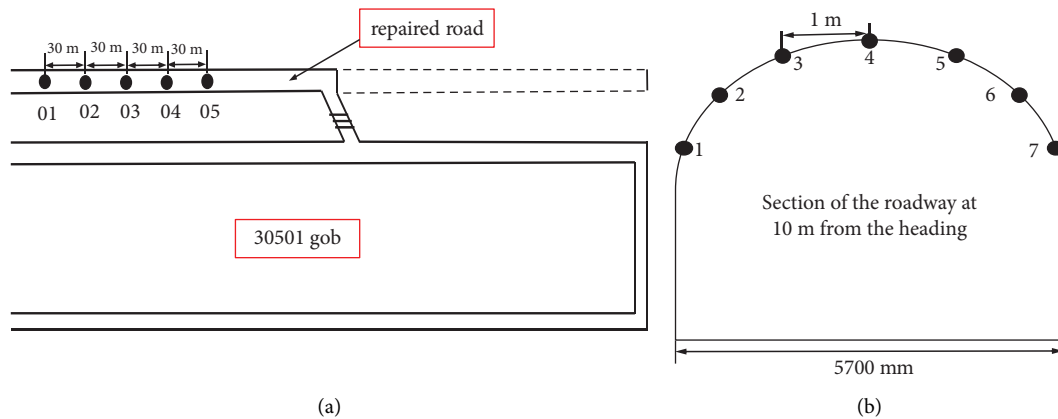
FIGURE 2: Layout of roadway roof measuring points. (a) Layout of roadway roof measuring points. (b) Layout of section measurement points.

2.2.1. Roof Drilling Peep. Distances from the return air duct heading head of 10 m (peeping point 01), 40 m (peeping point 02), 70 m (peeping point 03), 100 m (peeping point 04), 130 m (peeping point 05), and a point some 10 m from the return air duct heading at the roadway section were selected for drilling peeping. Besides, measuring points were arranged every other meter on the roof of the roadway section, giving a total of seven points. The layout of measuring points on the roadway roof and section is shown in Figure 2.

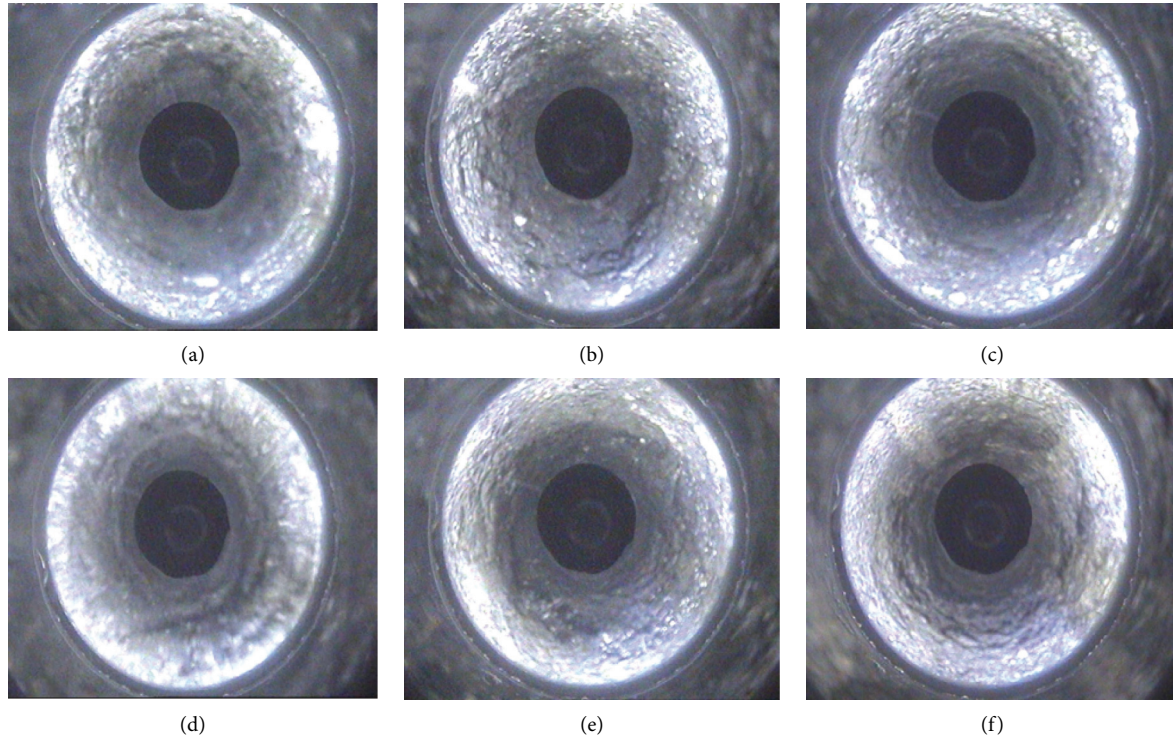
FIGURE 3: Drilling peep results of 30503 repaired roadway roof. (a) Cracks at 2.9 m in no. 01 borehole. (b) Cracks at 3.4 m in no. 02 borehole. (c) Cracks at 5.4 m in no. 03 borehole. (d) Cracks at 1.5 m in no. 04 borehole. (f) Cracks at 2.5 m in no. 04 borehole. (e) Cracks at 6.5 m in no. 05 borehole.

The results of drilling peeps (Figure 3) show that the rock structure within the drilling range of the roadway roof is mainly that of the coal seam, with small amounts of kaolinite mudstone and carbonaceous mudstone interlayer present. The overall performance of drill hole fragmentation indicates that the coal in the shallow part of the roof is broken, cracks therein are well developed, and separations are found in many places, such as at depths of 1.5 m and 1.8 m, but the shape of the drill hole has not changed significantly. With the increasing depth, the number of fractures in the hole gradually decreases, and the integrity of the hole wall is

gradually improved. However, there remain many cracks in the range of 5–6 m (mainly vertical cracks). Combined with the historical mining sequence and working face layout of the mine, it can be found that the distance between 2# and 3~5# coal seam is only 4.6 m, and the top coal of 30503 working face has been broken due to the influences of the remaining coal pillar and the upper coal seam working face.

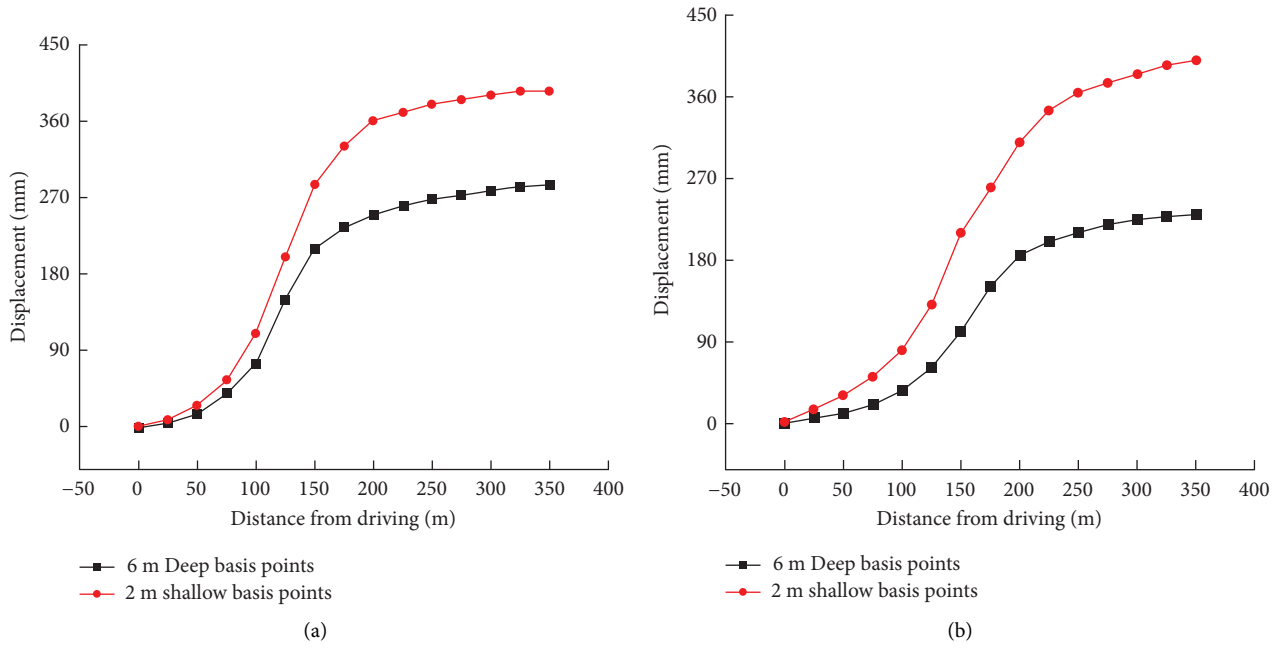
FIGURE 4: Roof deformation monitoring data from the repaired roadway. (a) Roof monitoring data at 540 m. (b) Roof monitoring data at 640 m.

2.2.2. Analysis of Roof Deformation. A set of roof separation gauges were arranged at 25 m intervals on the roof of the 30503 repaired roadway. They were used for real-time monitoring and recording of rock displacement of the roof. The monitoring data of roof fall at 540 m and 640 m during roadway driving were analyzed.

From the roof subsidence monitoring data (Figure 4), the subsidence at points where roof falls occur is found to be similar. The maximum subsidence at the shallow base point of 2 m is in the range of 400–450 mm, and the deep base point of 6 m is in the range of 200–300 mm. The roof subsidence of two places exhibits a similar trend: within 0–100 m behind the heading, the roadway subsidence increases slowly, and the difference in deformation between the shallow and deep base points is small (within 50 mm), indicating that the overall roof of the roadway within the range of 0~100 m starts sinking, and layer separation is small; from 100 to 300 m, the roof sinks rapidly, and the gap between the deep and shallow base point deformation also increases. This shows that the surrounding rock within 2 m of the roof is relatively

broken, and layer separation is increasing. When the layer separation in the roof of the roadway is too large, a roof fall will occur; beyond 300 m, the deformation increases slowly, and the roof subsidence tends to stabilize. The causes of such large roadway deformation can be attributed thus: on the one hand, the thickness of the 3~5# coal seam is 14 m, and the original air return roadway is 4 m high, so the roof subsidence to which we refer does not mean that of the overlying rock, but the subsidence of the coal overlying the seam. Due to the influence of the adjacent working face, the coal above the roadway is already in a broken state, so after the roadway is excavated, the roof coal seam of the roadway undergoes a greater deformation. On the other hand, the distance between 2# coal seam and 3~5# coal seam is only 4.6 m, which is affected by the overlying goaf. At this time, the roof of 3~5# coal seam must be affected. It can be calculated that, after the mining of # 2 coal seam, the affected area of the floor has a length of about 13 m, so the top coal of 3~5# is largely in a broken state.

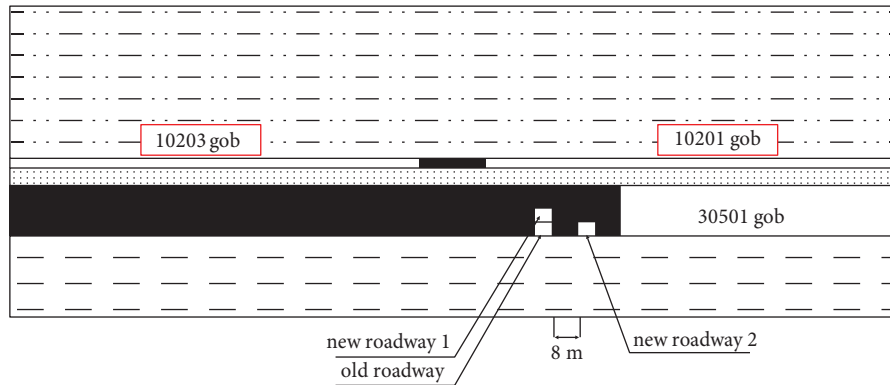
FIGURE 6: Calculation model of the return air roadway in the Tashan China coal mine.

3.2.1. Establishment of Numerical Model. To determine the influences of different roadway layouts in the 30503 working face on the working face driving, 3DEC simulation software was used to establish a three-dimensional numerical model. The model measures $272\text{ m} \times 9\text{ m} \times 60\text{ m}$ (length \times height \times width). To improve the efficiency of calculation, considering symmetry, half the length of the working face and 150 m length of the simulated working face were taken along each side of the coal pillar (Figure 6). The boundary and bottom of the model were fixed, and the top was subject to a stress boundary condition. The self-weight stress of 10 MPa was simulated on the top of the model. The commonly used composite Mohr-Coulomb model considering tensile failure, which can better describe the mechanical properties of coal and rock, was selected [35]. The parameters in the numerical simulation were modified based on laboratory measurements (Table 1). The old roadway represents the 30501 roadway and the original return air roadway, which has been filled with fine coal. The new roadway 1 denotes the return air roadway restored in Option 1, and the new roadway 2 is the new return air roadway to be excavated in Option 2. The horizontal distance between the new roadway 1 and the new roadway 2 is 8 m, and the horizontal distance between the new roadway 2 and the end of the 30503 working face is 8 m.

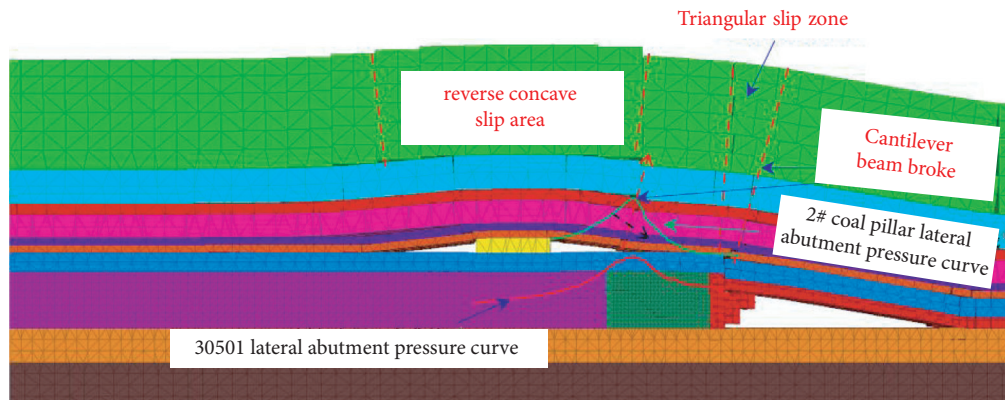
FIGURE 7: Migration of overlying rock during formation of 2# coal and 30501 gob.

(1) Stability Analysis of Old Roadways. After the gob on the left and right sides of the 2# coal is formed, the 30501 working face is excavated, and the deformation and collapse of the overall stope are shown in Figure 7. After completion of coal seam mining, the overlying rock above the working face collapsed to form a gob, which destroyed the equilibrium in the original rock. According to the classic theory of mine pressure, the stress in the length direction of the working face is transferred to the solid coal on both sides of

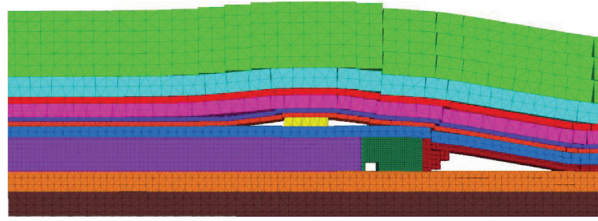
FIGURE 8: Overlying rock migration during the formation of the old roadway.

If the roadway is driven in the old roadway position, as shown in Figure 8, due to the combined action of the inverted convex breaking block and the lateral supporting pressure of the 30501 working face, the broken block will continue to slide to the side of the 30501 gob, and a fracture will be generated above the roadway, which breaks the roof of the roadway, making it very difficult to maintain. Unless as time goes by, the roadway can be maintained after the broken block in the inverted convex area and the gob has come into contact, there is also the risk that the moving boundary of the inverted convex slip zone will start again after the second disturbance to the 30503 working face. In

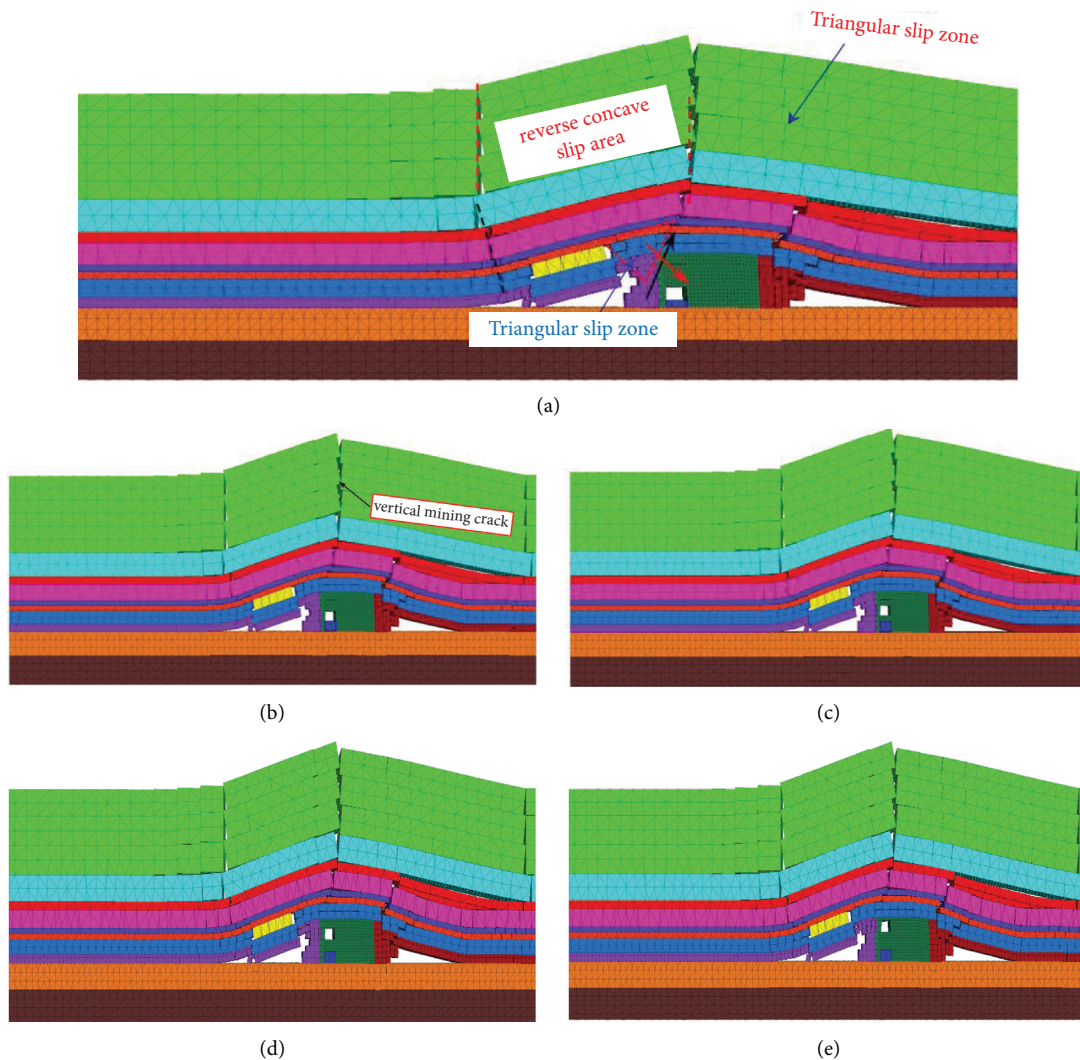
FIGURE 9: Overlying migration caused by mining in the 30503 working face. (a) $H = -2$ m. (b) $H = 0$ m. (c) $H = 2$ m. (d) $H = 4$ m. (e) $H = 6$ m.

The conditions of different distances between the old roadway and the new roadway 1 are simulated, the 30503 working face is mined, and the excavation is stopped at a position 9 m from the new roadway along the length of the working face. The migration of the overlying rock formed after the recovery of the 30503 working face under the driving conditions of new roadway 1 is shown in Figure 9. It can be seen that, due to the recovery of the 30503 working face, the inverted convex slip zone above the 2# coal pillar is

activated for the second time and continuously rotates and slips to the side of the 30503 gob, gradually forming two slip modes with the 2# coal gob as the hinge point. One is the vertical fissure above the gob, and the other is a new triangular slip area bordered by coal and rock above the 2# coal pillar, 2# coal gob, and the incline above the new roadway 1. The two modes of slipping are related to the horizontal force on the interlayer coal and rock mass above the new roadway 1. The vertical load acts to push the mass toward the 30503 gob, shedding more load onto the new roadway and causing the new triangular slip zone surrounding rock to rotate and slip instantly. The instability of the hinge point induces the vertical fissure and the cut-and-fall dislocation of the new roadway, and there is a severe risk of roof leakage and compression of the support. By then, maintaining this new roadway will be very difficult.

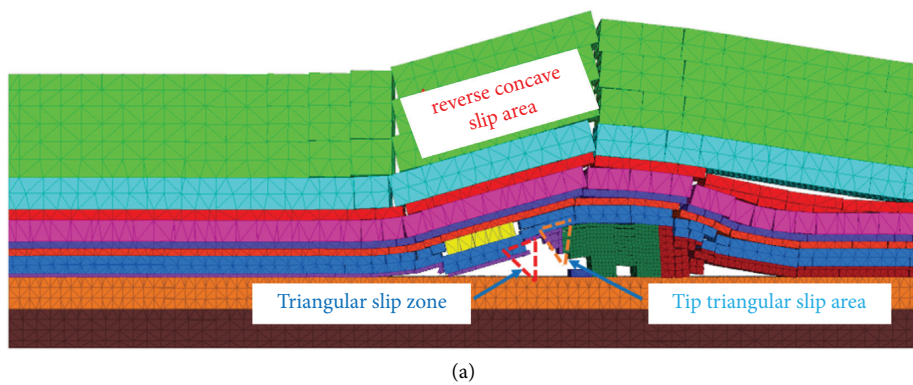
FIGURE 11: Continued.

FIGURE 11: Overlying rock movement caused by recovery at the 30503 working face and its influence on new roadway 2 (after new roadway 1 has been filled). (a) $H = -2$ m. (b) $H = 0$ m. (c) $H = 2$ m. (d) $H = 4$ m. (e) $H = 6$ m.

Figure 11 shows the movement of the overlying rock in the distributed excavation of the 30503 working face after the filling of the new roadway 1. Based on the above analysis, the excavation and filling of the roadway have little effect on the movement of the overlying rock, and the recovery of the working face is the main factor influencing the movement of the overlying rock. After filling the new roadway 1, the triangular slip zone and vertical fracture formed by mining in 30503 working face remain. For the new roadway 1, the filling material cannot fill the void and in a plastic state it produces a cushioning effect. Therefore, when the shearer cuts the remaining coal seam, it will inevitably cause the surrounding rock in the new triangular slip zone to rotate, slip, and gradually penetrate any vertical mining fissures. However, the triangular slip zone breaking block, the filling body of the new roadway 1, and the 2# coal gob are in full contact. The filling body provides a supporting force (and friction) on the broken zone, causing the slip zone to close, and extending the plastic zone. This eliminates the hidden danger of cut-and-fall dislocation caused by the sudden instability of the hinge point, which causes the vertical crack to pass through the new roadway 1, avoiding the risk of roof leakage and compression of the support. Combining the above analysis, it can be concluded that after filling the new roadway 1, due to the release of the overall pressure on the inverted convex slip by the new roadway 1, and the cushioning of the top coal and the filling body, the triangular slip zone at the end forms a plastic cemented structure, which protects the new roadway 2 to a certain extent.

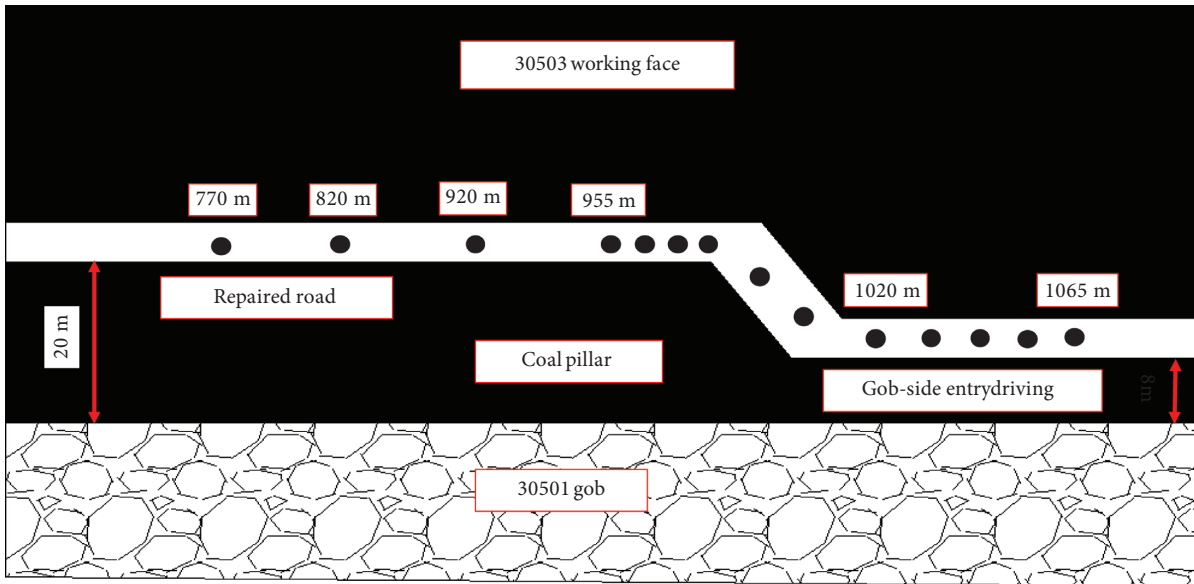
FIGURE 13: Schematic diagram of roadway deformation monitoring points.

3.3.1. Deformation Analysis during Roadway Excavation. The roadway was rearranged at chainage +955 m along the working face. The starting point of the roadway driving along the gob after the turn was at chainage +1020 m; we first excavated from chainage +1020 m to the side of the cut-off side of the working face and then reversed the excavation from the side of the roadway, to complete the return air roadway. The cross-observation method was used to monitor the deformation of the repaired roadway and the roadway driving along the gob before and after the roadway turns. The layout of the monitoring points is illustrated in Figure 13.

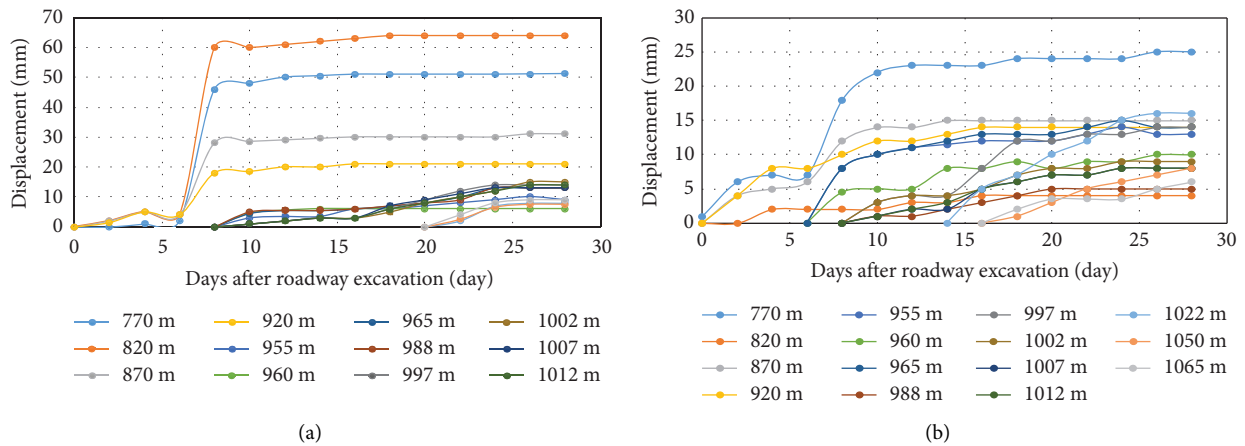
FIGURE 14: Deformation of roadways when using different layouts. (a) Roof and floor approach. (b) Two-sided approach.

The deformation of monitoring points within 770 m to 1065 m along the return air roadway is illustrated in Figure 14. Figure 14(a) indicates that the deformation of the coal roadway roof and floor is between 13 and 65 mm during excavation of the roadway. When driving along the gob, the deformation of the roof and floor is between 0 and 13 mm, and the deformation of the roof and floor in the turning section is between 0 and 15 mm. The deformation of the two sides of the repaired roadway is between 5 and 25 mm (Figure 14(b)), and the deformation of the roadway along the gob and the turning section is between 3 and 13 mm. Combining these data with the above analysis, the deformation of the roadway along the gob is found to be significantly less than that of the repaired roadway during roadway excavation.

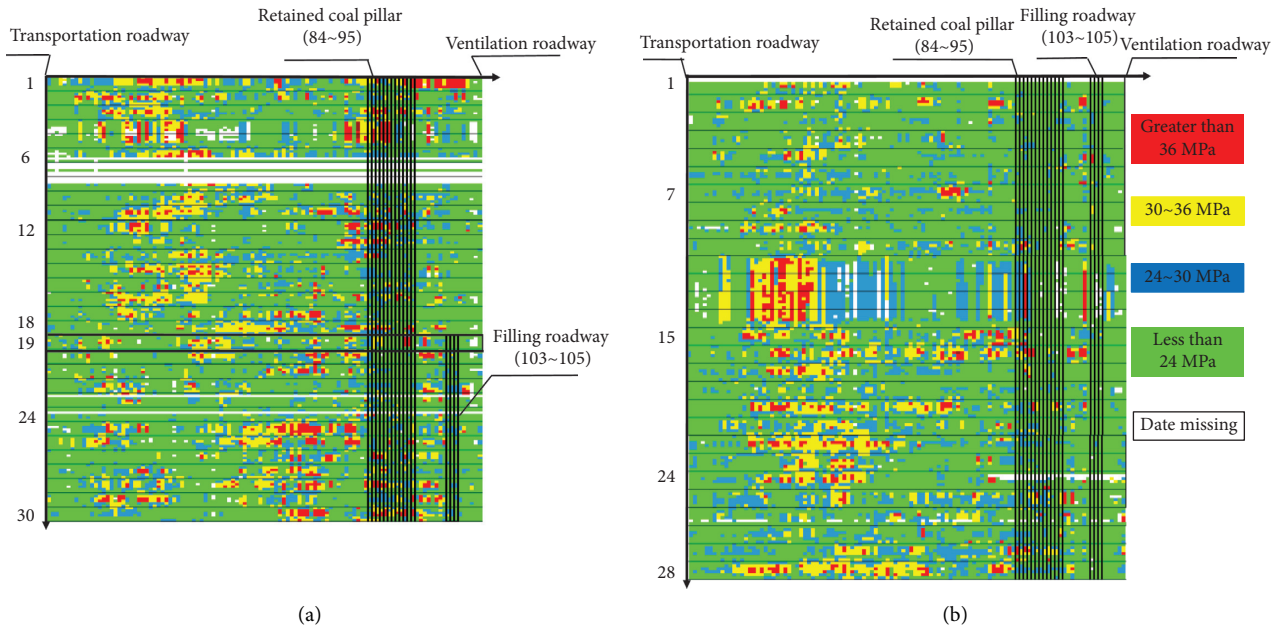
FIGURE 15: Data from the hydraulic support before and after overfilling the roadway. (a) Data from the hydraulic support in January. (b) Data from the hydraulic support in February.

The 30503 working face recovered the voided roadway area on 19 January: the support data within one month before and after the working face passed the filling roadway were classified, and different levels of support data were color-coded (Figure 15). After the working face passed through the filling roadway, the support pressure thereon increased to a certain extent, indicating that the filling roadway had affected working face mining, but the increase in the pressure on the support only reached a maximum value of 28 MPa, which was only 16% higher than the setting pressure of 24 MPa. In February, the support pressure on the

filling roadway area came to match that before recovery, suggesting that the high water content material had achieved a better cushioning effect in the backfill area and could deform in coordination with the roadway roof under the action of the applied mining stress.

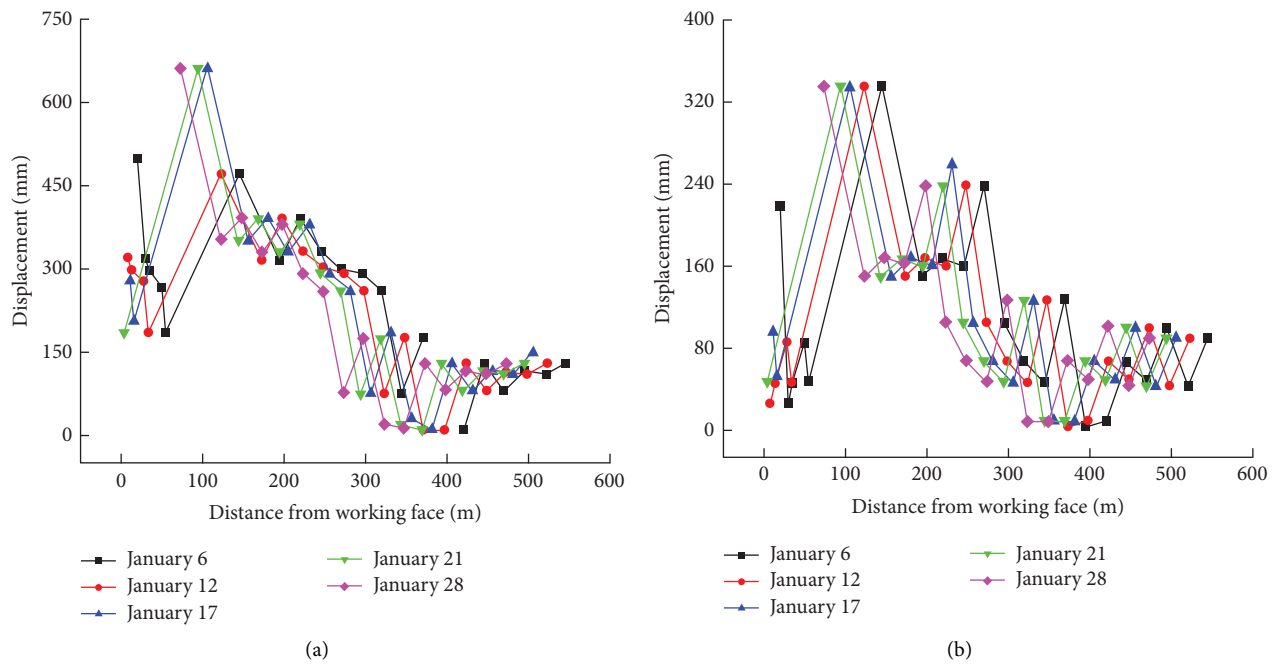
FIGURE 16: Deformation data from the return air roadway. (a) Roof and floor approach. (b) Two-sided approach.

3.3.3. *Analysis of Deformation of Overfilled Roadway during the Recovery Period.* The cross-observation method was used to monitor deformation of the return air roadway when passing the filling roadway (Figure 16). Before and after the

working face crosses the filling roadway, the deformations of the roof and floor of the roadway and the two sides are similar, indicating that the roadway is broken during the recovery process, and the existence of the filling roadway does not affect the return air roadway. During the recovery of the working face, the maximum approach of the two sides is 650 mm, which appears about 100 m in front of the

working face, and the maximum approach of the top and floor plates is 320 mm, both appearing about 100 m in front of the working face. The deformation of the roadway tends to be stable some 300 m ahead of the working face. This shows that, when the working face passes through the filling roadway, it has no major influence on the deformation of the 30503 return air roadway.
