Research Article

Numerical Investigation on the Ground Response of a Gob-Side Entry in an Extra-Thick Coal Seam

This study was aimed at the large deformation phenomenon of rock mass surrounding the gob-side entry driven in a 20 m extra-thick coal seam. Taking tailgate 8211 as the engineering background, a numerical investigation was employed to analyze the deformation law of the gob-side entry. The study results are as follows. (1) Because the immediate roof was composed of weak coal mass with a thickness of 17 m, the roof coal mass was vulnerable to fail with the effect of overlying strata pressure; thus, a visual subsidence of roof coal mass with a maximum convergence of 800 mm was observed in the field. (2) The bearing capacity of the coal pillar was significantly less than that of the panel rib, resulting in the pillar failing more easily under the ground pressure and then generating large-scale squeezing deformation. (3) The roof and panel rib were in a state of shear failure with a failure depth of about 5 m. The coal pillar was entirely in a state of plastic failure. (4) A support scheme including an asymmetric anchor beam truss, roof angle anchor cable, and anchor cable c

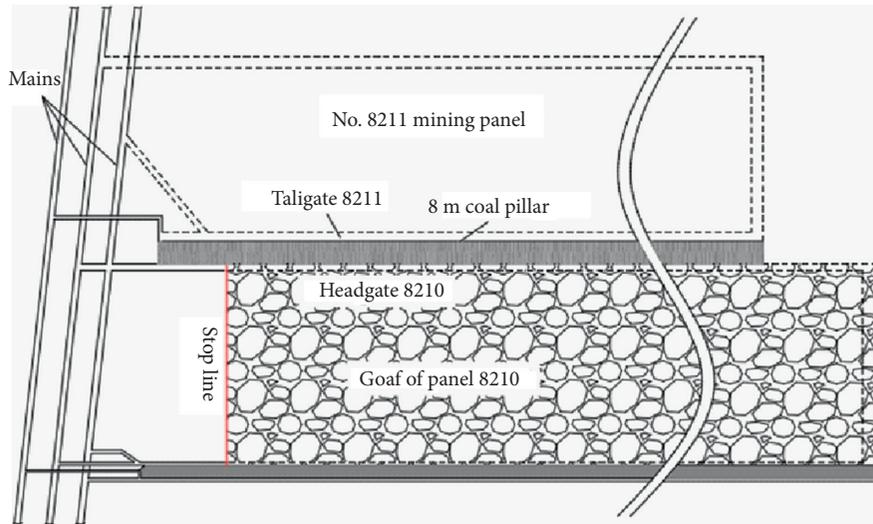
FIGURE 1: Diagram of the gob-side entry in section 8211.

The test site was tailgate 8211; it was a rectangular section with a height of 5 m and a width of 3 m. The coal pillar between the tailgate and the adjacent goaf of panel 8210 was 8 m wide, as shown in Figure 1. In actual engineering practice, to ensure the normal mining and excavation of the mine, tailgate 8211 had to be driven shortly after the panel 8210 was mined out. Thus, it became an urgent task to conduct research on the deformation and failure laws of the rock mass surrounding the tailgate 8211.

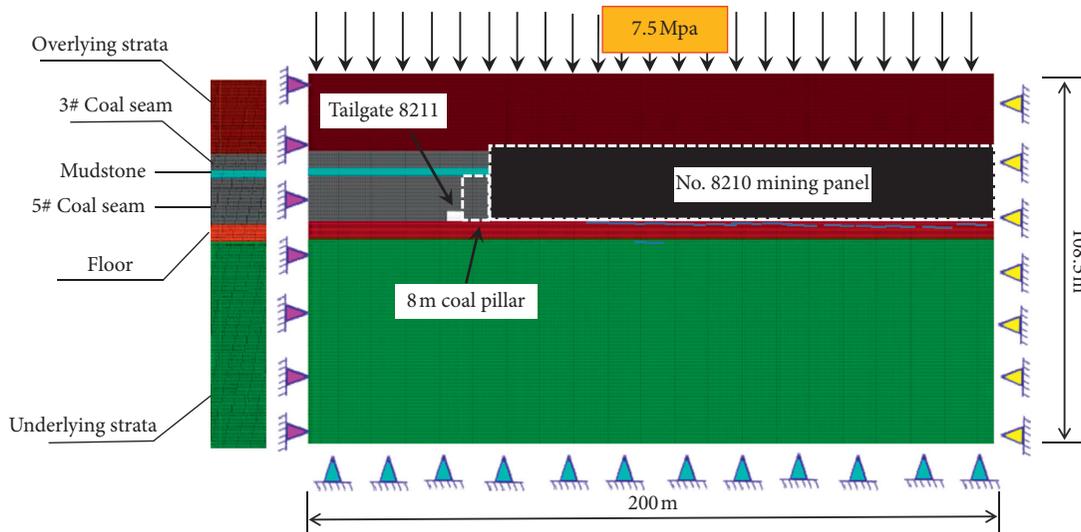
FIGURE 2: Numerical calculation model.

3.1. Numerical Model Establishment and Simulation Plan. Based on the actual geological production conditions of the panel 8211, a plane numerical simulation calculation model was established (see Figure 2). The model was 200 m long along the x -direction. The z -axis height of the model was 108.5 m. The velocities of the horizontal and bottom boundary were set as 0. The stress applied at the upper boundary was 7.5 MPa, representing the overburden pressure. The horizontal stress was applied in the x - and y -directions of the model, and the lateral pressure coefficient was set to 1.2.

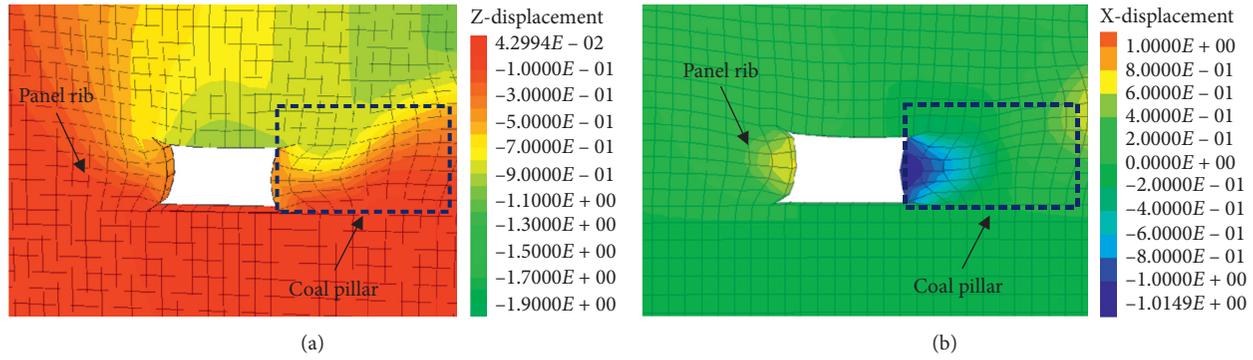
FIGURE 3: Displacement distribution developed around the gob-side entry in section 8211: (a) vertical displacement; (b) horizontal displacement.

3.2. Analysis of Simulation Results. The distribution of vertical and horizontal displacement contours is shown in Figure 3. The obtained results are as follows:

- (1) *Distribution Characteristics of Vertical Displacement:* On the whole, vertical displacement of the roof coal body above the coal pillar (about 1200 mm on average) was much larger than that of the roof coal body of the entry (about 700 mm on average). From the surface of the entry to the depth of 3.5 m, the roof coal body exhibited an overall sinking trend, with an average sinking of about 800 mm, as shown in Figure 3(a). The abovementioned vertical displacement distribution characteristics can be attributed to the following reasons. (1) The thickness of the mining coal seam reached 20 m, and the entry was driven along the coal seam floor. As a result, the immediate roof of the entry was a weak and fractured coal mass with a thickness of nearly 17 m. It was prone to large-scale failure under strong mining activities, which would result in insignificant damage overall [22, 23]. (2) Compared with the panel rib, the coal pillar rib had a smaller size and weaker bearing capacity. Under the same overburden movement, its plastic failure range was larger, which in turn led to a greater vertical displacement of the roof coal body above the coal pillar.

- (2) *Distribution Characteristics of Horizontal Displacement:* From shallow to deep, the horizontal displacement of the panel rib gradually decreased, with the maximum displacement of 700 mm occurring in the middle of the panel rib. The coal pillar side also presented similar deformation characteristics, but the deformation value was larger than that of the panel rib side, reaching 900 mm, as shown in Figure 3(b). The reason for this phenomenon is that the bearing capacity of the coal pillar was much smaller than that of the panel rib. Therefore, it was

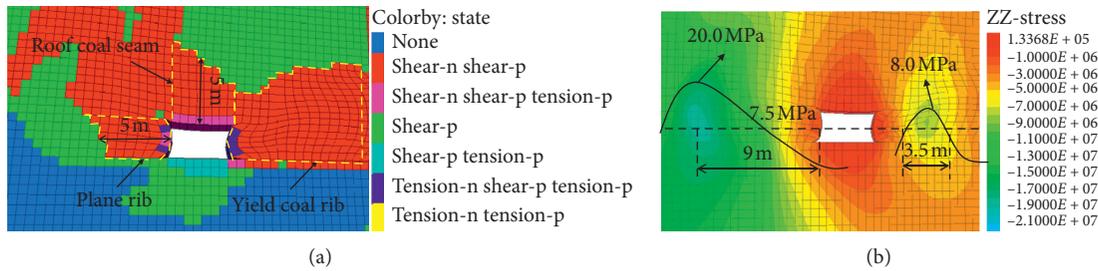
FIGURE 4: Stress and plastic zone distribution developed around the gob-side entry in section 8211: (a) plastic zone; (b) vertical stress.

The plastic zone and vertical stress distribution of the surrounding rock of the gob-side entry in panel 8211 are shown in Figure 4.

(1) *Distribution Characteristics of the Plastic Zone*: It can be seen from Figure 4(a) that the roof coal rock mass was in a state of large-scale shear failure, and the

failure depth was about 5 m. The panel and coal pillar ribs were in shear failure models. The failure range of the panel side was about 5 m, and the coal pillar rib was in a state of plastic failure. For the shallow coal body of the roof and two sides, it was in the tensile failure model.

(2) *Distribution Characteristics of the Vertical Stress*: From Figure 4(b), it can be seen that the shallow coal body of the entry was in a state of stress release, with

an average stress value of less than 1 MPa. For the panel rib, a peak stress of about 20 MPa occurred 9 m away from the rib side, and the stress concentration factor was about 2.2. For the coal pillar rib, a maximum stress of 8 MPa occurred, which was greater than the original rock stress by 7.5 MPa.

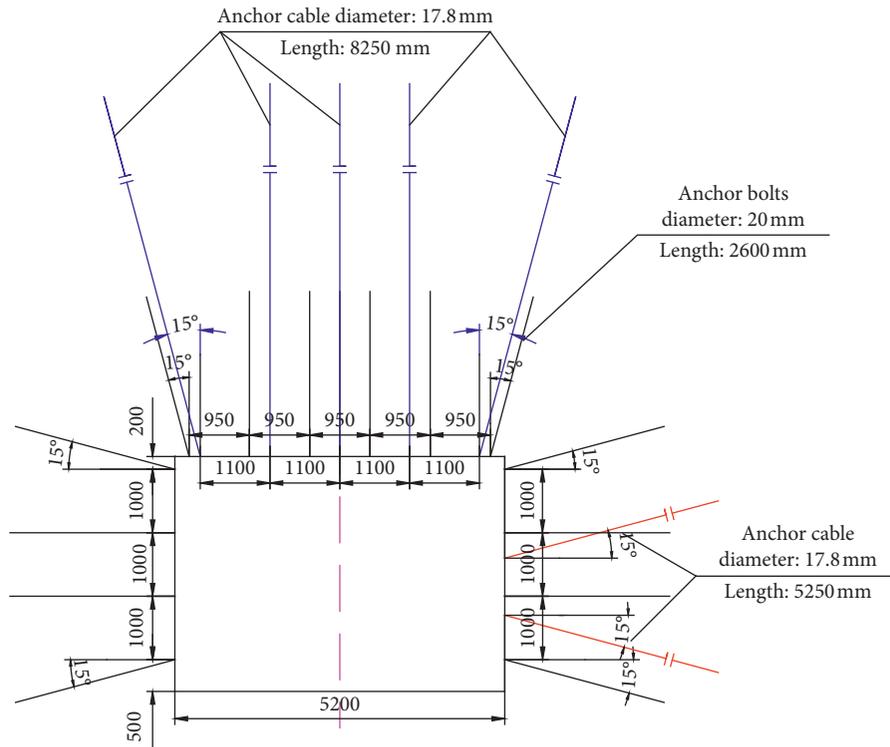
FIGURE 5: Support scheme of the gob-side entry.

4.2. Control Technology for the Gob-Side Entry with Narrow Coal Pillars in Extra-Thick Coal Seams. A support scheme, including high-strength bolts, strong roof anchors, and reinforced anchors for coal pillars, was determined, as shown in Figure 5. The specific parameters were as follows.

The entry roof adopted a $\phi 20 \times 2600$ mm thread steel bolt, and the row spacing was 900×900 mm. Each row was arranged with six bolts. The bolts at the two sides were inclined 15 degrees outward, and the rest were arranged vertically. The bolt was connected by a reinforced ladder beam made of $\phi 14$ mm round steel welding.

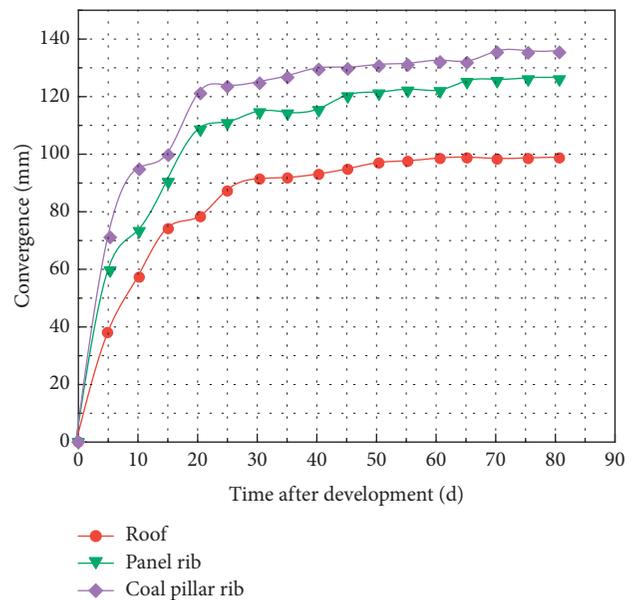
FIGURE 6: Deformation monitoring of the surrounding rock during roadway excavation.

During the excavation of the tailgate 8211, four measuring stations were arranged in the entry with a distance of 50 m. The JSS30 A digital display convergence meter was used for measurements. The displacement of the entry roof and two sides during excavation period is shown in Figure 6. It can be

seen that the surface displacement of the entry showed a changing trend of “coal pillar rib > solid coal rib > roof.” Finally, the deformation of the coal pillar was 131 mm, the deformation of the panel rib was 125 mm, and the subsidence of the roof was 99 mm. It can be seen that the deformation of the surrounding rock of tailgate 8211 was within a controllable range, which could meet the needs of

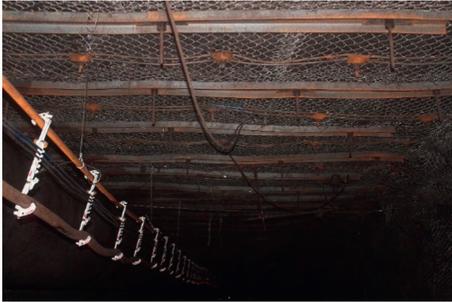
FIGURE 7: Control effect of the surrounding rock.

normal panel mining. The photo of site support effect is shown in Figure 7. It should be noted that the applicability of the proposed support scheme on other coal mines needs to be studied because every coal mine may have different geological and mining conditions, which greatly affect the support parameters design. Further case studies are needed in order to deliver some general principles of support scheme design.
