# Research Article

# **Change Detection and Feature Extraction of Debris-Flow Initiation by Rock-Slope Failure Using Point Cloud Processing**

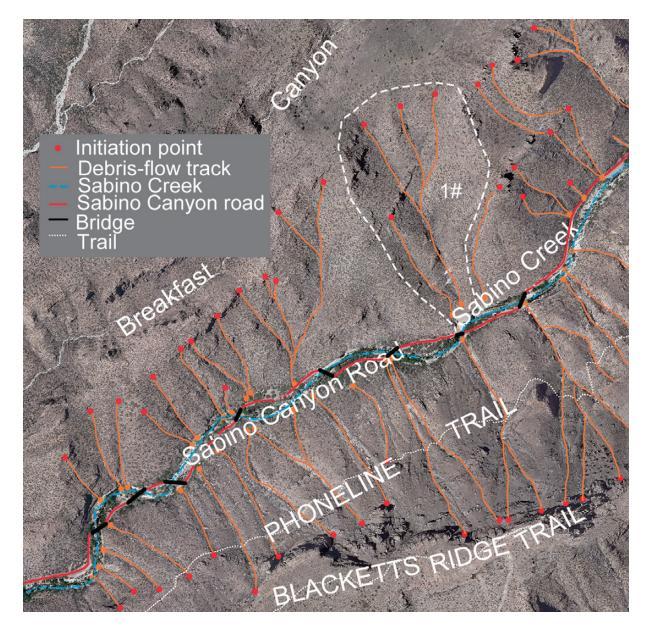
FIGURE 2: Orthophoto of Sabino Canyon collected in 2015 by PAG  $(2.56 \text{ km}^2 \text{ area with a } 15 \text{ cm accuracy, edited}).$

Digital orthophotography orthophotos produced by the Pima Association of Governments' (PAG's) Regional Remote Sensing Program show the debris-flow activities in Sabino Canyon (Figure 2).

There were more than fifty slope failures occurring in lower Sabino Canyon (Figure 2). Many of them aggregated debris-flow tracks and resulted in the creation of the steep chutes down to the Sabino Creek.

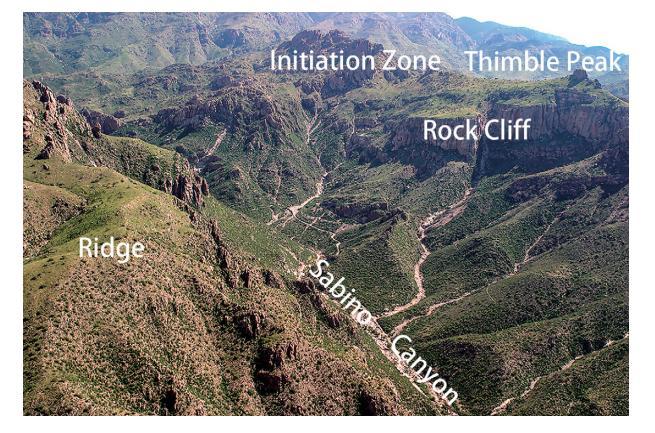
FIGURE 3: Slope failures and debris flows along the east side of Sabino Canyon. Photograph obtained from Magirl, 2009.

Debris flows were typically initiated on a steep slope before developing into a rapid flow confined by a steep channel and ultimately deposited the material downstream on the Sabino Creek (Figure 3).

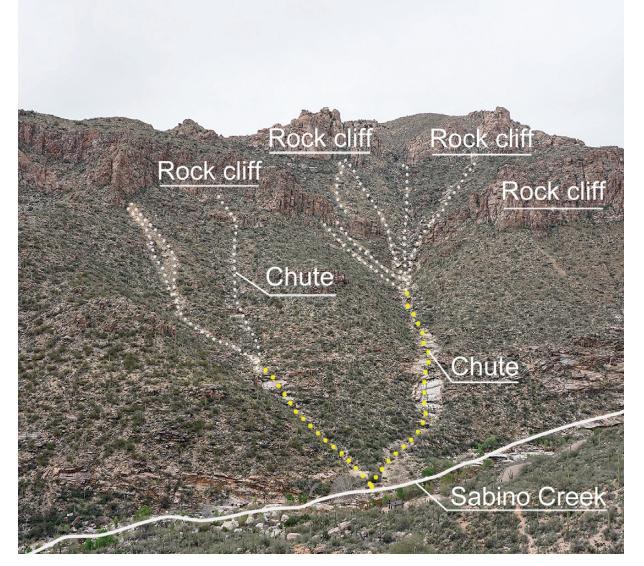
FIGURE 4: A large chute that passed the debris flows with its multiple, steep talus slope initiation points.

2.3. Rock Cliffs in Initiation Zone. The initiation zone of the debris flows was near vertical bedrock outcrops of the Wilderness Granite [21] and consisted of central core granitic intrusion flanked with a metamorphic core complex on the margins [25]. Steep talus slopes below these outcrops were covered with thin colluvium [24]. Each debris flow had one or multiple initiation points, finally gathered in Sabino Canyon (Figure 4).

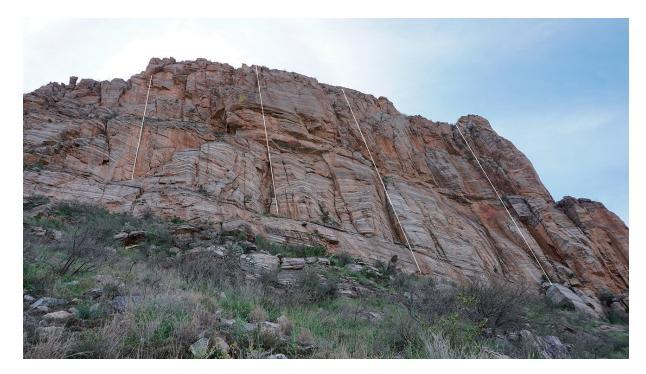
FIGURE 5: Two primary steeply dipping joint sets taken around the Thimble peak. The joint sets marked in the photo are the one along an  $\sim$ 240° azimuth, and the other joint sets are the slope orientation which is nearly east-west azimuth.

Two nearly orthogonal, steeply dipping structural joint sets (WSW-ENE trending and SSE-trending) incised the bedrock into blocks (Figure 5) that mobilized the sediment and contributed to the initiation of the debris flows and also to the enormous potential and kinetic energy of the debris flows, leading to the scouring of material from the hillsides, channels, and downstream channels [23].

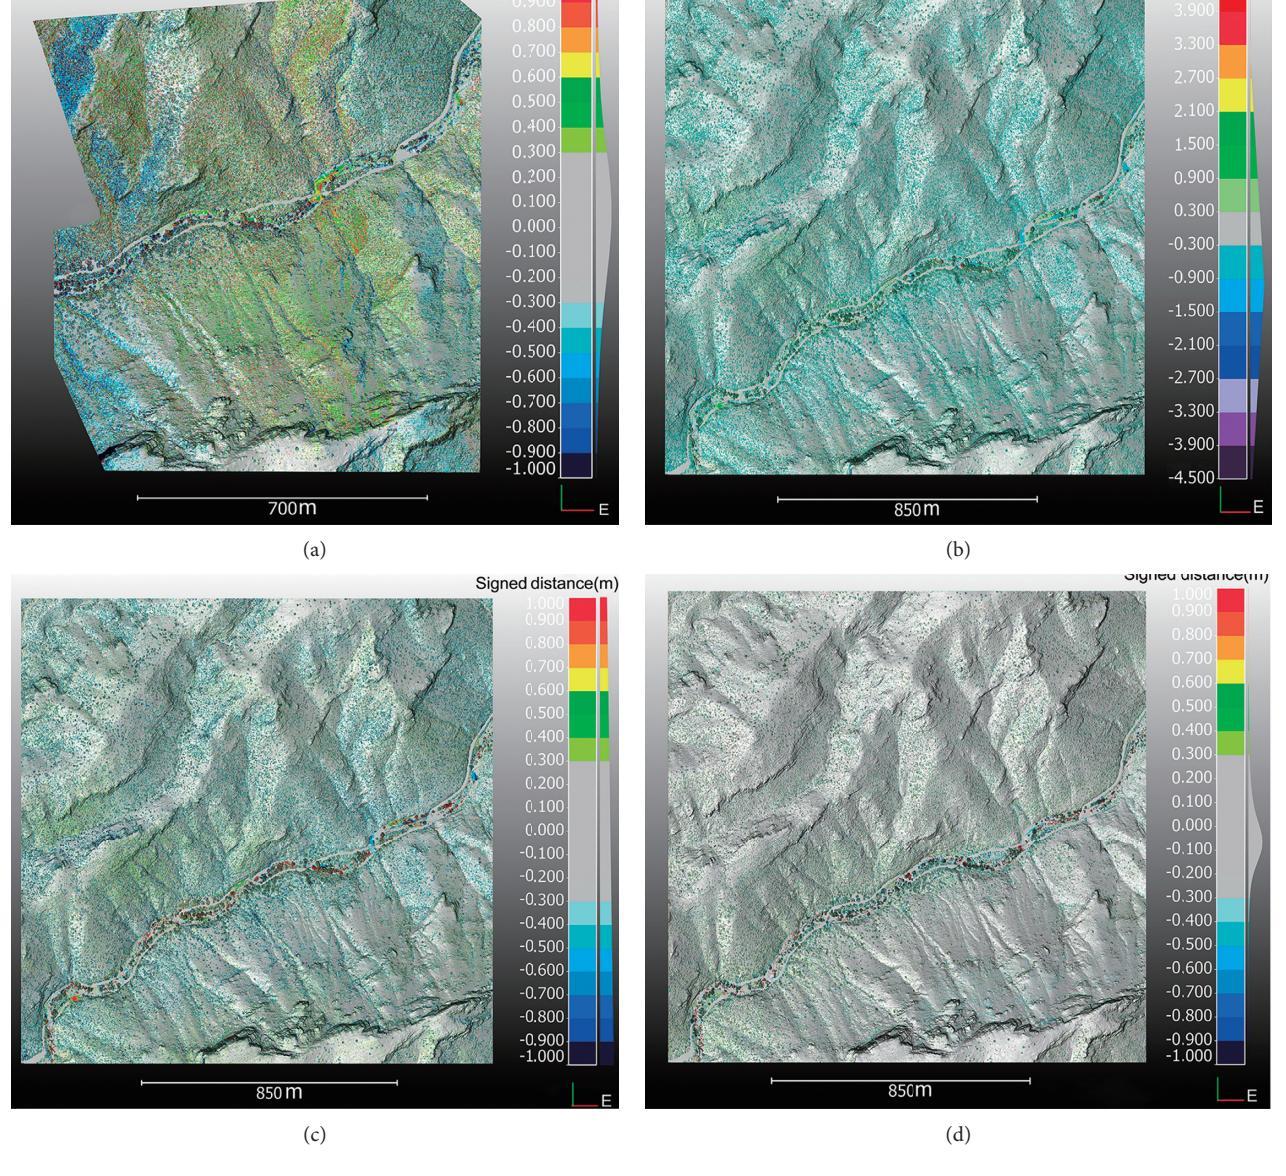
FIGURE 6: The result of distance computation.

The topographic changed maps using the LiDAR data recorded the land surface before and after event is shown in Figure 6, where the previous year was set as reference data and the subsequent year represented a compared data. The positive distance meant that the compared mesh was outside the reference mesh and the negative distance meant that the compared mesh was inside the reference mesh. Color scale referred to the range of signed distance and the bulge on the right of the color scale represented the distribution of computation results. 700 represented the plotting scale, meter.

Compared with the large spatial scale, the change was quite insignificant. Most of the changes between the two meshes were concentrated on a small interval ranging from -1 m to 1 m, since the colluvium covered on the slopes was thin (<1 m). In order to clearly observe the topographic change relative to its area, we edited the color scale to concentrate it on an interval ranged from -1 m to 1 m to show the primary topographic change (Figure 6). The distance computation results exhibited evident changes before and after the debris-flow events that occurred in 2006, showing an extensive positive change in 2007 compared with 2005 Compared with 2007, a constant negative change occurred later, and a relatively bigger negative change happened during the period from 2007 to 2011 (Figures 6(b) and 6(c)), whereas a relatively inconspicuous change was exhibited from 2011 to 2015 (Figure 6(d)).

No.	Year	Color scale (m)	Topographic changes
(a)	2005-2007	-1.0-1.0	An extensive positive change around 0.3 m to 0.9 m on the slope represents a mass deposition which is almost caused by the debris delivered by the debris flows. Obvious negative changes occurred along the big chutes of debris flows in lower Sabino Canyon, representing strong erosion caused by the scour of debris flows.

(b)	2007-2011	-4.5-4.5	A wide negative change represents continuous weathering and erosion, while a relatively small positive change existed at the lower canyon on its west side, signifying the continuous sediment deposition in that area.

(c)	2007-2011	-1.0-1.0	A more distinct weathering and erosion on the slopes and obvious sediment in the Sabino Creek.
(d)	2011-2015	-1.0-1.0	Positive change around 0.3 m to 0.9 exists on the slope showing a mass deposition caused by the debris delivered by the debris flows. Negative changes occurred along the big chutes of the debris flows in lower Sabino Canyon, representing the strong erosion caused by the scour of the debris flows.

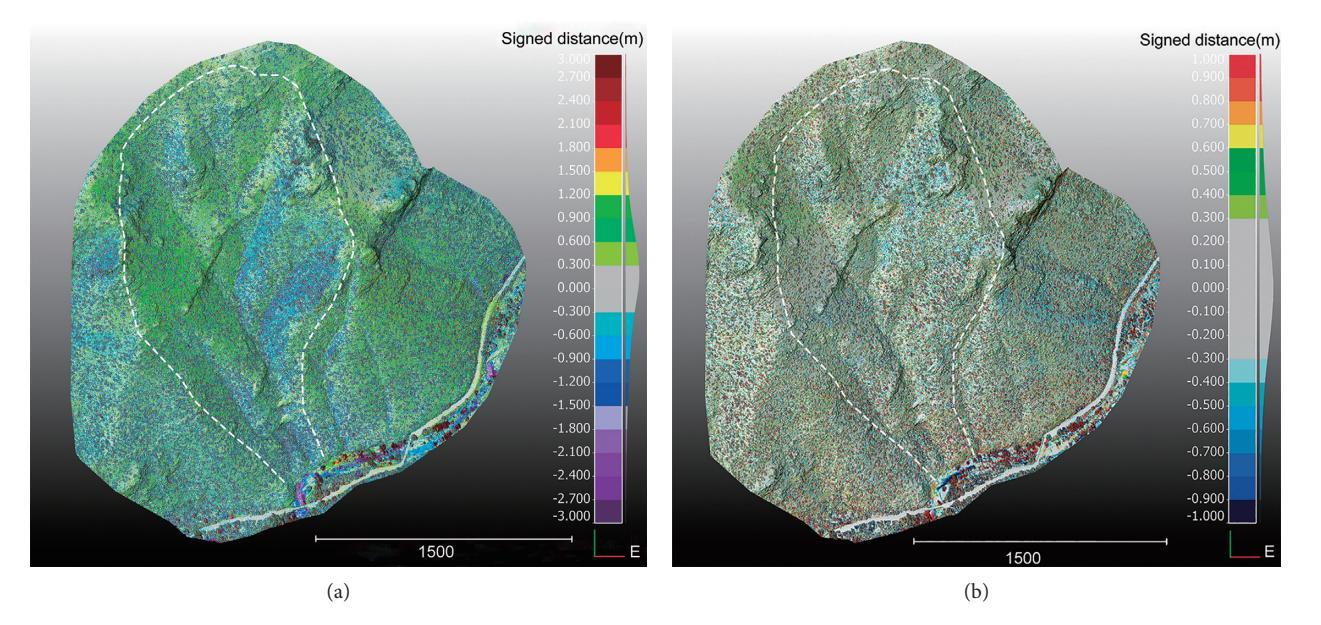
FIGURE 7: The change detection of debris-flow area. (a) The changes in the detection in 1# debris flow from 2007 to 2011. It showed strong erosion in debris-flow chute which ranged from 1.2 m to 1.5 m. A relatively small positive change ranging from 0.3 m to 0.6 m occurred outside the debris flow, representing the deposition on the slope due to the weathering and small pieces of rocks that fell down from the steep initiation points. (b) The changes in the detection in 1# debris flow from 2011 to 2015. It showed inconspicuous change during these 4 years which shows that the debris flow tends to be stable.

To show a more detailed change for all parts of debris flows, we segmented the point cloud in debris flows marked in Figure 2 and compared the change from 2007 to 2015 because of the fragmentary data of that area collected in 2005, as illustrated in Figure 7.

On comparing the changes in the detection results of the data collected in 2011 and those collected in 2007, a more visible change was seen and a stronger erosion occurred at the initiation area at the east side of the chute, about 1.2 m to 1.5 m, but a relatively positive change existed outside the debris-flow area due to probable deposition of the debris (Figure 7(a)). After 2011, the topographic changes seemed to

be slowed down, with a relative change distance  $\pm 1$  m, and mainly concentrated in a range less than 0.3 m (Figure 7(b)).

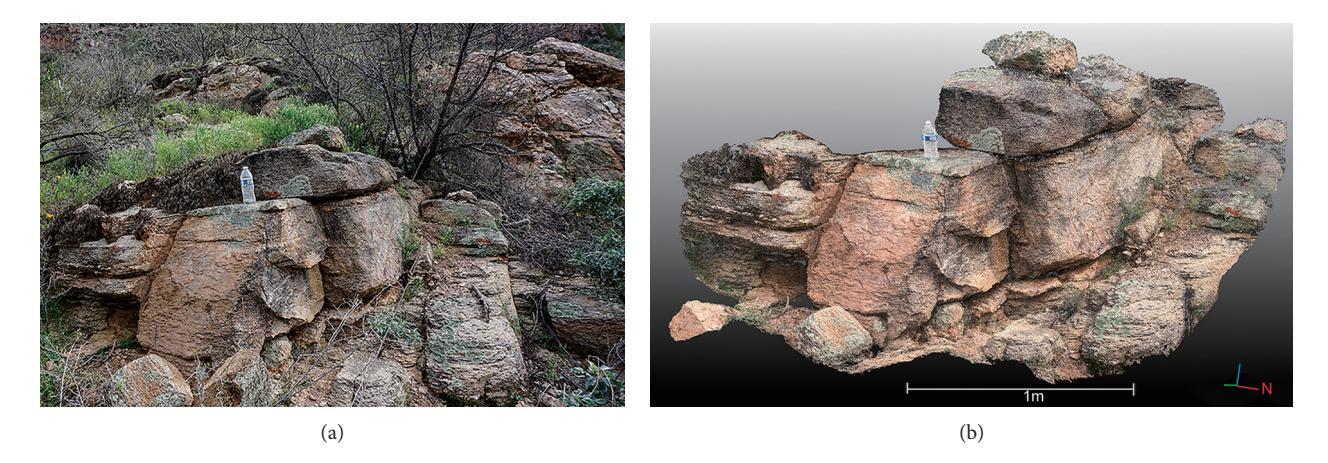
FIGURE 8: Point clouds of rock block sample generation by photogrammetry. (a) Rock block samples that were taken at the bottom of the Thimble peak. (b) Point cloud data of the rock block samples generated in Pix4D and segmented in CloudCompare software.

4.1. Point Cloud Data Generation by Photogrammetry. A rock block sample, closing to the initiation point of debris-flow chute, is shown in Figure 6(b) containing groups of joint sets selected in a talus rock slope (Figure 8(a)).

In order to acquire the joint parameters of the rock block, the point cloud file was imported to the Cloud-Compare software (7,080,405 points), the point cloud data were cleaned, and the vegetation was removed manually using a segmentation tool (4,559,945 points left) (Figure 8(b)).

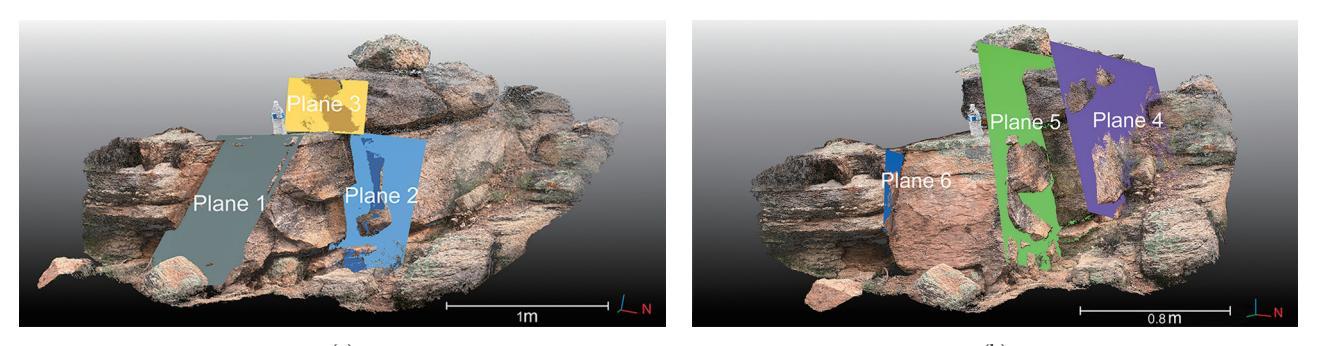
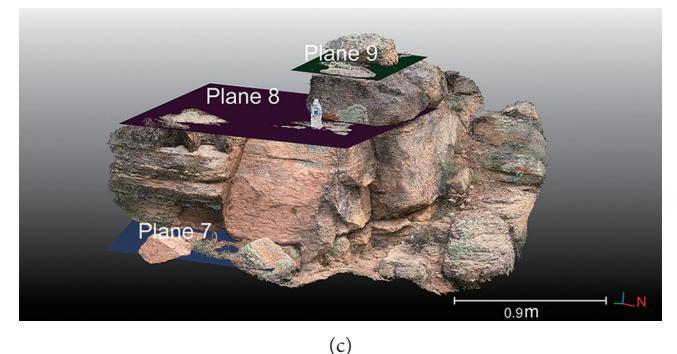
FIGURE 9: Joint sets of sample rock blocks. (a) Joint set 1. (b) Joint set 2. (c) Joint set 3.

Three joint sets were identified (Figure 9), while it was noteworthy that the orientation of the two joint sets detected by RANSAC matched well with the field observations conducted in December 2018. However, the third bedding plane did not match. The reason for this could be the horizontal orientation of the bedding plane, which caused an error between the reality and the field measurement.

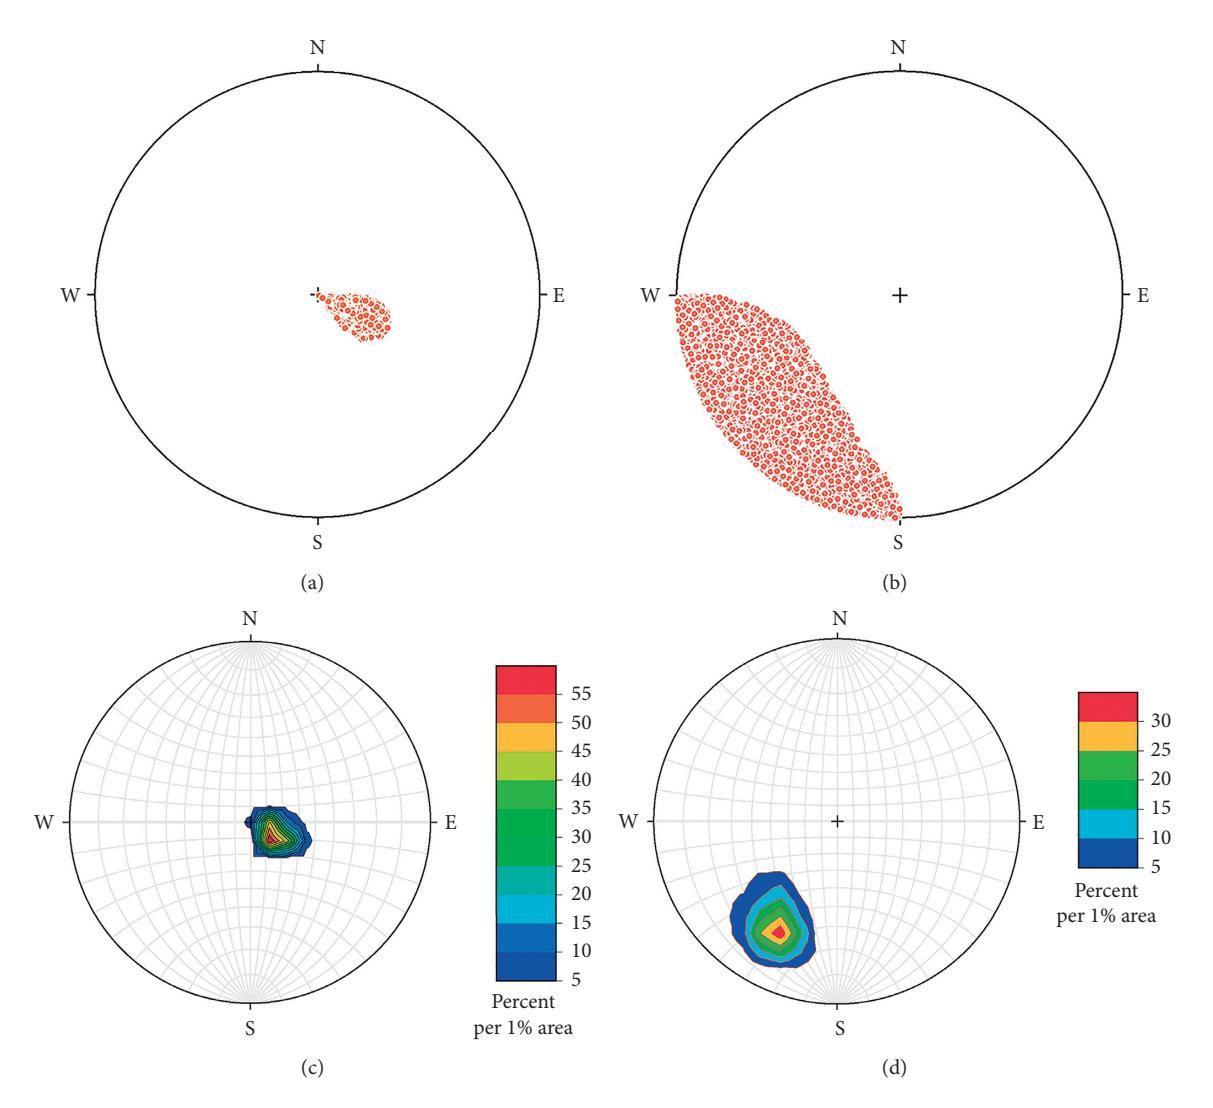
FIGURE 10: Scatter plot and the contour plot of the orient normal to polygons of detected joint sets. (a) Scatter plot of the orient normal to polygons of detected joint set 2 (plane 4). (b) Scatter plot of the orient normal to polygons of detected bedding plane (plane 8). (c) Contour plot of the orient normal to polygons of detected joint set 2 (plane 4). (d) Contour plot of the orient normal to polygons of detected bedding plane (plane 8).

The orientation of the normal was obtained and was plotted on a stereo net, wherein the scatter plot showed the point dense, and the contour plot displayed the distribution of orient normal (Figure 10).

The standard angular deviation of the orient normal along each detected joint surface could reflect the joint roughness, as shown in Table 2. Accordingly, the bedding planes exhibited the roughest surface, and the exposed joint surfaces were rougher than the fresh ones.
