Research Article

Experimental Study of a New Concrete Admixture and Its Function in Filling and Reinforcing Granite Fissures

Songnan Ru,¹ Zuozhou Li,² Handong Liu,³ Huaichang Yu ,³ Chunlei Wei,¹ Guangzhu Hu,² Fangfang Xue,² Congxian Wang,¹ and Jialiang Wang,³

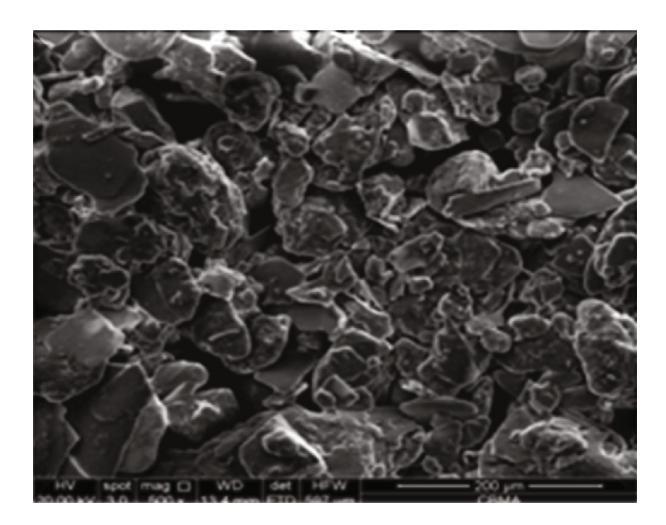
FIGURE 1: Microstructure of the HS admixture.

2.1. Materials. The high-strength (HS) admixture, which has a particle size of $100 \,\mu$ m, is a superhydrophobic powder containing both inorganic and organic materials. It has a floor structure, a flat structure, a spherical structure, and a smooth

sphere structure (see Figure 1). The thin sheet inorganic substrate has the properties of heat resistance, corrosion resistance, and high strength. The sheet structure, which has a high diameter to thickness ratio, can hinder the penetration of water and other corrosive substances in concrete linings. The chemical bonding between the surfaces of organic compounds and inorganic powders under alkaline conditions gives concrete materials hydrophobic properties.

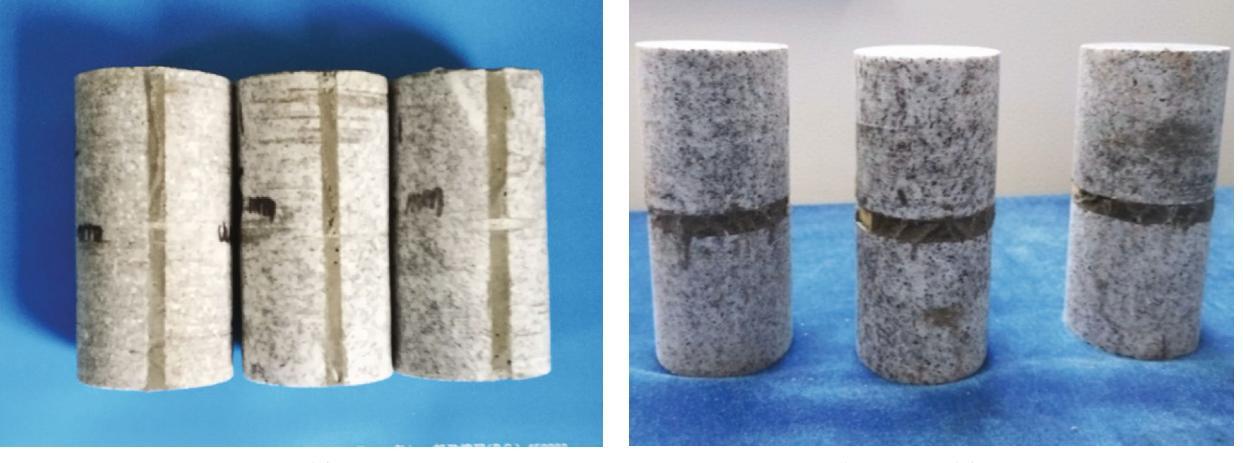
(a) Vertical fissures

(b) Horizontal fissures

FIGURE 2: Specimens with filled fissures.

2.6. Triaxial Compression Test by Filling Granite Fissures. The tested granite came from Lanzhou, Gansu, China. Cylindrical granite specimens 50 mm in diameter and 100 mm in height were prepared. To simulate the surrounding rocks, specimens containing vertical and horizontal fissures were prepared by cutting, and then, the fissures were

filled with concrete containing the HS admixture. The specimens are shown in Figure 2.

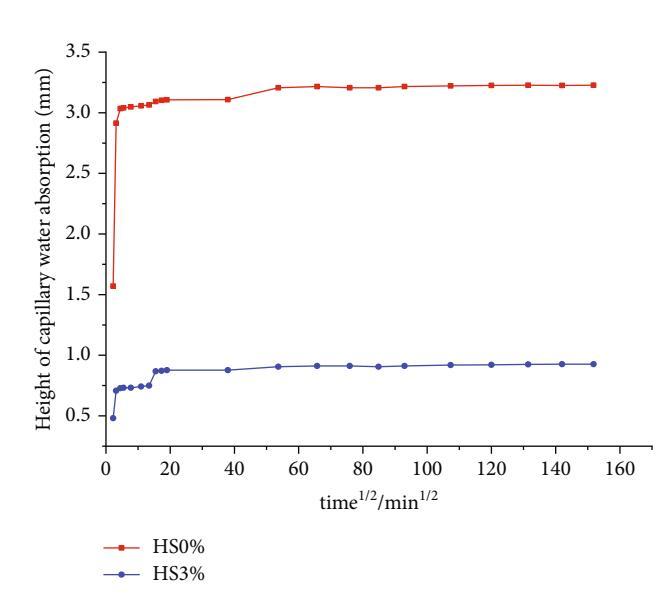
FIGURE 3: Results of the capillary water absorption test.

3.1. Results of the Capillary Water Absorption Test. The results of the capillary water absorption test are shown in

Figure 3. The benchmark specimen (0%) had a high capillary water absorption rate, and the capillary water absorption rate of the concrete with a 3% HS admixture was much less than that of the benchmark specimen for the entire process. The benchmark specimen (0%) absorbed water quickly in the first 1,440 min, then the absorption rate slowed, and finally, the water reached a height of approximately 3.21 mm after the adsorption rate stabilized. For the specimen with a 3% HS admixture, the capillary water absorption height was only 0.88 mm at 1,440 min, and it finally stabilized at a height of approximately 0.92 mm. The analysis showed that adding the HS admixture effectively improved the water absorption resistance of the concrete.

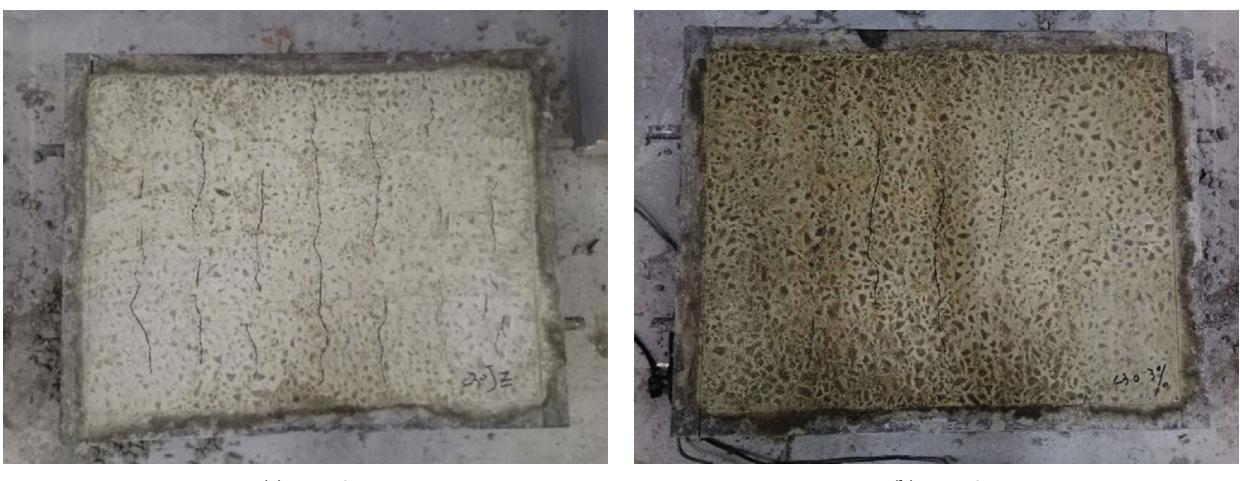
(a) 0% HS

(b) 3% HS

FIGURE 4: Distribution of fissures after 24 h.

3.2. Results of the Early-Age Anticracking Test. The surface conditions of the specimens after the early-age anticracking test are shown in Figure 4. Table 2 shows the number of fissures and the cracking area on the surface of the specimens with the two admixture dosages. As shown in Figure 4, the benchmark specimen (0%) had a much greater number of fissures than the concrete with a 3% HS admixture. Table 2 shows that the concrete with 3% admixture had a significantly lower number of fissures per unit area and a significantly smaller cracking area compared to the benchmark specimen (0%). Therefore, the HS admixture effectively improved the early-age anticracking ability of the concrete. At the same time, the concrete with the 3% HS admixture performed better in terms of the water retention, while that without the HS admixture lost more water.

The HS admixture improved the early-age anticracking ability of the concrete because it contains a substantial amount of active SiO₂, Al₂O₃, and CaO. These components can react with the substances generated by cement hydration and thereby improve the composition of hydrated cement and reduce both the internal and external migrations of water. Hydrated calcium silicate $Ca_5Si_6O_{16}$ (OH)·4H₂O with a low alkalinity, a high strength, and good stability is generated in this process, which improves the composition of hydrated gelatinous substances. In the early stage of concrete molding, adding the HS admixture can restrict contraction and prevent the loss of water from the concrete, which can reduce the amount of desiccation fissures and thereby decrease the cracking area and the number of fissures in the amended concrete.

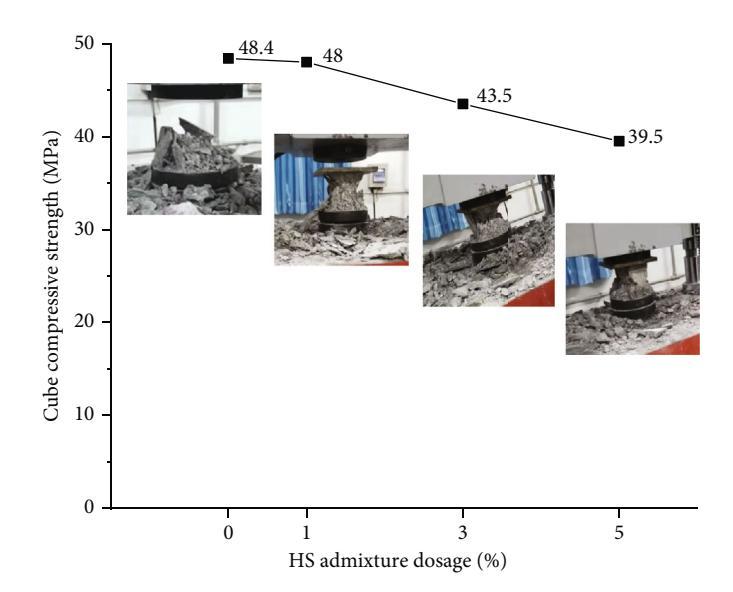
FIGURE 5: Results of the cube compressive strength test.

3.3. Results of the Cube Compressive Strength Test. The results of the cube compressive strength test are shown in Figure 5, which shows that the cube compressive strength of the specimens declined as the HS admixture dosage increased. The benchmark specimen (0%) had a compressive strength of 48.4 MPa. The cube compressive strength values for the specimens with 1% and 3% HS admixture were 48.0 and 43.5 MPa, respectively, which are 0.8% and 10.1% less than the values of the benchmark specimen; for the specimens with 5% HS admixture, the cube compressive strength was 39.5 MPa, which represents a decrease of 18.4% compared to the benchmark specimen.

In this test, the HS admixture lessened the damage to the concrete specimens. The benchmark (0%) specimen showed vertical fissures and a high degree of crushing. The specimen with 1% HS admixture showed a similar failure mode to the benchmark specimen; however, the occlusions between the fragments were more compact, and the degree of crushing was reduced. The specimens with 3% and 5% HS admixture were more intact, with a further decrease in the amount of crushing.

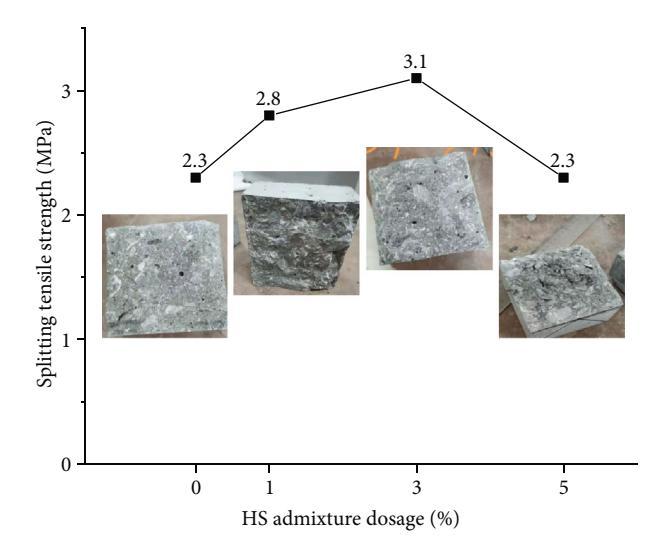
FIGURE 6: Results of the splitting tensile test.

3.4. Results of the Splitting Tensile Test. The results of the splitting tensile test are shown in Figure 6, which shows that the splitting tensile strength first increased and then

decreased as the HS admixture amount was increased. The splitting tensile strength of the benchmark specimen (0%) was 2.3 MPa; for the specimen with a 1% HS admixture, the splitting tensile strength was 2.8 MPa, which represents an increase of 21.7% compared to the benchmark specimen; for the specimen with 3% HS admixture, the splitting tensile strength reached a peak of 3.1 MPa, which is 34.8% higher than the value for the benchmark specimen; for the specimen with 5% HS admixture, the splitting tensile strength decreased to 2.3 MPa.

The HS admixture dosage also affected the splitting tensile failure mode of the specimens. The fissure surface of the benchmark specimen (0%) was neat, interface fissures were formed, and the specimen had no crush marks. The specimen with 1% admixture cracked locally, and the cracking surface was more rugged than that of the benchmark specimen. The specimens with 3% and 5% admixture showed uneven fissures.

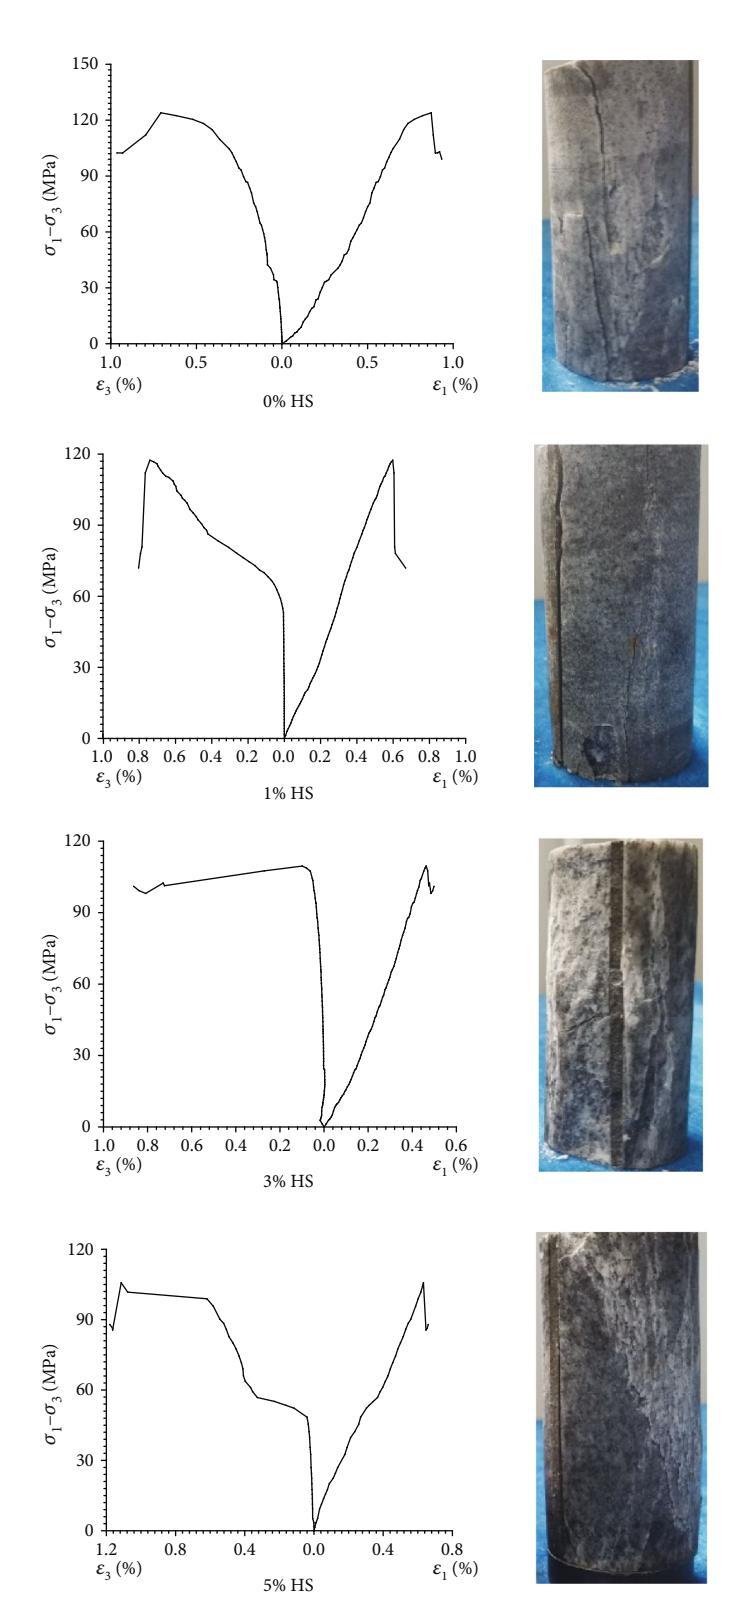
FIGURE 7: Stress-strain curve and typical failure mode of specimens with different HS admixture dosages.

4.1. HS Admixture Dosage. To study the reinforcement effect of the HS admixture dosage on the rock mass, rock specimens with 4 mm wide vertical fissures were prepared and filled with concrete containing 0%, 1%, 3%, and 5% of the HS admixture. Then, triaxial compression tests were conducted on a TAW-2000 triaxial tester with a confining pressure of 2 MPa. The stress-strain curve and failure mode are shown in Figure 7.

As shown in Figure 7, the damaged benchmark specimen (0%) had one fissure from top to bottom, with a width of 0-2 mm, which was serrated along the depth direction. The entire specimen cracked and peeled off, and the filled layer became fragmented.

The damaged specimen with 1% HS admixture had two fissures from top to bottom on both sides of the filled layer, with depths of 1-2 mm. The specimen cracked and peeled off between the two fissures that were serrated along the depth direction. The surface rock peeled off from the specimen, and the failure surface was characterized by steps.

The specimen with 3% HS admixture had two clear fissures from top to bottom on both sides of the filled layer. The rock and filled layer within these two fissures cracked and peeled off. One serrated fissure was oriented from top to bottom, with a width of 1-1.5 mm, and had pinnate fissures on both sides. The other fissure in the middle was short and oblique, and the entire peeling surface was uneven and had a steep dip angle, with a 2 mm wide crack, which extended upward from the lower part of the specimen through the middle part of the specimen and then gradually

The damaged specimen with 5% HS admixture had four fissures on the back of the filled layer. In particular, one fissure was a short vertical fissure, two fissures developed obliquely and intersected with the main fissure, and the remaining main fissure was serrated and crescent-shaped on the side face, with a depth of 0.5-2 mm. The rocks between the main fissure and the filled layer cracked and peeled off, and the damaged surface had two steps. The hoop strain at the stress-strain curve was greater than the axial strain.

With the increase in the HS admixture dosage, the overall peak strain decreased, which indicates that adding the HS admixture improved the axial and radial stiffnesses of the specimen with fissures. The specimen with 5% HS admixture showed an evident decrease in the peak strength, while the other specimens had similar peak strength values, which is consistent with the results of the splitting tensile test. Therefore, the concrete containing 3% HS admixture was recommended for filling fissures.

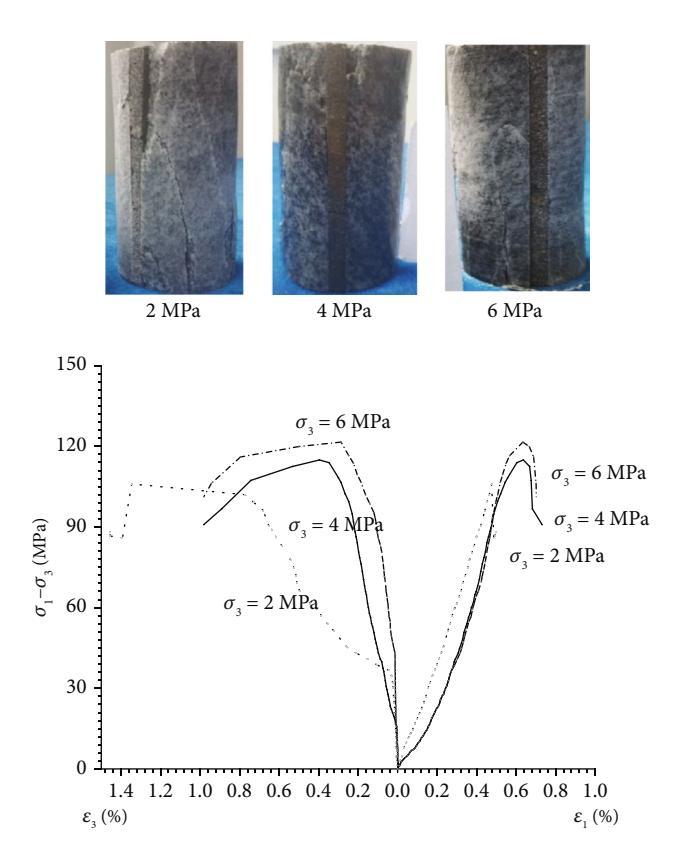
FIGURE 8: Stress-strain curve and typical failure mode under different confining pressures.

4.2. Confining Pressure. To study how the confining pressure affects the mechanical properties of rocks filled with concrete containing the HS admixture, rock specimens with 6 mm wide vertical fissures were prepared. Samples containing 3% HS admixture were tested under confining pressures of 2, 4, and 6 MPa. The stress-strain curve and failure mode are shown in Figure 8.

Figure 8 shows that under a confining pressure of 2 MPa, the damaged specimen had two inverted Y-shaped fissures and two oblique fissures. One inverted Y-shaped fissure was seriously damaged, and the rocks between this fissure and the filled layer were completely crushed. The rocks between a short oblique fissure in the lower part and the filled layer also peeled off, and the rocks in the upper part of the specimen collapsed. Under a confining pressure of 4 MPa, two small transverse fissures and two small oblique fissures appeared and converged at the filled layer, and the rocks at the upper part were broken. Under a confining pressure of 6 MPa, there was one oblique fissure with a high dip angle on the side of the filled layer, which ran from top to bottom and clearly cracked at the bottom. In addition to the fissure, unclear small closed pinnate fissures appeared.

In conclusion, under different confining pressures, the stress-strain values of the specimens with filled fissures were similar to those of the specimens without fissures. When a specimen was damaged, the filled layer was closely connected to the rock without evident sliding. The broken surface, which ran from top to bottom, appeared on the rock rather than on the filled layer itself, which indicates that concrete containing the HS admixture can effectively fill rock fissures.

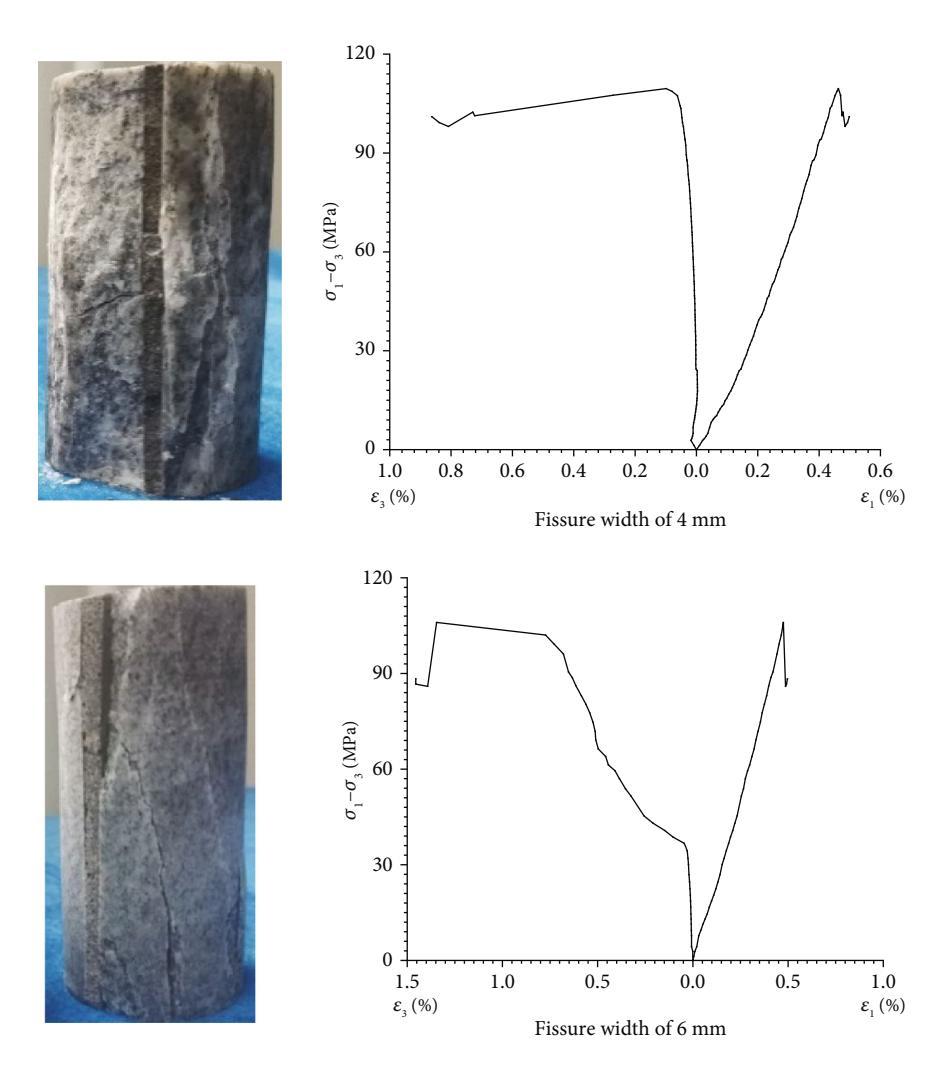
FIGURE 9: Stress-strain curve and typical failure mode of specimens with different fissure widths.

4.3. Fissure Width. To study how the concrete containing the HS admixture reinforced rock masses with different fissure widths, rock specimens with vertical fissures of 4 mm and 6 mm were prepared. The HS admixture dosage was 3%, and the confining pressure was 2 MPa. The stress-strain curve and failure mode are shown in Figure 9.

Figure 9 shows that the damaged specimen with a fissure of 4 mm had two fissures that ran from top to bottom on the side of the filled layer, with a depth of approximately 1-1.5 mm. The rocks and filled concrete between the two fissures were broken and peeled off, the fissures showed a zigzag shape, and there were pinnate cracks on the side. There was a damaged fissure with a width of approximately 2 mm on the peeling surface, which extended upward from the lower part of the specimen through the middle part of the specimen and then gradually ended. There were transverse cracks and step-like damages in the filled layer.

The damaged specimen with a fissure of 6 mm had one inverted Y-shaped fissure on the side of the filled layer that ran from top to bottom. The rocks above the fissure were broken and peeled off, and there were more fissures in the specimen. Two inverted Y-shaped fissures were also formed on the side of the filled layer. For one inverted Y-shaped fissure, the rocks at the fissure bifurcation were broken and fell. The Y-shaped fissure on the side gradually diminished and ended at the convergence of the filled layer. The upper part of the filled layer was broken and peeled off due to the broken and peeled rocks. Although there were many longitudinal fissures in the specimen, the overall skeleton of the specimen was intact.

Overall, the damaged specimen with a fissure width of 4 mm was highly intact, while the specimen with a fissure width of 6 mm had many longitudinal fissures. The peak strengths of the specimens with the two different fissure

widths did not significantly change, and the axial strains after damage were also almost the same. In addition, both specimens showed high residual strengths after the peaks, which shows that concrete containing the HS admixture can effectively reinforce fissures of different widths.
