Research Article

Damage Assessment of Low-Velocity Impacted Sandwich Composite Structures Using X-Ray Micro-Computed Tomography

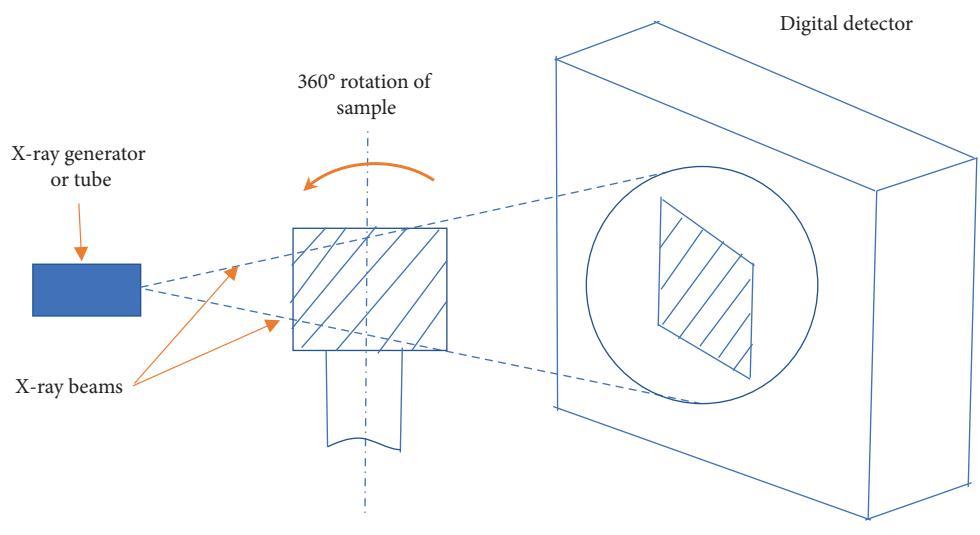
FIGURE 1: Schematic representation of the X-ray micro-computed tomography.

X-ray μ -CT technique uses X-ray radiation to capture 2D images of an object in many positions about the axis of rotation on which the platform is mounted. In this work, the specimen underwent a complete 360° revolution while the X-ray generator emitted X-ray beams that passed through the specimen and reflected on the digital detector in the form of radiographs (projected 2D images) as shown in Figure 1. The 2D images were subsequently transformed into 3D images using specific algorithms included in the Volume Graphics software. This conversion was done to provide qualitative and quantitative data for more in-depth analyses.

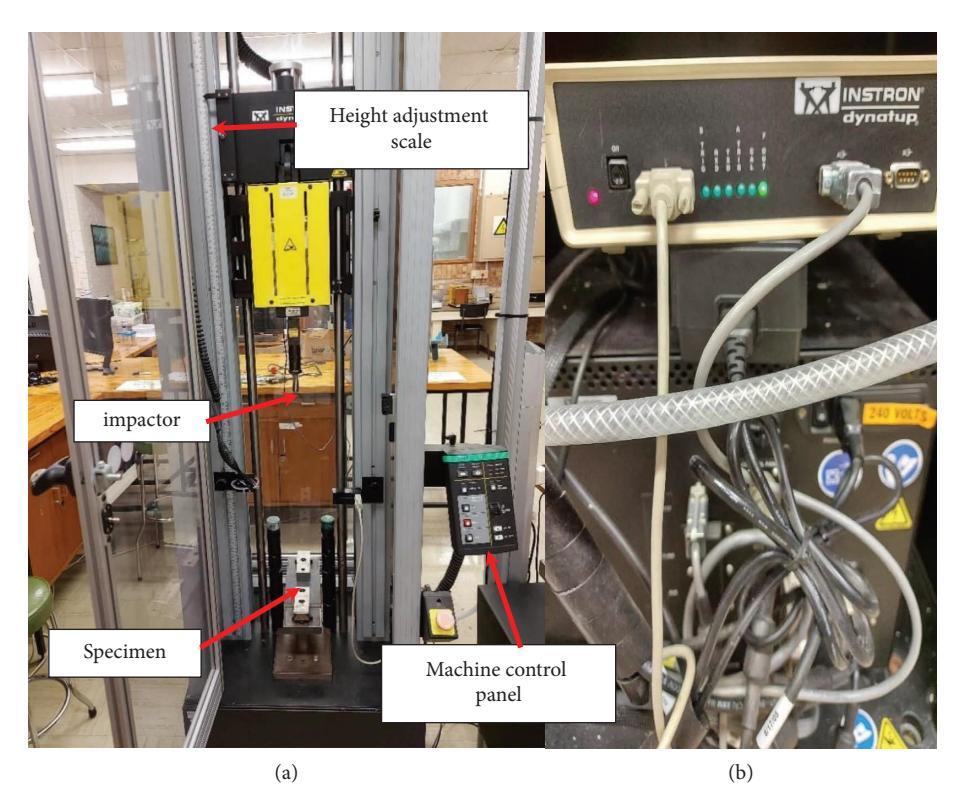
FIGURE 2: (a) Instron Dynatup Impact Testing Machine. (b) Data acquisition equipment.

3.1. Impact Tests. Low-velocity impact tests were conducted on an Instron Dynatup Impact Testing Machine equipped with a hemispherical impactor of diameter 12.5 mm. Various levels of impact energy were applied to the specimens, ranging from barely visible impact damage (BVID) to the point of achieving complete penetration. The total impact mass of 5.61 kg was used. All tests were conducted at a room temperature of 21°C. The testing machine was equipped with a data acquisition device as depicted in Figure 2. The specifications of the testing machine are provided in Table 1.

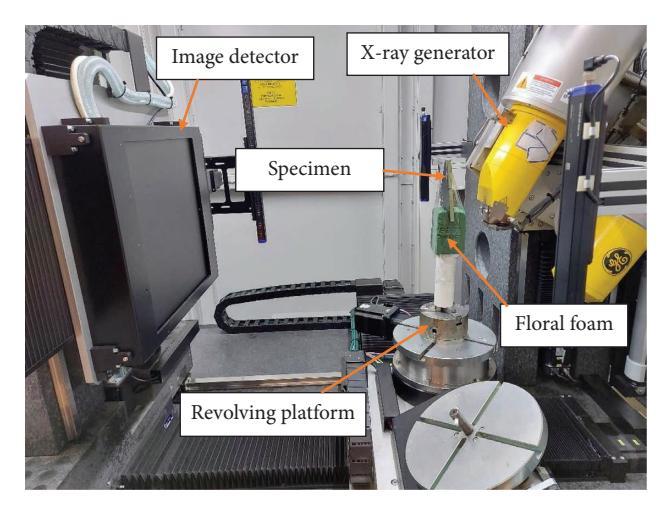
FIGURE 3: Experimental setup for the X-ray micro-computed scanner.

- (1) Positioning of the X-ray source, the detector, and the specimen: The X-ray source, the detector, and the specimen were positioned as illustrated in Figure 3, to optimise the geometric parameters. The detector was positioned at an angle perpendicular to the X-ray beam to prevent image distortion.
- (2) Specimen mounting: Each specimen was mounted on a rotating stage located between the X-ray source and detector. It was placed in such a way that the centre of rotation was aligned with the axis of the Xray beam to avoid reconstruction errors. Each specimen was secured on a low-density floral foam

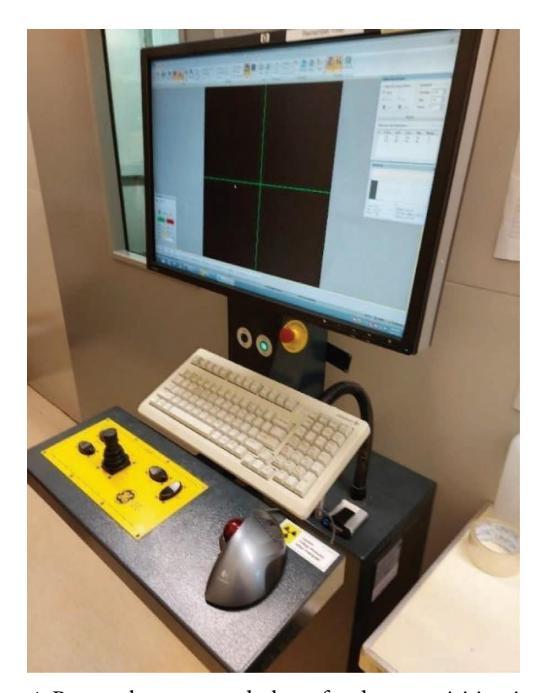
FIGURE 4: Personal computer desktop for data acquisition installed outside the scanner room.

robust shielding designed to impede radiation leakage effectively. This includes enclosures fortified with lead lining, complemented by observation windows crafted from leaded glass, which allow for secure monitoring of the scanning procedure. As an additional safety measure, the computer utilised for data capture is stationed externally to the scanner chamber, as depicted in Figure 4.

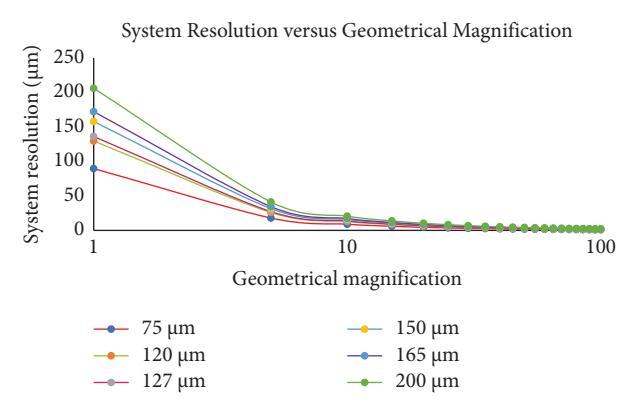
FIGURE 5: System resolution versus geometrical magnification for spot size of $7 \,\mu$ m.

The resolution of the cone-beam X-ray μ -CT system depends on the geometrical magnification as illustrated in Figure 5.

The graph shows a steep reduction of system resolution up to a geometrical magnification of 5 for the range of commercial flat panel detectors. The system resolution curves then decreased gradually as the geometrical

magnification increased, approaching the minimum system resolution. Given a focal spot size of $7 \mu m$ and a detector resolution range of 75–200 μ m, the system produced a resolution range of $11-26\,\mu\text{m}$. This suggests that the system's resolution is more influenced by the detector resolution than the focal spot size or any other parameters. When the focal spot size was changed to $4 \mu m$, the system resolution was estimated between 10 and $25\,\mu m$ for the same range of flat panel detector resolution. In other words, even with the very small focal spot size $(4 \,\mu m)$, it is the detector's resolution that primarily determines the system resolution. It is also worth noting that the system resolution is much smaller than the detector resolution, which indicates that the reconstruction algorithm and system geometry successfully resolved details smaller than a single detector pixel. This setup, with a highresolution detector and small focal spot size, provides the capacity to image fine details within the specimens being examined.

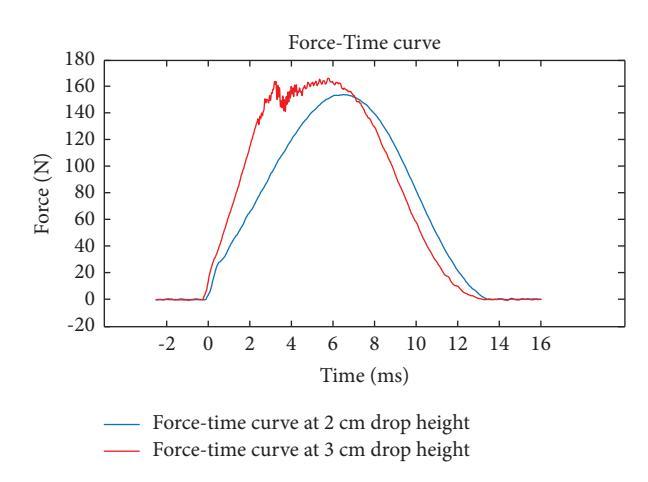
FIGURE 6: Damage initiation at the second lowest drop height.

The impact responses were observed on load-time curves. The area under each curve is representative of the total energy absorbed during the impact event. For all curves, the load increased linearly with the increase in time before the peak load was reached. The time to reach the peak load depended on the impact energy values. Thus, the higher the impact energy, the shorter the time to reach peak value. For barely visible impact damage, two cases exist. (1) The impact energy is completely dissipated throughout the specimen, as reflected on a load-time graph with a smooth curve. For this loading profile, the peak load was reached at 6 ms. (2) The profile depicting a sharp drop in load by approximately 18% is a manifestation of damage initiation as well as a reduction of stiffness in the structure. In this case, the peak load was reached at only 3 ms. From the sharp bottom end, the load increased nonlinearly to below the initial peak load. The second peak load was followed by a smooth curve to zero load at the end of the impact event that lasted for a total 13 ms, as shown in Figure 6. The first notable damage mechanism to manifest was delamination (interfacial debonding or debonding of the face sheet and the foam core). However, delamination is preceded by matrix cracking caused by shear and tensile stresses during impact.

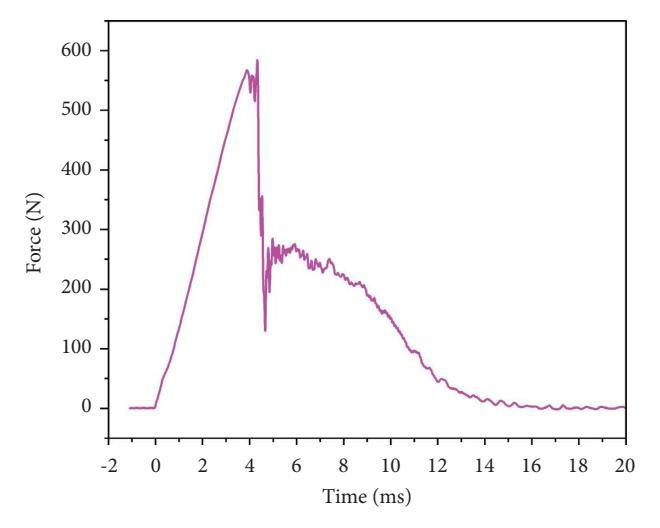
FIGURE 7: Damage evolution with top face sheet penetrated.

The reduction in stiffness continued until the top face sheet was completely perforated with a sharp drop of the load to approximately 75% of the peak load. This drop in load suggests a minimum contact force recorded at the impactor at the time of perforation. When the impactor regained full contact with the foam core, it occurred at a lower load in comparison to the peak load before another slight sharp increase. The load then gradually decreased from a lower peak load to zero and remained constant, as illustrated in Figure 7.

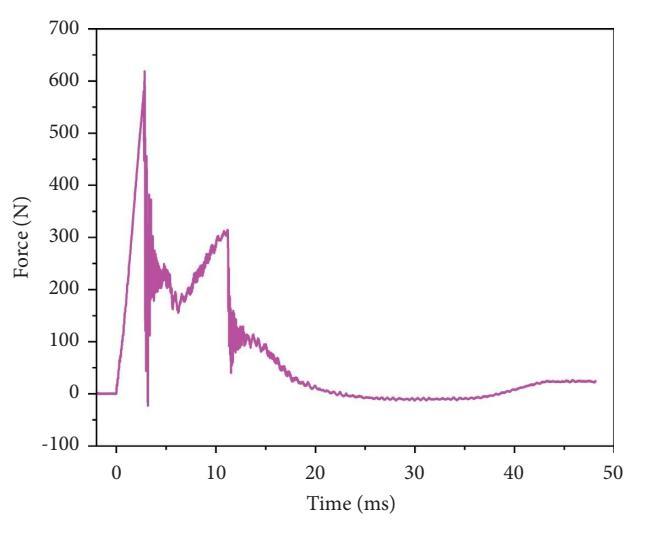
FIGURE 8: Damage evolution for a nearly perforated specimen.

In the near penetrated specimen, the foam core was crushed immediately after the top face sheet was penetrated. This resulted in a decrease in load before the densification of the foam core due to load increase as shown in Figure 8. The second sharp curve shows that the back face sheet was nearly perforated because it did not reach the zero load. At this stage, the perforated foam core remained in contact with the impactor. The load started to decrease gradually from a point above the end point to indicate a complete perforation of the foam core. The decrease reached the zero load, remained constant for a while before a gradual increase, and then became constant again. The gradual increase is perhaps an indication of residual energy before full penetration.

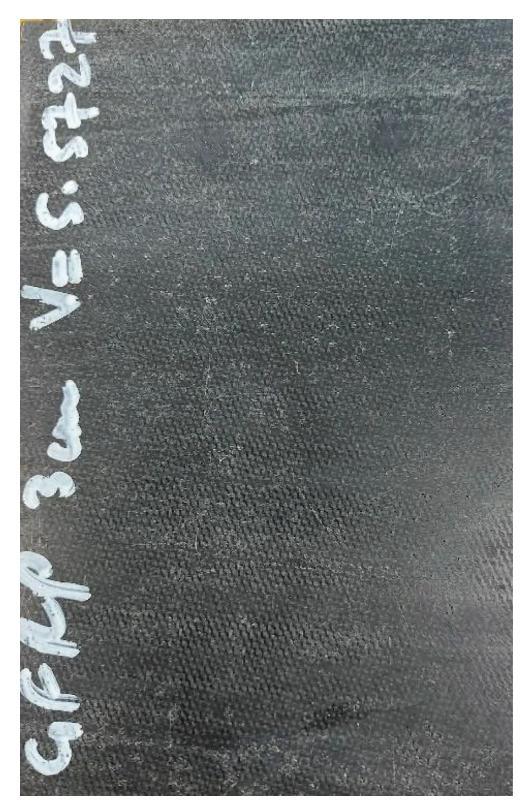
FIGURE 9: Front face sheet of impacted specimen with delamination BVID.

It was important to carry out visual inspections for the impacted sandwich composite structures for the different impact energies. However, visual inspection failed to identify the delamination inflicted on the specimen, as shown in Figure 9.

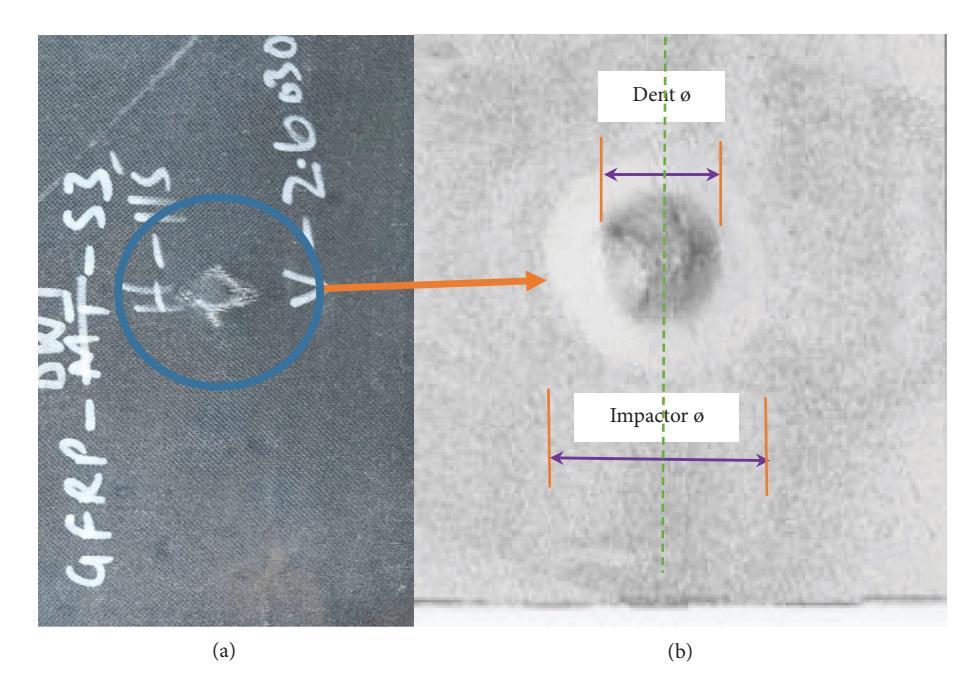
FIGURE 10: (a) Specimen showing the state of closer to full perforation. (b) Specimen illustrating the relative damage morphology tomogram.

Near penetration and its corresponding damage morphology suggested a dent diameter to impactor diameter ratio of 1:2 as depicted in Figure 10. The fully perforated damage morphology served as an indicator of the specimen's impact response for the utilised stacking sequence, as demonstrated in Figure 11.

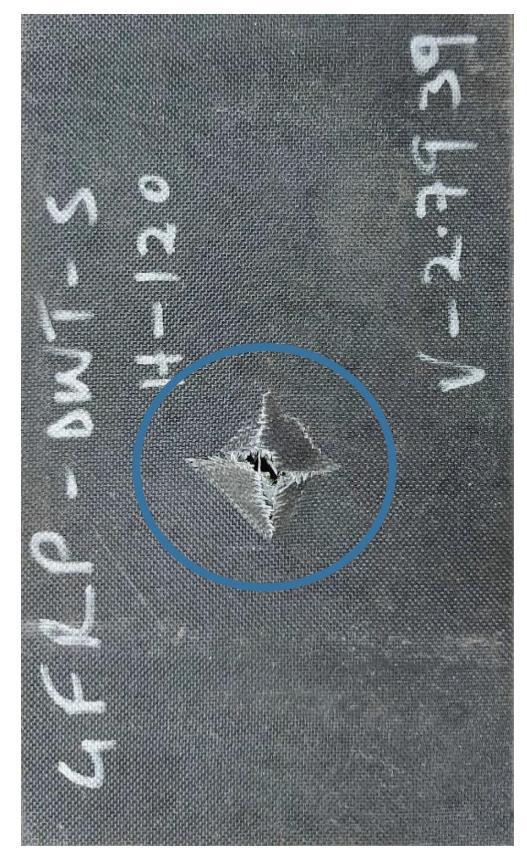
FIGURE 11: Fully penetrated bottom side of the impacted specimen.

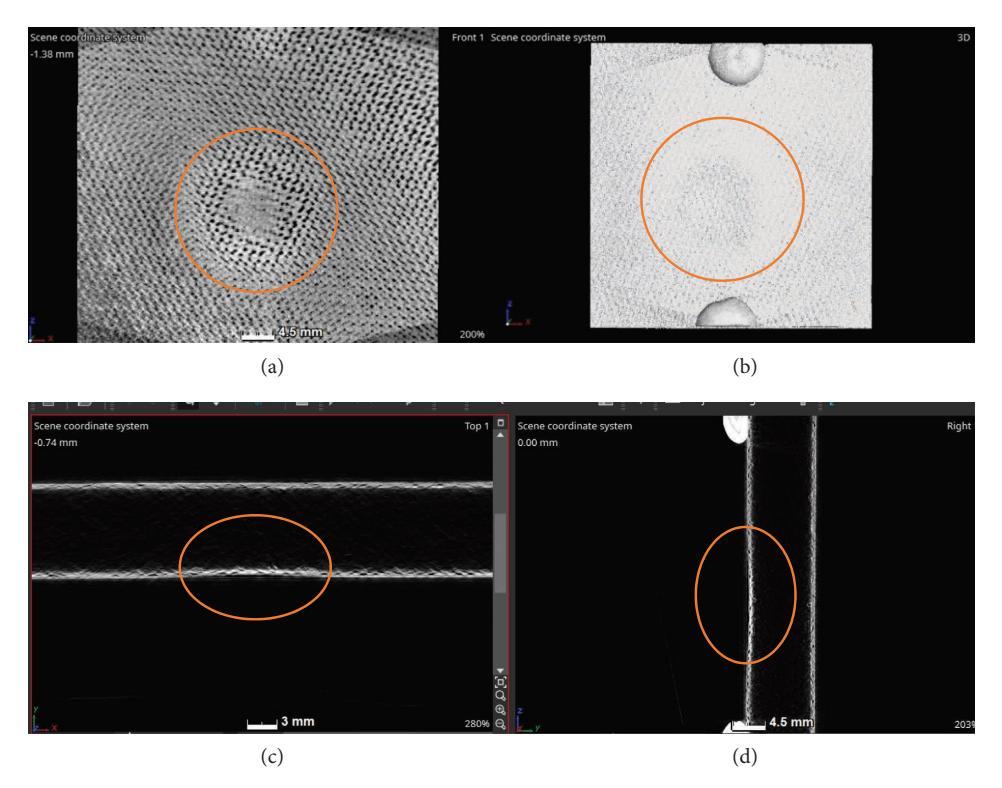
FIGURE 12: (a) Front view. (b) Front (original view). (c) Top view. (d) End view.

4.2. Damage Assessment on the Impacted Specimens Using X-Ray Micro-Computed Tomography. Figure 12 shows the position of impact with respect to the orthogonal views, while Figures 13 and 14 are surface and profile plots, respectively, for the 2 J impact energy.

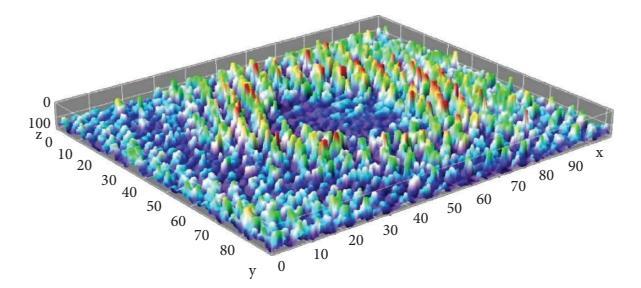
FIGURE 13: Surface plot around the impacted zone for 2J impact energy.

The plot was generated using data from the impacted zone and its peripheries. It reveals that within the region of interest (the impacted zone), there is a notable and consistent decline in gray values when contrasted with the adjacent areas.

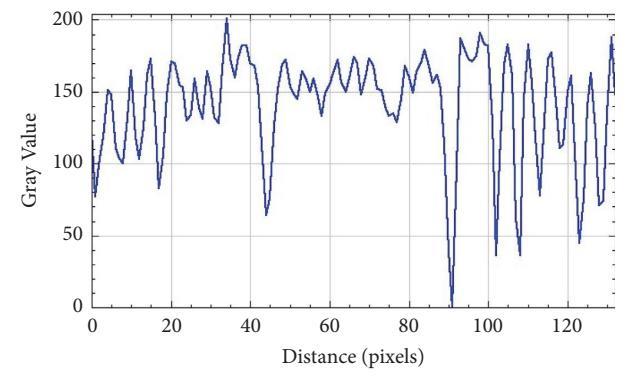
FIGURE 14: Profile plot around the impacted zone for 2 J impact energy.

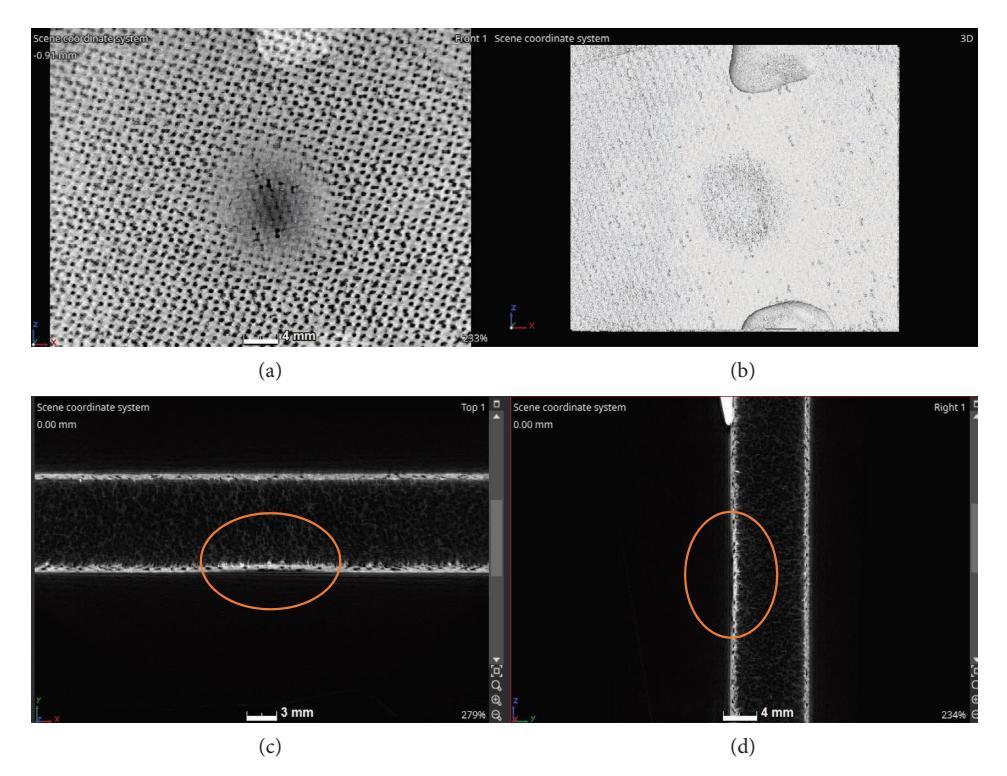
FIGURE 15: (a) Front view. (b) Front (original view). (c) Top view. (d) End view.

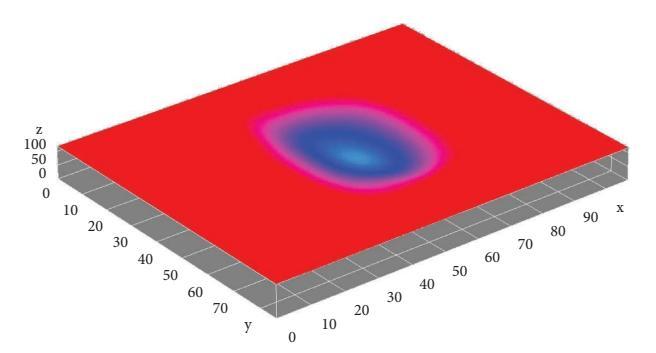
FIGURE 16: Surface plot around the impacted zone for 3 J impact energy.

of crack tips in the matrix along different stacking sequence orientations. An indentation was observed at the impacted zone that resulted in initiation of delamination that could not be visually noticed, as illustrated in Figure 15. The respective surface and profile plots for the 3 J impact energy are depicted in Figures 16 and 17.

The intensity-distance plot shows a drop in intensity as the depth of penetration increases. Thus, the lower gray values were identified at the impacted zone.

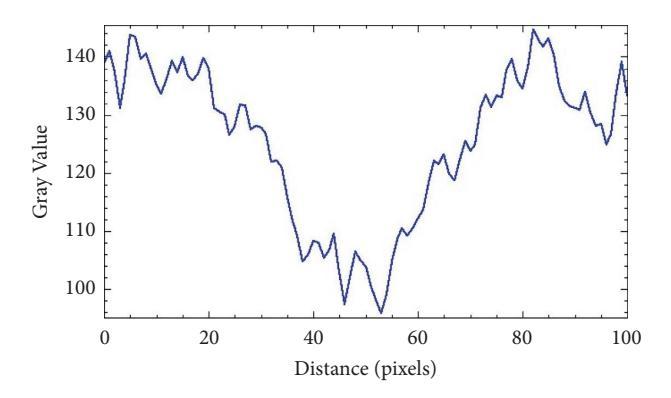
FIGURE 17: Profile plot around the impacted zone for 3 J impact energy.

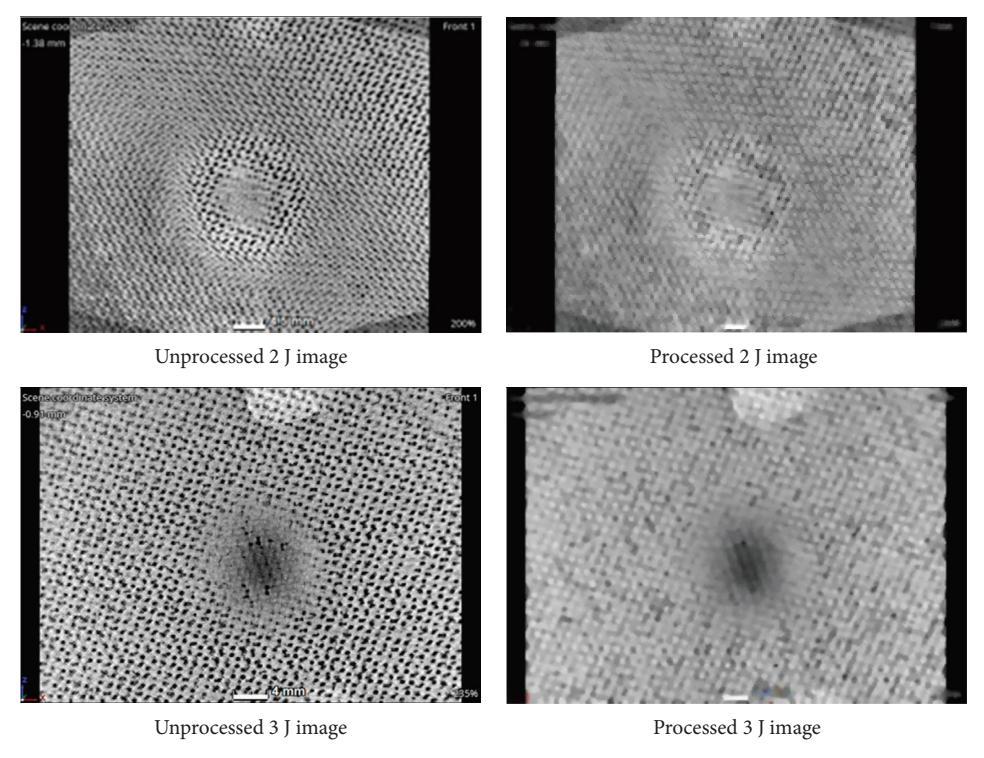
FIGURE 18: Comparison of raw (unprocessed) and processed images.

X-ray μ -CT system. Figure 18 shows the comparison of reconstructed (raw) and processed images for 2 J and 3 J impact energies.

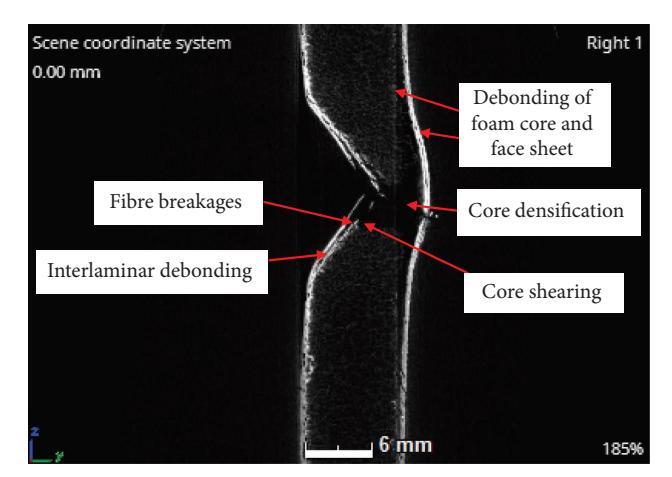
FIGURE 19: Failure modes for the near penetrated specimen.

Barely visible impact damage was observed at low-level impact energies. Progressive damage was attained through increasing the drop heights and observing the damaged areas until full perforation. The area of complete penetration displayed a diamond shape, as shown in Figure 11. This shape could have been influenced by the stacking sequence which featured 0/90° at the outer surface. In a nearly perforated specimen, all failure damage mechanisms were vividly visible using X-ray microcomputed tomography, as featured in Figure 19.

The top face sheet underwent delamination, matrix cracking, and fibre fractures. It was also subjected to interlaminar debonding prior to penetration. The debonding between the foam and top face sheet was localised within the impact area. The foam core failure damage mechanisms included shearing and densification. Shear action originated from the penetrated top face, forming shear bands of almost 45° angle. Densification was a result of the foam core's

compression from the top face sheet to the bottom face sheet due to the impactor. The back face sheet experienced delamination as the primary failure damage mechanism. Fibre breakages occurred at the point of impact, as there was no complete penetration of the impactor at the bottom face sheet.
