Failure Mechanism and Control Technology of Thick and Soft Coal Fully Mechanized Caving Roadway under Double Gobs in Close Coal Seams

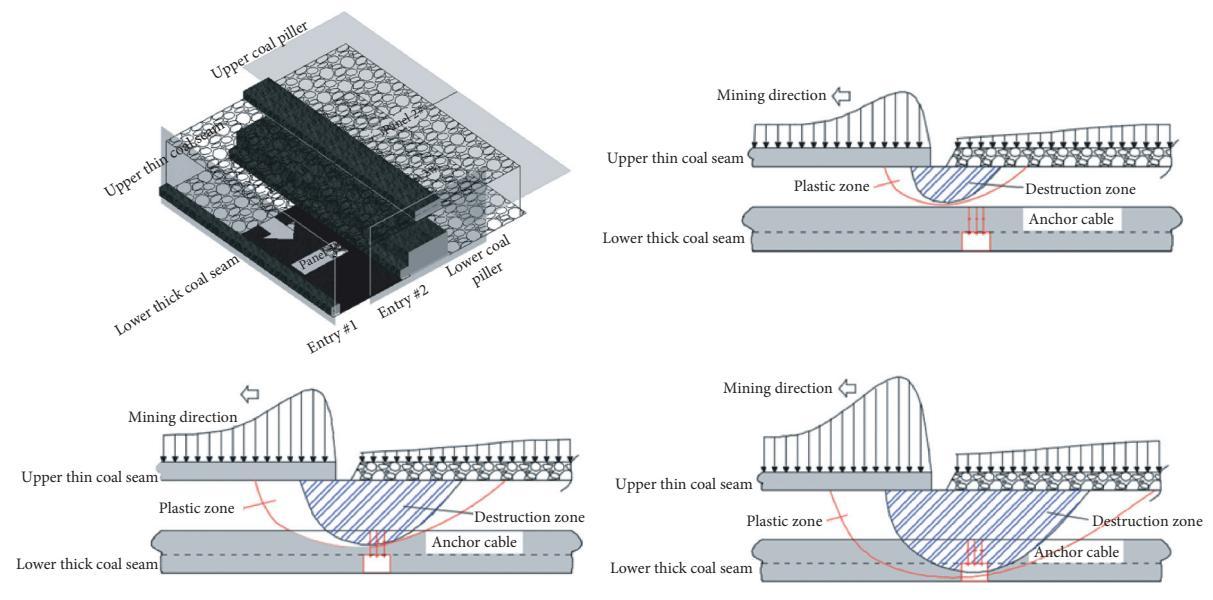
FIGURE 1: Influence of mining in upper coal seam on damage to the lower coal seam.

mining between the upper and lower coal seams will gradually increase, especially when the distance between the coal seams is extremely close. The integrity of the roof before the mining of the lower coal seam has been damaged by the strong mining of the upper coal seam [1, 2]. After the upper coal seam has been mined, the roof structure and stress environment of the lower coal seam mining area have changed [3]. The remaining sections of the coal pillars form a stress concentration, which has a strong influence on the layout space of the lower coal roadway and the stability of the surrounding rock, as shown in Figure 1.

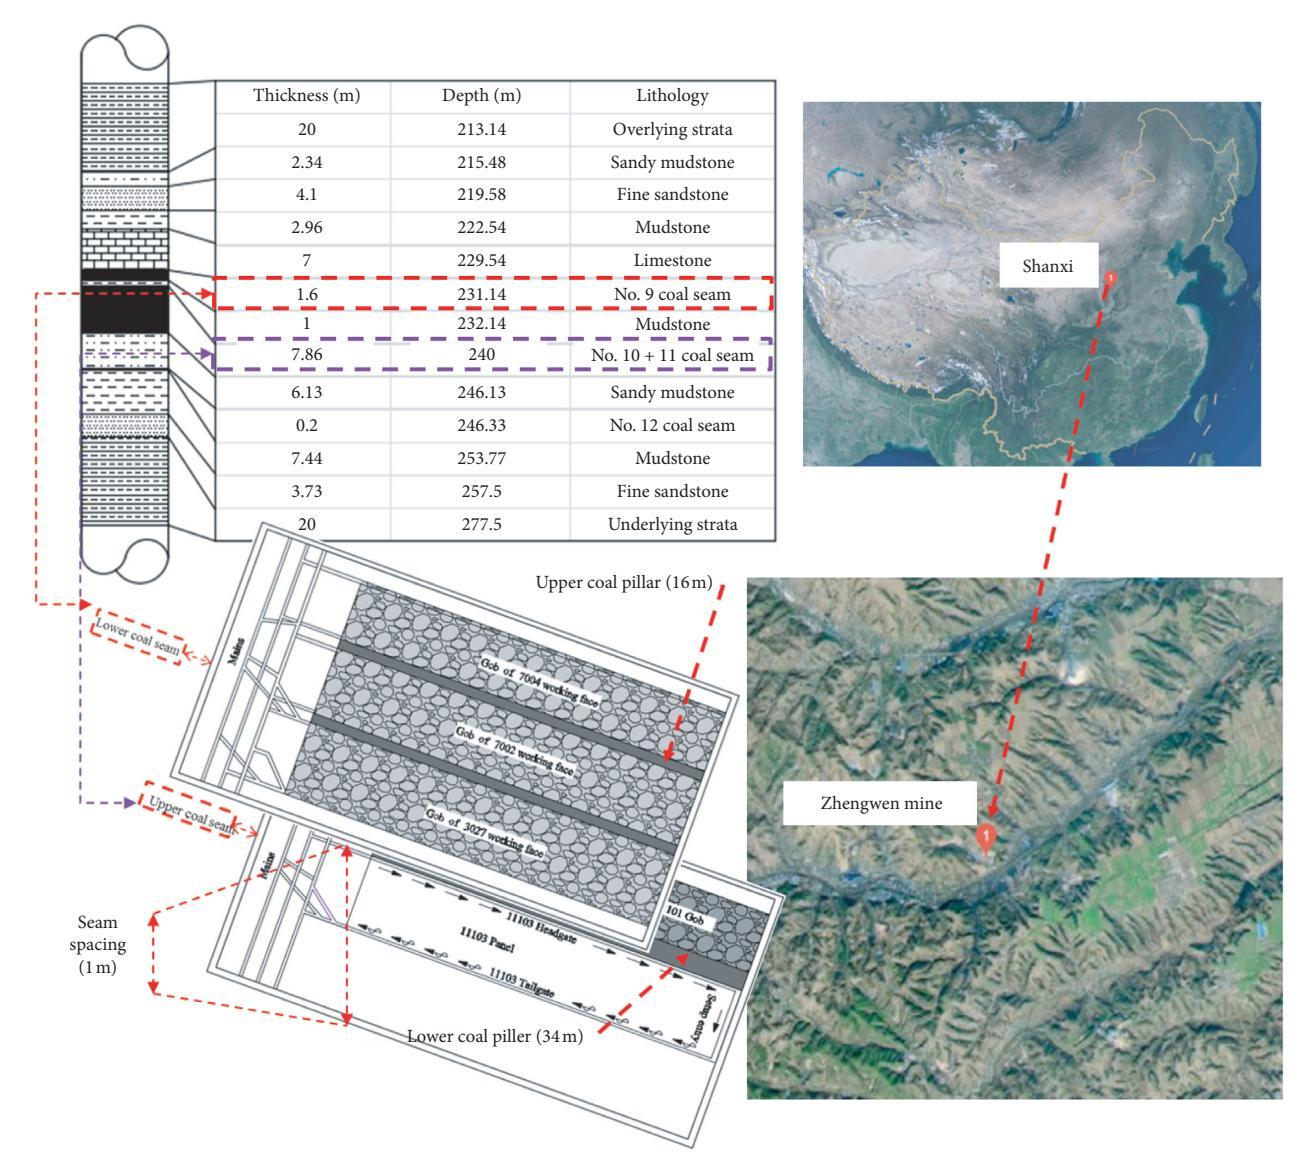
FIGURE 2: Distribution and excavation under double gobs in close coal seams.

2.1. Geological Conditions and Mining Conditions. The Zhengwen Coal Mine that was studied is located in Xiaoyi City, Shanxi Province, China. The No. 1 mining area of the Zhengwen Coal Mine produces mainly #10+11 coal, and the stratum is classified as the Carboniferous Taiyuan Formation. The coal seam elevation of the 11103 working face is between +745~+773, the corresponding ground elevation of this working face is +926~+1014, and the average coal seam inclination angle is 6.5°, which is a near-horizontal coal seam, and the coal seam is more complicated and contains multiple layers of mudstone gangue. The average thickness of the coal seam is 7.86 m. The #10 + 11 coal seam is separated from the upper #9 coal seam by 1 m of thick mudstone, and the average thickness of the upper #9 coal seam is 1.6 m. The overburden layer of the #9 coal seam is K2 limestone (7 m), mudstone (2.96 m), fine sandstone (4.1 m), and sand mudstone (2.34 m). At present, the 11103 working face is arranged under the #10+11 coal seam with an average thickness of 5.86 m. The overburden under the #10 + 11 coal seam is sand and mudstone (6.13 m), #12 coal (0.2 m), mudstone (7.44 m), and fine sandstone (3.73 m). The distribution and excavation under double gobs in close coal seams is shown in Figure 2, and the mining sequence of double gobs in close coal seams is shown in Figure 3.

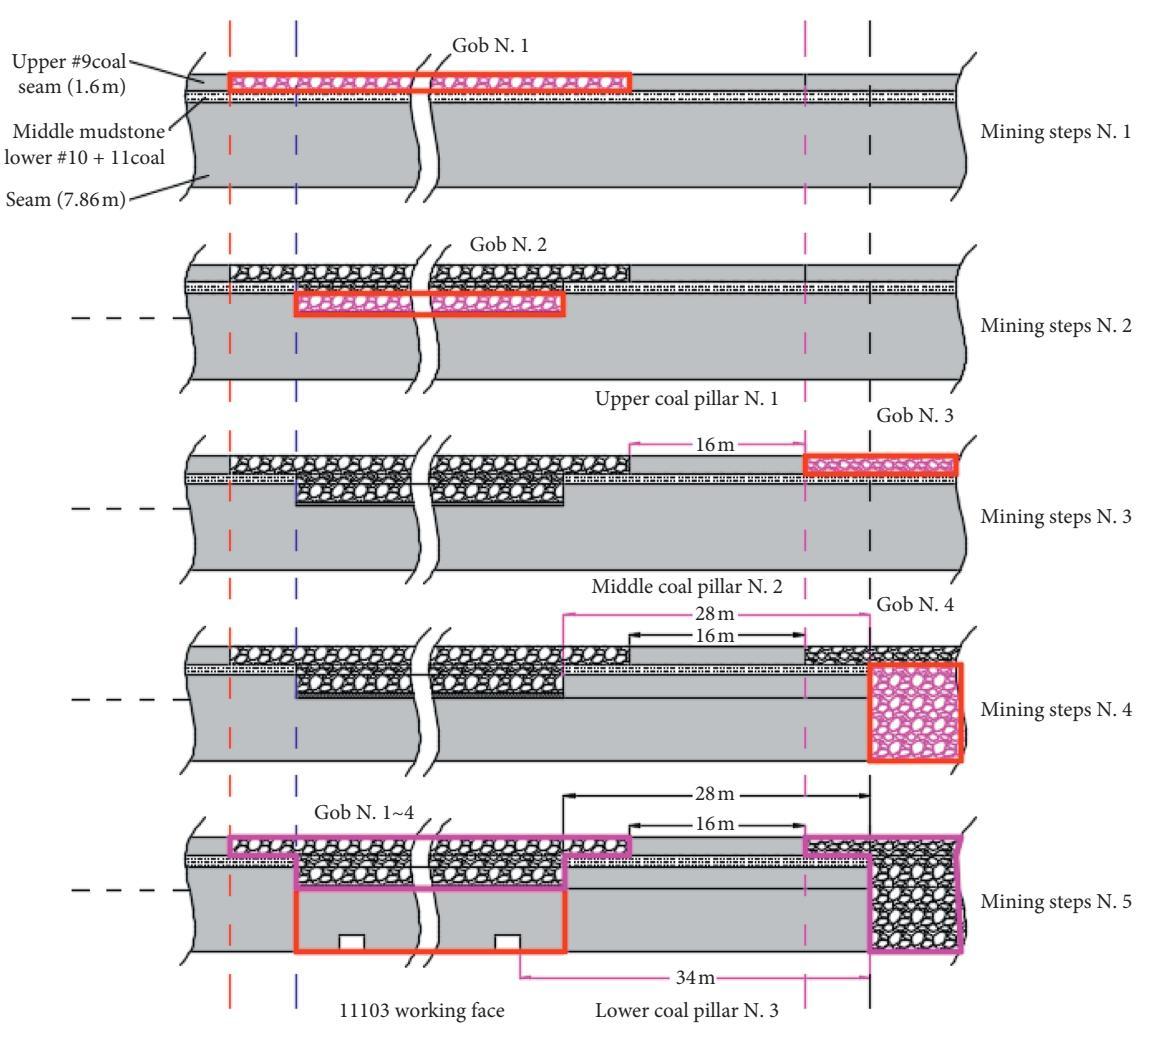
FIGURE 3: Mining sequence of double gobs in close coal seams.

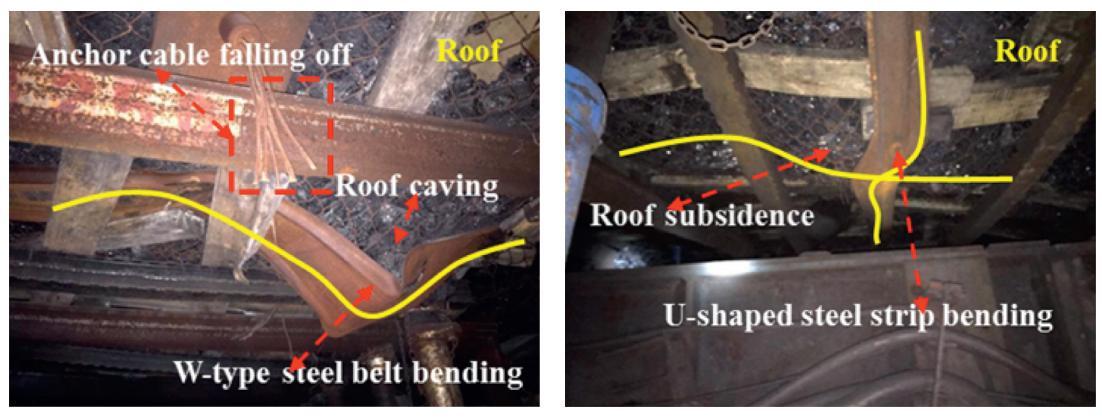
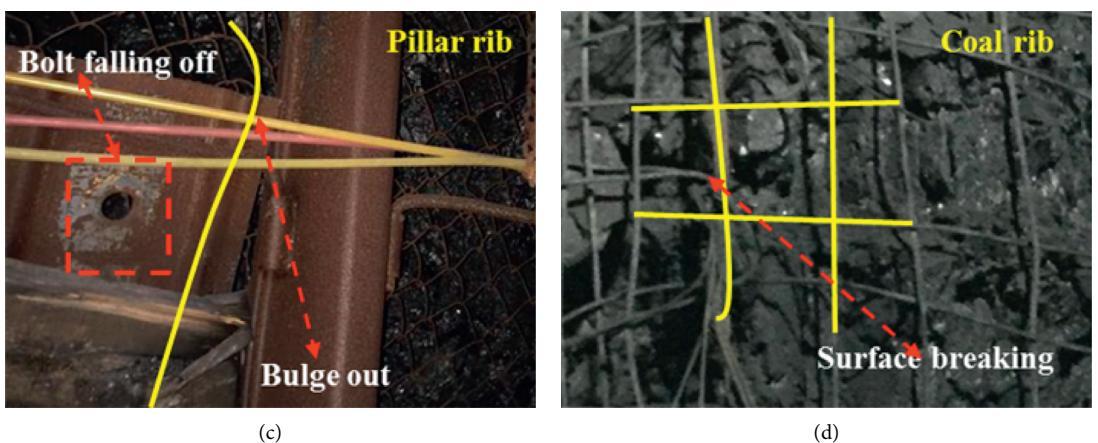
(a)

(b)

2.2. Roadway Mining Pressure Monitoring. The average interval between the #9 coal seam and the #10 + 11 coal seam is 1 m, so the coal seam is close. The 11103 haulage roadway is arranged under the double gobs, and this roadway is affected by the mining of the upper coal seam and the stress of the stepped coal pillars resulting in the roof structure of the lower coal seam mining area with multiple cracks and easy instability. After excavation and recovery, the surrounding rock cracks and roof cracks of the roadway promote each other and penetrate each other. The 11103 haulage roadway also has the characteristics of close coal seams, double gobs, strong mining, thick coal seams, etc. The following rock pressure phenomenon occurs during the roadway process, as shown in Figure 4. As shown in Figure 4(a), the squeezing deformation in the plumb direction of the roadway is significant, and the plumb movement in the roof stratum is violent. The supporting structure cannot adapt to the roof movement, which causes the W-type steel belt to bend severely and exhibit a "V"-shaped squeeze failure. The roof shows that some anchor cable locks are damaged and invalid. As shown in Figure 4(b), the roof of the roadway is sinking, and the 29U-shaped steel is distorted in both vertical and horizontal directions. As shown in Figure 4(c), the side roadside bulges against the coal pillars, and the

anchor bolts are unanchored. As shown in Figure 4(d), the surface of the coal shack on the side of the working face is partially broken.

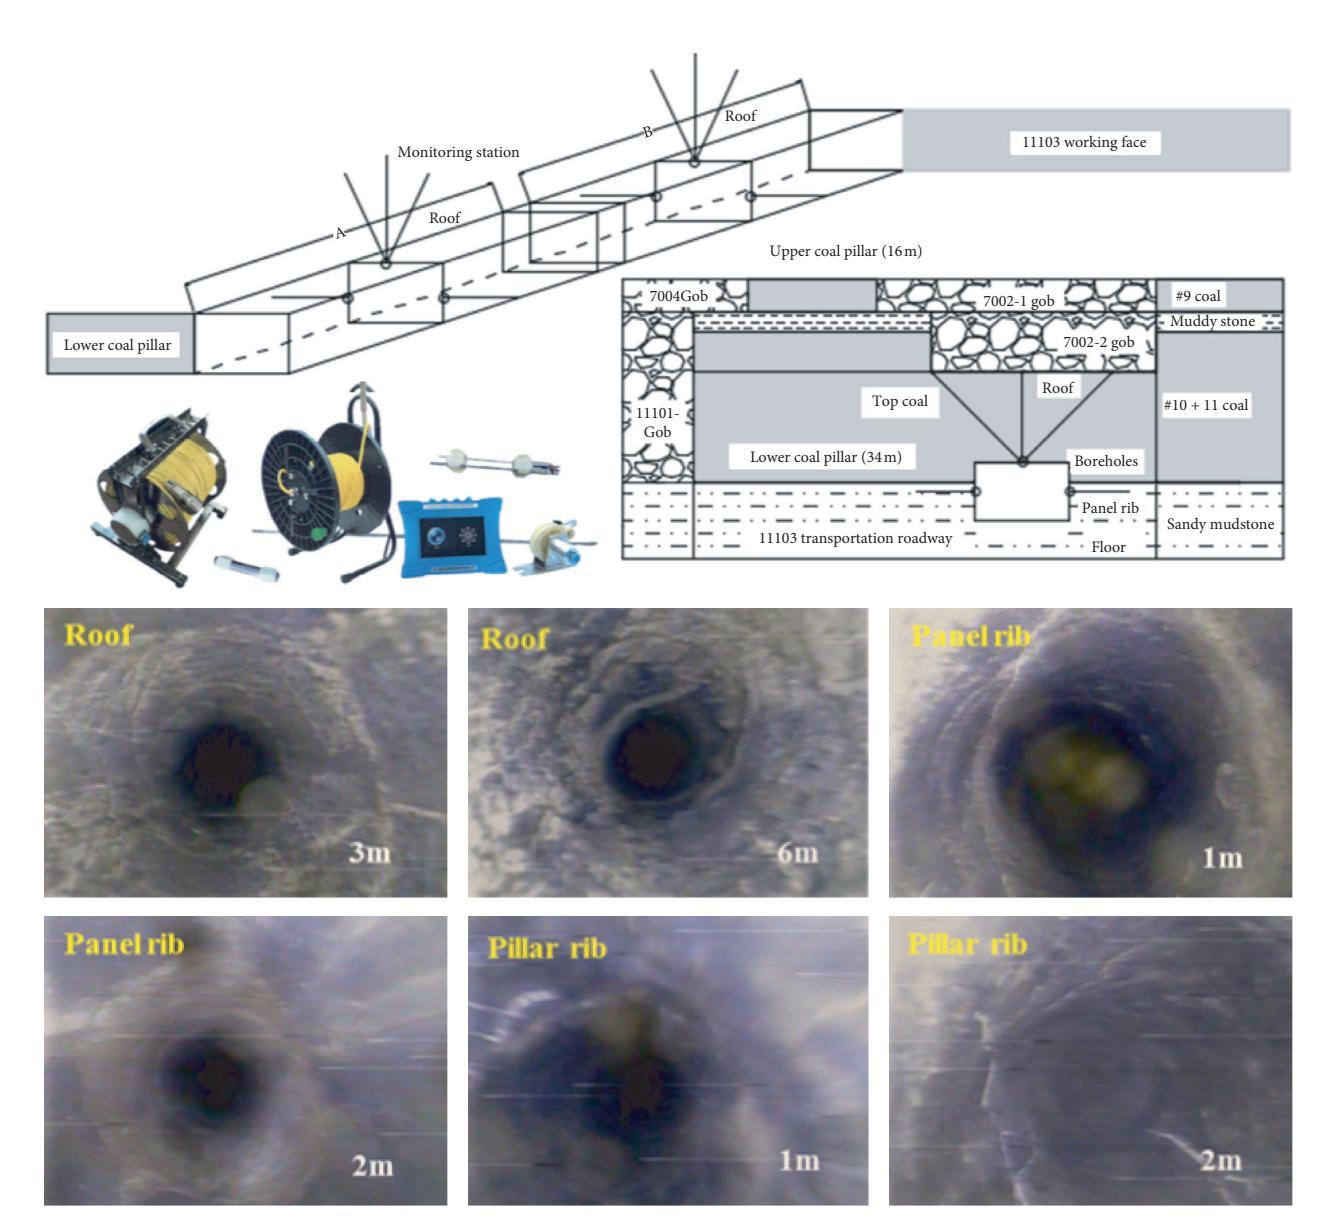
FIGURE 5: The borehole observation.

Through the borehole peep of the surrounding rock of the 11103 haulage roadway, the results of analysis show that under the close double gobs, the lower coal is affected by the superposition of upper coal mining and stepped coal pillar stress. The borehole observation figure is shown in Figure 5. The borehole observation instrument is used to observe the roof of the roadway and the two sides of the roadway. When the depth of the roadway roof is 2 m, the surrounding rock of the roof is relatively complete, and there is no obvious crack. When the depth of the roadway roof is 4 m, there are small cracks in the surrounding rock of the roof. When the depth of the roof of the roadway is 6 m, the cracks in the surrounding rock of the roof are obvious. The crack is not obvious when the depth of the roadway on the side of the working face is 2 m, but it is more obvious when the depth of the side roadway near the coal pillar is 2 m.

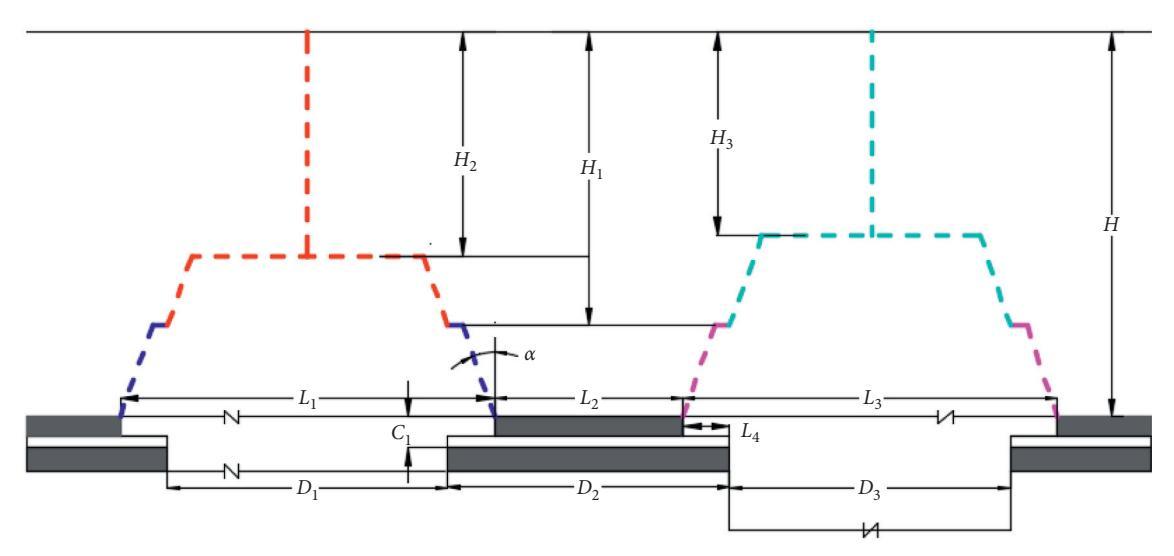
FIGURE 6: A mechanical model of the load of an extremely close stepped coal pillar.

The collapse height of the overlying strata increases, as shown in Figure 6. This is a preliminary estimation method of the loading of the stepped coal pillars.

The calculation formula for the total load of the doublelayer stepped coal pillar (P_n) is as follows:

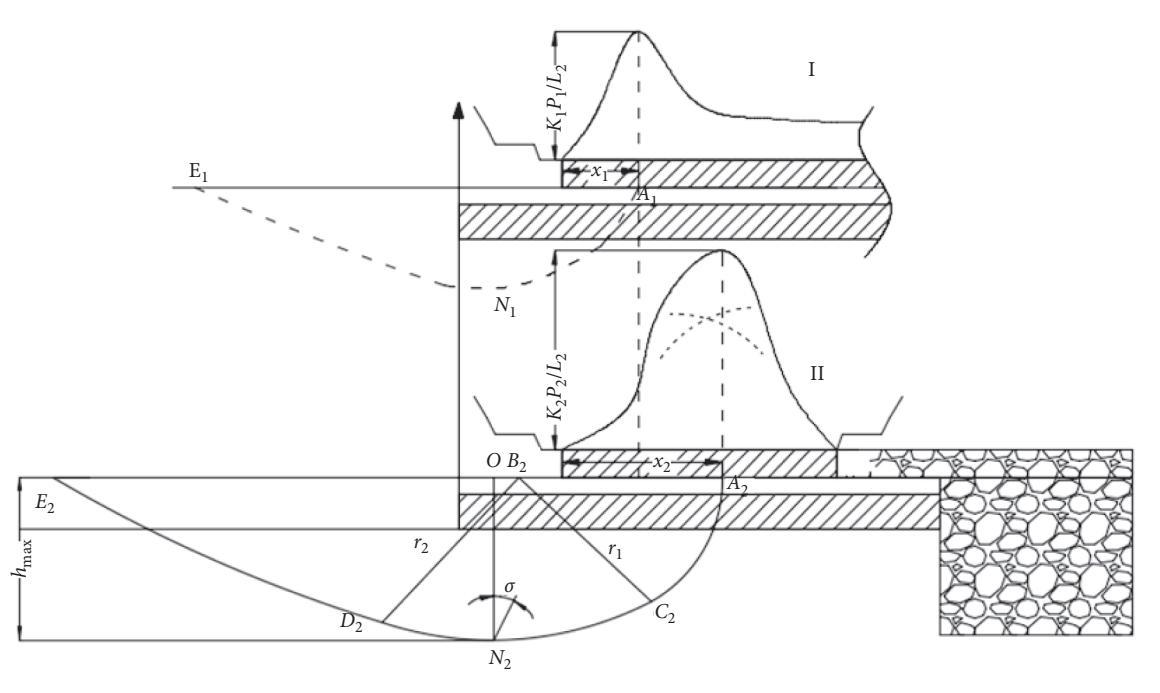
I: loading distribution of coal pillars with mining double gobs on one side

II: loading distribution of coal pillars with mining double gobs on both sides

FIGURE 7: Mechanical model of floor failure caused by stress superposition of extremely close double-layer stepped coal pillar.

The floor failure slip field caused by the coal pillar can be calculated by the slip line field theory method, and the simplified mechanical model is shown in Figure 7.

According to the slip line theory of the floor, the formula of the failure depth of the floor is as follows:

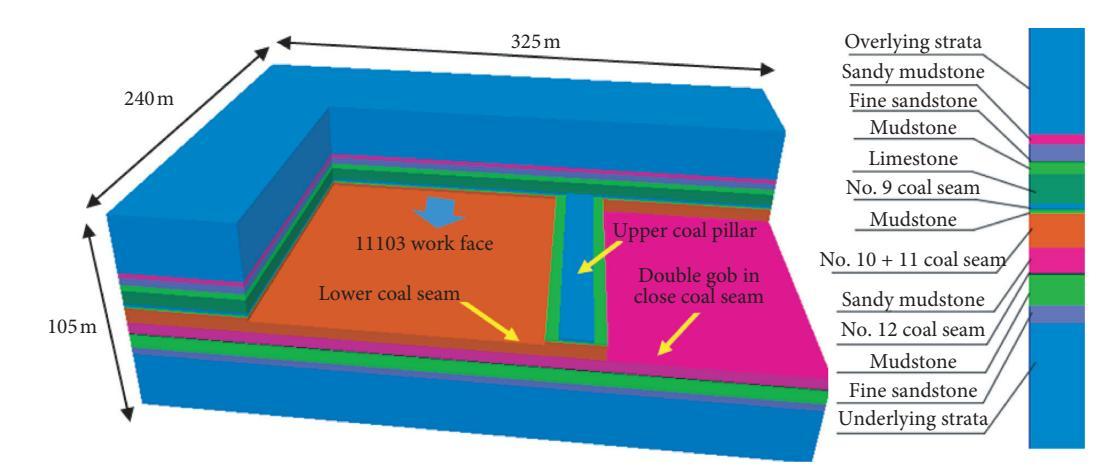
FIGURE 8: Numerical simulation model of mining under double gobs in close coal seams.

3.3.1. Numerical Model of the Excavation and Mining with Double Gobs in Close Coal Seams. The numerical model with a size of 325*240*105 (length*width*height) was established based on the problem studied and the mesh density shown in Figure 8. In this numerical model, a load of 4.03 MPa was placed on the upper boundary of the model to simulate the weight of the overlying strata according to the geostress measurement. Then, the horizontal pressure coefficient along the x- and y-axes was set to 1.2 times the upper load, and the displacement constraint was adopted in the horizontal direction of the left and right boundaries and the vertical direction of the bottom boundary. Additionally, as shown in Table 1, the rock parameters used in this numerical model were tested in the laboratory. Meanwhile, to determine the rationality of the simulation, the double yield model with two different parameters and the strain-softening model were adopted to simulate the double gobs and the ladder coal pillar, respectively. The structural diagram of the checking calculation in the numerical simulation is shown in Figure 9.

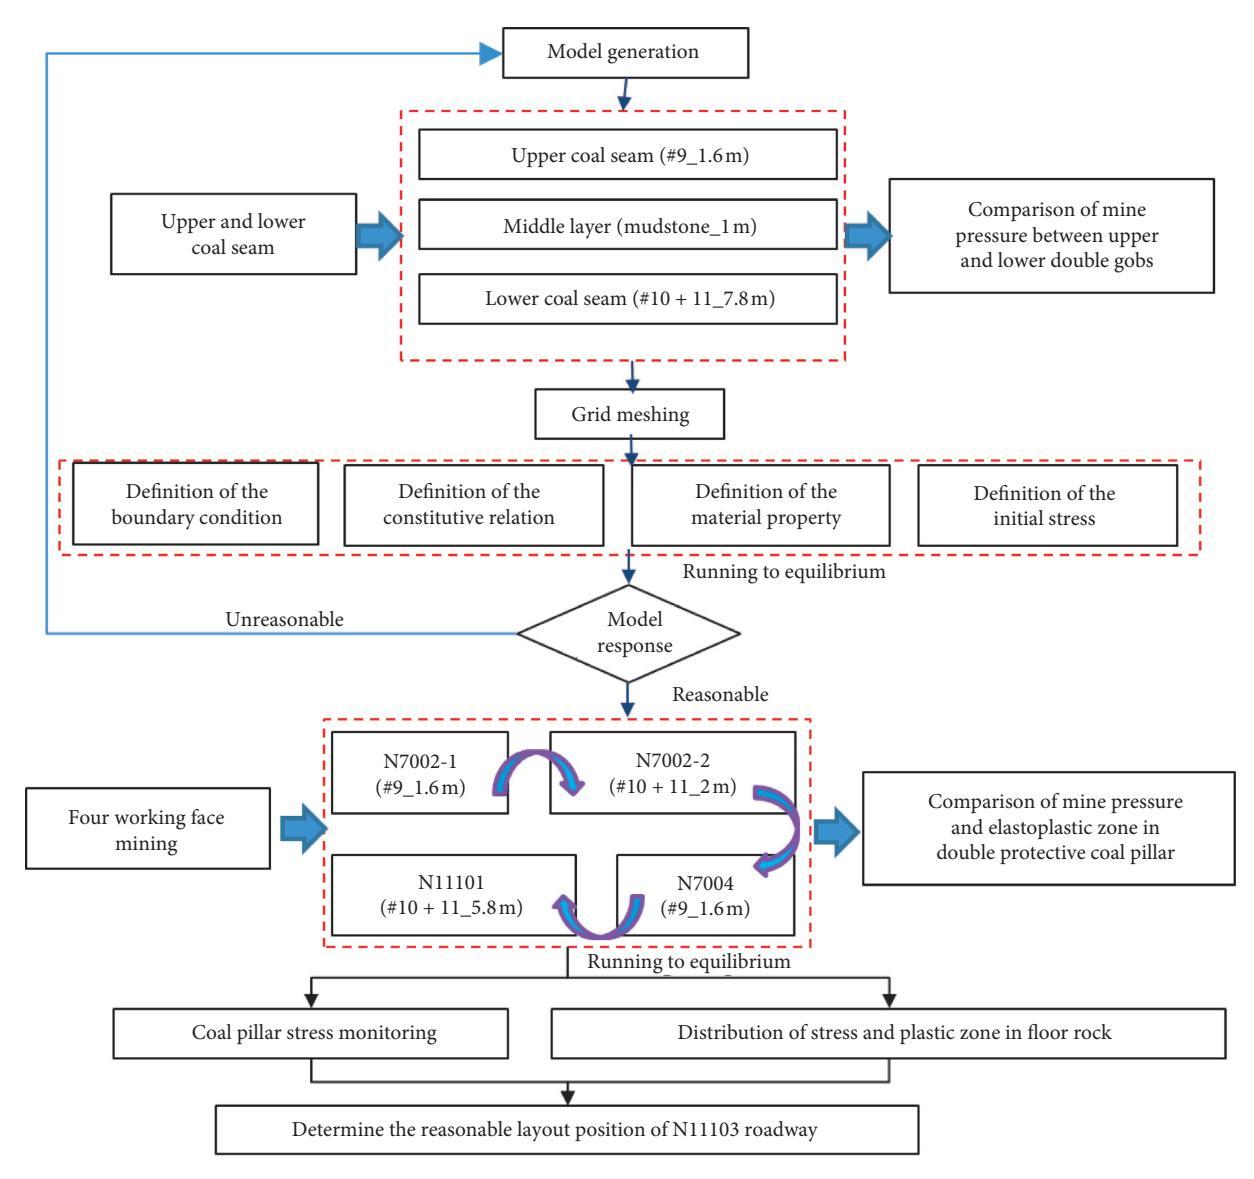
FIGURE 9: The structural diagram of the checking calculation.

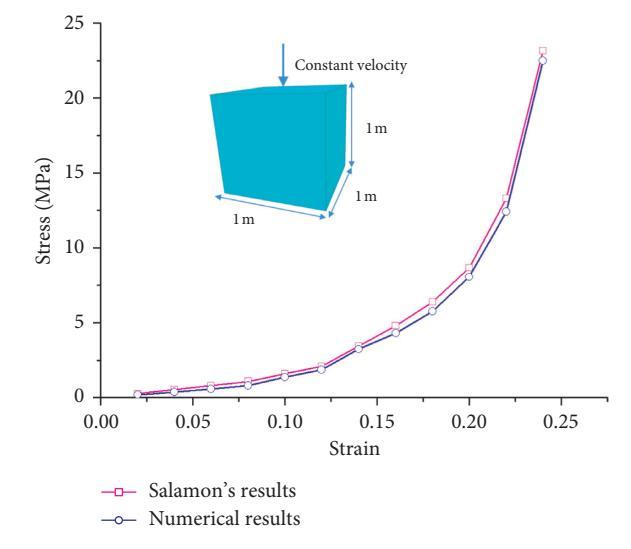
FIGURE 10: Stress-strain in the double yield model.

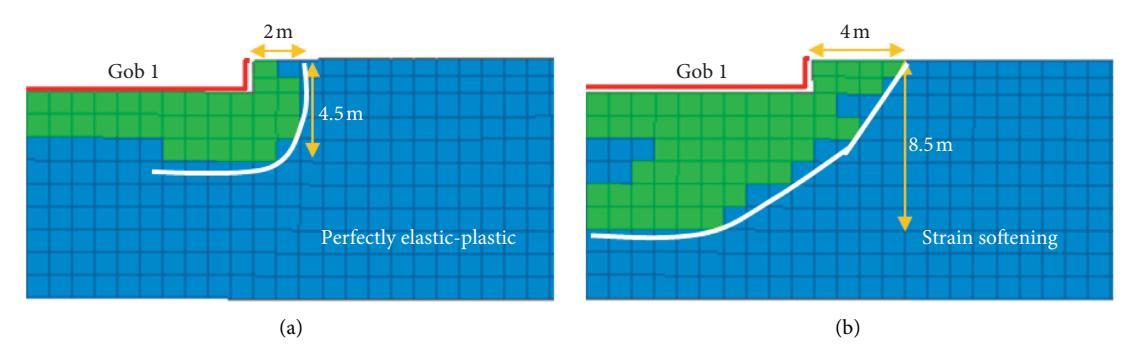
FIGURE 12: Changes in the plastic zone of the softening model.

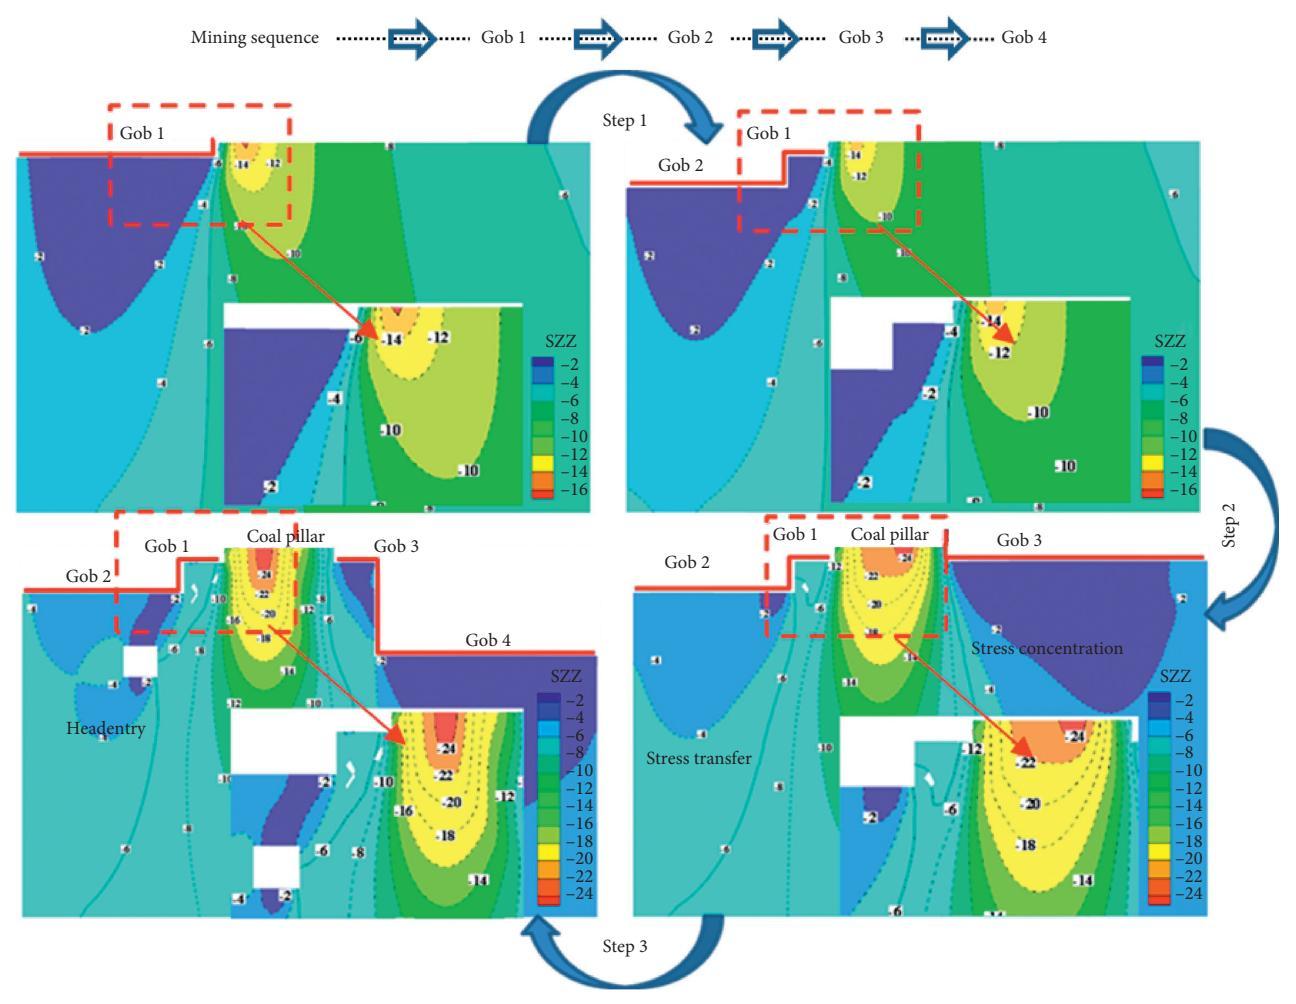
FIGURE 13: Stress distribution diagram of double gobs in close coal seams.

biased towards gob 3, and the low stress on the coal side of the lower coal seam is 6 MPa. Step 3: gob 4 is formed by excavating the working face in the lower coal seam, and a 28 m coal pillar is left. The stress concentration area of the coal pillar appears in the middle, and stress transfer occurs. The stress distribution of the fully mechanized top-coal caving roadway under thick-soft coal in a short-distance gob is shown in Figure 13.

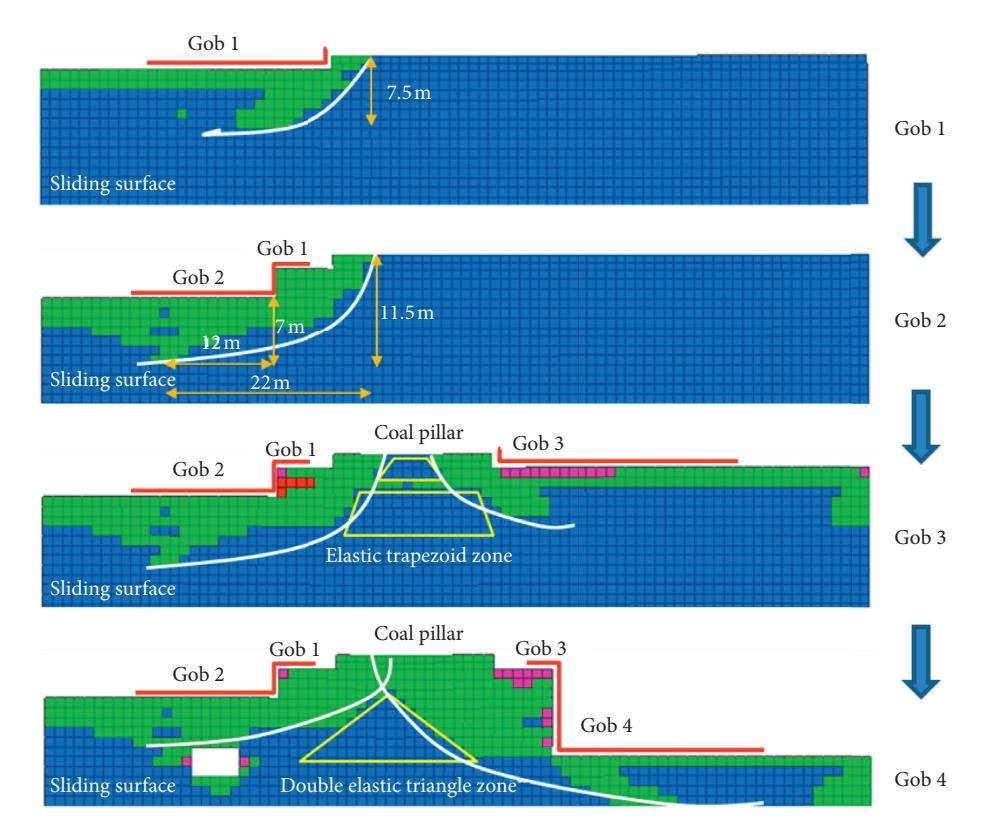
FIGURE 14: Distribution map of plastic zone under double gobs in close coal seams.

The distribution of the plastic zone of the fully mechanized caving roadway under thick-soft coal in the close-up double mined-out area is shown in Figure 14. The shape of the plastic zone of the coal side and the bottom rock layer is generally a semislip surface. When excavating the working face of the upper coal seam to form gob 1, the depth of the influence of the plastic zone on the coal side is 7.5 m. When excavating the lower coal seam working face to form gob 2, the depth of the influence of the plastic zone on the side of the lower coal gangue is 7 m, and the total depth of the upper and lower coal gangue is 11.5 m. When the upper coal seam is excavated to form gob 3 near the working face, a small trapezoidal elastic area is formed in the middle of the upper coal pillar. A large trapezoidal elastic region is formed in the lower part of the lower coal seam, and the

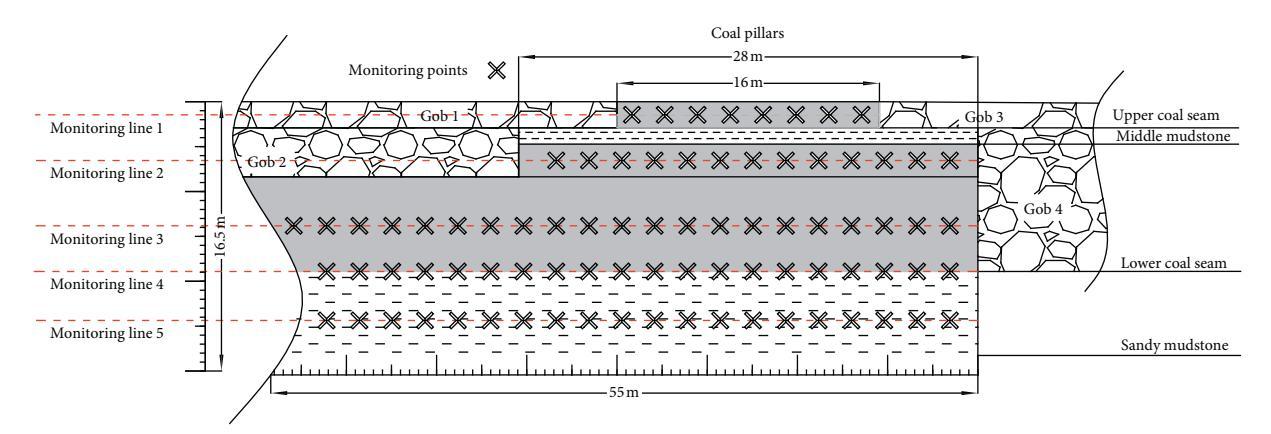
FIGURE 15: Monitoring curve of coal seam and floor rock.

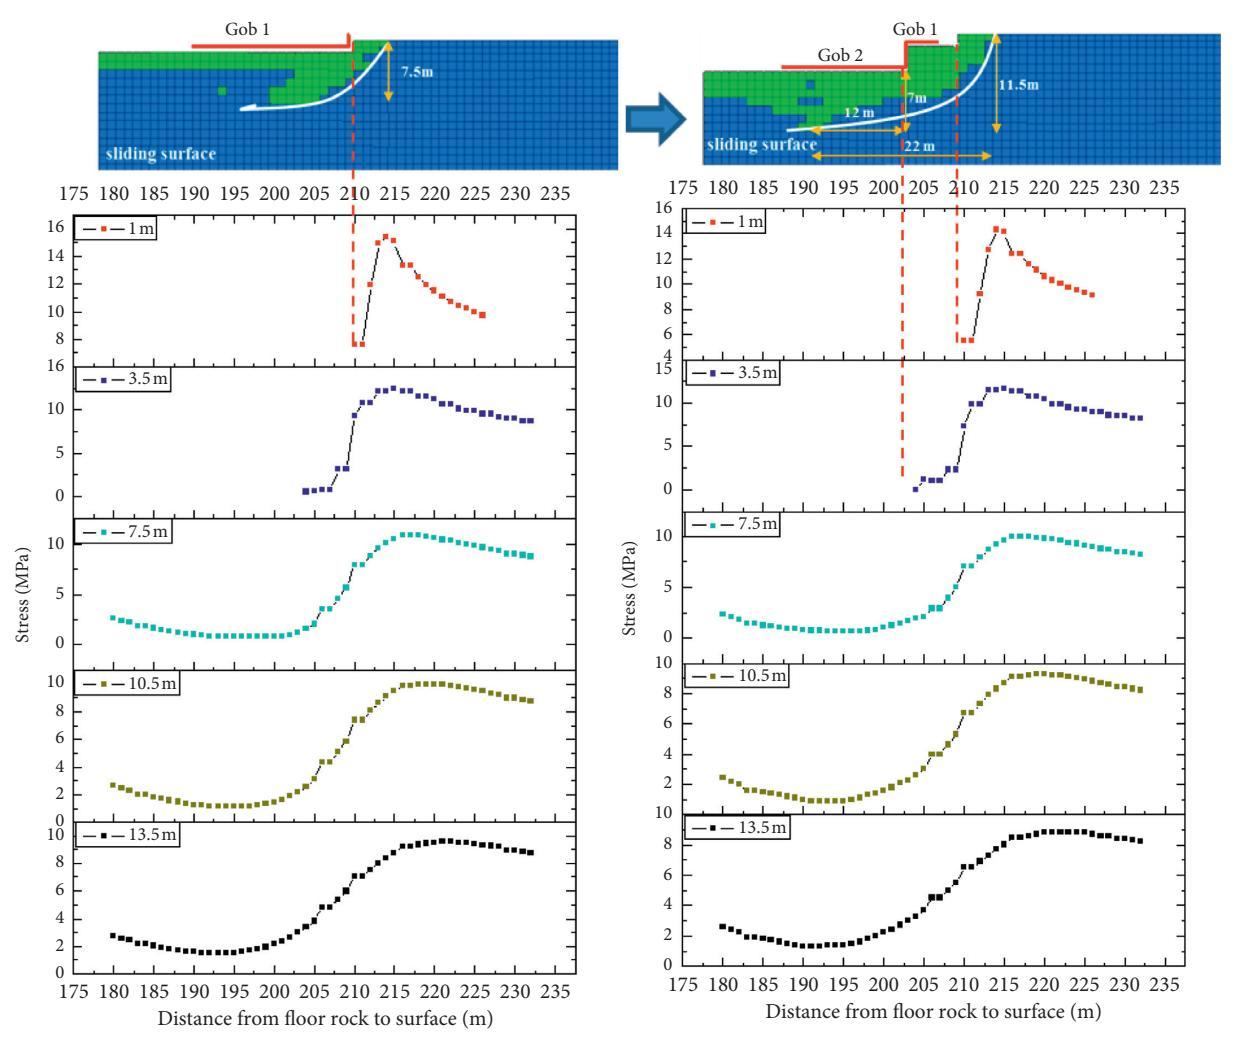
FIGURE 16: Double gobs in close coal seams.

4.1. Stress Monitoring. Five survey lines are arranged in the model: line 1 is arranged in the middle of the upper coal seam pillar, and line 2 is arranged in the middle of the lower coal seam pillar. Survey line 3 is arranged in the middle of the lower coal seam, survey line 4 is arranged between the lower coal seam and the sandy mudstone of the floor, and survey line 5 is arranged on the sandy mudstone of the floor. The layout of the measuring lines is shown in Figure 15, and the measurement results are shown in Figures 16–19. The stress

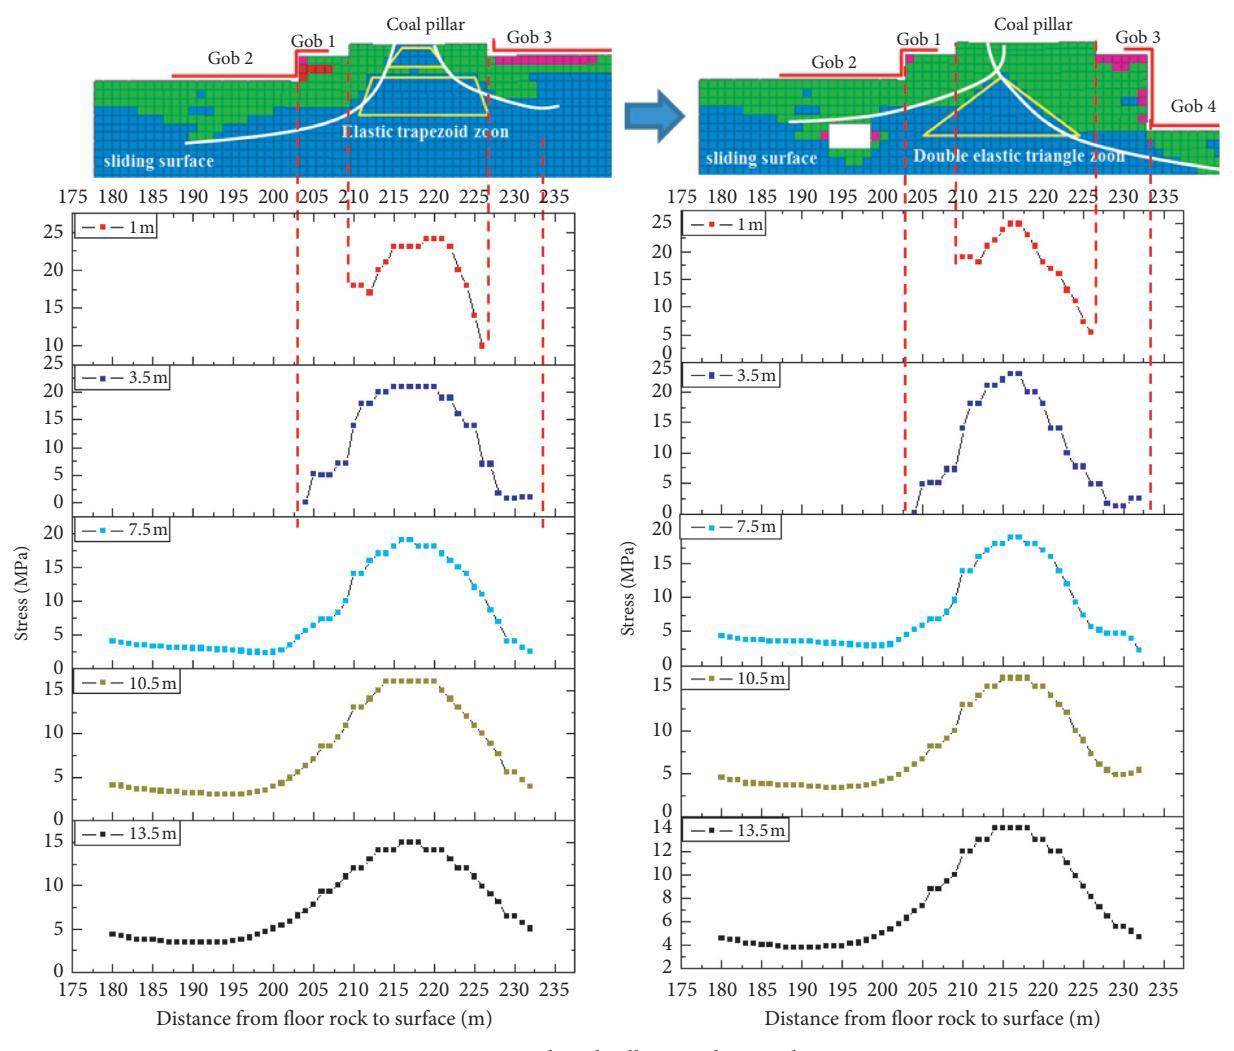
FIGURE 17: Stepped coal pillars in close coal seams.

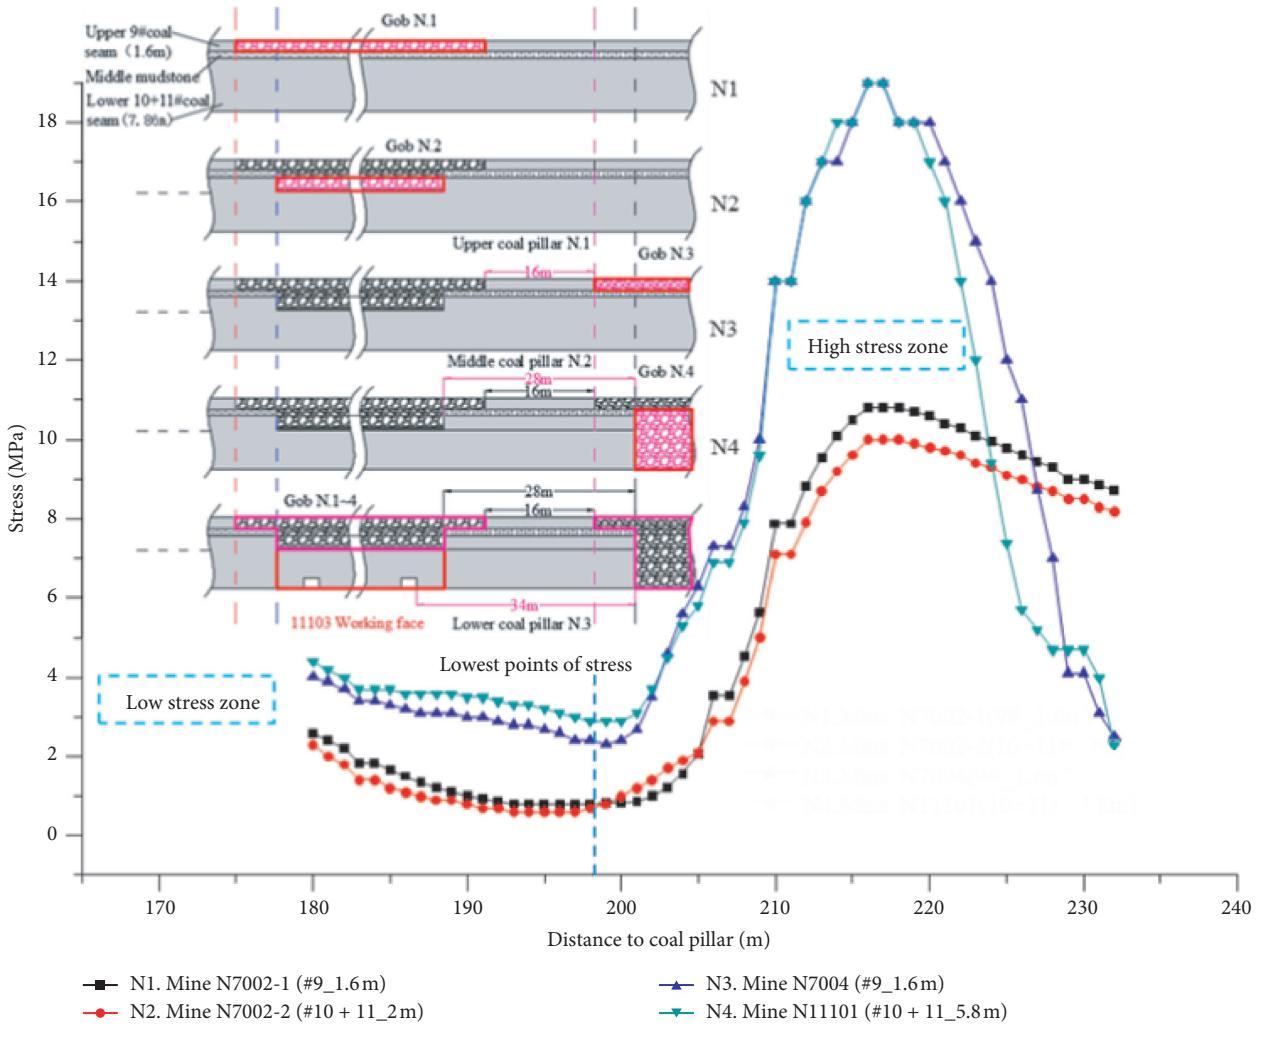
FIGURE 18: Mining stress change curve under double gobs in close coal seams.

As shown in Figure 18, when the thick-soft fully mechanized coal roadway is excavated under the close-up double mined-out area, the coal gangue and coal pillar are in

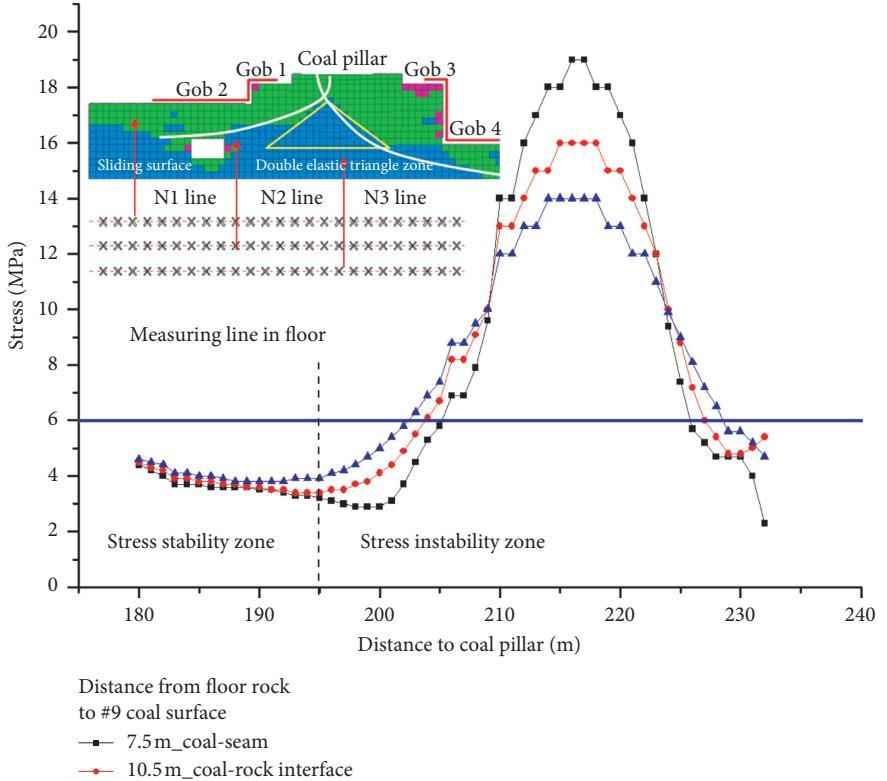
FIGURE 19: Stress distribution curve of different layers of floor.

the high-stressed area, and the mined-out area is in the lowstressed area. The stress distribution law first decreases and then increases. As shown in Figure 19, the survey lines arranged in the surrounding rock of 7.5 m, 10.5 m, and 13.5 m in the lower coal seam can be divided into the stress stability zone and the stress instability zone according to the rising and falling trends of the survey lines. The stress stabilization area is at a distance of 4 m from the left side of the stepped coal pillar. All three lines are in a smooth transition stage, and the 10.5 m line tends to be stable here. Based on the above, the location of the roadway in the lower coal seam is evaluated according to the stress distribution of

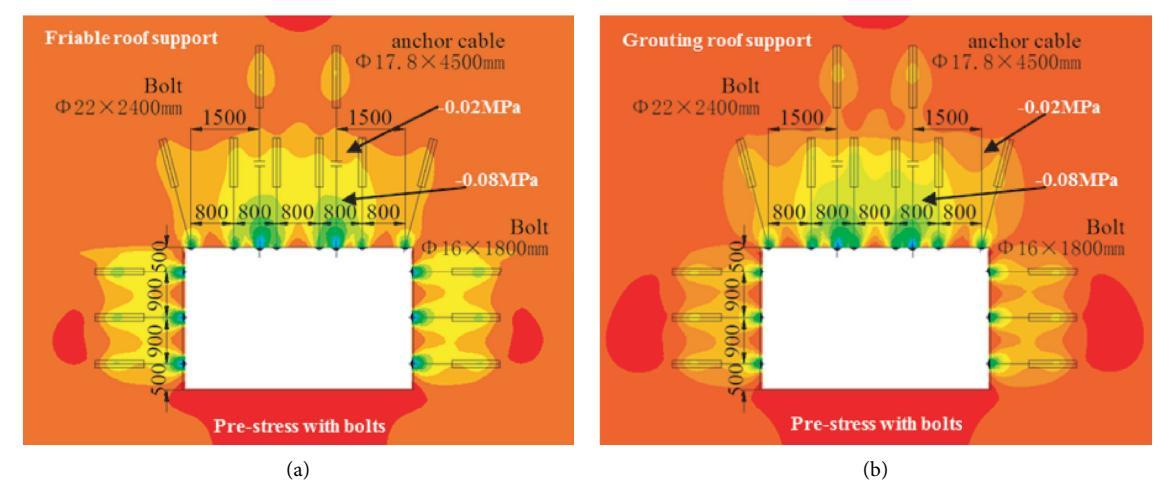
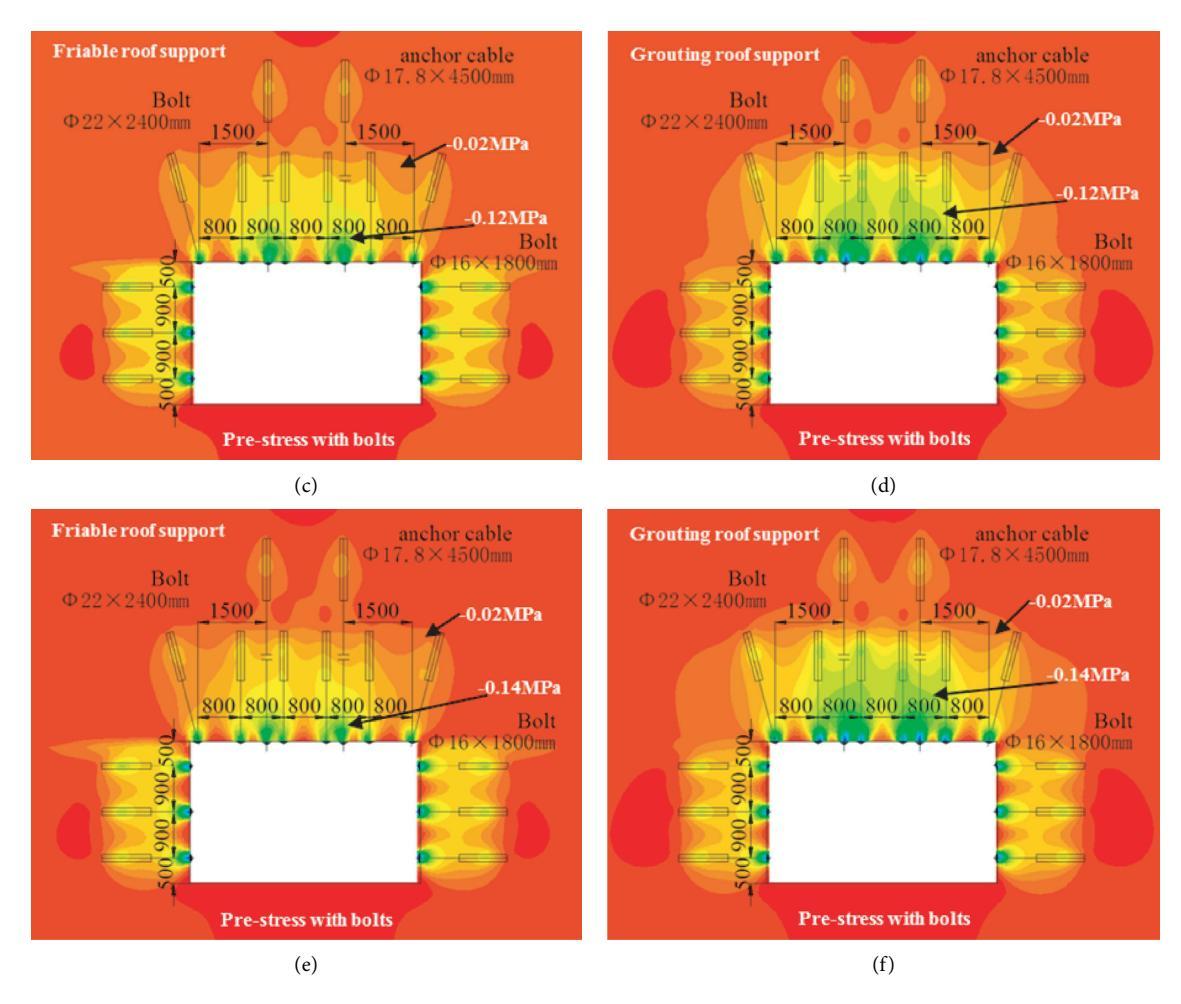
FIGURE 20: Distribution of the prestressed field of the grouting anchor cable. (a) Bolts with prestressed 60 kN and anchor cables with prestressed 120 kN. (b) Bolts with prestressed 90 kN and anchor cables with prestressed 150 kN. (c) Bolts with prestressed 120 kN and anchor cables with prestressed 180 kN.

4.2. Prestressed Field Distribution of Grouting Anchor Cable in the Broken Roof. Considering the grouting support effect of broken roofs, the prestressed field of grouting and ungrouting roof anchor cables was simulated and analyzed. The "cable" structural element embedded in FLAC3D is used to simulate the anchor cable. The mechanical and geometric parameters of the "cable" structural element are shown in Table 4. Among these parameters, the length, diameter, elastic modulus, and tensile yield strength can all be obtained manually. The parameters C_g and K_g are expressed by formula (10). The support mode in the simulation is shown in Figure 20.
