Failure Mechanism and Control Technology of Thick and Soft Coal Fully Mechanized Caving Roadway under Double Gobs in Close Coal Seams

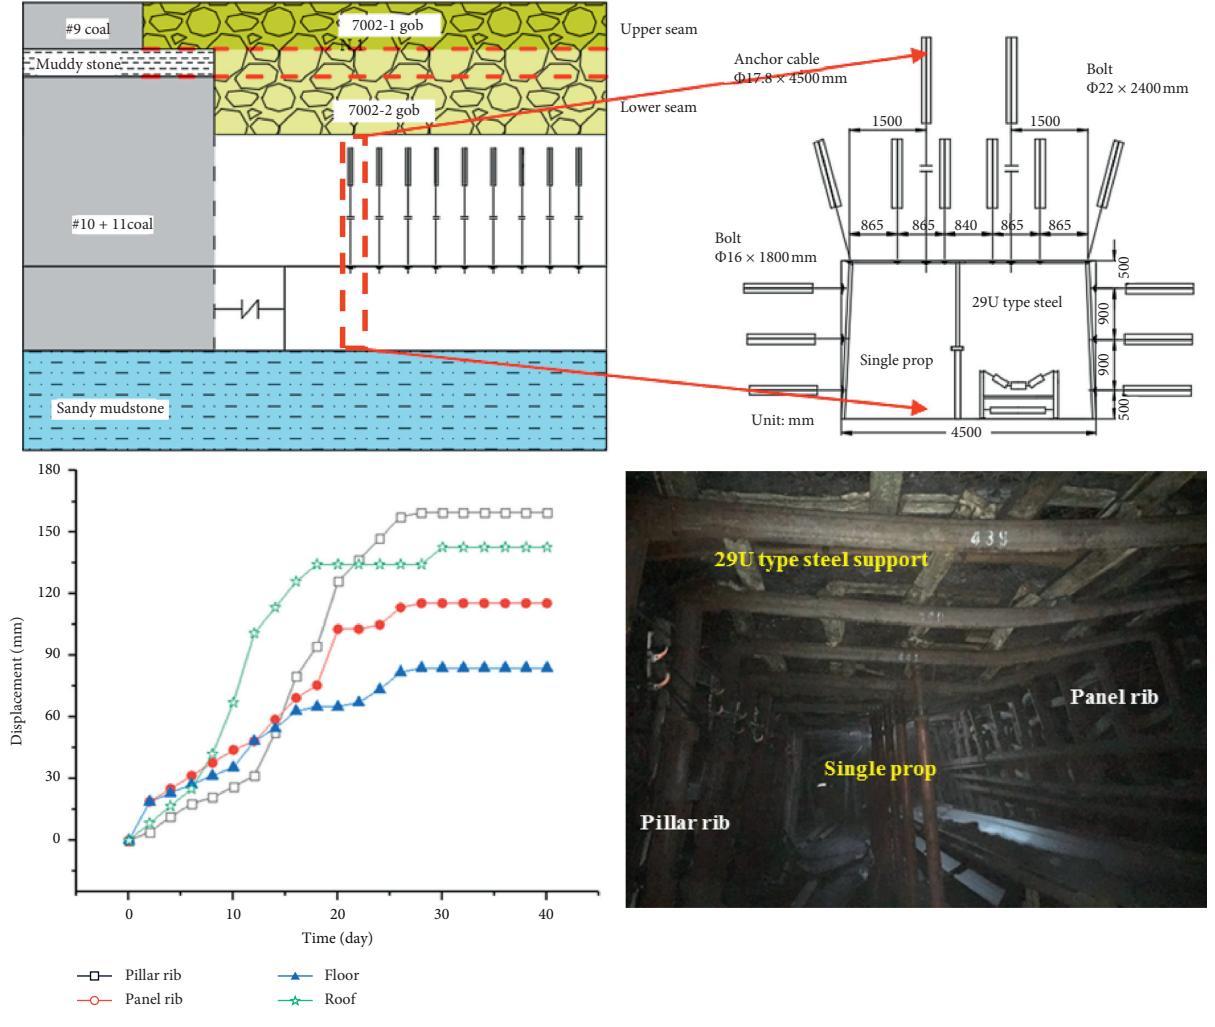
FIGURE 21: Roadway combined support scheme.

5.2. Grouting Anchor Cable + Single Prop + 29U Type Steel Combined Support. The 11103 haulage roadway in the Zhengwen Coal Mine has a design section of $4.5 \text{ m} \times 2.8 \text{ m}$ (width \times height), and the length of the roadway is 1340 m. To improve the stability of the surrounding rock of the roadway, the combined support of "bolt (cable) + 29U type steel" is adopted for the 11103 haulage roadway. $\Phi 22 \times 2400$ mm lefthanded nonlongitudinal rebar threaded steel bolts and Φ 17.8 × 4500 mm high-strength hollow grouting anchor cables with an elongation of 5% were installed on the roof with row spacing and column spacing of 865 mm × 800 mm and 1500 mm × 1600 mm, respectively. The matching steel bolt plate is 120 mm ×120 mm ×8 mm. The anchor cable is a highstrength and low-relaxation steel strand with a prestress of 150 kN, which greatly enhances the stiffness of the bolt support system and effectively controls roadway deformation. To solve the problem of breaking and the failure of the side bolt, three rows of $\Phi 16 \times 1800 \text{ mm}$ A3 steel bolts were installed on the solid coal side with row spacing and column spacing of $900 \text{ mm} \times 900 \text{ mm}$, and the distance from the bolt to the top and bottom plate was 500 mm. The matching steel bolt plate size is 300 mm ×275 mm × 3 mm. The roadway support parameters are shown in Figure 21.

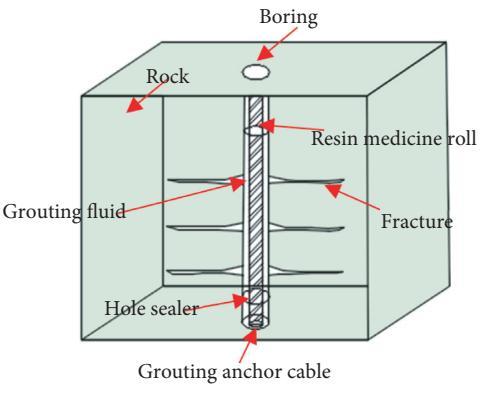
FIGURE 22: Grouting technology.

5.3.3. Laboratory Monitoring. The grouting anchor cable technology is shown in Figure 22. The technology starts to turn holes and then uses resin anchoring agent to anchor, install grouting anchor cable, and then inject cement slurry into the broken rock body through the anchor cable hollow pipe. The grouting pressure is 0.8–0.9 MPa. Directional grouting is adopted, which not only eliminates the cavitation generated during grouting but also ensures that the

anchoring slurry is filled with rotating holes and cracks. After grouting and waiting for the initial setting of the slurry, the outer stopper plug is opened to block the outflow of the slurry and complete the grouting.

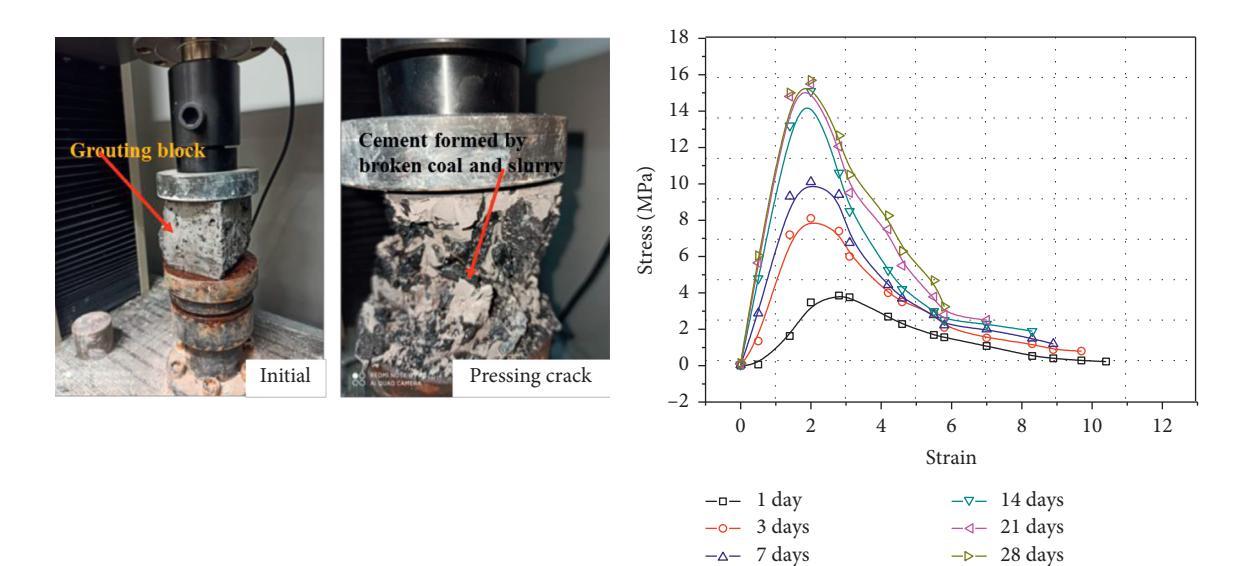
FIGURE 23: Uniaxial compression test of laboratory grouting block strength.

In the initial stage of grouting the surrounding rock, at 1 day, the grouting liquid was not solidified, and the strength of the grouting surrounding the rock increased slowly; the strength was 3.8 MPa, and the overall performance was low strength and high viscosity. In the middle stage of grouting the surrounding rock, the strength of the grouting surrounding the rock increased significantly, and the deformation of the surrounding rock decreased. At 3 days, the grouting could basically reach 62.5% of the maximum strength, and at 7 days, the grouting could basically reach 87.5% of the maximum strength. In the later stages of grouting the surrounding rock, the strength of the grouting surrounding the rock increased, and the strength of the grouting surrounding the rock reached approximately 95% of the maximum strength at 21 days. After 28 days, the strength of the grouting surrounding the rock reached the maximum, and the strength of the surrounding rock stabilized at the maximum of 16 MPa, as shown in Figure 23.

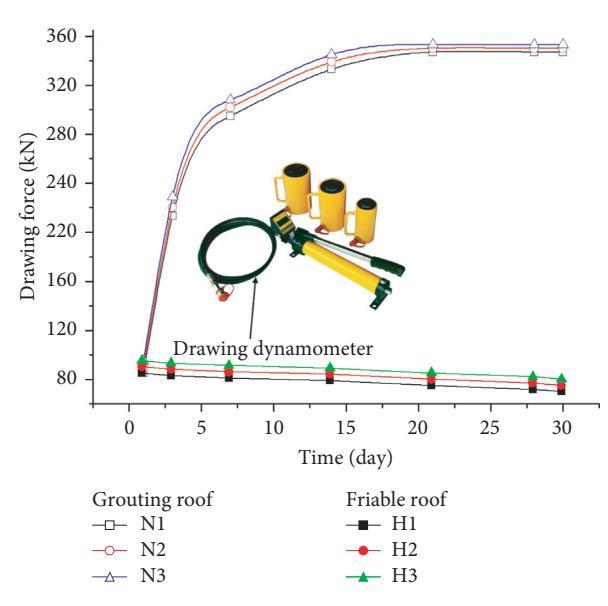
FIGURE 24: The drawing force of the grouting anchor cable.

- (2) The actual drawing force of the anchor bolt and the anchor cable is only approximately 50 kN and 80 kN, respectively, in the thick soft coal fully mechanized caving roadway under double gobs in the lower coal seams. After the grouting anchor cable is used, the drawing force of the anchor bolt can reach approximately 160 kN, and the drawing force of the anchor cable can reach approximately 350 kN. In the numerical simulation, when the grouting is not performed, the broken surrounding rock causes the prestress of the anchor cable to be released, which cannot form a straight-line stress limit of 0.02 MPa. However, after the grouting, the width and height of the stress field formed by the prestress of the anchor cable in the surrounding rock increase, and an effective prestress field with the straight-line stress limit of 0.02 MPa can be formed.
