Research Article

Experimental Study on Physicomechanical Properties of Sandstone under Acidic Environment

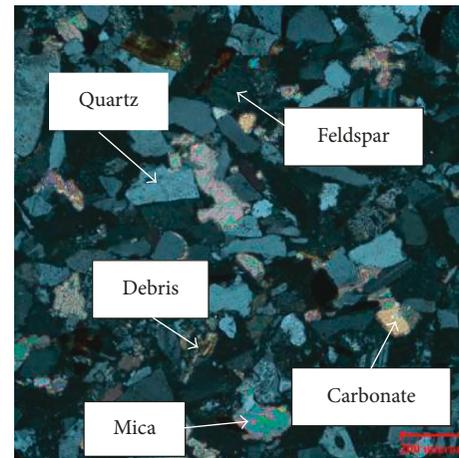
FIGURE 1: Microscope image of the sandstone sample.

2.1. Materials. The sandstone specimens used in the tests were sampled from the water conservancy project in Shanxi Province, China, where the sandstone samples have high homogeneity and integrity. The X-ray diffraction test identified that the name of the sandstone is green-grey fine-grained calcareous feldspar sandstone. Table 1 summarizes the main features. Figure 1 shows the microstructure of the sandstone sample.

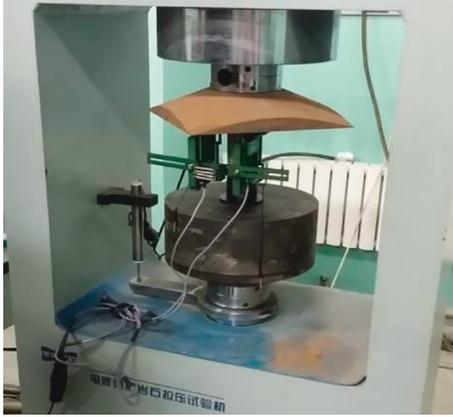
FIGURE 2: Uniaxial compression test.

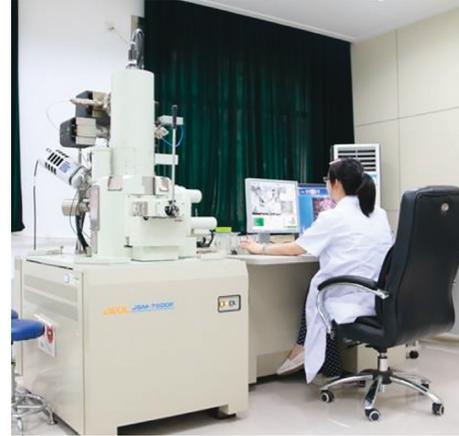
FIGURE 3: SEM test.

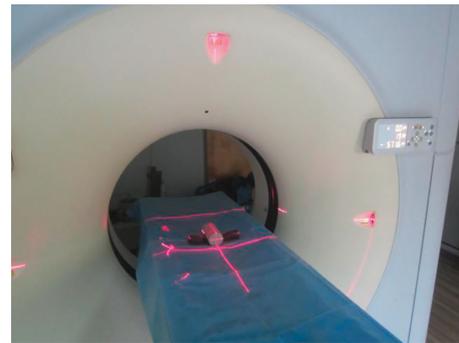
FIGURE 4: CT test.

2.3. Test Apparatus. The pH test equipment and ion concentration test equipment used in the experiment are Leica PHS-3C and Metrohm 792 Basic IC, respectively. The weighing instrument is electronic balance JA12002 with a dividing value of 0.01 g. The oven is WGL-30B with a temperature range of room temperature plus 5~300°C. The uniaxial compression tests were conducted in a LETRY electrohydraulic rock pressure testing machine (Figure 2). The maximum axial load was 1500 kN. Japan JSM-7500F electron microscope equipment (Figure 3) was used to obtain SEM images of the samples. Philips Brilliance 16 spiral CT machine (Figure 4) was used to obtain the CT images of the samples.

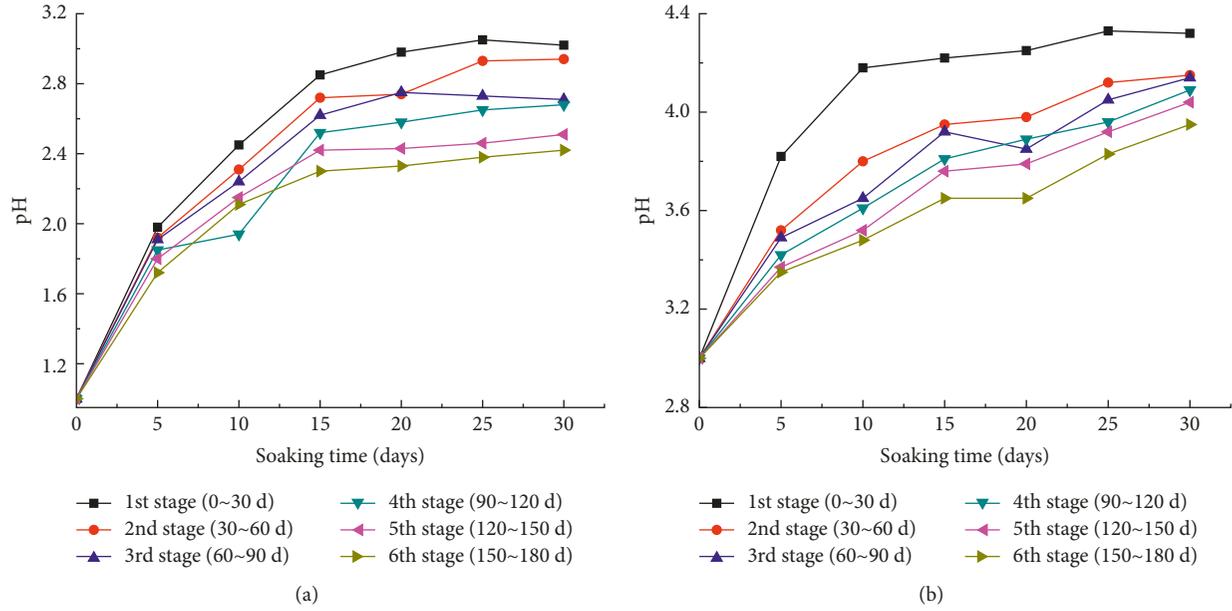
FIGURE 5: Variation curves of the pH values of sulfuric acid solution with time: (a) pH = 1 and (b) pH = 3.

3.1. Change Law of pH Values of the Soaking Solution. The variation curves of the pH values of the soaking solution in different stages are shown in Figures 5(a) and 5(b). It is observed in the figures that the pH values of the soaking solution show an increasing trend first and then tend to be stable with the lengthening of soaking time. The acidity of the soaking solution becomes balanced gradually in the process of rock being acidified. The pH value of the soaking solution increased rapidly in the initial soaking period (0~15 d), which increased to 2.85 and 4.22 at the first stage for sulfuric acid solutions with pH = 1 and 3, respectively, indicating that the chemical reaction between the samples and acid solution is fierce during the first 15 days of immersion. With the increase of immersion time and lengthening of the infiltration path, the pH value of the solution increased gradually and then tended to be stable, indicating that sulfuric acid had visible time effect on the chemical corrosion of sandstone. For the different acid soaking

solution, the change law of pH in each stage is the same. It can be seen from the growth of the pH value that the smaller the pH value of the initial solution (the stronger the acidity), the more severe the chemical reaction of acid rock, the greater the change in the pH value.

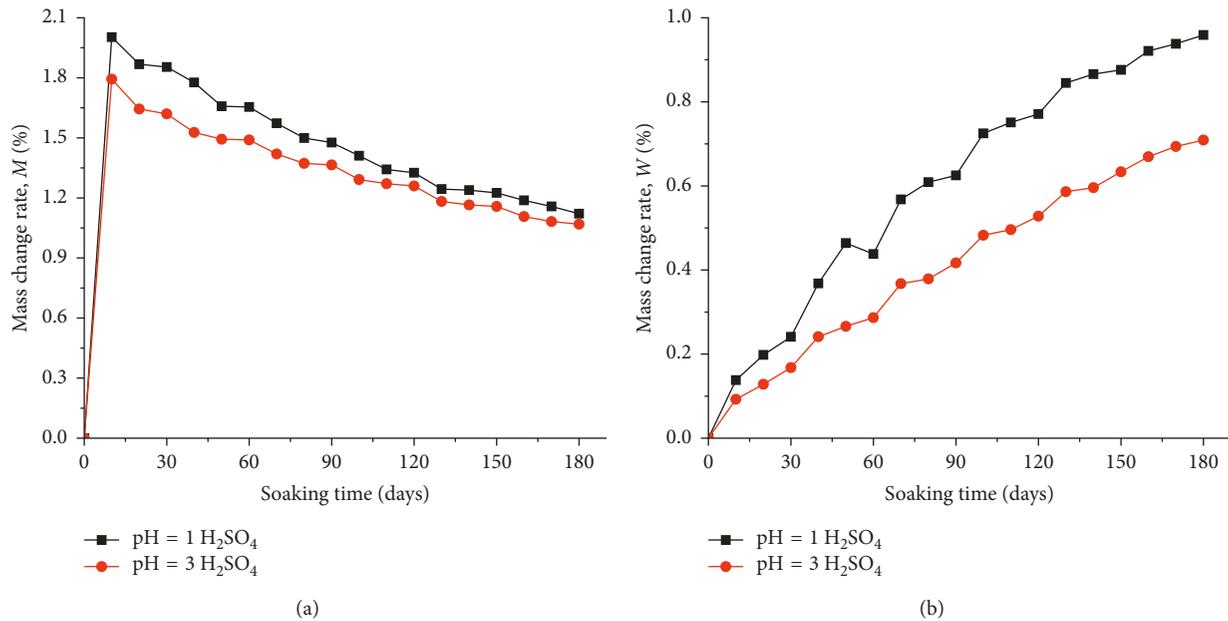
FIGURE 6: Mass change rate curves of the sandstone samples in different pH solutions: (a) wet samples and (b) dry samples.

The variation curves of the relative mass change rate of the sandstone samples before and after drying are shown in

Figures 6(a) and 6(b). As observed in the figures, the relative mass change rate of the samples soaked in different pH solutions shows different changing rules with prolonging the soaking time. The relative mass change rate of the wet samples soaked in the sulfuric acid solution with pH = 1 and 3 increases rapidly at the initial soaking time (0~15 d) and then decreases gradually with the increase of soaking time (Figure 6(a)). This shows that the diffusion of the solution is dominant during the initial reaction of acid rock reaction, and the mass of the sample increases due to water absorption. With the samples gradually saturated, the chemical corrosion plays a dominant role. The sandstone mineral components are hydrolyzed and dissolved, and the mass of the samples decreases. However, the relative mass change rate of the dry samples shows an increasing trend with the extension of soaking time (Figure 6(b)), and the smaller the pH, the greater the mass change rate of the dry samples. This means that the concentration of H^+ in the soaking solution is the main factor that determines the chemical reaction rate. The higher the concentration of H^+ , the more the mineral components of the sample dissolved and the greater the mass loss.

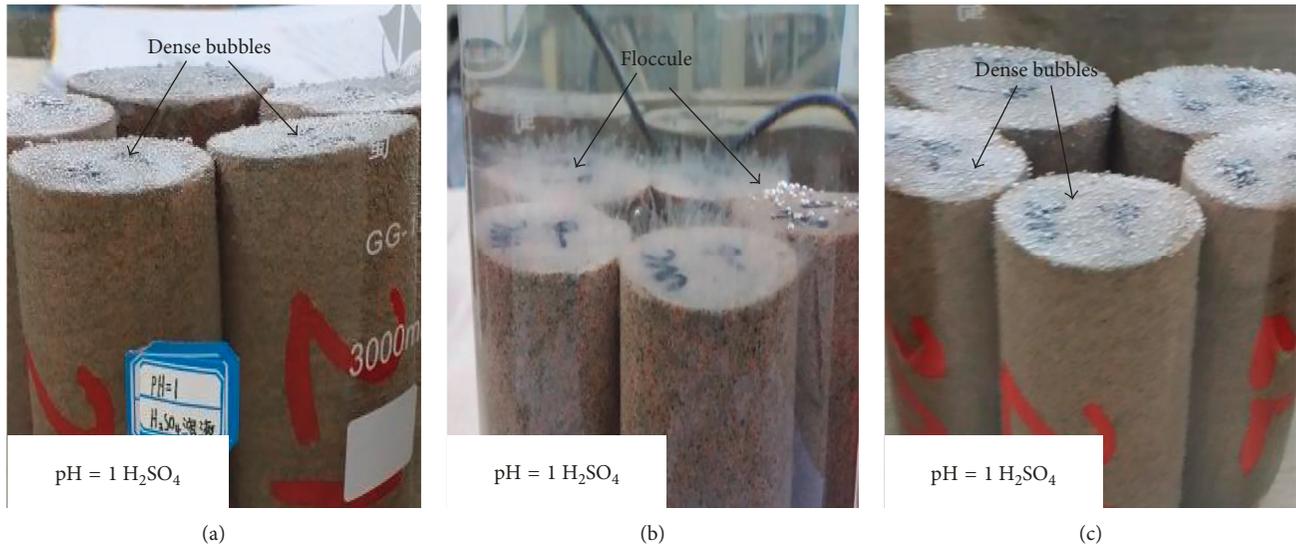
FIGURE 7: Experimental phenomenon of the samples in different pH solutions after soaking for 15 days.

In the first three soaking stages (0~90 d), the mass change rate of the dry samples increases significantly during the first 15 days of each stage (30 d) and then gradually slows down (Figure 6(b)). The mass change rate of the wet samples decreases significantly during the first 15 days of each stage and then slows down gradually (Figure 6(a)). In the last three soaking stages (90~180 d), the mass change rate of samples tends to be stable gradually. Experimental observation showed that a large number of bubbles generated in sulfuric acid solution with pH = 1 after 15 days of each soaking stage, and then floccule is gradually generated around the samples. However, only some bubbles formed in pH = 3 sulfuric acid solution, and no floccule is produced (Figure 7). The above

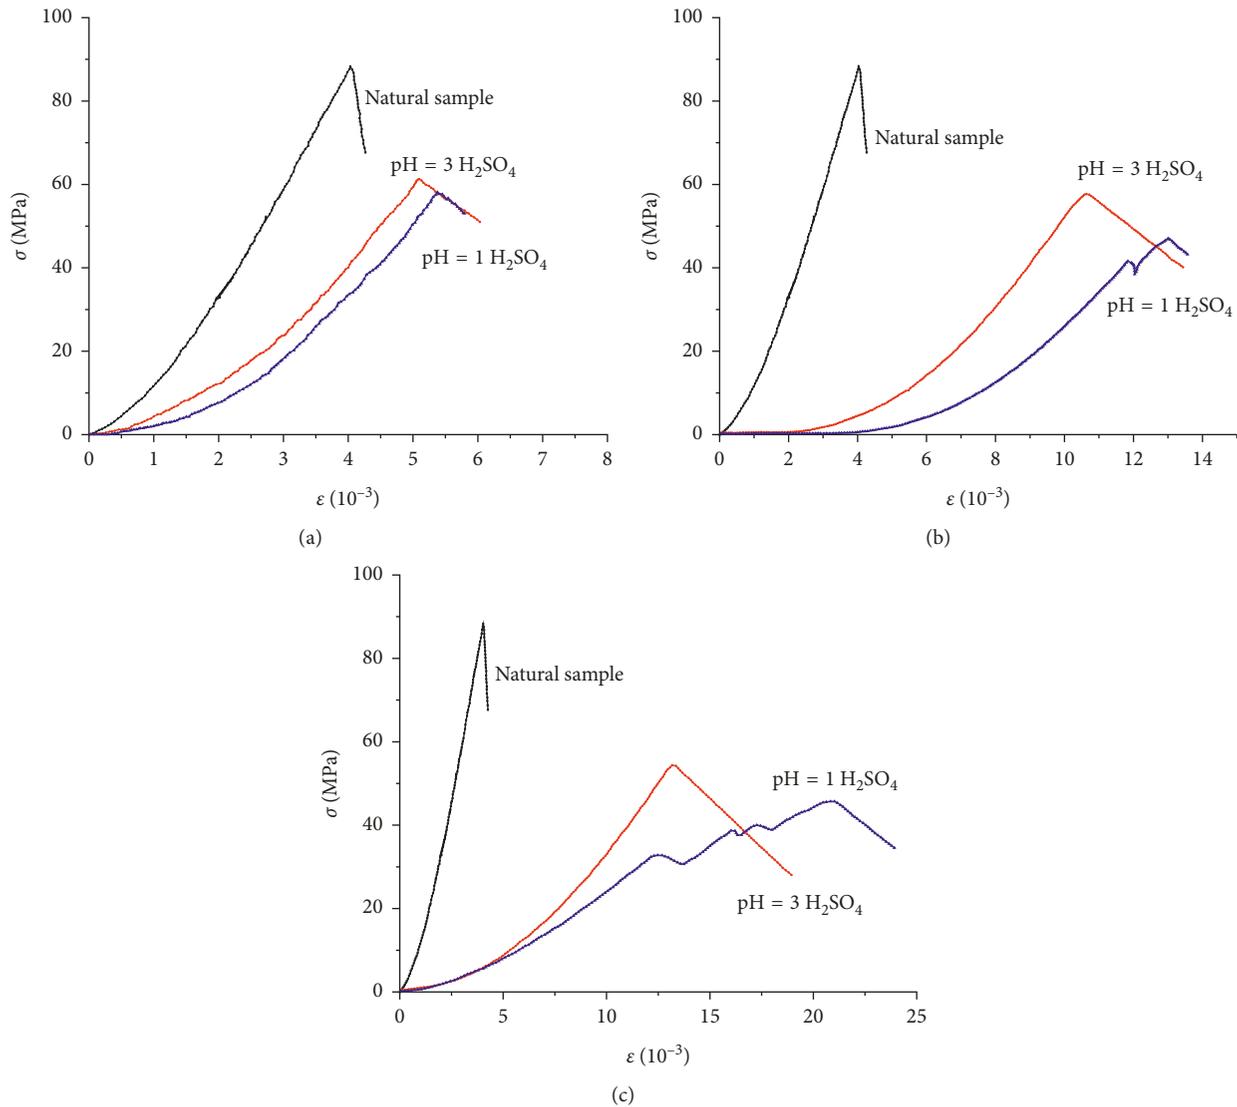
FIGURE 8: Uniaxial compressive stress-strain curves for the sandstone samples attacked by acid solutions for different soaking days: (a) 30 days, (b) 90 days, and (c) 180 days.

(1) Compaction Stage. As can be seen from Figure 8 that the concave length of the natural specimen is short and the degree of deformation is small, it enters the elastic phase quickly. However, the compression stage of the sample attacked by acid solution increases obviously. Under the same immersion time, the compaction stage of the acid-corroded sandstone samples increased obviously, and the degree of depression gradually increased with the decrease of the pH values of the soaking solution. Under the same soaking solution, the compaction stage of the sample increased obviously, and the compaction point strain increased significantly with the soaking time prolonging. It shows that with the increase of acidity of the soaking solution and the prolongation of immersion time, the pore development in sandstone becomes more significant due to the dissolution of mineral particles,

(3) *Plastic Stage.* As can be seen from Figure 8, the plastic deformation stage of the sample is not obvious. The peak point strain of the plastic deformation stage reflects the deformation amount when the sandstone is damaged, and the greater the deformation, the greater the degree of softening of the sandstone by acid corrosion. The axial strain value of the peak point of the sandstone samples corroded by acid solution can be seen from Table 4. Figures 9(a) and 9(b) show the change rule of the axial strain of the peak point of the samples with the pH value of the soaking solution and soaking time, respectively. As can be seen from Figure 9(a)

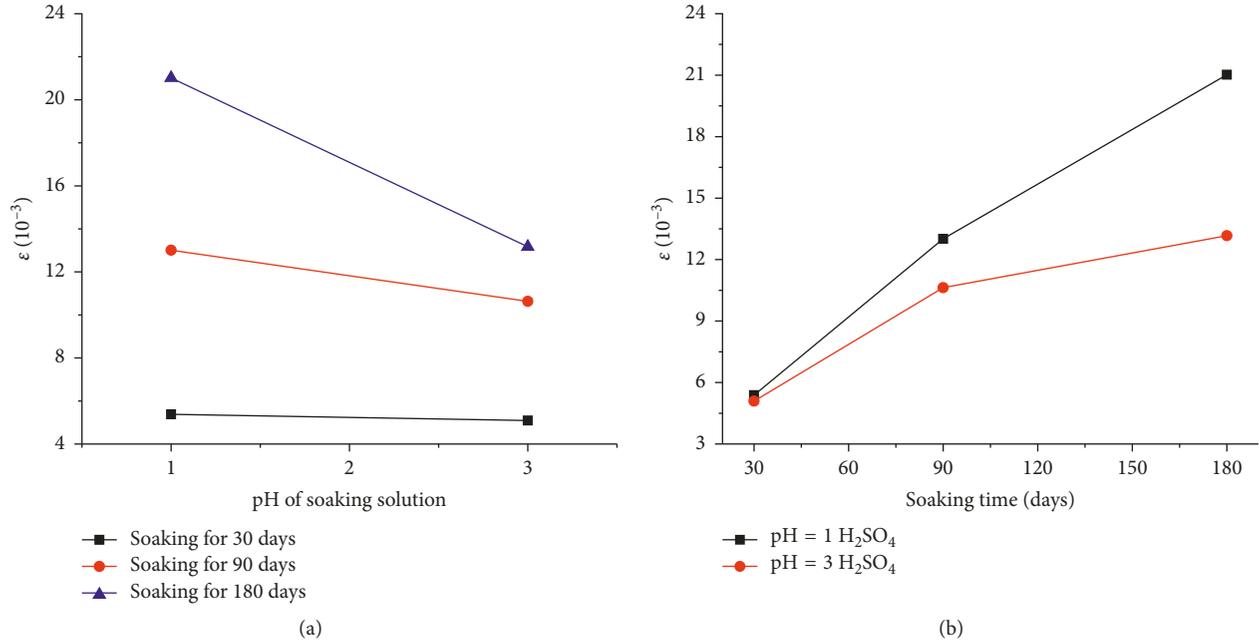
FIGURE 9: Relationships between axial peak strains of samples and (a) pH of solutions and (b) immersion time.

and Table 4, the axial strain of the peak point of the samples increases gradually with the increase of the acidity of the chemical solution at the same soaking time. As can be seen from Figure 9(b) and Table 4, the axial strain of the peak point of the rock sample corroded by acid also tends to increase with the immersion time. After 180 days of soaking, the peak point strain of the sample in the sulfuric acid solution with pH = 1 and 3 was multiplied by 5.216 and 3.268 times, respectively, than that of the sample in the natural state.

As can be seen from Figure 9 and Table 4, with the increase of acidity and immersion time, the uniaxial compressive strength of the acid-corroded sandstone specimen decreases, and the axial strain of the peak point increases. This indicates that the deformation characteristics of the sandstone samples under acid attack are characterized by the softening of rock, and the softening degree gradually increases with the increase of the acidity and the soaking time.

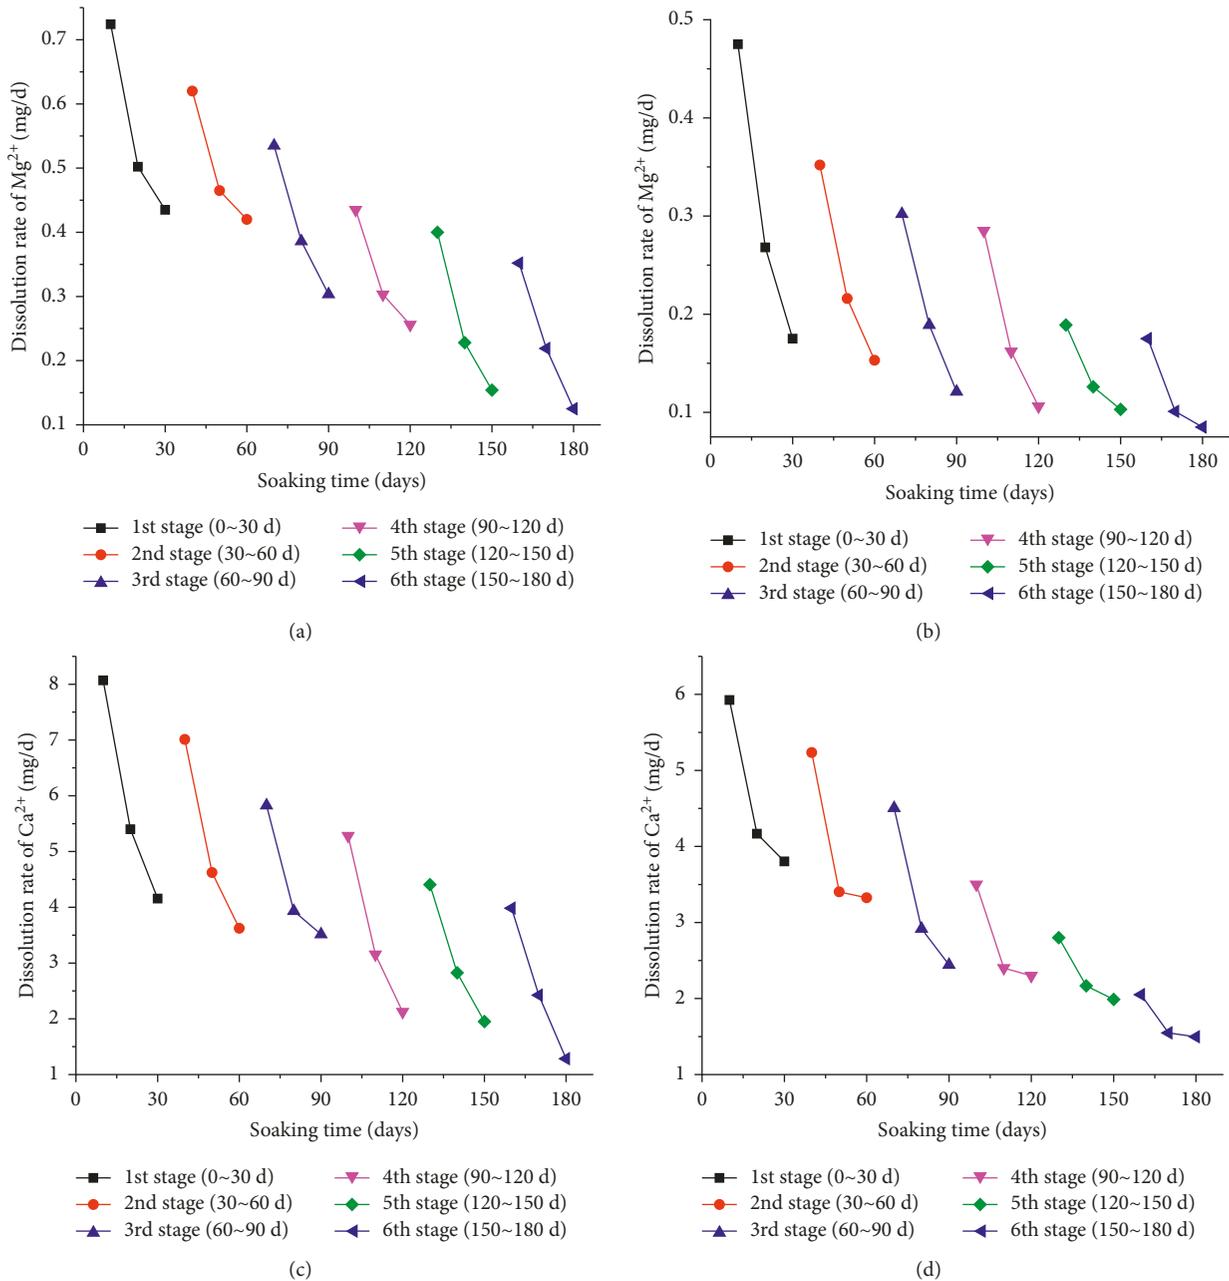
FIGURE 10: Cation dissolution rate diagram of soaking solution. Dissolution rate of Mg²⁺ in H₂SO₄ solution at (a) pH = 1 and (b) pH = 3. Dissolution rate of Ca²⁺ in H₂SO₄ solution at (c) pH = 1 and (d) pH = 3.

As observed in Figure 10, the dissolution rates of Mg^{2+} and Ca^{2+} in two soaking solutions showed large change at the initial soaking stage (0~15 days) and then gradually decreased with the increase of soaking time. Under the same conditions, the smaller the pH value of the soaking solution, the higher the rate of cation dissolution. For example, the maximum dissolution rate of Ca^{2+} in the sulfuric acid solution with pH = 1 is 8.07 mg/d, which is 1.36 times that of the sulfuric acid solution with pH = 3. The dissolution rates of Mg^{2+} and Ca^{2+} in two different solutions at each soaking stage (30 days) were the same. The dissolution rate of cation in the initial immersion stage was higher and then decreased gradually. Moreover, in the same soaking solution and immersion stage, the dissolution rate of Ca^{2+} is larger than Mg^{2+} , which is the result of reaction of calcite and other calcium fillings with the acid solution.

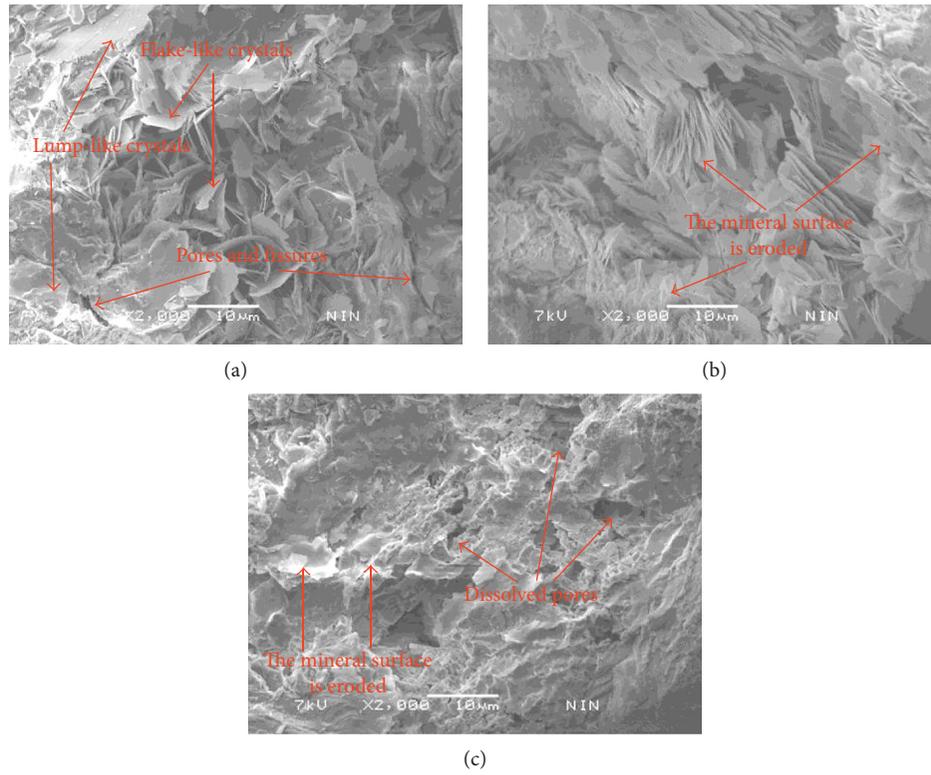
FIGURE 11: SEM images of the sandstone samples attacked by pH = 3 H₂SO₄ solution. (a) Natural sandstone sample. Sandstone samples soaked in sulfuric acid solution at pH = 3 for (b) 30 days and (c) 90 days.

As can be seen from Figures 11(a) and 12(a), in the natural state, the mineral crystals of sandstone are mostly irregular flake-like or lump-like, and the mineral particles are disorderly distributed without apparent directionality. The mineral particles are in point-like or linear contact with each other, and the pores and fissures of the sample are developed. The SEM images of the sandstone samples soaked in the pH = 3 sulfuric acid solution for 30 days (Figure 11(b)) show that the surface of the mineral crystal becomes rough due to the dissolution. The interlayer cementing materials of the sandstone samples are dissolved, and the lamellar crystals are decomposed after the acid attack. When soaked

for 90 days (Figure 11(c)), the surface of the mineral crystals becomes rougher, the original large-size crystal particles in the form of flakes and blocks no longer exist, and the dissolution holes appear on the surface of the crystals, which make the rock pores increase. Compared with the pH = 3 sulfuric acid solution, the SEM images of the sandstone samples attacked by the pH = 1 sulfuric acid solution (Figures 12(b) and 12(c)) show that the microstructure change is more visible. Especially after soaking for 90 days (Figure 12(c)), the dissolution degree of mineral particles is severe, the cementation degree between particles is worse, the initial microcracks are fully developed, and the penetration of

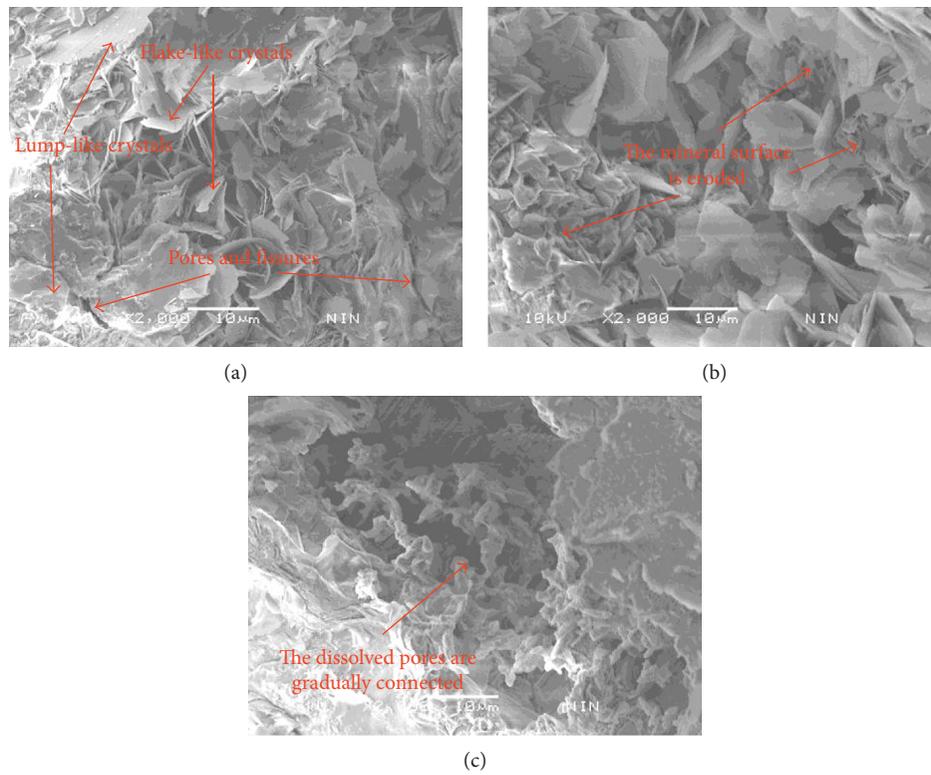
FIGURE 12: SEM images of the sandstone samples attacked by pH = 1 H₂SO₄ solution. (a) Natural sandstone sample. Soaking in pH = 1 sulfuric acid solution for (b) 30 days and (c) 90 days.

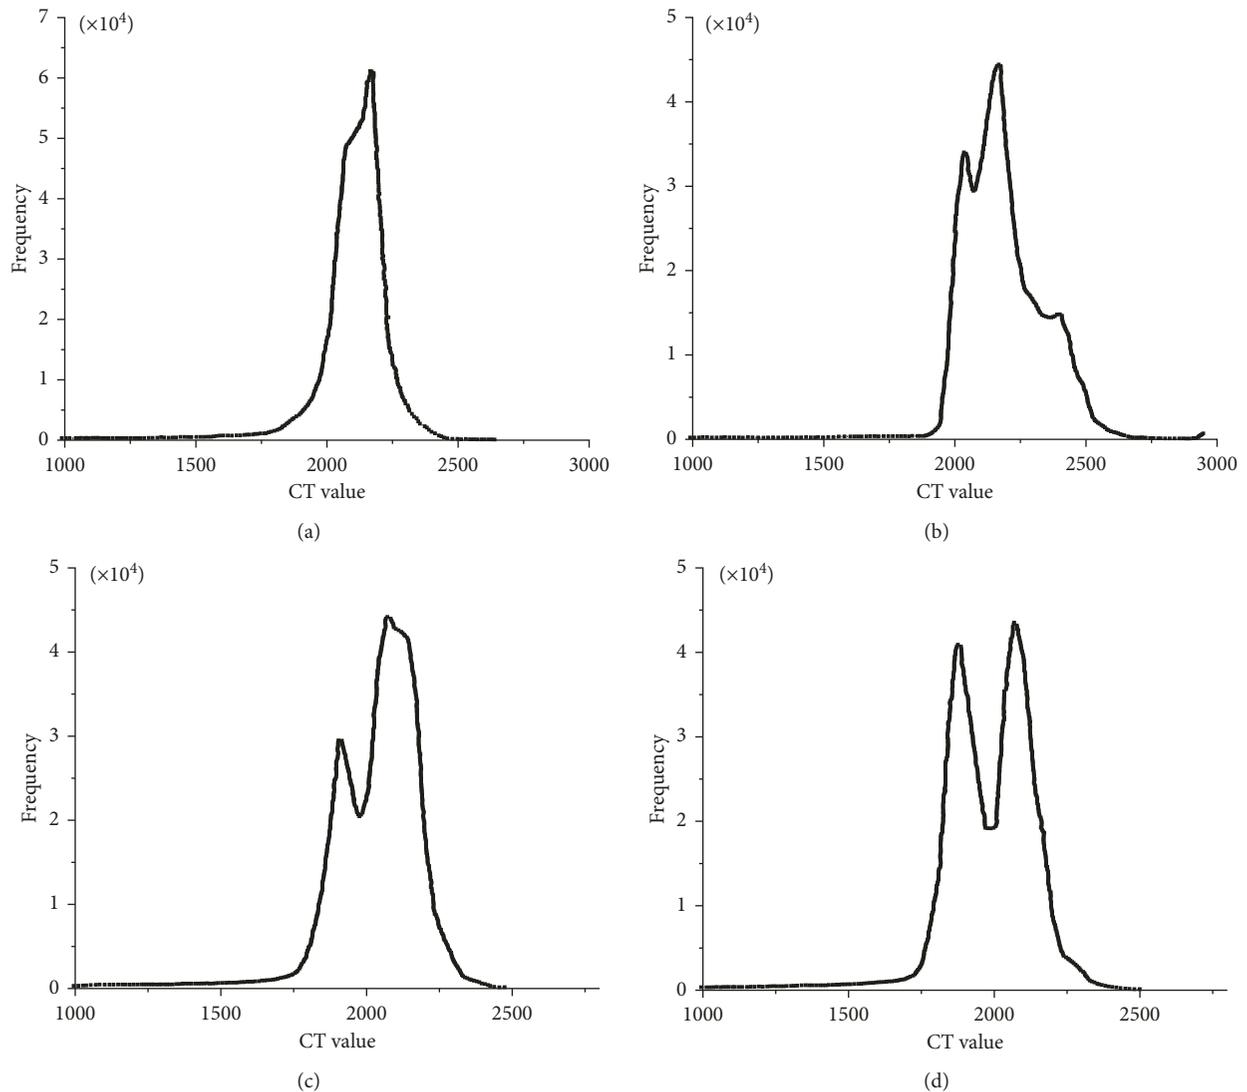
FIGURE 14: CT number distribution diagram of the sandstone specimens attacked by sulfuric acid solution (pH = 1) for (a) 0 day, (b) 30 days, (c) 90 days, and (d) 180 days.

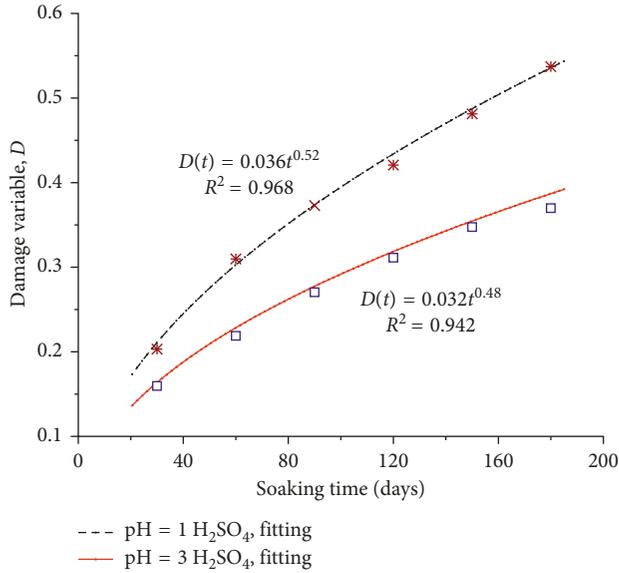
FIGURE 15: Relationship between the damage variables of the sandstone samples and immersion time under different pH sulfuric acid solutions.

Fitting the damage variables can obtain the relationship between the damage variable of acid-corroded sandstone and the soaking time (Figure 15):
