## Research Article

# Does Metal Transfer Differ on Retrieved Ceramic and CoCr Femoral Heads?

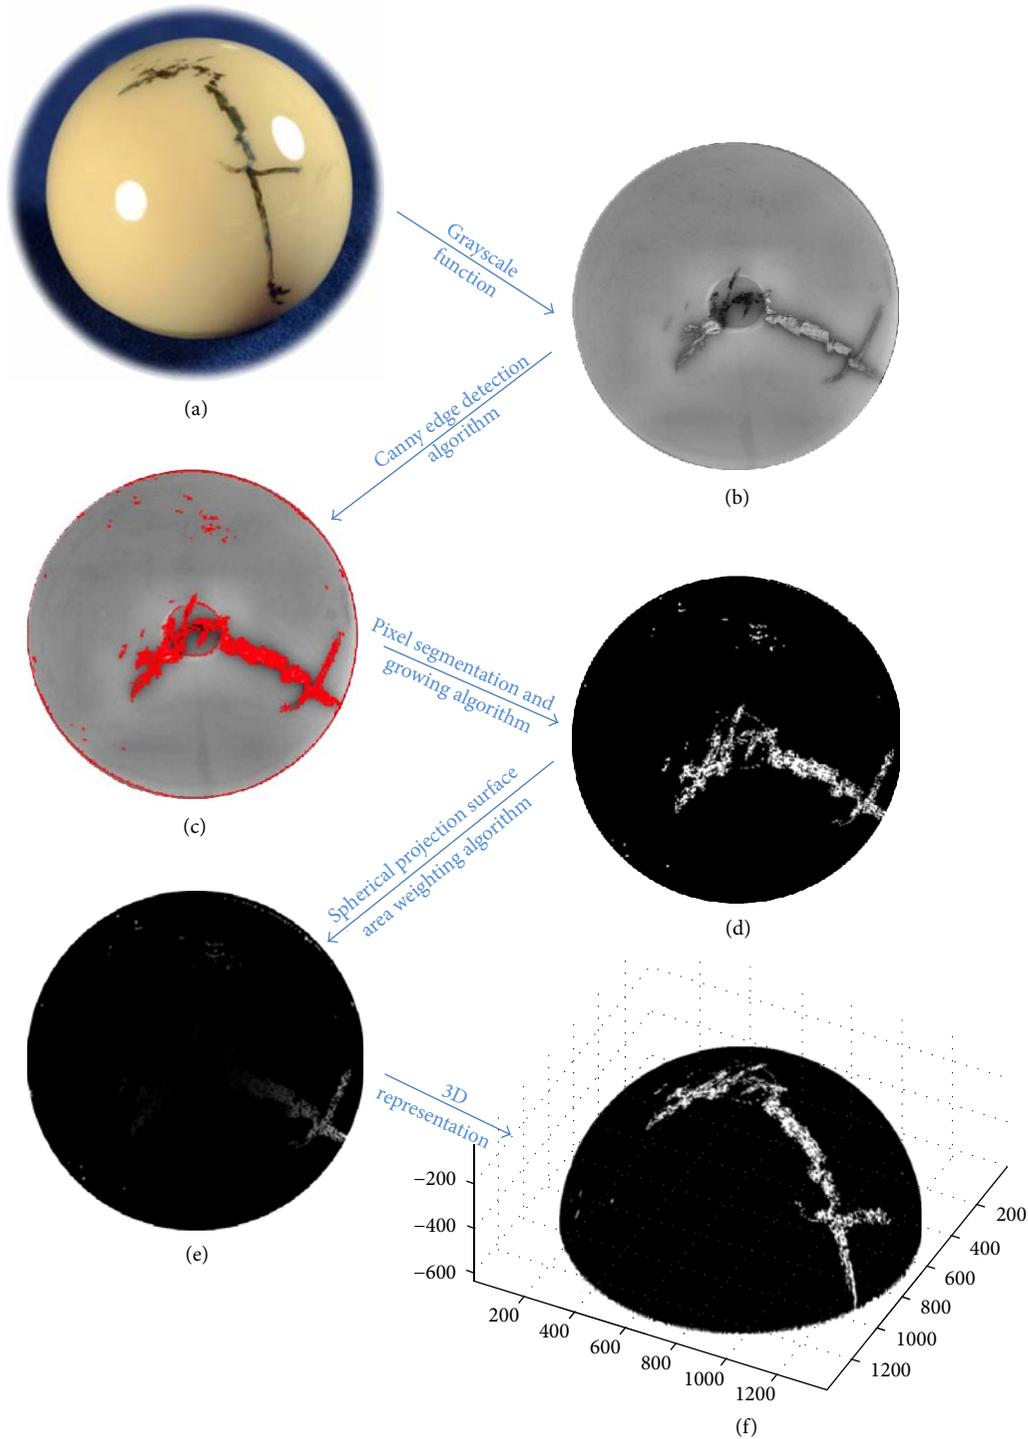
FIGURE 1: Procedure for analyzing metal transfer damage on a ceramic femoral head. (a) Initial photo documentation of a ceramic femoral head with metal transfer damage. (b) Photo documentation with grayscale enhancement applied. (c) Canny edge detection defining the edges of the metal transfer. (d) Pixel segmentation isolating metal transfer from the femoral head for the upper hemisphere, expanded to full metal transfer surface area using a Nearest-Neighbor growing algorithm. (e) Reverse azimuthal projection producing a weighted two-dimensional image of the total upper hemisphere featuring metal transfer, and the percent coverage. (f) An equivalent 3D representation of the isolated metal transfer.

**2.4. Metal Transfer Surface Area Calculations.** We quantitatively analyzed components with visual evidence of metal transfer (corresponding to a transfer score  $\geq 2$ ), using a customized MATLAB (Mathworks; Natick, Massachusetts, USA) algorithm applied to all images of the femoral heads. All photographs were enhanced using a standard MATLAB monochromatic photograph filter. Metal transfer was identified using an edge detection filter (Canny Edge Detection) to isolate metal transfer using pixel segmentation [6, 10, 12]. Outlines of the transfer were filled in using a customized Nearest-Neighbor algorithm. The two-dimensional image was projected onto an idealized half-sphere using a reverse azimuthal projection (Figure 1). Metal transfer was reported as a percentage of the surface area of the upper hemisphere covered by metal transfer and then converted to the surface area in  $\text{mm}^2$  for a half sphere based on the femoral head size. A repeatability study was conducted in accordance with ASTM International Designation: E 691-08 [13]. It was determined that this procedure, when repeated three times consecutively under similar conditions by the same operator, allowed for an average repeatability standard deviation ( $s_r$ ) of 0.348% across the cohorts. This was derived from the standard deviation of the percentages produced three consecutive times per head, over an entire population of 74 analyzed heads ( $s_r = \sqrt{\sum_1^p (s^2/p)}$ ;  $p = 74$ ).

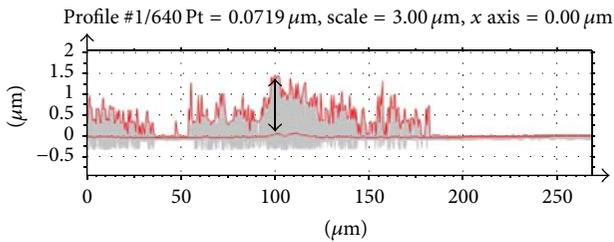
FIGURE 2: Optical microscopy surface scan converted into a series of profiles with profile envelopes for the maximum and mean values. Distance between the mean line and the highest peak was measured per scan and averaged per head ( $SR_{pm}$ ).

The dimensions of the three most frequently observed patterns (longitudinal stripe, random stripe, and random patches) were measured. The most prominent mark (i.e., largest metal transfer surface area, darkest, and most consistent in color) was measured for total length and width using calibrated calipers. Length was considered to be the main exhibited direction, and each mark was measured only to the upper hemisphere boundary at the head equator. Arc length was calculated from the chord length measured with the calipers (Arc Length = Diameter \*  $\sin^{-1}$ (Measured Chord Length/Diameter)). Metal transfer height was measured using white light interferometry (WLI) (NewView 5000, Zygo; Middlefield, Connecticut, USA). A total of 5 WLI measurements per femoral head were taken for visually identified regions of metal transfer. Using commercial three-dimensional surface analysis software (TalyMap Platinum, Taylor Hobson, Leicester, United Kingdom), the spherical form was removed from each surface scan and converted into a series of two-dimensional height profiles encompassing the entire measured surface (Figure 2). The maximum metal transfer peak height for each femoral head was calculated as the mean peak areal height ( $SR_{pm}$ ): the single maximum mean-to-peak height per each measurement location averaged over all scanned regions (Figure 2).

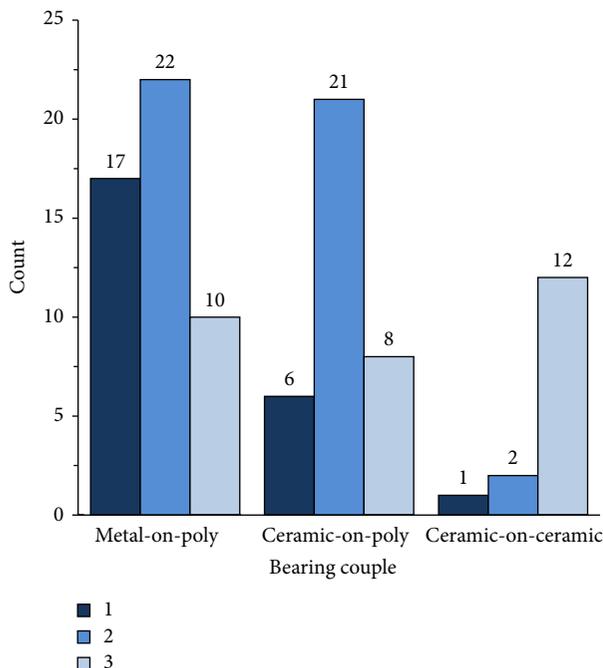
FIGURE 3: Count of femoral heads in each material cohort (M-PE, C-PE, and C-C) belonging to each visual score classification. Scores  $\geq 2$  were analyzed further for having visual metal transfer.

**2.2. Visual Scoring of Metal Transfer.** The extent of metal transfer on the femoral heads was scored using a 3-point semiquantitative scale adapted from Kim et al. [1] and a diffused lighting technique established by Heiner et al. [10]. Three independent observers (EKF, JSJ, and JTS) scored each femoral head, discussing dissimilar visual scores until a consensus was reached. Resting on the taper surface, the heads were viewed while being shrouded in an opaque tube. The tube diffused the room lighting, replacing any reflections with a smooth white background. Only the portion of the head that would articulate with the acetabular liner in a normal gait pattern was observed and scored in this manner (i.e., the upper hemisphere) [6, 11]. A score of 1 was given when no metal transfer was observed. A score of 2 was

given when minimal metal transfer was observed, defined as isolated marks, a few marks in concentrated areas, or markings very light in color. A score of 3 was given for severe metal transfer, that is, when a longitudinal, concentrated metal transfer stripe was observed or when metal transfer of any type was observed over the majority of the upper hemisphere [1]. We used the visual score of metal transfer as a screening process to identify femoral heads suitable for quantitative analysis.

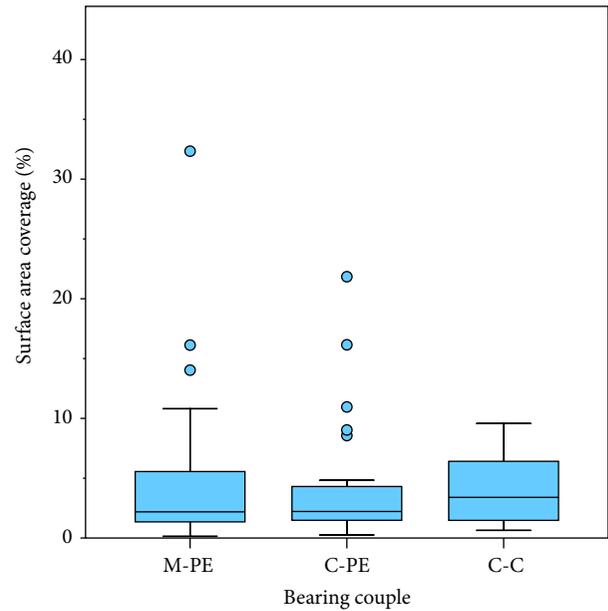
FIGURE 4: The distribution of metal transfer surface coverage was similar across the three material cohorts ( $p = 0.90$ ).

coverage was similar among the 3 cohorts, with an overall median coverage of 2.3% of the upper hemisphere (IQR: 4.1%;  $p = 0.90$ ) (Figure 4). The median metal transfer surface area coverage was 2.2% (IQR: 4.3%) for the M-PE cohort, 2.2% (IQR: 2.9%) for the C-PE cohort, and 3.4% (IQR: 5.3%) for the C-C cohort. Similarly, the curved surface area of metal transfer was similar among the three cohorts (overall median surface area = 39.8 mm<sup>2</sup> (IQR: 67.5 mm<sup>2</sup>);  $p = 0.98$ ). The surface area of metal transfer was 38.6 mm<sup>2</sup> (IQR: 70.9 mm<sup>2</sup>)

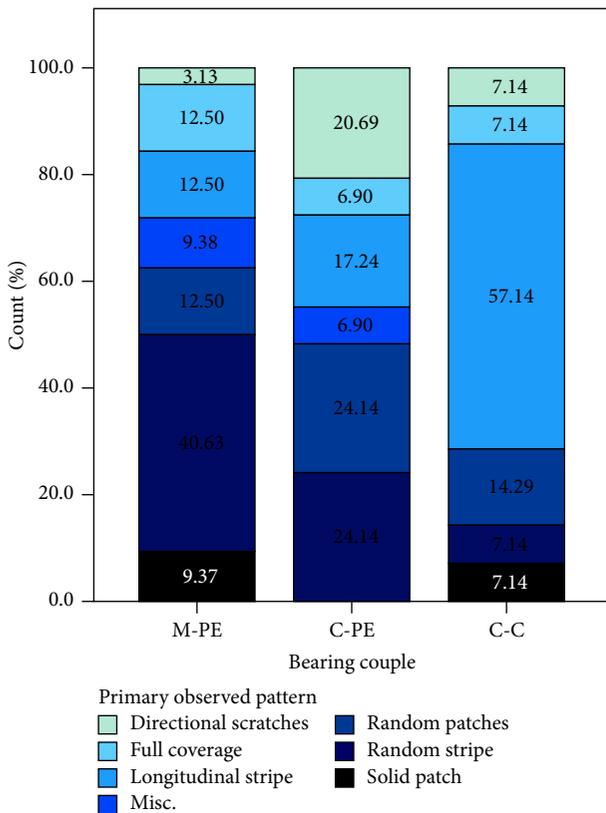
FIGURE 5: Distribution of identified metal transfer patterns across the three cohorts.

Seven metal transfer patterns were observed on the 75 analyzed femoral heads across all three cohorts, occurring in different proportions ( $p = 0.02$ ; Figure 5).

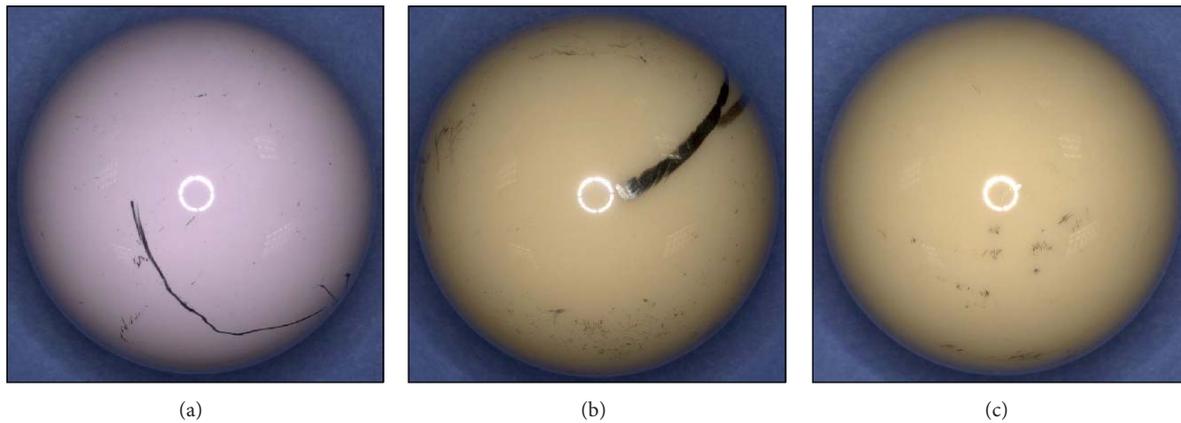
FIGURE 6: Digital photographs of the three most common patterns: (a) random stripe, (b) longitudinal stripe, and (c) random patches. Both the longitudinal stripe and the random stripe also feature the most common secondary pattern: patterned coverage over the entire upper hemisphere.

For femoral heads with evidence of metal transfer, the three most common primary patterns observed were random stripe ( $n = 21/75$ ), longitudinal stripe ( $n = 17/75$ ), and random patches ( $n = 13/75$ ) (Figure 6). For 72% ( $n = 54/75$ ) of the femoral heads, only one of the seven metal transfer patterns was observed on the upper hemisphere. A secondary metal transfer pattern (lighter in color, less surface area coverage, and more sporadic in appearance) was observed for 28% ( $n = 21/75$ ) of the femoral heads: 12% ( $n = 9/75$ ) of the M-PE cohort; 9% ( $n = 7/75$ ) of the C-PE cohort; and 7% ( $n = 5/75$ ) of the C-C cohort. The most common secondary pattern observed was patterned coverage ( $n = 6/21$ ) accompanying a longitudinal stripe ( $n = 5/21$ ).
