Research Article

Analysis of Shear Bond Strength and Morphology of Er:YAG Laser-Recycled Ceramic Orthodontic Brackets

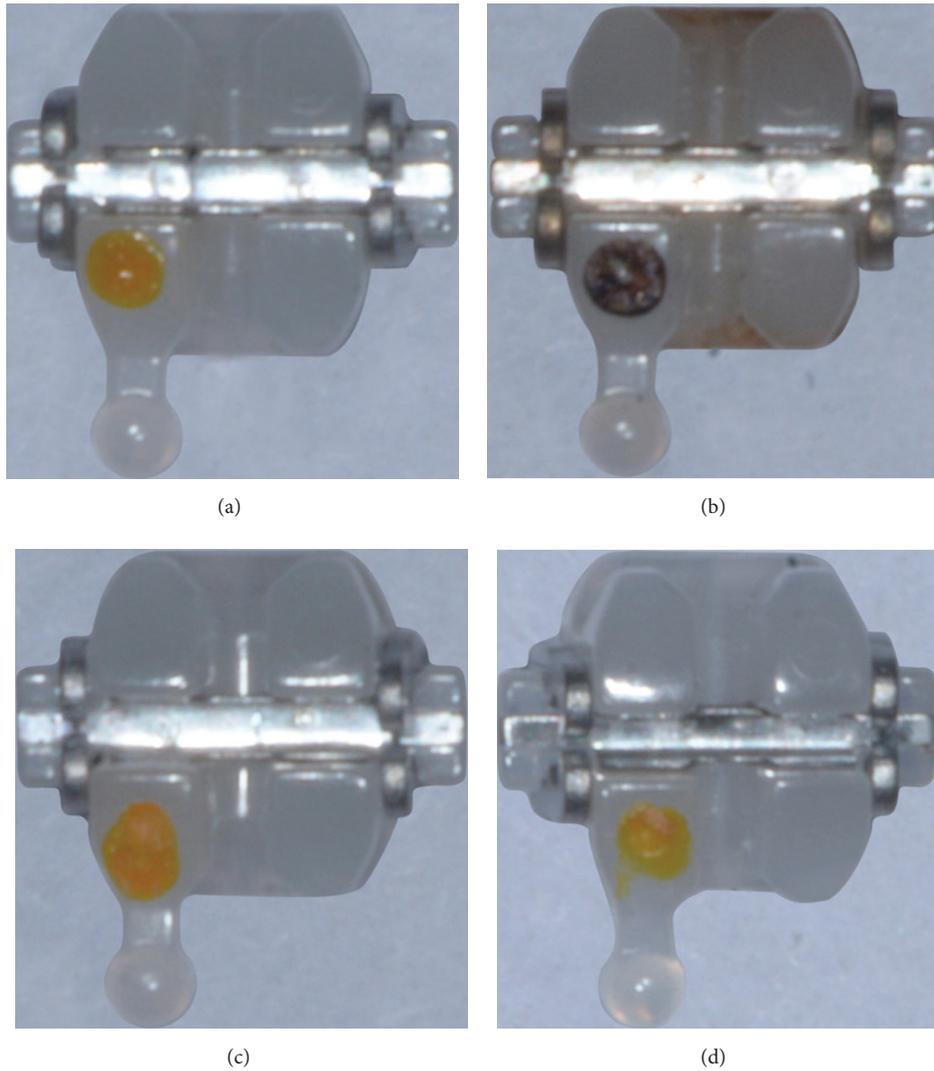
FIGURE 1: Photographs of ceramic brackets. (a) New bracket. (b) Flame-processed bracket. (c) Sandblasted bracket. (d) Bracket exposed to an Er:YAG laser.

New ceramic brackets had a clear porcelain appearance, while brackets processed by flaming were faded and dark

(Figure 1). The colors of brackets exposed to sandblasting or to the laser were similar to that of control brackets (Figure 1).

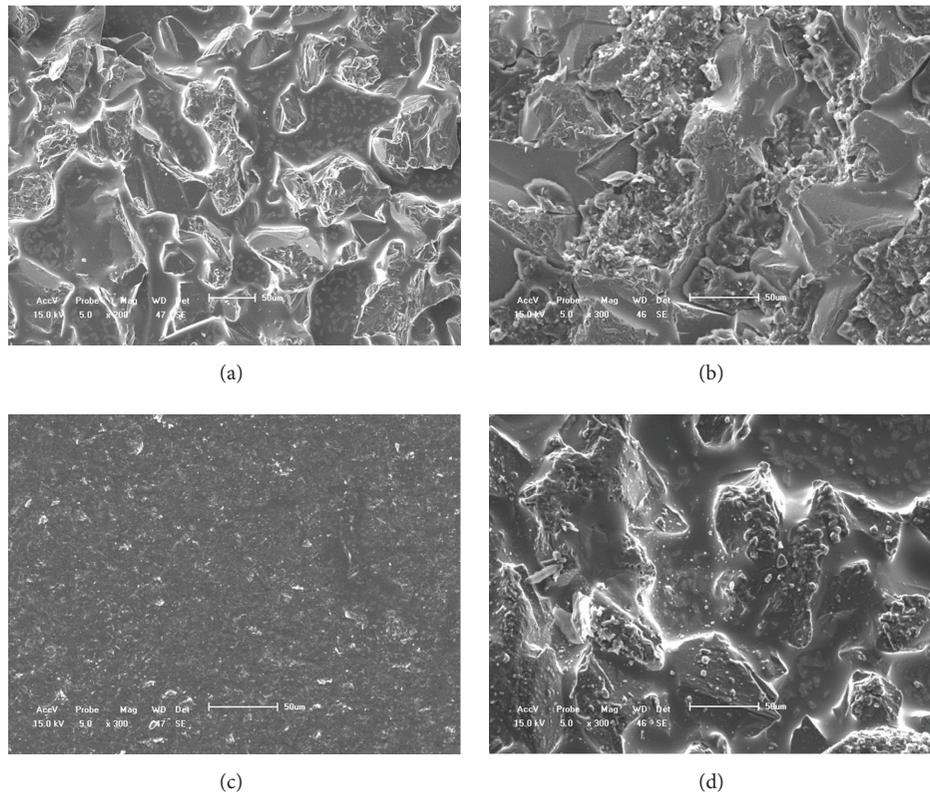
FIGURE 2: SEM (300x magnification) of the bases of ceramic brackets. (a) New bracket. (b) Flame-processed bracket. (c) Sandblasted bracket. (d) Bracket exposed to an Er:YAG laser.

SEM and CLSM demonstrated that new ceramic bracket bases were made up of irregular microcrystalline structures. Some residual adhesive was evident in the hollows of the microcrystalline structures of ceramic brackets processed by flaming (Figure 2). Sandblasting removed all adhesive, but destroyed the bracket bases (Figure 2). However, the Er:YAG

laser removed all adhesive completely and maintained the integrity of the microcrystalline structure (Figures 2 and 3).

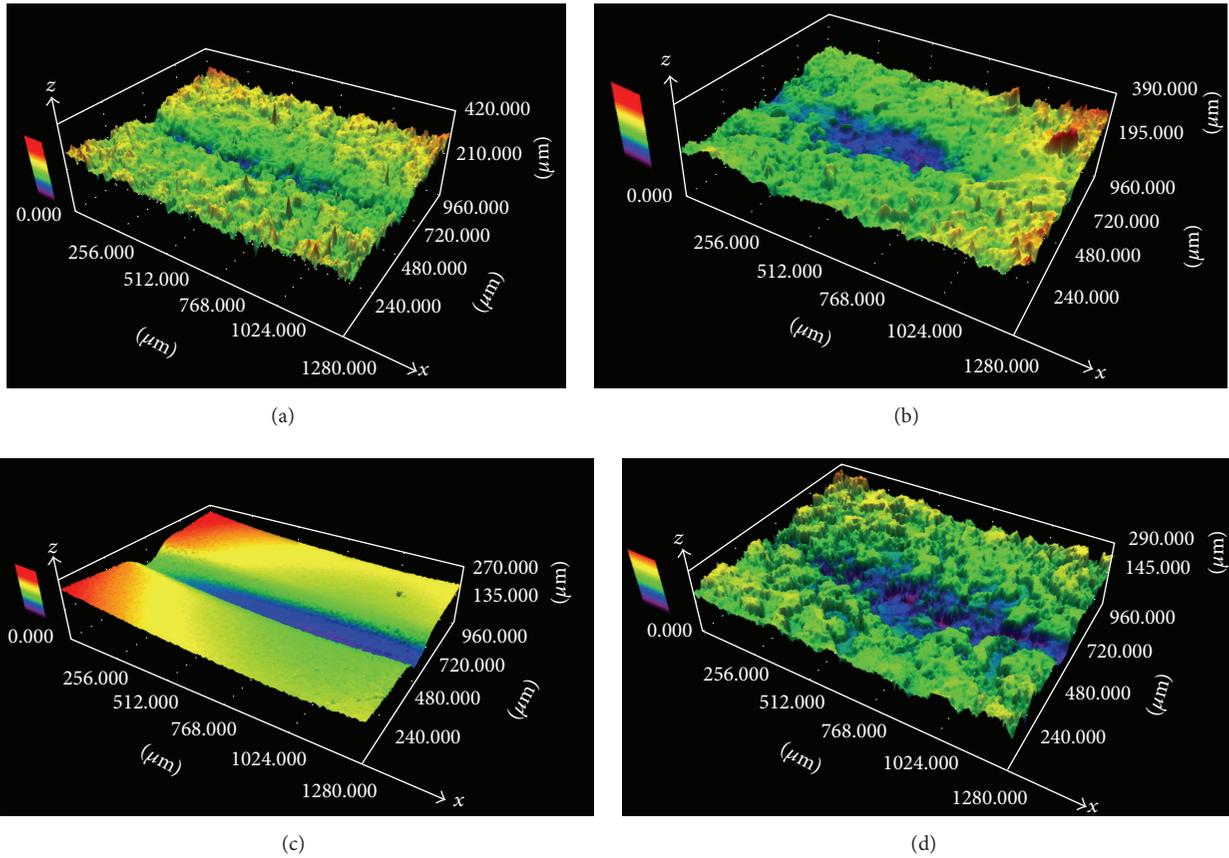
FIGURE 3: Three-dimensional reconstruction of the bases of ceramic brackets. (a) New bracket. (b) Flame-processed bracket. (c) Sandblasted bracket. (d) Bracket exposed to an Er:YAG laser.

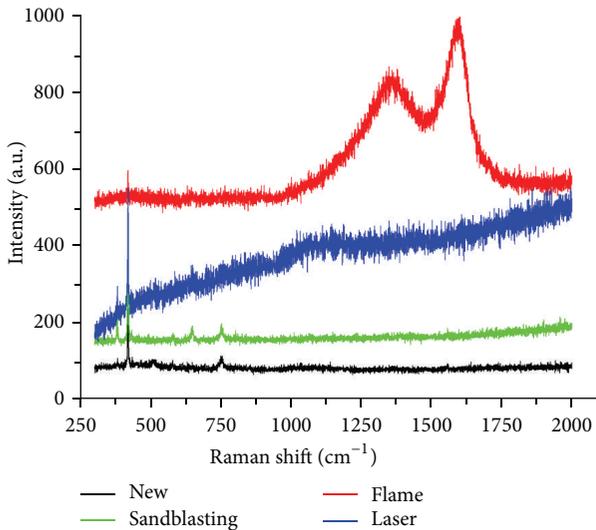
FIGURE 4: Raman spectroscopy.

An overlapping Raman peak related to aluminum oxide was visible on Raman spectroscopy (Figure 4). For ceramic brackets processed by flaming, the other Raman peak on the spectrogram suggested that carbide remained on the base (the peak reflected the ash of the adhesive; Figure 4). No other Raman peak appeared for new brackets or for brackets processed via sandblasting or the laser (Figure 4), indicating that there was no adhesive on the bases of these brackets. These results of the Raman analysis were consistent with SEM and CLSM.
