Case Report

Removal of Implant and New Rehabilitation for Better Esthetics

Dental School of Ribeirão Preto, Dental Materials and Prosthodontic Department, University of São Paulo, Ribeirão Preto, SP, Brazil

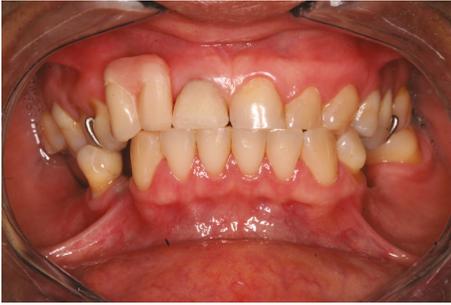
FIGURE 1: Temporary crown on teeth 11 adapted to the removable prosthesis.

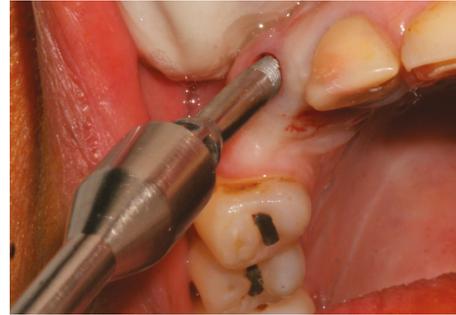
FIGURE 3: Removal of the implant with a retrieval tool.

The implant was gradually removed using the implant removal instrument (Implant Retrieval Tool; Nobel Biocare), with antirotational movement (Figure 3). Following this surgical procedure, a new implant was installed (cone Morse 3.5 × 11 mm, Conexão, Brazil), with a torque of 30 N, and positioned in the mesiodistal direction. Specifically, the implant was placed closer to tooth 14 in the buccal-palatine direction on the bone ridge (located around 1 mm for the palatal from an imaginary curvature passing through the buccal surfaces of the present teeth and 1 mm infraosseo in the coronoapical direction) (Figure 4).

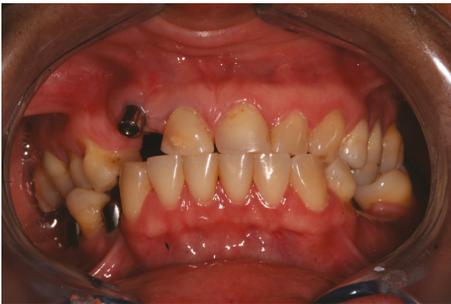
FIGURE 2: Poorly positioned implant.

After approximately 8 months, it was verified that the implant located in the anterior region was positioned further apical and buccal (Figure 2) making it impossible to fabricate a successful implant crown from an esthetic point of view.

Some points are worth making for this report. In this case, despite the careful presurgical planning, complications during the surgery resulted in a case with no prosthetic solution, even if using angled implant abutment due to the buccal positioning of the implant. The angled abutment presented a metallic platform wider than the straight one, thereby negatively affecting esthetics. This condition could have been avoided if the positioning of the implant had been 1 to 2 mm more palatal from an imaginary line passing through the buccal surfaces of the other teeth [1, 6]. This would facilitate prosthetic procedures, preserve facial esthetics, and conserve bone tissue on the buccal surfaces.

The apical placement of the implant is another deficient aspect of the case study, because it created a misalignment

in relation to the natural teeth. Ideally, it should have been placed 3 to 4 mm apical to the cemento-enamel junction of the adjacent teeth [6] to achieve the esthetic goal. This would have resulted in a smooth gingival contour, without abrupt changes in tissue height [1]. In addition, this implant positioning would necessarily require a very long clinical crown, disproportionate to adjacent teeth and visible during the patient's smile.

Therefore, due to the poor prognosis, the treatment option was to remove the implant and carefully replace it with a new one that was three-dimensionally well positioned, enabling the prosthetic rehabilitation. Among the various possibilities [9, 11, 12], the selected technique allowed the implant to be removed quickly, atraumatically, and without the need for incisions or manipulation of bone tissue. Considering the prosthetic planning, even if the implant had been adequately placed in the apicocoronal and buccopalatal direction, the prosthetic resolution for the implant in the site of tooth 12 would be a distal cantilever of tooth 13. This is a controversial option from a mechanical and biological point of view [18]. Another option could have been a fixed partial denture using the implant abutment in the site of tooth 12 and a tooth abutment on tooth 14, which was also not considered as the first choice [19, 20]. The surgeon was then asked to place the new implant in the mesiodistal direction, closest to tooth 14, in the position of tooth 13, to serve as an abutment for a mesial cantilever prosthesis in the site of tooth 12, avoiding the trauma caused by the placement of another implant [21]. In addition, studies have shown that the lateral incisor had the thinnest alveolar ridge compared to the central incisor and cuspid, probably due to the presence of the lateral fossa which creates the buccal concavity adjacent to the lateral incisor [15].

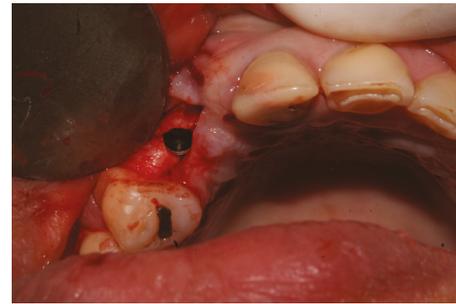
FIGURE 4: Installation of the new implant.

Another important aspect was the position of the new implant, in the mesiodistal direction closest to tooth 14. This allowed the placement of a mesial cantilever that is more favorable to the occlusal loads than a distal cantilever [3], and the screw-type prosthesis is more easily retrievable than the cemented type and, therefore, technical and sometimes biological complications can be treated more easily [23].

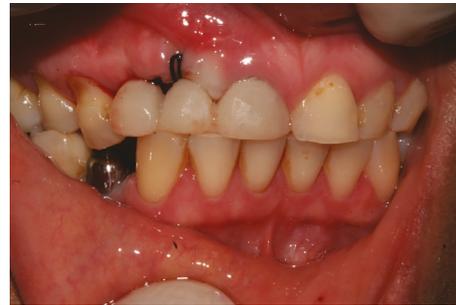
FIGURE 5: Installation of the temporary fixed partial denture.

After the surgery, the removable partial denture was removed. This was followed by the fabrication of a temporary fixed partial prosthesis with retention used during the

osseointegration phase on teeth 11 and 14 (Figure 5): this was only for esthetic purpose. This was in addition to the installation of prostheses on the implants in the regions of teeth 35, 36, 44, and 46.

Regarding the immediate provisionalization, because the temporary prosthesis was retained only by tooth 11, its main objective was the patient's satisfaction with the esthetics during the period of osseointegration [1, 22] despite some benefit in preserving the tissue integrity. It is important to emphasize that this temporary restoration presented no functional characteristic. In other words, occlusal loads were not incident on it, and after second stage surgery, the prosthesis was adjusted and additionally retained on the healing cap.

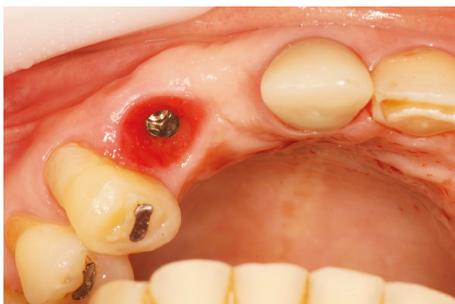
FIGURE 6: Occlusal view of the gingival conditioning.

Immediately after the second stage surgery, the temporary fixed partial denture was performed using the healing cap as an abutment and a lateral incisor as a mesial cantilever. Following the rehabilitation procedures, this temporary fixed partial denture was changed to a provisional fixed prosthesis with the mesial cantilever screwed into the implant. During this phase, periodic acrylic resin implements were added to the temporary prosthesis to promote gingival conditioning (Figures 6 and 7) and black triangle closure (Figures 8 and 9) and also to improve gingival esthetics.

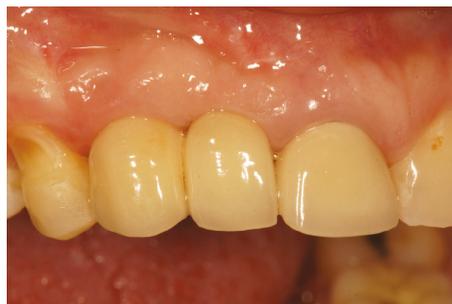
FIGURE 10: Final appearance of the implant prosthesis.

At the end of two months, the implant prosthesis with a mesial cantilever was installed (Figure 10). This case report

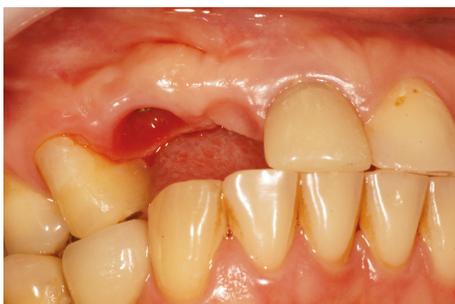
FIGURE 7: Buccal view of the gingival conditioning.

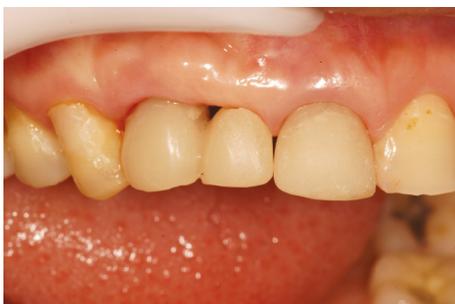
FIGURE 8: Presence of the black triangle before gingival conditioning.

After the osseointegration period and during the prosthetic treatment, the alignment of the gingival height and adequate conformation of the gingival papilla between the first right upper premolar and the implant were verified. According to Buser et al. [1], the harmony of the gingival margins around the implant and the adjacent tooth requires sufficient height and thickness of the bone, mainly in the buccal side, which was verified in the present case. However, in the cantilever region, there was a need for tissue conditioning by the gradual addition of self-curing resin, giving an oval characteristic to the pontic of the provisional prosthetic restoration to conform to the underlying soft tissue. As bone and connective tissue grafts were not performed, the shape of the interproximal papilla was not completely reestablished. It was necessary to modify the interproximal contact from point to facet of contact with the goal of reducing the

black triangle and improving the esthetics of the region, as suggested by Jivraj and Chee [3].

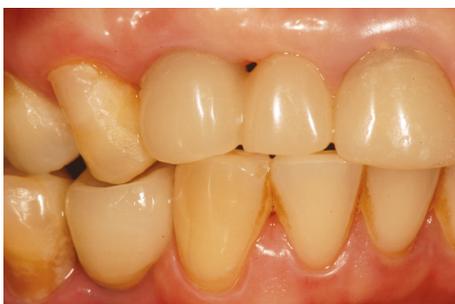
FIGURE 9: Gradual closing of the black triangle.
