Case Report

Rare Case of Dental Implantation in the Segment with Residual Filling Material in the Mandibular Canal

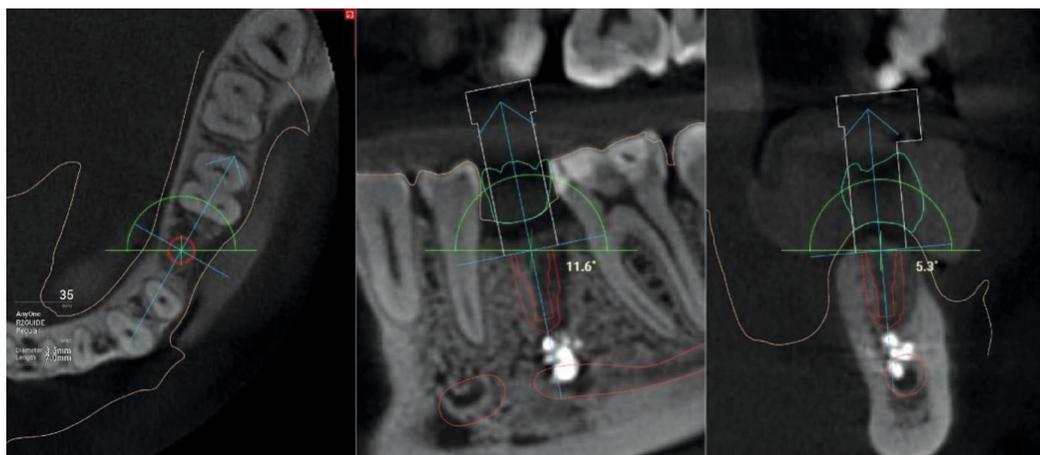
FIGURE 1: CBCT. The implant is installed virtually in the area of the missing 3.5 tooth. Fragments of filling material are visualized in the lumen of the mandibular canal.

The patient, 29 years old, went to the clinic to make a fixed structure in the area of the missing 3.5 tooth. The tooth was removed due to complications from apical periodontitis. During the consultation, the patient made panoramic zoning of the jaws, which showed a foreign body in this jaw segment projected into the mandibular channel. When collecting anamnesis, the patient denied any symptoms associated with damage to the inferior lunatic nerve. In view of the complexity of the situation and a more detailed analysis of the possibility of implantation, the patient was made cone-beam computed tomography with a special X-ray contrast positioner, so that in the future it will be possible to make a navigation guide. Analysis of the tomogram showed the presence of a foreign body, which was visualized as a heterogeneous, high-contrast round shadow with a clear, irregular contour of 4×3.4 mm in size, partially localized in the lumen of the mandibular channel, classified as a sealer. The foreign body was surrounded by bone tissue on all sides except the mandibular canal. The absence of symptoms is explained by the preservation of the integrity of the nerve sheath. In view of the complexity of the situation, it was finally agreed to conduct a dental implant with a navigation guide R2Gate to preserve the security zone between the apex of the implant and the top edge sealer, to avoid possibility of displacement in the channel. The entire planning protocol was conducted in digital mode (Figure 1).

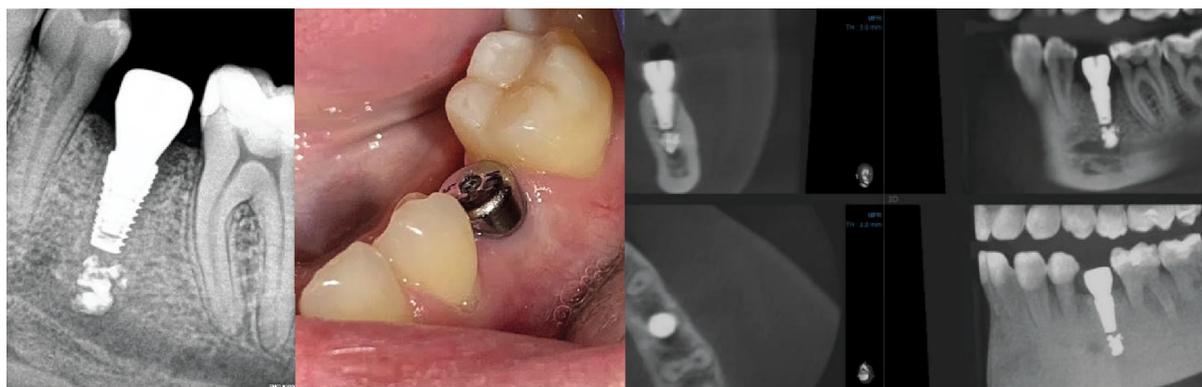
FIGURE 2: Intraoral X-ray. Condition in the oral cavity with the installation of the gum shaper. CBCT 1 month after implant placement.

The operation algorithm included anesthesia, positioning of the surgical guide on adjacent teeth, and a complete protocol for drilling through the guide with the installation of a dental implant. The drilling speed did not exceed 300 rpm. The torc when fixing the implant was 35 N/cm. The ISQ Index was equal to 69 units of CI. Since the use of a “supercortical” implant virtually eliminated the loss of stability at the obtained torc and ISQ values, a gum shaper with a diameter of 5.5 mm and a height of 5 mm was immediately installed. It is important to note that due to the complexity of the situation, it was decided to install a gingival cuff shaper for the observation period and not to carry out immediate loading, despite the design of the implant. The postoperative image showed the optimal location of the implant with the preservation of the safety zone between the apex and the sealer border (Figure 2).

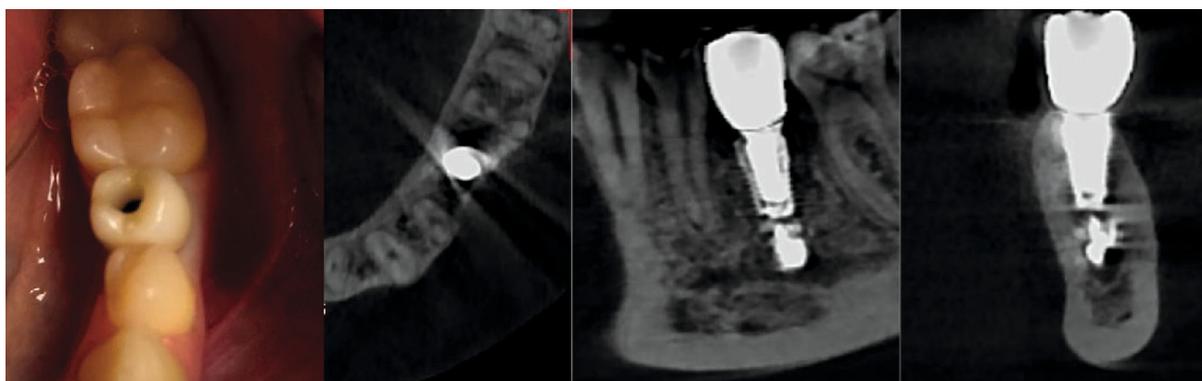
FIGURE 3: Fixing a permanent structure. CBCT. After the final restoration, the implant is also located in compliance with the safety zone.

During the three months of follow-up, the patient made no complaints. Before the prosthetics stage, the frequency-resonance analysis indicators demonstrated the onset of osteointegration. Prosthetics was performed with an all-zirconium crown on a titanium base with transocclusal fixation. Two months after fixation of the permanent crown, a CT scan was performed to assess the position of the implant after loading. According to CBCT, the distance from the implant apex to the upper border of the sealer is 0.72 mm. The peri-implant bone structure was normal. The patient did not complain (Figure 3).
