Case Report

Imaging of Posterior Interosseous Neuropathy following Distal Biceps Repair: A Report of 3 Cases

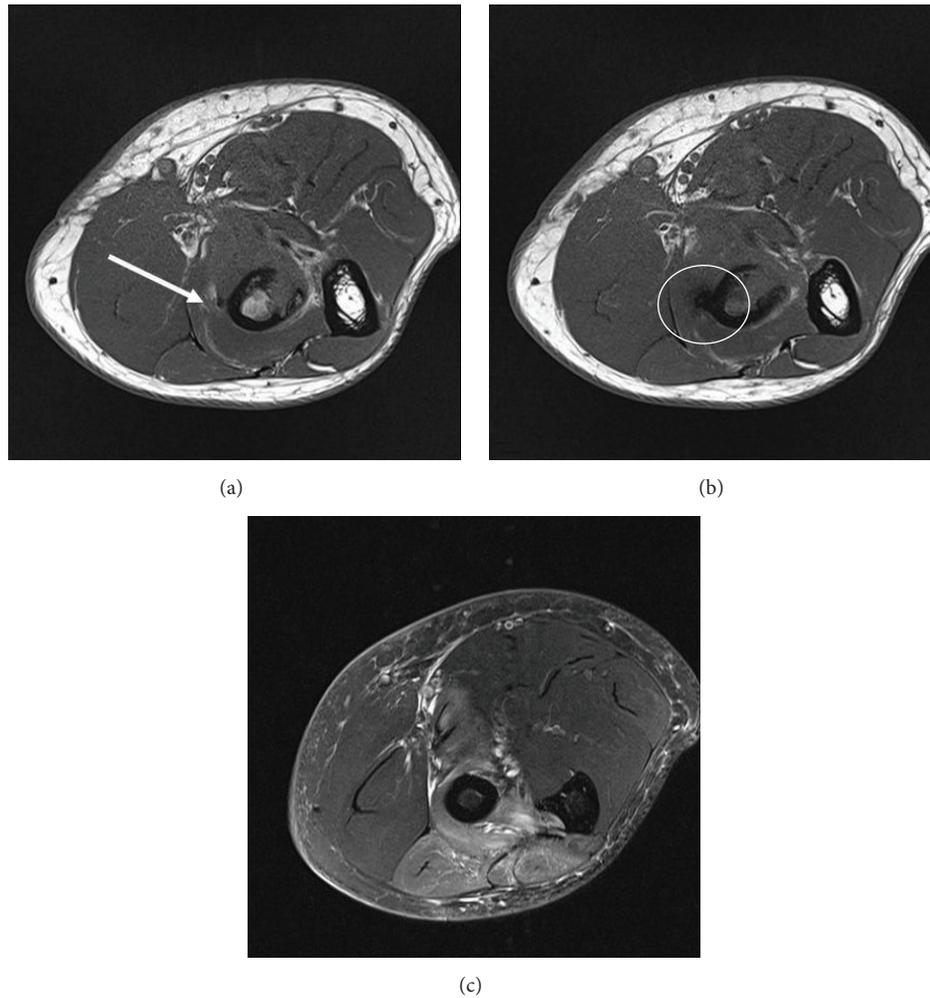
FIGURE 1: Axial T1 ((a), (b)) and T2 fat saturated images (c) from patient 1. (a) demonstrates the PIN in the supinator tunnel just proximal to the exit point of the radial tunnel posterolaterally where it is clearly identified (white arrow). Slightly more distally, (b), artifact from the cortical fixation button obscures the plane of the PIN (circle). A pattern of muscle edema involving the ECU, EDC, EDM, and supinator muscles is consistent with injury to the PIN in (c).

In the area of cortical button deployment, along the postero-medial radial cortex, the PIN and corresponding fat plane within the supinator tunnel were focally obscured by small susceptibility artifact. The biceps tendon was not clearly visualized at its insertion prompting the interpreting radiologist to suggest rerupture. However, clinical examination demonstrated intact biceps function and the findings at imaging were attributed to edema and hemorrhage related to the recent postoperative state.

If information about the surgical technique is not readily available, the radiologist might be able to glean this information by assessing signs of a posterolateral incision. It is likely in these patients that the injury was due to posterior dissection and careful inspection for signs of hemorrhage, scarring, nerve discontinuity, or susceptibility obscuring the PIN, as was seen in case 3, is warranted. Conversely, if a single anterior incision was used, the site of nerve injury is likely at the posterior aspect of the surgically created radial tunnel and may have been sustained at time of tunnel creation or deployment of the fixation devices used (i.e., cortical fixation button). Thus, inspection of the fixation device and its relationship to the PIN should be attempted. In case 2, the PIN was noted in close proximity to the cortical fixation button, whereas in case 1, the nerve was completely obscured by susceptibility artifact in proximity to the device.

The trajectory of the tunnel has been pointed out as critical when performing cortical button fixation. Several groups have demonstrated that creation of the tunnel in 30 degrees of ulnar deviation results in greater distance between the posterior exit site of the tunnel and the PIN [10, 12]. Lo et al. found that tunnel drilling from proximal to distal placed the PIN at the greatest risk [13]. These authors further noted that a small transverse anterior antebrachial incision advocated by some authors may in fact force the surgeon to angle distally and suggested a slightly larger longitudinal incision to allow the surgeon more latitude in tunnel trajectory. The slightly proximal to distal orientation of the tunnel in case 1 may have increased the risk of nerve injury.

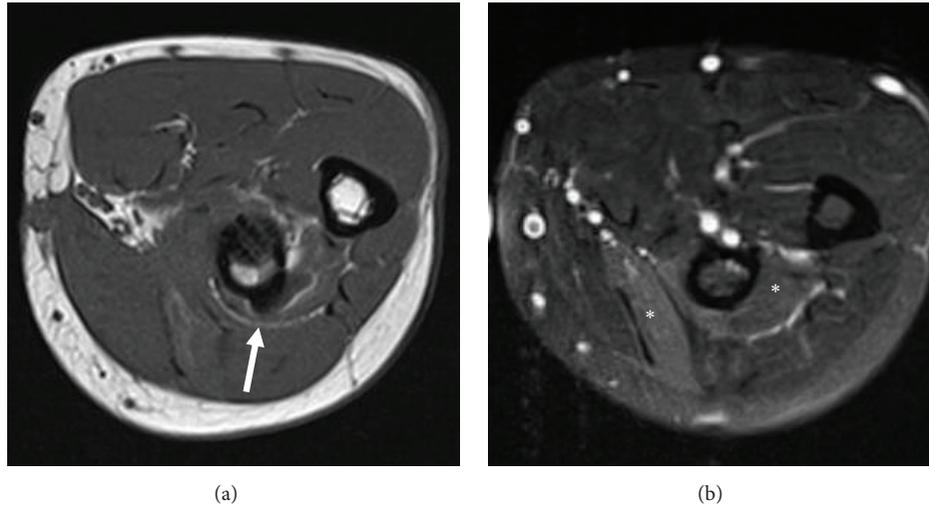
FIGURE 2: Axial T1 (a) and T2 (b) fat saturated images from patient 2. In (a), surgical artifact along the posterolateral margin of the radius can be seen approaching but not definitively compressing or obscuring the deep radial nerve or proximal PIN (white arrow). Neurogenic edema is noted in the ECRB and supinator muscles in (b) (asterisks).

Approximately 4 months after the surgery and 7 months after the initial injury, a second MRI was performed (Figure 2) which demonstrated an edema-like pattern within the supinator and extensor carpi radialis brevis muscles consistent with denervation. No muscle atrophy was noted. As with the first case, a single anterior scar was identified with no evidence of a posterior incision. Artifact from the area of the cortical fixation button was noted in proximity to the plane of the traversing PIN, but without effacement of the nerve or surrounding fat plane. The biceps repair was intact.

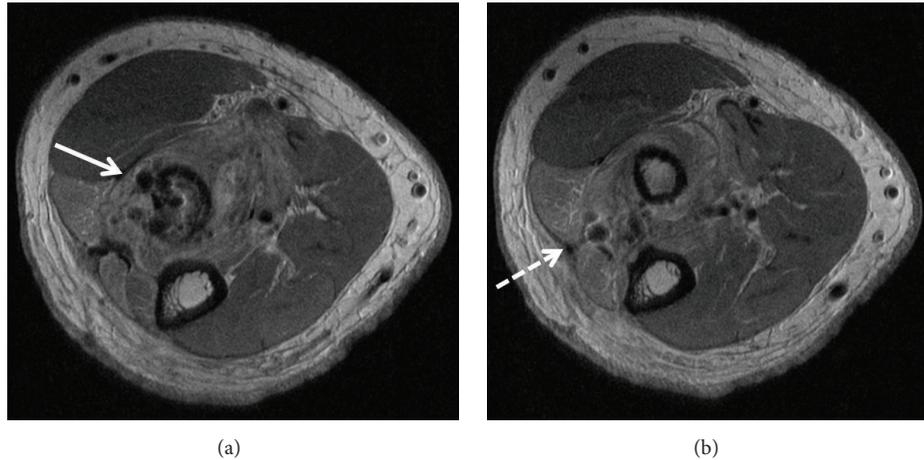
FIGURE 3: Two sequential axial proton density images ((a), (b)) in patient 3. Susceptibility artifact is noted in the expected location of the PIN along the posterolateral margin of the proximal radius (solid arrow, (a)). Note the scarring posteriorly indicating a two-incision approach (dashed arrow, (b)).

identified with proximal tendon retraction of approximately 6 cm. There were surgically created defects in the area of the bicipital tuberosity and adjacent posterolateral radial cortex with no discrete transosseous tunnel. Scarring and susceptibility artifact in the planes between the ECU and EDM muscles posteriorly were consistent with a second posterolateral incision.
