Case Report

Ureteral Guidewire Looping and Entrapment above an Impacted Ureter Stone

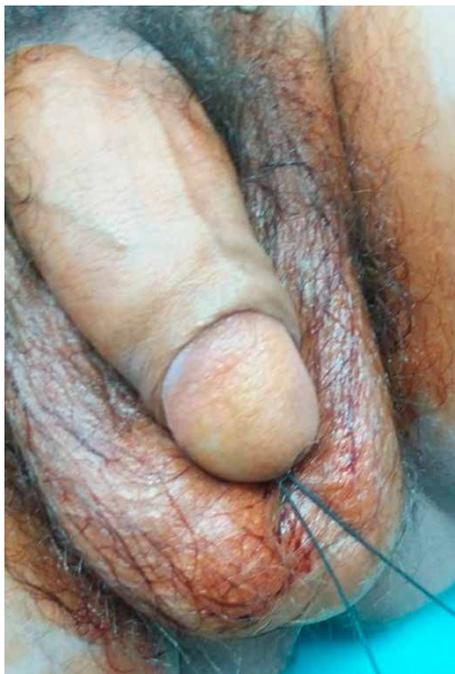
A 57-year-old man was referred to our department by a district hospital, after a previous unsuccessful effort of a double-J ureteral stent placement without real-time fluoroscopy. The patient arrived at the emergency department with both parts of a guidewire (Terumo RadiofocusR Guidewire, 180 cm)

FIGURE 1: Both parts of the guidewire protruding out of the urethral meatus.

Our first step was to pull gently one end of the guidewire under fluoroscopic guidance and local anesthesia, but our effort was unsuccessful. Next, we inserted another hybrid guidewire (Sensor™ Straight Tip, Boston Scientific), which could not bypass the stone and was looping under it. The retrograde urography showed full stop of the contrast at the level of the stone and no extravasation was revealed. Since the patient had no signs of infection, we decided to continue our handling under general anesthesia, so we could inspect the ureter with the semirigid ureteroscope (Karl Storz, 27002L, 43 cm length, 9.5 Fr). The ureteroscope was advanced easily up to the stone. The guidewire had initially perforated the mucosa of the ureter under the impacted stone, was looping intraluminally above the stone, returned submucosally and finally passed intraluminally to get out of the ureter orifice

and out of the meatus. Subsequently, we performed an active stone removal via laser lithotripsy (Dornier. Medilas H Solvo, laser fiber 600 μm). The entrapped guidewire was released after fragmentation of the stone and was easily removed from the ureter. Finally, a 7F-28 cm open-end double-J stent was placed over the second guidewire fluoroscopically. The patient was discharged the next day, with no complications after the

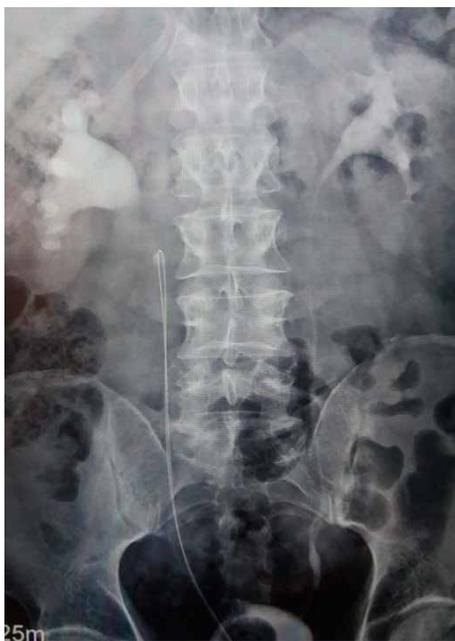
protruding out of his urethral meatus (Figure 1). The intravenous urography (IVU), which had been performed at the district hospital after the failed stent insertion, revealed a right proximal ureteral obstructing stone with approximate maximal diameter 9 mm ($9 \times 4 \times 6$ mm) and the guidewire looping above it (Figure 2). IVU was performed instead of CT urography due to unavailability of CT urography at the referring center. The admission laboratory tests revealed no leukocytosis (WBC $10900 \times 10^3/\mu\text{L}$) and normal serum creatinine values (Cre 0.85 mg/dL). Rest of laboratory exams were normal. Also patient was in a good general clinical status.

FIGURE 2: IVU reveals a right proximal ureteral obstructing stone and the guidewire looping above it.
