Research Article

Detecting the Activation of a Self-Healing Mechanism in Concrete by Acoustic Emission and Digital Image Correlation

E. Tsangouri,^{1,2} D. G. Aggelis,¹ K. Van Tittelboom,³ N. De Belie,³ and D. Van Hemelrijck¹

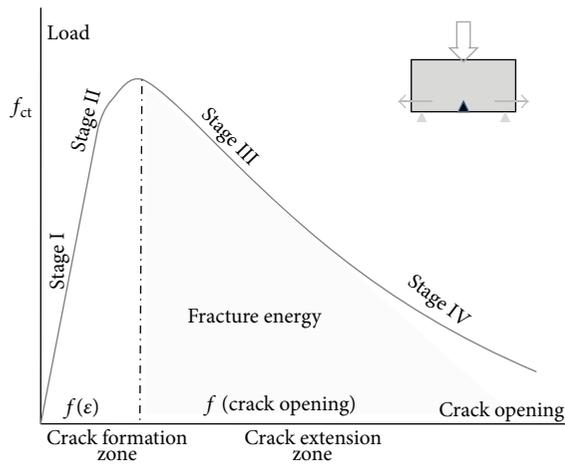
FIGURE 1: Fracture model of three-point bending crack opening test.

In the literature, different fracture models analyze the crack path morphology and crack tip performance under bending. For instance, the fictitious crack model, generalizing several quasibrittle fracture models, defines the linear elastic zone of loading as the stage at which loading depends on the strain capacity of the material and defines the postpeak zone as the stage at which crack opening controls the decrease in load. Graphically, the fracture theory splits the loading graph into two zones as shown in Figure 1. The energy release due to crack extension is analogous to the area under the curve of Figure 1.

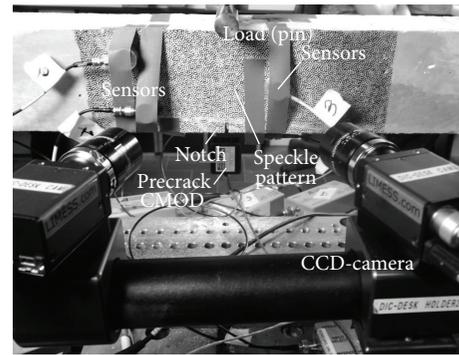
FIGURE 2: Experimental set-up.

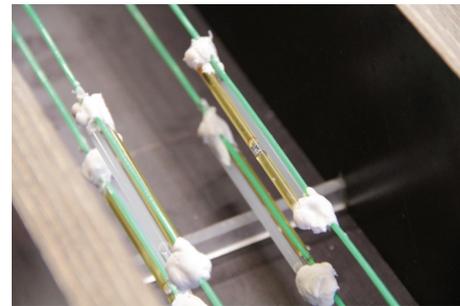
FIGURE 3: Series of capsules placed into the mold during casting.

Two-component polyurethane-based healing agent was embedded into borosilicate glass capillaries [1, 2]. The tubes, shown in Figure 3, are 50 mm long, the inner and outer diameters are 3.00 and 3.35 mm, respectively, and are sealed by glue at both sides. To prevent movement of the capsules during mixing, the capsules were attached to thin, poor in stiffness metallic wires crossing the length of the beam.

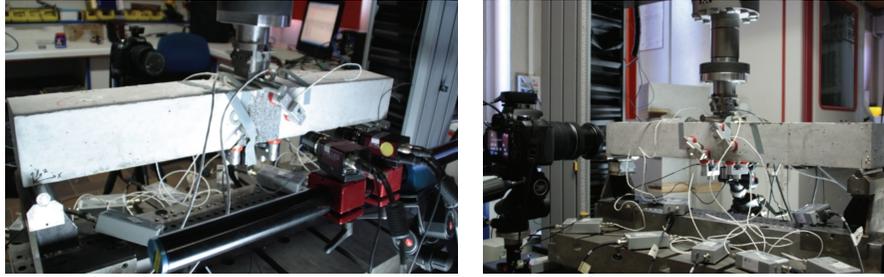
FIGURE 4: View of experimental setup configuration.

The present study focuses on the initial crack formation and capsule activity. Digital Image Correlation (DIC) and AE full-field monitoring of the testing process crucially contributes to this goal. Indicatively, the experimental setting up combining the different techniques is shown in Figure 4.

A 2-camera system fixes an orthogonal coordinate system as shown in Figure 4— X, Y, Z (measured in mm or pixels)—and observes the random black-white speckle pattern painted at the surface of the sample. The stereoscopic cameras set-up captures periodically (every 3 seconds) high-resolution images and provides a series of virtual strain gauges fully covering the fractured area. Stereo-correlation between the images allows calculation of the sample position and deformation— $U/V/W$ (measured in mm or pixels)—as crack opening occurs. Local derivative calculations provide Lagrangian strain tensor profiles— $e_{xx}/e_{yy}/e_{zz}$ (measured in μstrain , mm/mm, or %)—across the entire surface under analysis. Also, the DIC software is able to calculate the maximum principal strains e_1 and e_2 obtained by the e_{xx} and e_{yy} combinations for $e_{xy} = 0.00$ [11].

The cameras were positioned next to the INSTRON device and aligned on a metallic cylinder attached to a tripod. The DIC set-up was balanced and both cameras were oriented perpendicular to the concrete sample. The set-up parameters are shown at Table 1 and Figure 4.

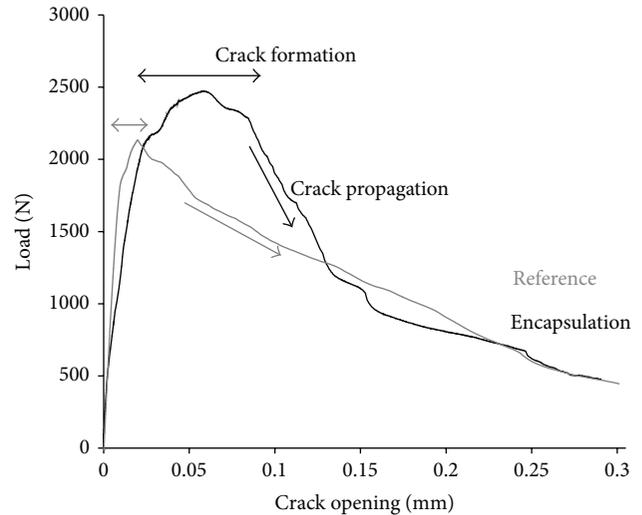
FIGURE 6: Load-crack opening graph for a representative sample of the reference and encapsulation series.

The evolution of the crack during performance of the three-point bending test provides primary information of the behaviour of samples with embedded capsules compared to reference samples. The load-crack opening displacement (measured by the CMOD device at the bottom of the beam) curves shown in Figure 6 are derived from a representative sample of the reference group of four beams (i.e., reference series) and another of the group of six beams into which healing system is embedded (i.e., encapsulation series).

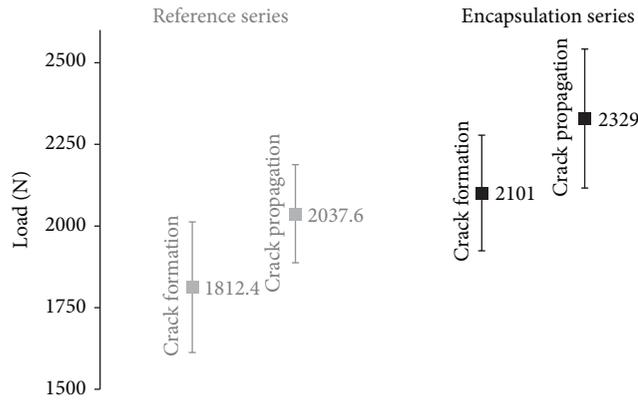
FIGURE 7: Material properties under bending: mean and standard deviation distribution for the sum of the beams.

Material properties of both test series as the initial stiffness, the load at crack formation, the maximum load, and the post peak load evolution can be derived from the graph in Figure 6. The values accounting for fracture response are quantitatively presented in Figure 7.

It is concluded that the initial stiffness (represented by the slope of the first part of the curves shown in Figure 7) is relatively similar for both series. As expected, the addition

of capsules does not influence the linear elastic behaviour of the concrete matrix. On the other hand, the load at the moment of crack formation is slightly increased in the case of encapsulation test series indicating potential influence of capsules on the loading performance of the samples [1]. Further on, the encapsulation series maximum load obtained is significantly elevated compared to the reference one. The behaviour of the encapsulation series during crack propagation is greatly diversified and in combination with the extended fracture energy release offers a clear evidence of the effect of capsules on the loading response and resistance of the concrete samples.

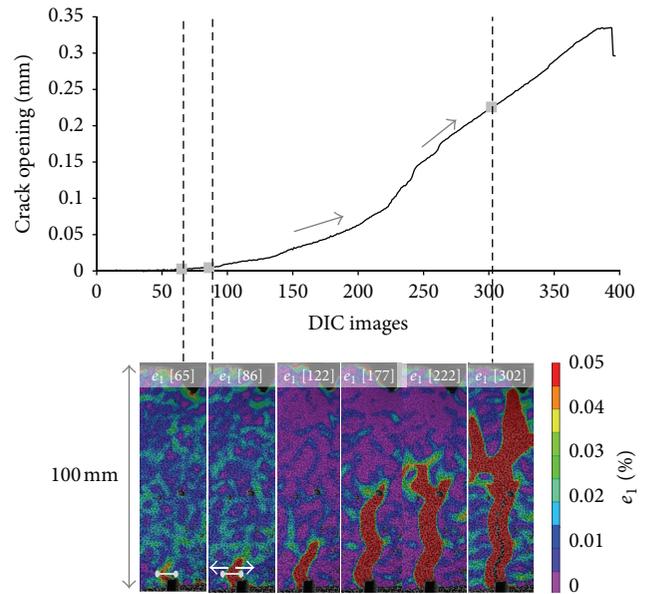
FIGURE 8: DIC monitoring strain and crack opening during bending.

of the crack morphology is presented and the continuously rising crack opening quantitatively measured at the bottom of the sample is shown. The position, at which the crack opening was calculated, is shown with a white mark in Figure 8.

In agreement with the fracture models analyzed above, at first, limited strain concentration appears at the edge of the notch. The principal— e_1 —strain profile of DIC image 65, corresponding to the end of Stage I of fracture indicates, the damage initiation before crack opening occurs. At the beginning of the experiment, the crack opening calculated at the concrete area above the notch remained negligible until that moment at which strain concentration locally appears, as shown at the strain profile e_1 [65] graph of Figure 8.

The principal strain of DIC image 86 defines the end of crack formation and the beginning of crack extension. Crack initiation is confirmed by the limited crack opening shown at the crack displacement graph in Figure 8.

Subsequently, upon completion of stage II (visualized in images 122, 177, and 222), the crack propagates and gets wider in two different opening rates, indicated by arrows at the graph of Figure 8 up to the DIC strain profile of image 302 at which cracking propagates till the highest region across the height of the sample. That moment defines the end of fracture Stage III. Further on, mainly crack widening occurs leading to final failure (Stage IV of fracture).

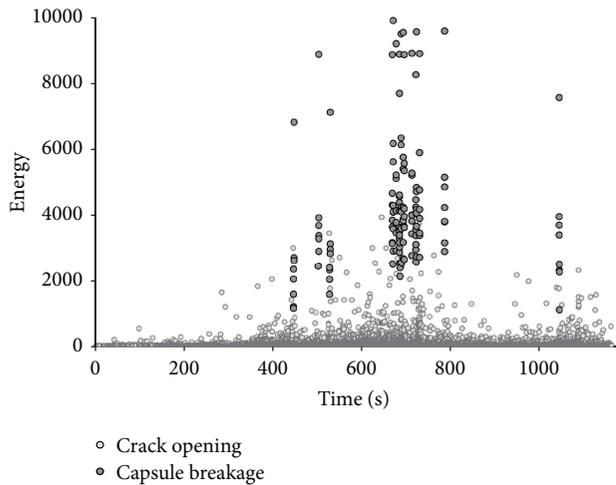
FIGURE 9: Hits energy activity during testing-detection of capsule breakage high energy hits.

In more detail, every time a glass tube breaks, each of the AE sensors captures a waveform, represented by a set of descriptors analyzed in this research. Thereby, the AE hits energy derived from the area under the waveform shape is indicative to the released fracture energy and its magnitude and general characteristics are indicators of the damage mode. High energy hits correspond to discrete events of capsule breakage and are well differentiated from the rest of the AE events. Only in case of capsule breakage, the energy received by all the eight sensors placed at surface of the beam exhibits values ranging from 2000 to 12000 depending on the receiver's sensor distance from the event location (the energy of hits is relatively low in case of sensors placed far from capsules region and higher in case of sensors standing closer to the capsule fracture). Any other AE activity belongs to the second cluster as plotted in Figure 9 and its source is investigated below.

is a combination of complex fracture phenomena. Capsules placed above the notch create stress concentration and increase of the energy required to form cracks. Furthermore, capsule rupture involves the high energy release due to brittle fracture of the tube, potential debonding at different places across the capsule length, and friction or sliding forces between concrete and glass tubes that provide continuous AE activity and constant low energy release. The fracture activity is marked also at the energy-based analysis graph discussed already in Figure 9.

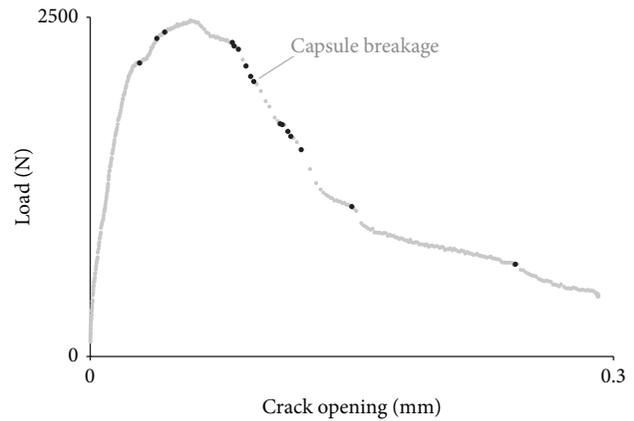
FIGURE 10: Capsules breakage events localization by AE at the load-crack opening graph.

load-crack opening graph and are shown in Figure 10. Primary capsule rupture is coincided with crack initiation. Further, crack formation and propagation lead to a series of capsule breakages well-distributed in the postpeak region of the load graph.

Consistent with the graph in Figure 10, the fact that capsules break after crack initiation is verified. Stress concentration at the notch during Stage I is not sufficient to rupture the glass tubes. On the contrary, primary deformation, visualized at DIC image 86 strain profile of Figure 9, is the trigger mechanism of autonomous crack healing. Furthermore, it is concluded that the extended crack formation stage for the encapsulation series compared to the reference series appears due to breakage of the capsules, as shown in Figure 8. The release of stresses concentrated at the interface between the tubes and the concrete matrix and the undistributed crack propagation due to capsule irregularities leads to the steep decrease in load as capsule rupture occurs.

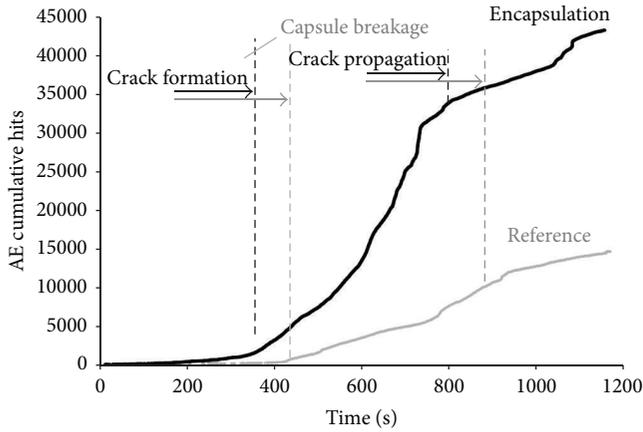
FIGURE 11: AE cumulative hits activity during testing for reference and encapsulation series.

For further information, the sum and the distribution of AE hits during testing for both series is included in this study. An augmentation of the number of hits due to capsule embedment is observed at the cumulative hits graph as presented in Figure 11. In more detail, linear loading response provides limited AE hits activity in both series. Crack formation leads to energy release due to crack deformations and gradually the number of AE hits increases. It is noticed that AE hits activity initiates earlier in the case of encapsulation beams. Local heterogeneity and stress concentration at the region of capsules placed above the notch can justify the prior AE activity. Building up of the fracture zone and crack expansion signifies the sharp rise of hits for both series of testing. In total, the AE activity of the encapsulation series at the end of the crack propagation stage is three times more extended than for the reference series. AE activity of the reference beam is related to crack opening and microcrack formation in the vicinity at both damaged sides of the beam. Well-distributed concrete material components may not arrest the crack propagation as it is shown already at the featureless postpeak region of the load-crack opening curve in Figure 6. On the other hand, crack opening of encapsulation series

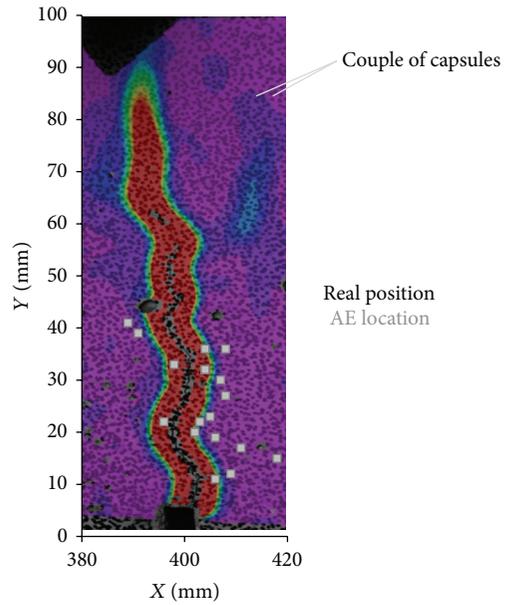
FIGURE 13: AE capsule location across the length of the beam and crack opening DIC fracture profile.

Apart from the crack plane observations, the capsule breakage phenomena are also located across the length of the sample. In Figure 13 the capsule rupture events are projected at the surface of one side of the beam. In parallel, a DIC strain profile is fixed to the same coordinate system and shown as background plot of the analysis. It is concluded that capsules

do not always break at the crack plane. It should be kept in mind that the DIC monitors surface strain profiles and that crack propagates in different paths across the thickness of the sample avoiding aggregates and capsule constraints.

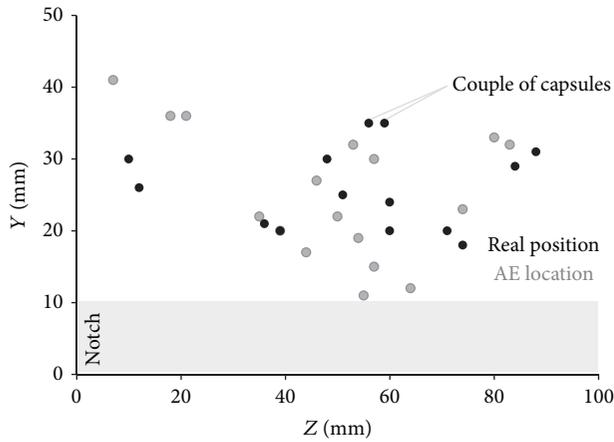
FIGURE 12: Real and AE located capsule breakage position at the crack plane.

5.4. Further AE Postprocessing Analysis-Location of AE Capsule Events. After completion of the two-cycle bending test, the sample is broken in two pieces and the capsule coordinates were determined. Probable shortage of precise AE analysis can be assessed when the real location of capsules measured at the crack plane is compared to the coordinates given by the 3D localization algorithm. In Figure 12 the two-dimensional (Y-Z coordinates in mm) map of capsule breakage events at the crack plane is presented. In different gray-scales the actual and AE calculated location of the

capsules is given. Slight variations—less than 8.00 mm—in the results observed fall within the accuracy limits of AE. In general, accurately located capsule rupture validates the localization approach and AE seems as a promising method to detect embedded healing systems in concrete.

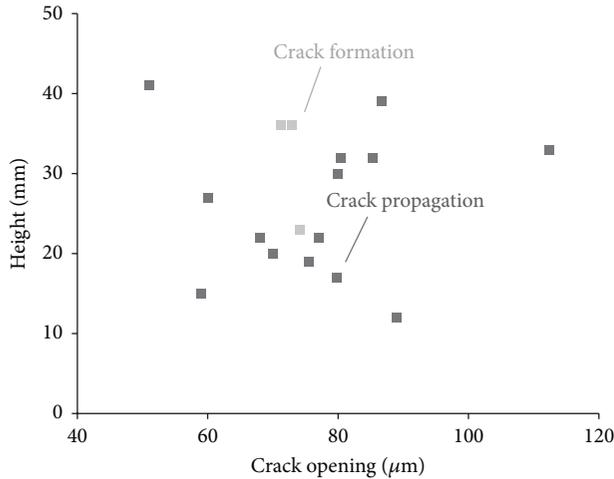
FIGURE 14: Local crack opening during capsules breakage.

5.5. Further AE Postprocessing Analysis: Measuring by DIC and AE the Crack Opening Whereby Capsules Break. Accurate AE events localization and DIC deformation profiles were combined once again to quantify the crack opening which was sufficient to fracture the glass capsules. In practice, knowing the coordinates of capsule failure events and the loading stage at that time, full-field DIC displacement recording provides the displacement at different heights along the crack improving the measured CMOD values of crack opening. The associated results are presented in Figure 14. According to the damage evolution, it was chosen to allocate a different

color to the capsule breakages that appear at the stage of crack formation and those during crack propagation. For all cases, the crack opening ranges from 50 to 90 μm proving that low crack opening may sufficiently trigger capsule breakage. The location of the tube at upper positions across the height of the crack plane appears not to delay the rupture nor to require higher values of crack opening. In parallel, it is observed that similar loading and stress conditions lead to capsule fracture throughout the entire bending test. Widening of the crack during loading does not further damage the tubes and after tube breakage the release of the agent should successively fill the crack plane.

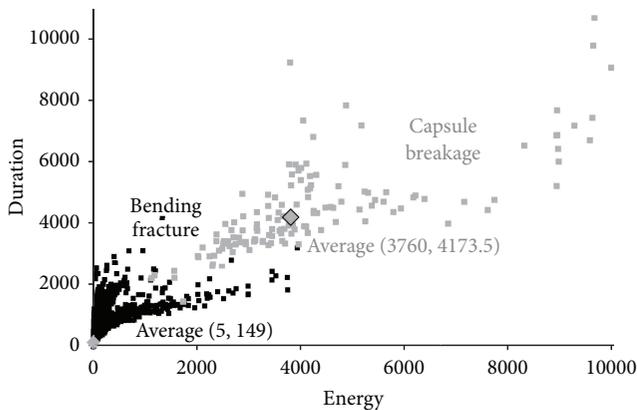
FIGURE 15: Clustering based on energy and duration features.

To start with, the signal duration was investigated since this is together with the energy values are the most representative waveform strength indicator. The plot of hits energy and duration captured during testing provides a clear evidence of clustering between material fracture and capsule breakage as shown in Figure 15.

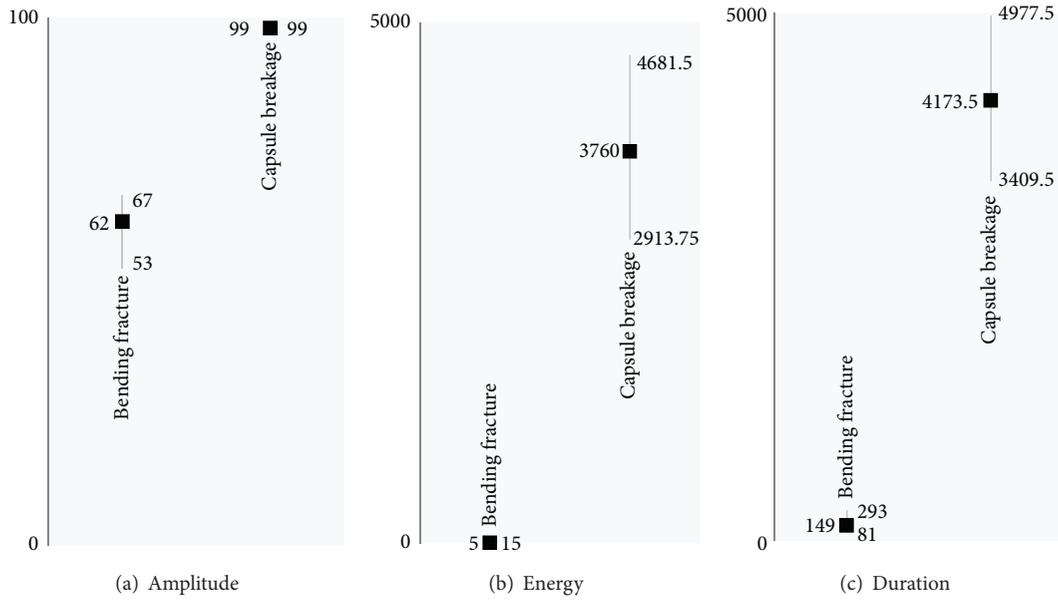
FIGURE 16: Clustering of AE features-part 1.

In parallel, a concise summary of other AE features is presented in Figure 16. Energy and duration classification is reviewed providing the mean, the first, and the third quartile of their values. Box plots of median and spread values are also prepared for the amplitude population of hits. Even in this case, the amplitude of capsule breakage significant differentiation is evident.

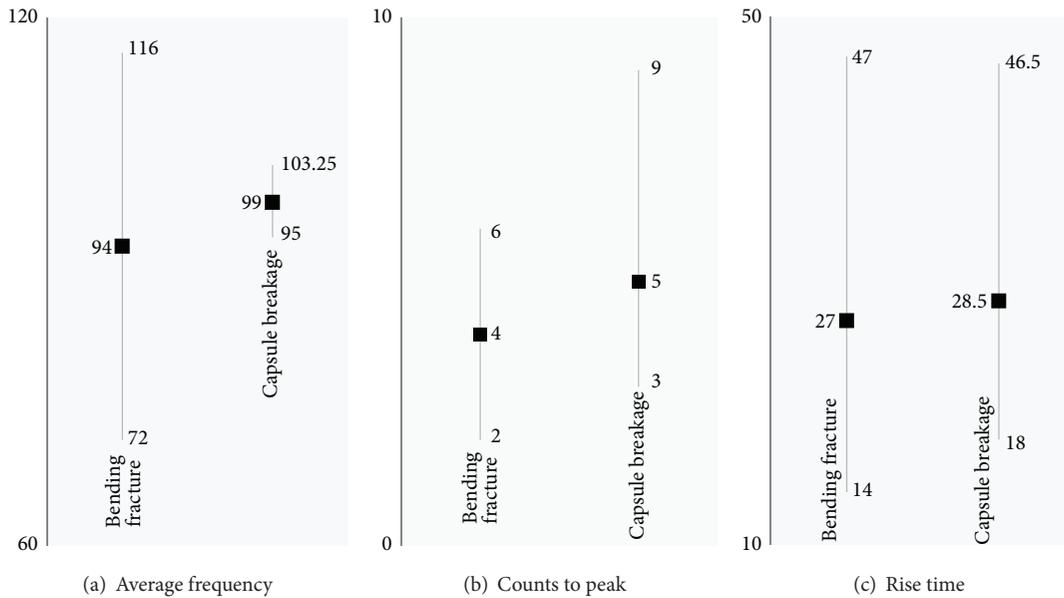
FIGURE 17: Clustering of AE features-part 2.

In contrast, the classification of hits based on average frequency, counts to peak, and rise time is not as straightforward as above. The hits of capsule breakage are masked by the opening mode of damage as shown in Figure 17. It is worth noticing that the average frequency values of the second cluster (capsule breakage) are well concentrated around the mean value. On the other hand, the different fracture phenomena falling in the first cluster show a wide spread frequency range.
