# **Retracted: Electrochemical Studies of WC-Flyash HVOF Coating Interface on SA209-T1 Steel under 3.5 NaCl Solution**

### **Advances in Materials Science and Engineering**

# Electrochemical Studies of WC-Flyash HVOF Coating Interface on SA209-T1 Steel under 3.5 NaCl Solution

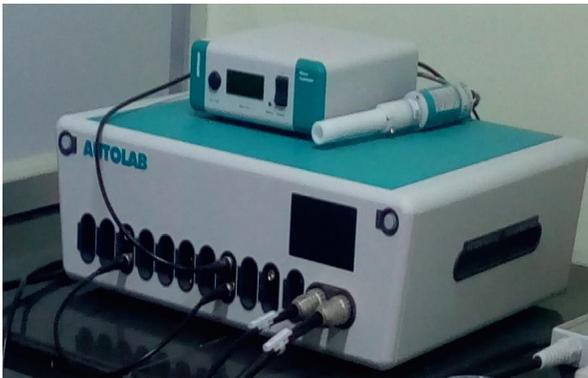
FIGURE 1: Electrochemical workstation to identify the utilization of potentiodynamic polarizing bends and electrochemical impedance spectroscopy.

**2.4. Electrochemical Studies.** Figure 1 shows the Autolab electrochemical workstation; the consumption opposition is examined by the utilization of potentio-dynamic polarizing bends and electrochemical impedance spectroscopy at  $28^\circ\text{C}$  of ambient temperature. The examinations have been conducted through utilizing Autolab instruments, CECRI, Karaikudi, Tamil Nadu, India, with polarization forecast programming. Saturated calomel anode and platinum were used as cathode. On a superficial level zone, the examination has been performed for  $2\text{ cm}^2$  for every single time. At a time frame  $\text{mV}-1.500\text{ mV}$ , the curves of polarisation were estimated at a pace of scan of  $\text{mV/s}$ . A specimen of WC-flyash covered at OCP for sixty minutes was held with electrochemical impedances [3].

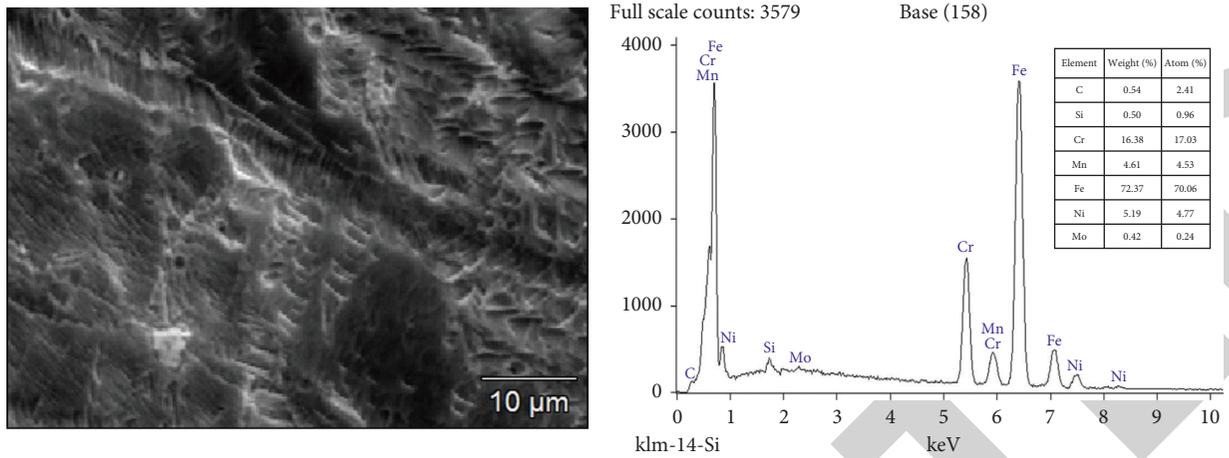
FIGURE 2: EDS and SEM investigation of the good material at dendritic multiperiod of 100 microns.

3.1. *EDS-Based Morphological Study.* The surface morphology of the coated and uncoated prepared after cyclic hot erosion was shown by the SEM images and is shown in Figure 2.  $\text{Fe}_2\text{O}_3$  could be the dominating stage which demonstrates the uncoated steel by EDAX investigation. EDAX examination of size of WC-flyash covered example showed little amounts of  $\text{Cr}_2\text{O}_3$  and  $\text{Fe}_2\text{O}_3$  presence alongside largest level of NiO (96%). The coated specimen size has high level of NiO and  $\text{Cr}_2\text{O}_3$  alongside other minor stages MnO,  $\text{Fe}_2\text{O}_3$ ,  $\text{SiO}_2$ , and so on. The EDAX of the WC flyash coated steel scale showed CoO,  $\text{Fe}_2\text{O}_3$  with an exceptionally small amount of  $\text{WO}_3$ . The size of coated steel

stellite-6 shows the predominance of CoO alongside  $\text{Cr}_2\text{O}_3$  and  $\text{Fe}_2\text{O}_3$ .

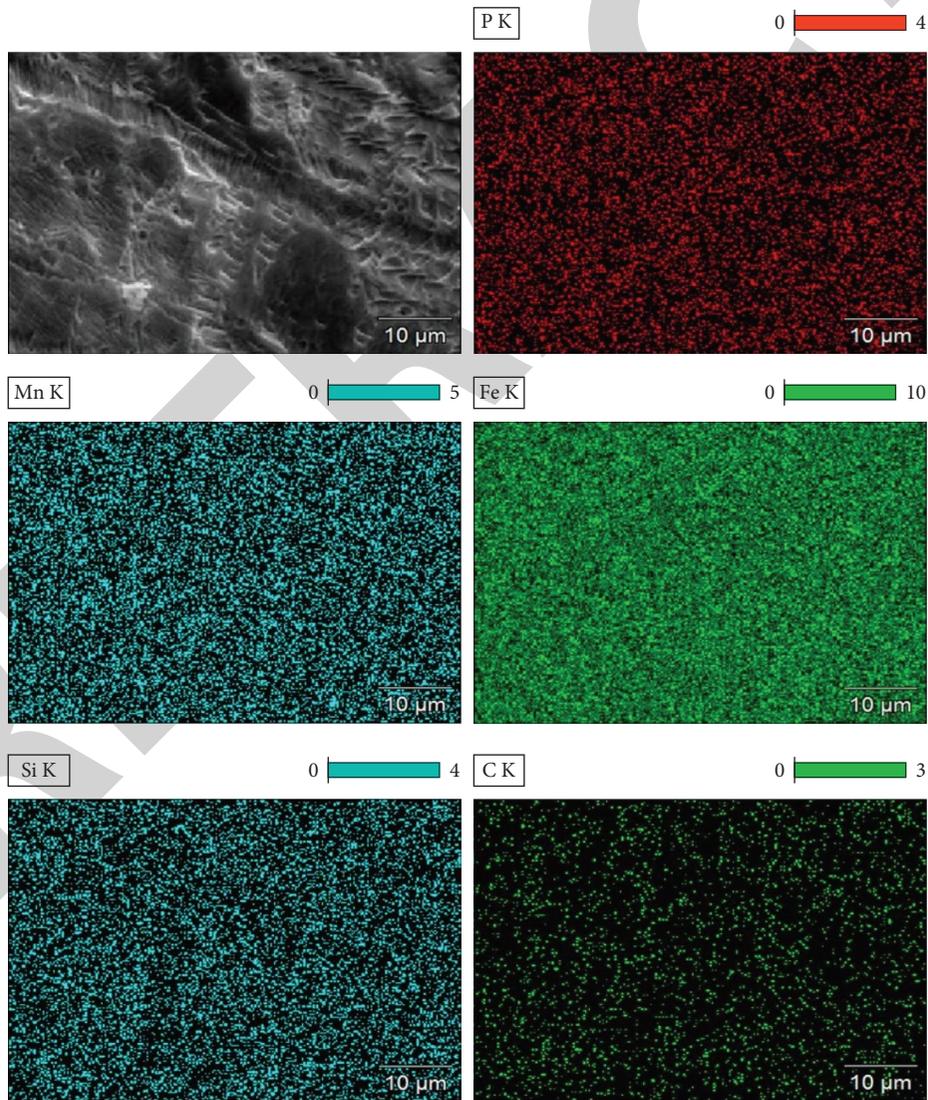
FIGURE 3: Arrangement picture BSEI and X-ray mapping of the cross segmentation of WC-flyash-covered GrA1 steel exposed to electrochemical consumption under 3.5%NaCl solution.

Figure 3 shows the WC-flyash-coated steel EPMA planing analysis; it shows that the substrate diffuses Fe in to coatings whereas Si and Mn concentrated at the substrate and coating interface. Throughout the scale, Cr and Ni are present. Also, the coating shows the Ni-rich pockets. The nickel (Ni) rich region depletes the chromium (Cr) region. The uncoated steel EPMA mapping of scale shows Co-rich layer in the scale top and contains chromium. The presence of the tungsten-rich streaks was also seen in the scale. Si is precipitated out to the substrate boundary [12–15]. Whereas EPMA mapping for uncovered steel. Figure 4 shows that top layer to be Cr rich and below that presence of Ni in higher concentration. Notification of iron migration from the substrate to the top layer of the scale. The oxide scale mainly consisted of  $\text{Fe}_2\text{O}_3$  has been indicated by WC-flyash-coated steel EPMA map. Fe has been diffused from substrate into the coating for all [16, 17].

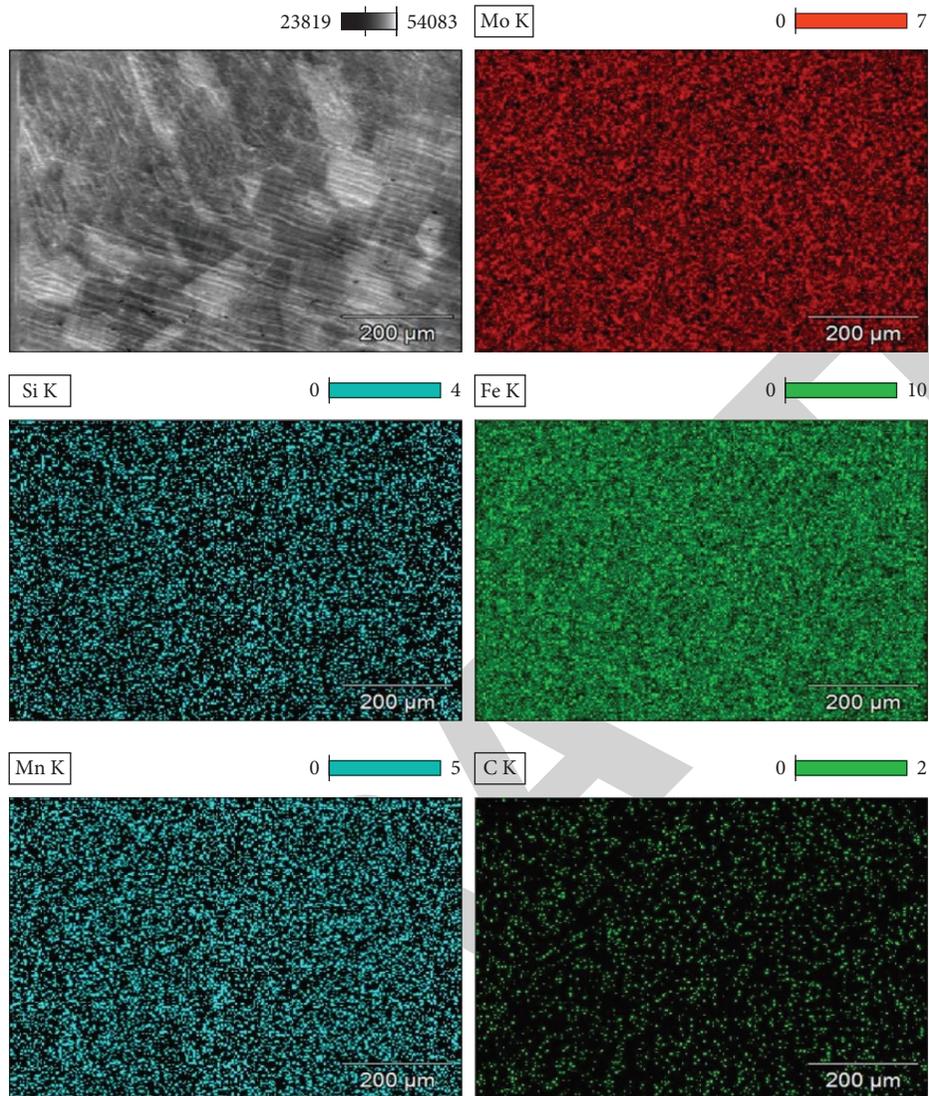
FIGURE 4: Arrangement picture BSEI and X-ray mapping of the cross portion of uncoated GrA1 steel exposed to electrochemical consumption under 3.5%NaCl solution.

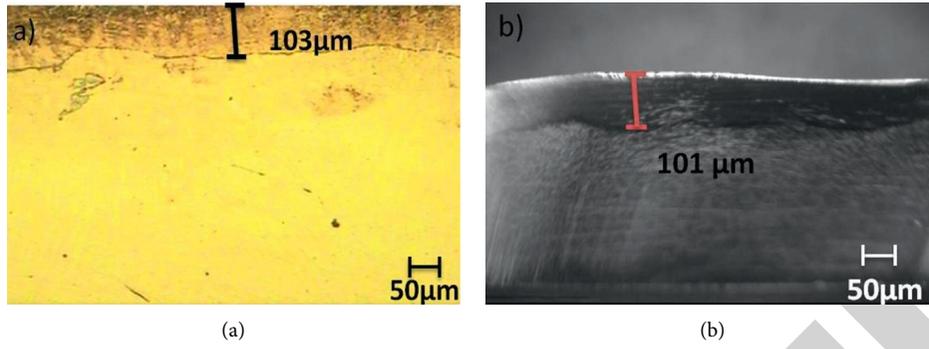
FIGURE 5: Micrographs of the coatings obtained by HVOF (a) and (b).

3.2. *Optical Microscopic Studies.* By analyzing the proof of micrographs of the coating obtained by HVOF, the coatings deposited on GrA1 steel substrates shown in Figure 5 also show uniform thickness,  $103 \pm 6 \mu\text{m}$ , as well as good adhesion to the substrate.

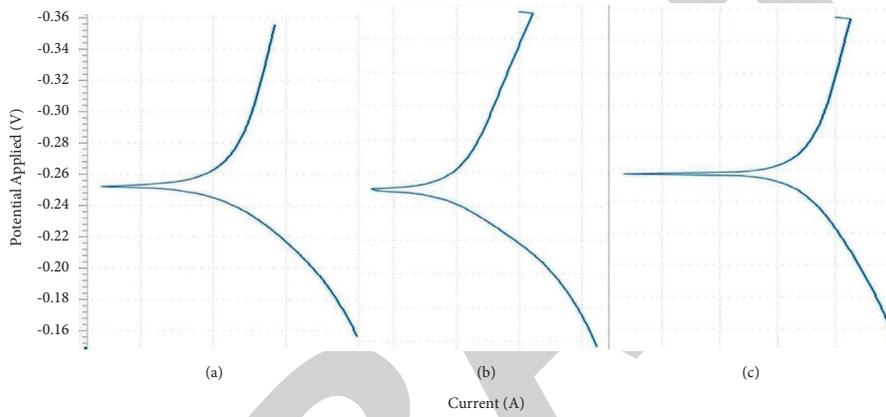
FIGURE 6: Polarization curves obtained on GrA1 steel specimen at uncoated GrA1, interface, and WC-flyash-coated GrA1 steel.

3.3. *Potential Dynamic Polarization Studies.* The unique polarization is performed for uncoated steel at 28 °C room temperature as per ASTM G59-97(2020) standards. The checking of polarization at the rates between  $0.01 \text{mVs}^{-1}$  to  $50 \text{mVs}^{-1}$  and plotting of chart are shown in Figure 6. The outcome is derived from three separate sources: the uncoated base material, the WC-flyash-coated base material, and the interface. The run of the mill anodic terminal polarization conduct of SA209-T1 in NaCl arrangement comprises of dynamic disintegration, lack of involvement, and abrupt addition in the thickness of the current due to the pitting on the base material. Due to this abrupt augmentation of thickness of the current, the pitting is steady. The covered and uncoated examples are likewise tried at greatest output rate, neglected to show a stable pitting. Due to this reason, the  $\text{Cr}_2\text{O}_3$  is present in the coated specimens [18–20]. The uncoated locales are the most noteworthy consumption district as opposed to the interface area of the WC-flyash covered SA209-T1 steel concentrate through polarization bends. The degree of pitting at the uncoated is too poor contrasted with the WC-flyash covered SA209-T1 steel.

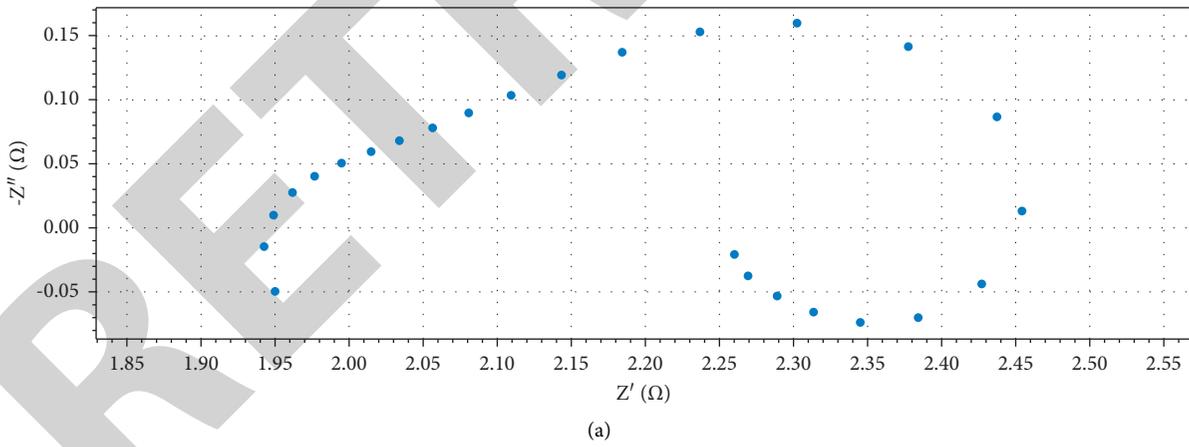
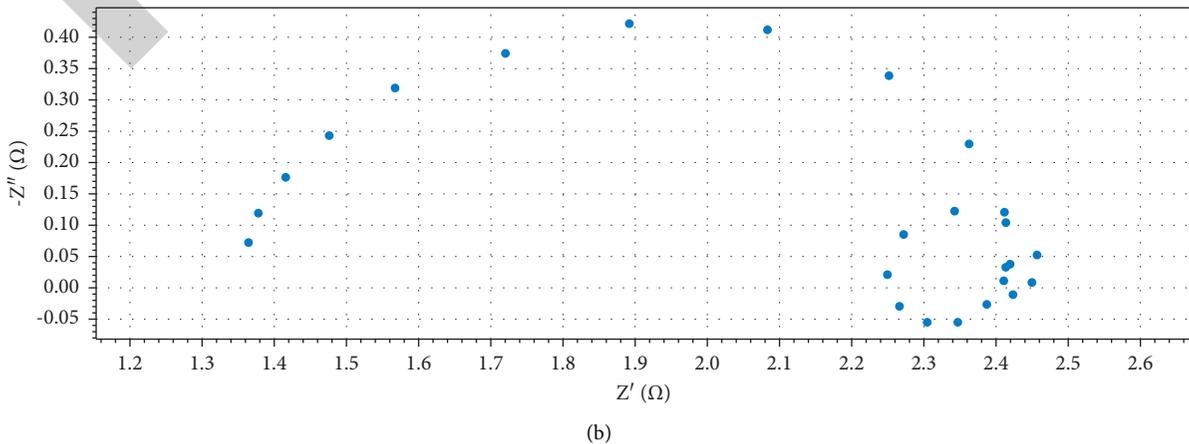
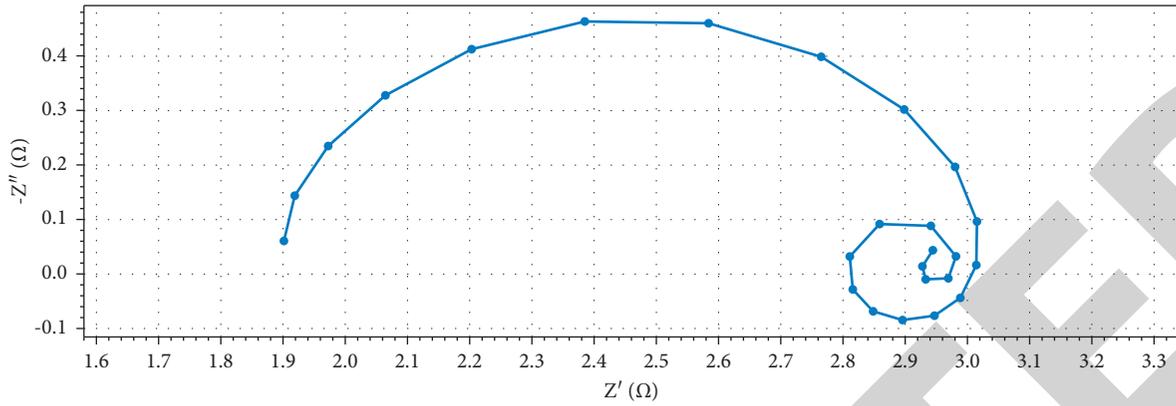
FIGURE 7: Electrochemical impedance spectra (Nyquist plot) of WC-flyash-coated GrA1 steel.

EIS was utilized to research the erosion insurance for the steel. Figure 7 shows the Nyquist plots and Bode plots recorded for the WC-flyash-covered GrA1 steel. As shown in Figure 7, the measurement of the crescent in the Nyquist circle of the example with in various environments is bigger than that of the covered GrA1 steel, demonstrating that the tempering interaction has upgraded the consumption obstruction. The biggest crescent breadth was noticed, for example, WC-flyash covered GrA1 steel, which affirms its best consumption hindrance execution among all specimens [25–27].

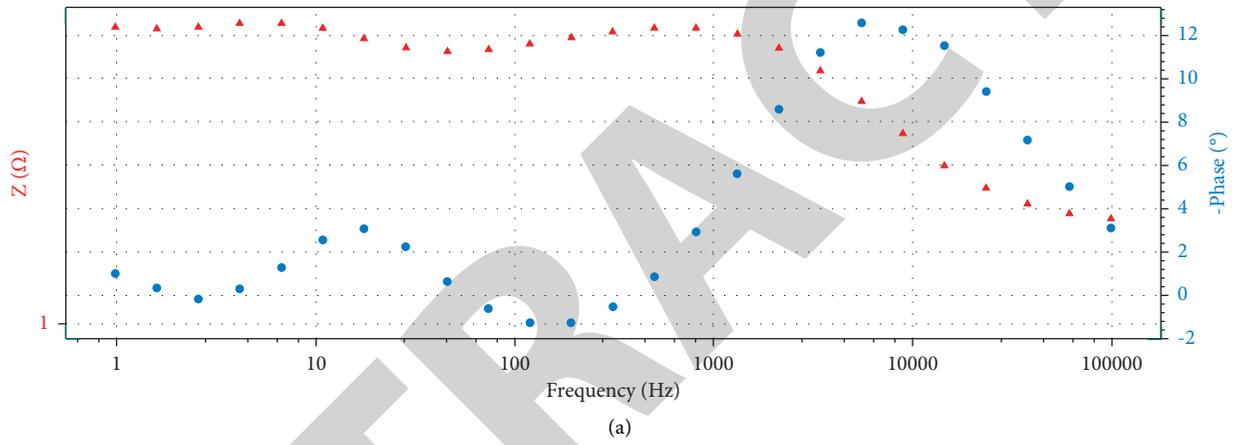
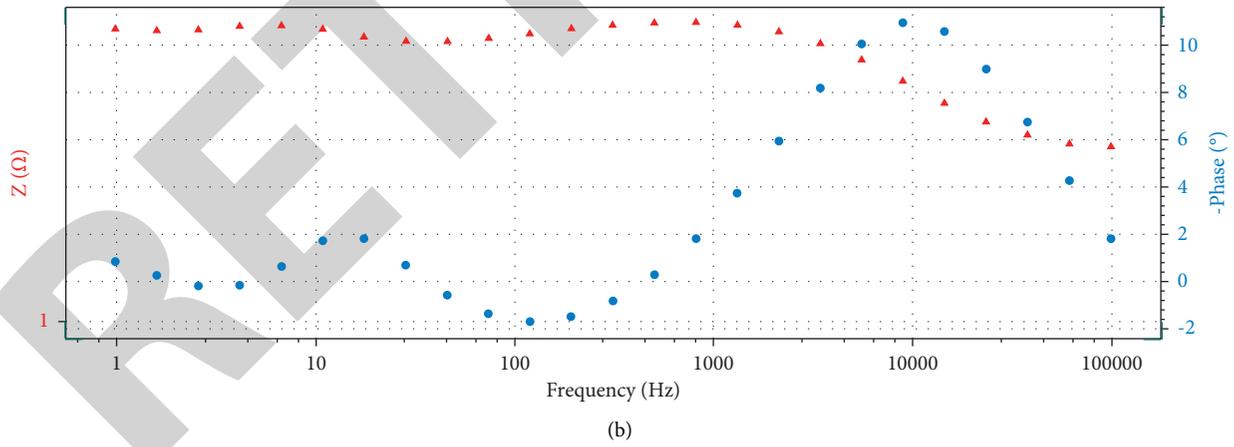
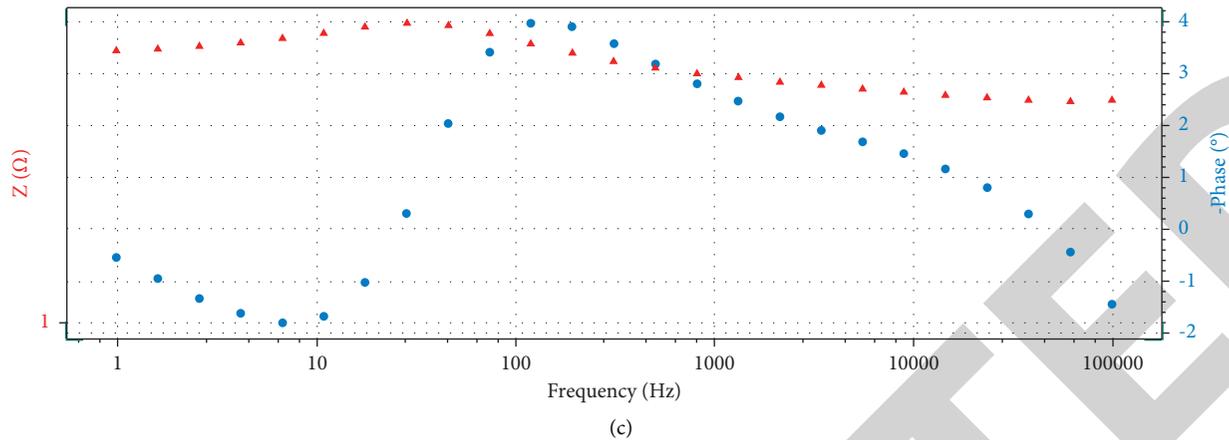
FIGURE 8: Phase angle plots of uncoated GrA1, interface, and WC-flyash-coated GrA1 steel.

Figure 8 shows the phase angle plots of uncoated GrA1, interface, and WC-flyash-coated GrA1 steel. Another time steady was seen in the low recurrence area, and the first one was moved to a higher recurrence locale.
