# Fretting and Corrosion in Modular Shoulder Arthroplasty: A Retrieval Analysis

Tribocorrosion in taper junctions of retrieved anatomic shoulder arthroplasty implants was evaluated. A comparison of the tribocorrosion between cobalt-chromium and titanium alloy stems was conducted and the observations were correlated with the individual's clinical data. Adverse effects caused by metal debris and subsequent elevated serum metal ion levels are frequently reported in total hip arthroplasty. In total shoulder arthroplasty, to date only a small number of retrieval analyses are available and even fewer address the issue of tribocorrosion at the taper junctions. A total of 36 retrieved hemiarthroplasties and total shoulder arthroplasties were assessed using the modified Goldberg score. The prevalence of fretting and corrosion was confirmed in this cohort. Titanium stems seem to be more susceptible to damage caused by tribocorrosion than cobalt-chromium stems. Furthermore, stemless designs offered less tribocorrosion at the taper junction than stemmed designs. A weak correlation between time to revision and increased levels of tribocorrosion was seen. Whether or not tribocorrosion can lead

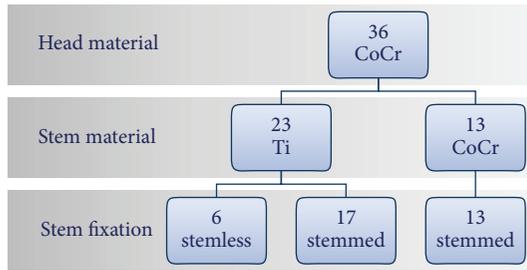
FIGURE 1: Distribution of material and fixation among the retrieved components.

Of the 36 retrieved implants, 30 (83%) had a stemmed and 6 (17%) a stemless fixation. All stemless implants were made of Ti alloy. In designs with a stem, the stem material was Ti in 17 (57%) cases and CoCr in 13 (43%) cases. To compare

the effect of the stem fixation, only Ti tapers were included (Figure 1). The stemmed designs showed significantly higher tribocorrosion ( $p = 0.002$ ) for the stem tapers (Figure 6). Time to revision of stemless ( $2.3 \pm 1.4$  years) and stemmed ( $3.4 \pm 3.6$  years) designs was comparable. For the head tapers, stemless designs showed a tendency for less tribocorrosion ( $p = 0.052$ ), although the differences were not statistically significant.

The subgroup of stemless implants was small (Figure 1). As such, further research is necessary to support the observation of less tribocorrosion in stemless implants. Furthermore a comparison between male and female tapers has not been performed due to the limited number of female tapers. Also, prostheses from eight different companies were included in this study. Thus, the high number of different designs and the partially low numbers for the respective prostheses make it impossible to assess the effect of design factors on tribocorrosion.

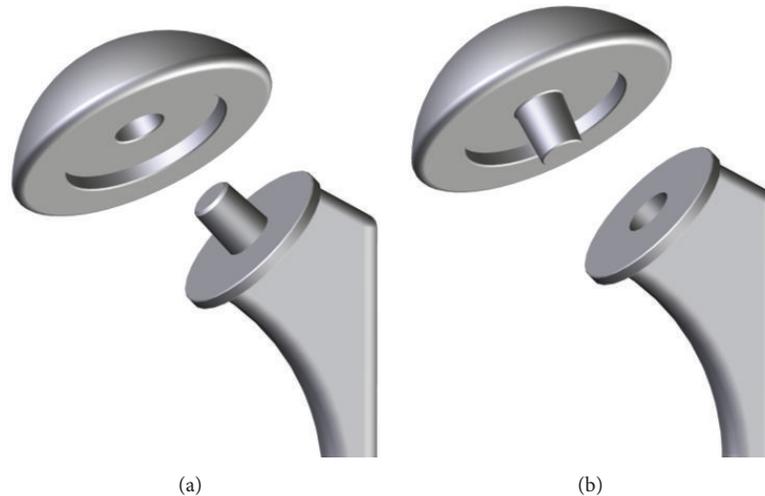
FIGURE 2: Analyzed types of shoulder implants: two different stems types were analyzed: retrieved stems had either a male (a) or a female (b) taper.

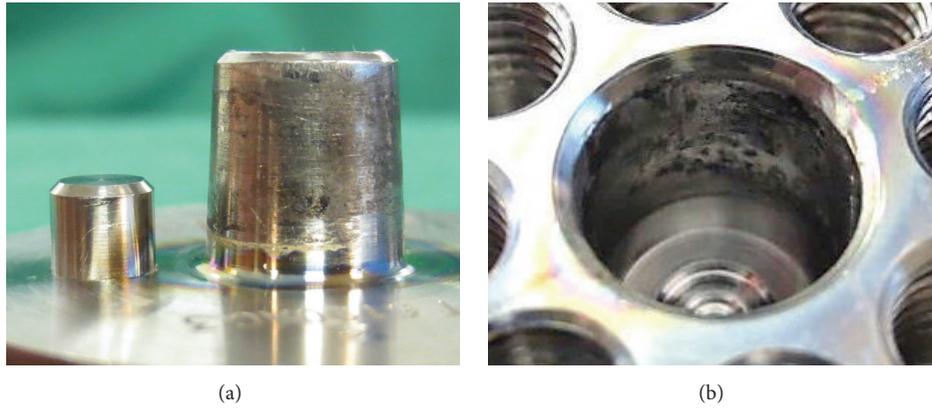
FIGURE 3: Severe tribocorrosion on male (a) and female (b) taper of a retrieved prosthesis. The time to revision was 9.2 years.

**3.2. Assessment of Tribocorrosion.** Tribocorrosion (score  $\geq 2$ ) was present on 27 of the 36 heads (75%) and 29 of the 36 stems (81%). Seven of the 36 implants (19%) showed at least moderate tribocorrosion (score  $\geq 3$  for both tapers), three of which (8%) showed severe tribocorrosion (score = 4 for both tapers). One of the severely affected cases is shown in Figure 3 and one of the minimally affected implants is seen in Figure 4.

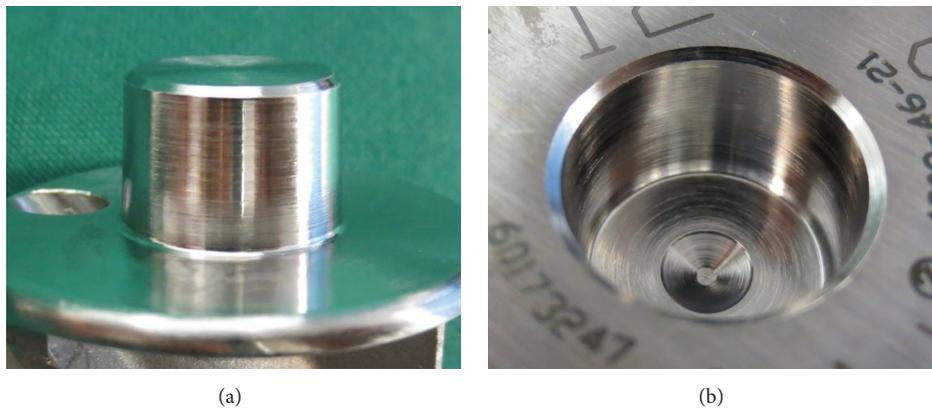
FIGURE 4: Minimal tribocorrosion on male (a) and female (b) taper of a retrieved prosthesis. This prosthesis was implanted for 8.8 years.

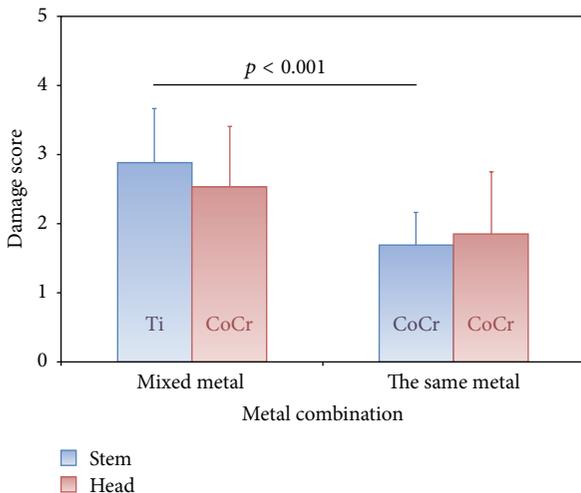
FIGURE 5: Comparison of the damage scores for the head and stem taper depending on stem material. Heads are all made of CoCr.

Significantly greater tribocorrosion ( $p < 0.001$ ) was seen in mixed metal combinations where Ti stems were used ( $2.88 \pm 0.78$ ) compared to the same metals using CoCr stems ( $1.69 \pm 0.48$ ). For the CoCr heads there was a tendency of increased tribocorrosion when combined with Ti stems ( $2.53 \pm 0.87$ ) compared to the combination with CoCr stems ( $1.85 \pm 0.90$ ), although this difference was not statistically significant ( $p = 0.072$ ; Figure 5).

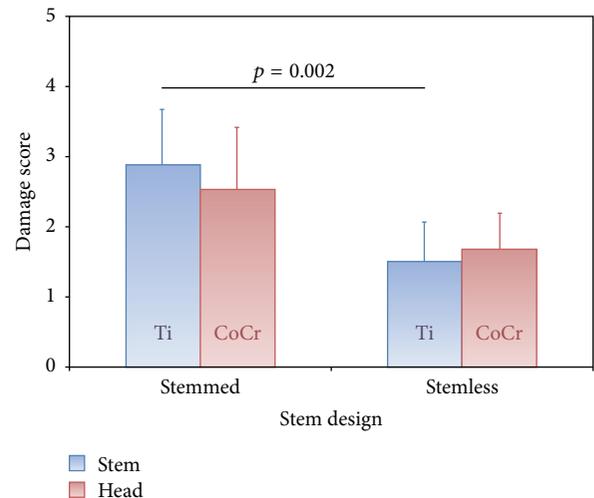
FIGURE 6: Comparison of the damage scores for the head and stem taper depending on stem design. Only titanium stems are included.
