Case Report

Use of Digital-Conventional Method for Managing a Patient with Severely Worn Dentition: A Clinical Report

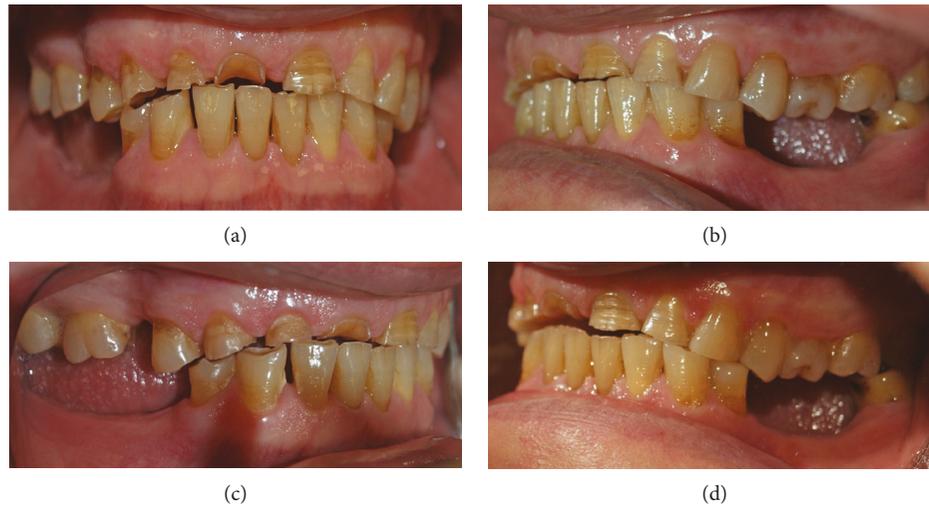
FIGURE 1: Preoperative images: (a) frontal view; (b, c) lateral views; and (d) opposing tooth facets in eccentric movement.

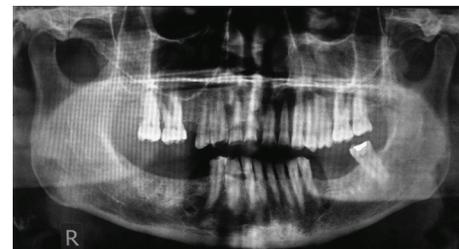
FIGURE 2: Preoperative radiograph.

control. After patient interview, it was found that she was taking oral bisphosphonates over the past year. The left second molar had been restored with a class I amalgam restoration. In extraoral examination, the patient's face was symmetrical, the facial proportions were equal, and the lips were competent. There were no signs or symptoms of temporomandibular joint disorder. In intraoral examination, severe wear was found in maxillary anterior teeth, and other teeth had mild occlusal wear (Figures 1(a)–1(c)). In eccentric movements, the opposing tooth facets were matched confirming the presence of attrition (Figure 1(d)). In radiographic examination, a remaining root related to the left mandibular second molar was found. The root had been surrounded completely by the intact bone with no clinical or radiographic signs/symptoms. After consulting with an oral and maxillofacial surgeon and since the patient was taking bisphosphonates, it was decided to avoid any aggressive intervention and the root remained untouched. No other remarkable findings were observed (Figure 2).

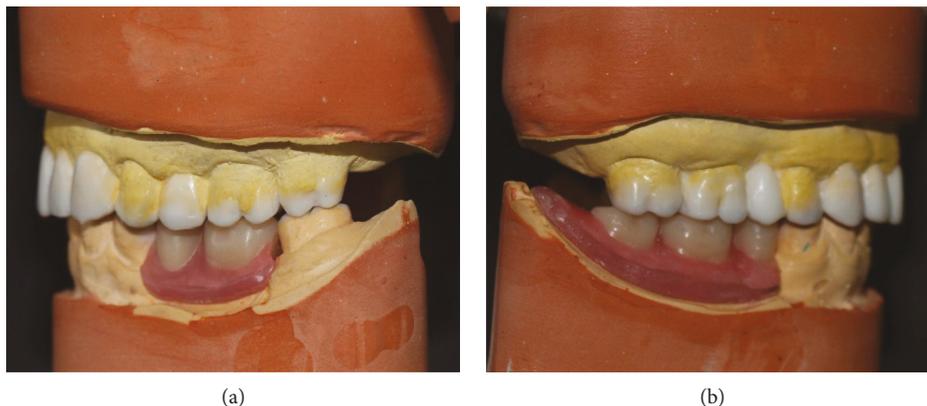
FIGURE 3: (a, b) Diagnostic wax up in lateral views.

Alginate impressions (Tropicalgin, Zhermack, Badia Polesine, Rovigo, Italy) were made from both arches to obtain the diagnostic casts. The base record with a wax rim was fabricated for the mandibular cast. The vertical dimension of occlusion (VDO) was established using the described methods. The required amount of VDO increase was approximately 2 mm. An interocclusal record was made with zinc oxide eugenol paste (Luralite, Kerr Corp., Orange, CA, USA) on wax rims using an anterior deprogramming device in the considered VDO. A face bow record was used to mount the maxillary cast in relation with the transverse condylar axis. In the next step, the mandibular cast was mounted against the opposing arch on a semiadjustable articulator (Denar Mark II, Whip Mix Corporation, Louisville KY, USA) by centric relation bite record. The check bite records were obtained to set the condylar elements. First, the mandibular anterior wax-up was performed. After the intraoral verification of the mandibular canine wax-up with the corner of the mouth and relationship of the lip to the teeth, a Broadrick occlusal plane analyzer was used to determine the occlusal plane. Then, the wax-up procedure and mandibular posterior tooth setup were accomplished and the mandibular interim removable partial denture was fabricated (Figure 3). Duplicate casts were obtained from the diagnostic wax-up, and mockup shells were fabricated (Drufolen H; Dreve Dentamid GmbH, Unna, Germany). Shells were used to fabricate directly bonded build-ups for lower anterior and all of the upper teeth, and the mandibular interim removable partial denture was delivered. The occlusal centric stops and the anterior guidance were adjusted. Also, the smile line and phonetics were verified. For three months, the patient's condition was assessed in terms of the temporomandibular joint and muscle comfort, phonetics, chewing ability, and esthetics. Next, the available treatment options were discussed with the patient. Since the patient used oral bisphosphonates for more than 3 months in the past year and according to the consultation with her attending physician, implant treatment and surgical procedures were excluded. According to the diagnostic procedure, full-coverage restorations were chosen for the upper jaw. A RPD was chosen for the lower jaw to restore the posterior segment. Porcelain veneer laminates and full coverage restorations were

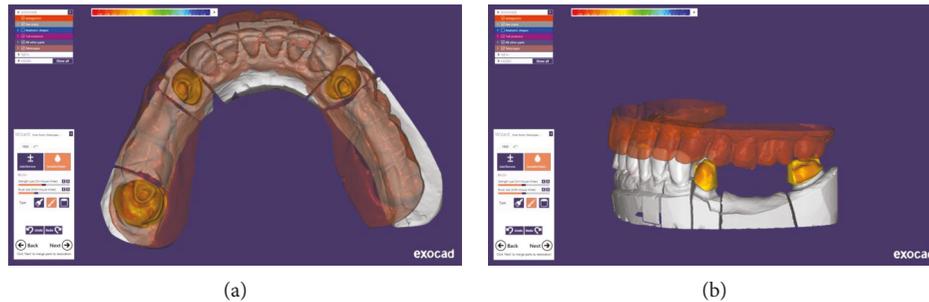
FIGURE 4: Mandibular restoration digital design: (a) occlusal view and (b) lateral view.

2.1. Rehabilitation of Mandibular Arch. Tooth preparation was performed using a putty index made from the diagnostic wax-up. Anterior lower teeth were prepared for the porcelain laminates with light chamfer finishing line, and the other teeth were prepared for metal ceramic restorations with a deep chamfer margin to serve as RPD abutments. A complete arch putty-wash impression was made with polyvinylsiloxane (Panasil, Kettenbach, Hesse, Germany) after retracting the gingiva using the retraction cords. The temporary restorations were made and cemented using temporary cement (Temp Bond, Kerr Corp., Orange, CA, USA). The impression was poured, and the base record and wax rim were fabricated on the definitive cast. In the next appointment, an impression was made from the mandibular temporary restorations to be used as an index for the fabrication of final restorations. After removal of temporary restorations, interocclusal record was made using an anterior deprogramming device and zinc oxide eugenol paste on wax rims in centric relation. A2 shade heat-pressed lithium disilicate glass-ceramic (IPS e.max press, Ivoclar Vivadent, Liechtenstein) was chosen for the fabrication of the laminates. In laboratory procedures, the definitive cast and the cast from temporary restorations were scanned by a 3Shape laboratory scanner (D700; 3Shape A/S; Copenhagen, Denmark). It was decided to use CAD/CAM-generated wax patterns. Therefore, digital designing software (Exocad DentalCAD, Exocad, Darmstadt, Germany) was used to prepare the wax patterns according to the cast from finalized temporary restorations. For RPD abutments, it was tried to survey the guide planes digitally as well (Figure 4). Wax patterns were milled using a milling machine (Arum milling machine, Dowoom, Daejeon, Korea). Wax patterns of RPD abutments were surveyed and refined conventionally when necessary. The metal frameworks of RPD

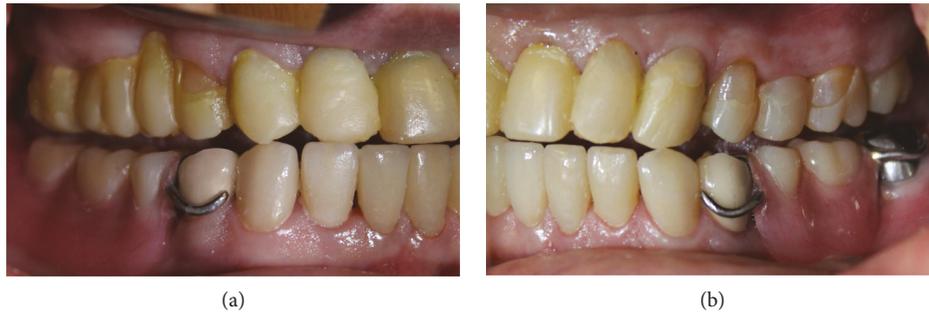
FIGURE 5: Establishment of mutually protected occlusion after mandibular restoration delivery: (a) right side and (b) left side.

abutments were tried in after resurveying. Finally, porcelain veneering was done and final restorations were cemented. A mutually protected occlusion was established for the patient. In the next step, the procedures for RPD fabrication were started. The primary cast was obtained from the preliminary impression. Definitive impression was made with polyvinylsiloxane (Monopren, Kettenbach, Hesse, Germany) using a custom tray. In RPD framework try-in appointment, the altered cast technique was applied by making an impression from the free-end region with an acrylic tray attached to the framework. Finally, after tooth arrangement try-in, the definitive RPD was processed and delivered to the patient. A mutually protected occlusion was established (Figure 5).

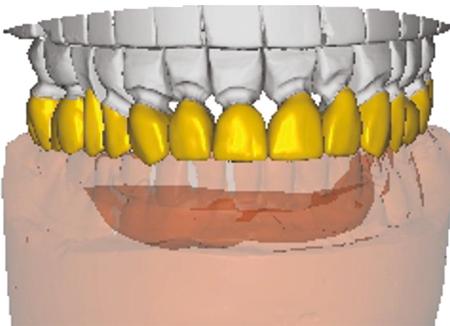
FIGURE 6: Full contour design of maxillary restorations.

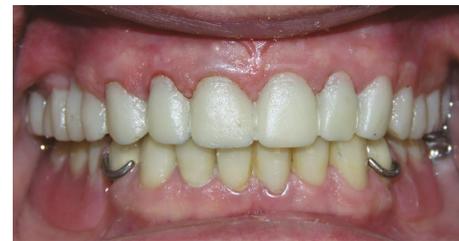
FIGURE 7: Maxillary temporary restorations.

opposing arch and cemented with Panavia F2 (Kuraray Noritake Dental Inc.). Tooth preparation was done with a round shoulder margin and checked with the index from diagnostic wax-up. Temporary restorations were made using wax-up and cemented with zinc oxide temporary cement (Temp Bond, Kerr Corp., Orange, CA, USA). Then, mutually protected occlusion was established. In the next appointment, the temporary restorations were finalized by checking the occlusal contacts, phonetics, and esthetics, and an impression was made from the temporary restorations (Figure 6). The final impressions were made with a 2-step impression technique (putty and light body impression materials) (Panasil, Kettenbach, Hesse, Germany) after gingival retraction. Definitive cast was poured, and an interocclusal record was obtained to mount the cast on a semiaadjustable articulator. A laboratory scanning procedure was accomplished, and A2 shade zirconia frameworks (IPS e.max ZirCAD, Ivoclar Vivadent, Liechtenstein) were designed according to the temporary restorations verified in the clinic (Figure 7). Try-in of the frameworks was performed, and

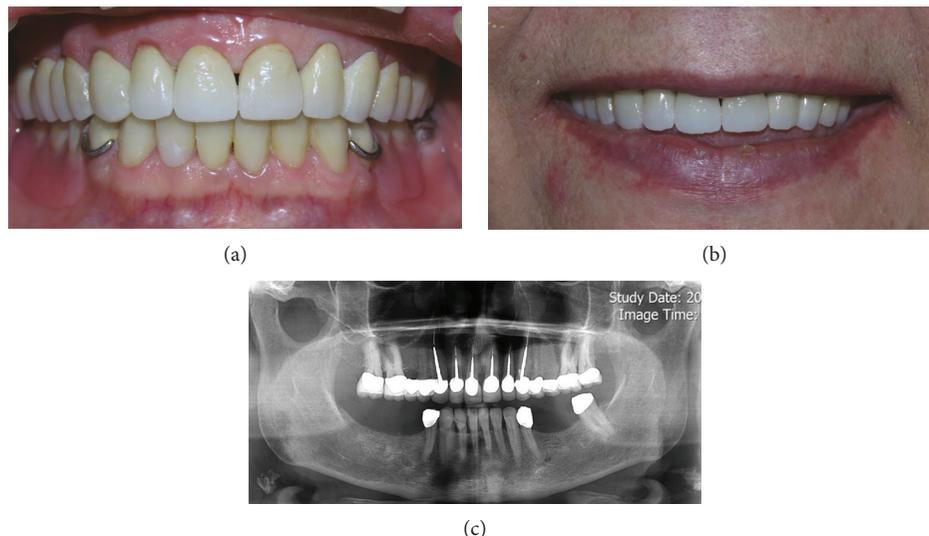
FIGURE 8: Postoperative images: (a) intraoral view, (b) smile view, and (c) postoperative panoramic view.

then porcelain veneering was done using customized anterior guide table. After porcelain try-in appointment and establishing mutually protected occlusion, the restorations were stained and glazed. The final restorations were cemented with glass ionomer cements (GC Fuji II, GC America, Illinois, USA) (Figure 8). Oral hygiene instructions were given to the patient, and follow-up appointments were scheduled. No problem was reported by the patient during 18 months of follow-up.
