## Case Report

# Macroabrasion and/or Partial Veneers: Techniques for the Removal of Localized White Spots

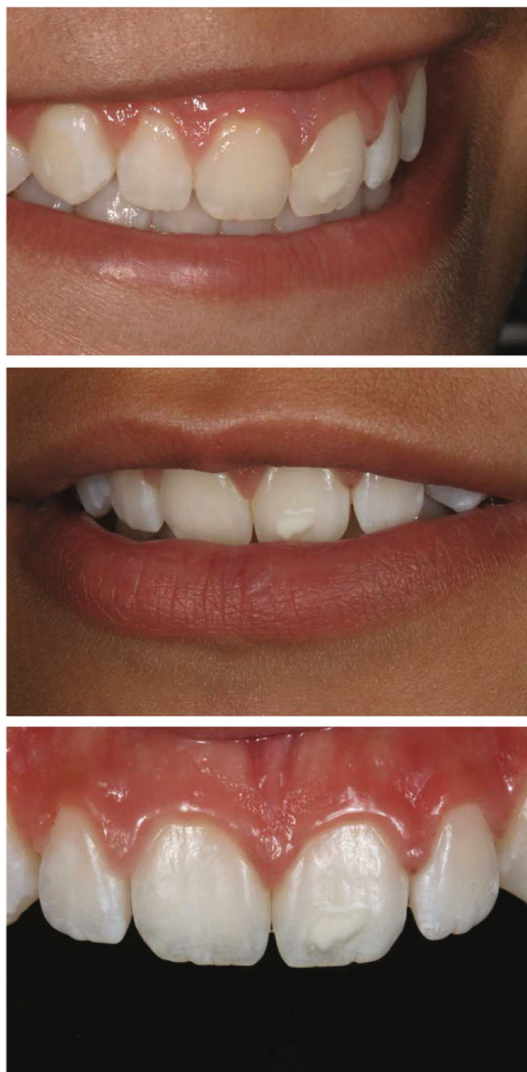
FIGURE 1: Initial smile and upper anterior teeth. Note the hypoplasia spots on the incisal third of the upper central incisors in the form of streaks and hypoplasia opaque white spot on the upper left central incisor.

A 16-year-old female patient sought dental care with small hypoplastic spots on the upper incisors in the form of stretch marks on the incisal third of the upper central incisors and a wider white spot on the upper left central incisor, which generated the patient's discontent in her smile (Figure 1). After anamnesis and clinical examination, the enamel macroabrasion and partial veneer technique with direct composite resin were proposed as a treatment.

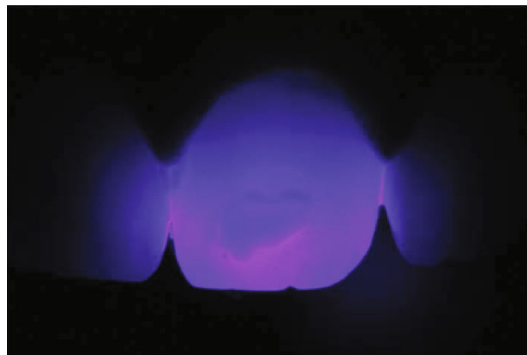
FIGURE 2: Transillumination to evaluate the spots. An LED unit positioned close to the palatal face of the tooth can help the clinician to examine the enamel stains.

An LED photopolymerization unit was placed on the palatal or lingual surface of the incisors to help examine the enamel stains (Figure 2) (Radii Xpert, SDI, Victoria, Australia), and the depth of the lesion can be estimated, since a darker color with more defined edges indicates a deeper stain.

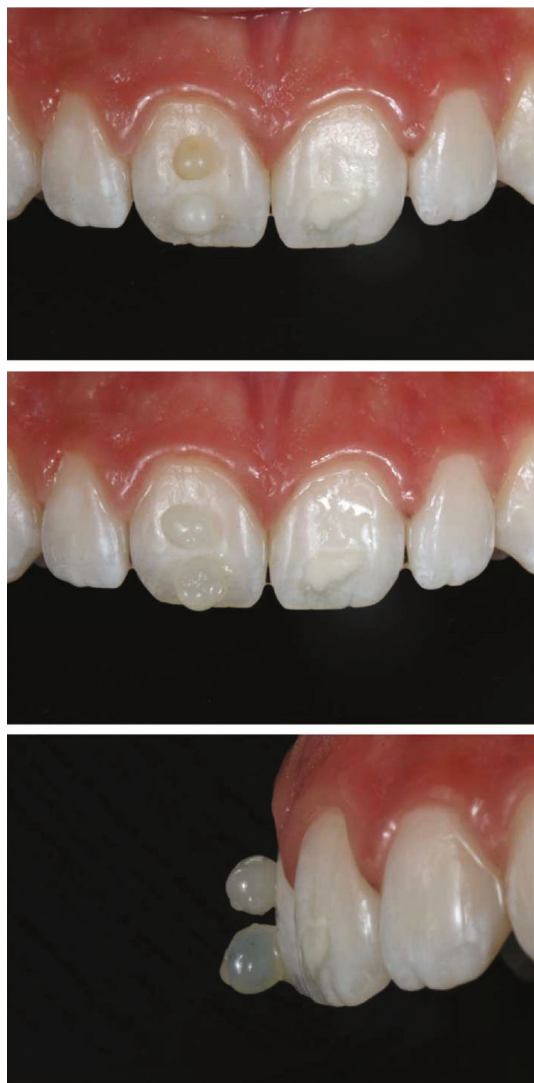
FIGURE 3: Macroabrasion was performed with high rotation and fine diamond tip for finishing to remove stains in the form of streaks, superficial enamel defects. Positioning of dentin (a) and enamel (b) resin increments on the tooth for color selection.

Prophylaxis was performed, and then, macroabrasion was performed with a fine diamond tip (JOTA do Brasil, São Paulo, São Paulo, Brasil) in high rotation with refrigeration in the incisal third of the central incisors to decrease the small hypoplastic spots in the form of stretch marks. With the teeth still hydrated, the Essentia GC (GC Corporation, Tokyo, Japan) resin color was selected (Figure 3). The dentin colors LD (light dentin) and MD (medium dentin) were positioned to check the color, the LD being selected. Next, the enamel colors were positioned LE (light enamel) and DE (dark enamel), with LE being selected.

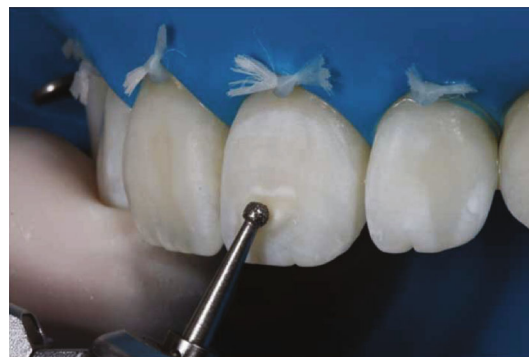
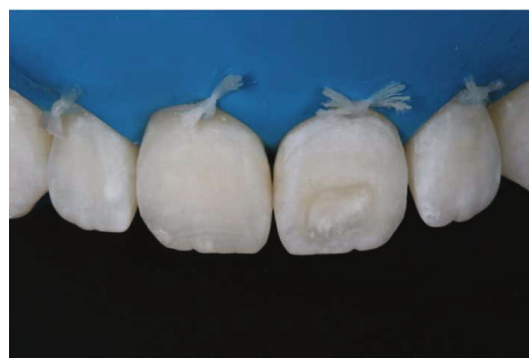
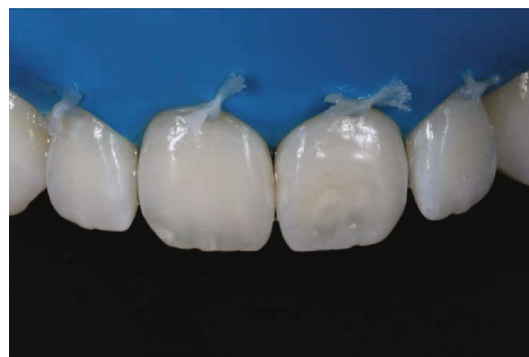
FIGURE 4: Absolute isolation was done with a rubber dam. The defect was removed with a spherical diamond tip. Lateral view of the central incisor after removal of the hypoplastic stain.

The absolute isolation of the operative field was performed using rubber and kept in position with dental floss. The white spot located dictates the shape of the contour by the extent of the defect and must include all discolored areas. High rotation with a spherical diamond tip (Figure 4) with air/water cooling was used to prepare the tooth to a depth that the stain could no longer be observed, being hydrated as can be seen in Figures 4(b) and 4(c). During preparation, high rotation irrigation is recommended to keep the tooth in a hydrated state to facilitate assessment of stain removal because teeth that have white stain defects are particularly susceptible to dehydration [1]. Dehydration exaggerates the appearance of white spots and makes it difficult to assess the removal of defects. When the stain is no longer seen, it means that the restorative material will be effective in masking the stain without having to prepare the tooth further.

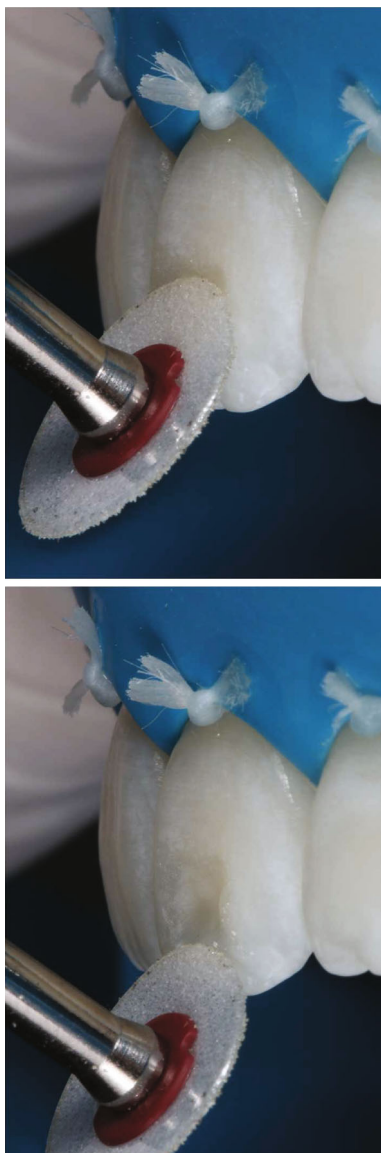
FIGURE 5: The finish of the bevel was made with coarse-grained sanding discs (OptiDisc, Kerr), thus eliminating fragile marginal prisms.

After preparation, the cavo-superficial angle was finished with a coarse-grained sanding disc (OptiDisc, Kerr Corporation, Orange, California, USA) at low speed (Figure 5). The buccal surface of the incisor enamel was conditioned with 37% phosphoric acid to avoid the application of resin over an unconditioned area; then, the surface was dried, and the G-Premium Bond (GC) adhesive was applied. Polymerization was carried out according to the manufacturer's instructions (Radii Xpert, SDI, Victoria, Australia) (Figure 6).

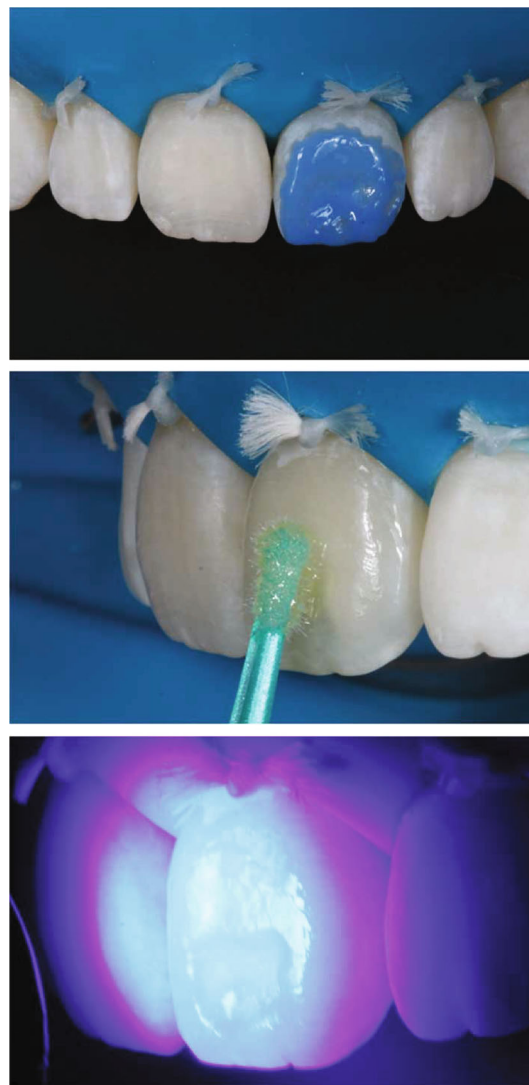
FIGURE 6: Application of the adhesive system.

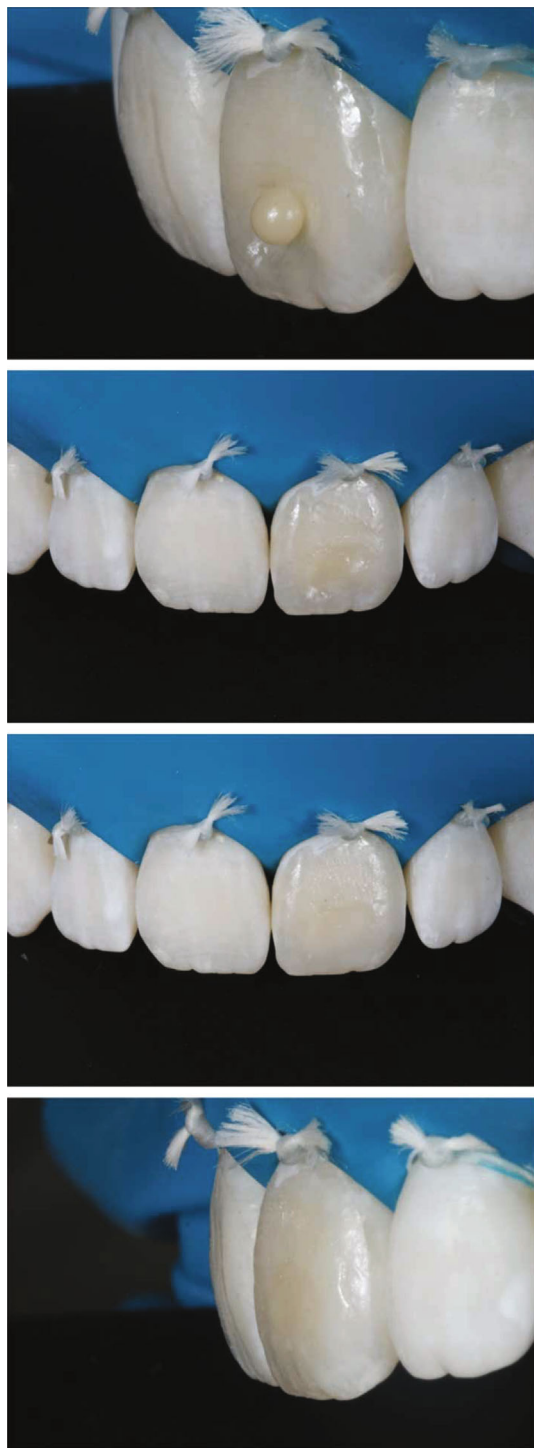
FIGURE 7: The first increment of the composite resin was applied in the color LD Essentia-GC. Then, the resin color LE Essentia-GC was applied, corresponding to the enamel region.

The stratification of the composite resin was initiated by the resin layer in the dentin LD color (Essentia, GC), and a single layer of LE resin (Essentia GC) was applied over the vestibular surface to provide a more harmonic contour (Figure 7). The increments were polymerized for the time recommended by the manufacturer with an LED-based device (Radii Xpert - SDI).

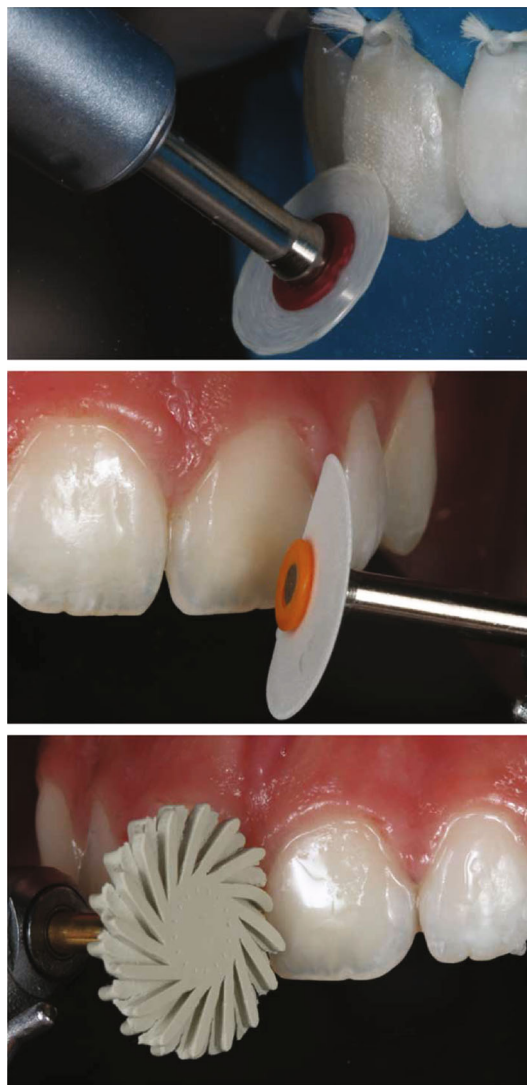
FIGURE 8: Resin finishing and polishing with discs (OptiDisc, Kerr) and resin rubbers (Jota do Brasil).

In the next clinical session, finishing and final polishing were performed (Figure 8). The contour of the restorations was delimited with abrasive discs with sequential granulometry (OptiDisc) and resin rubbers (JOTA do Brasil, São Paulo, São Paulo, Brasil).

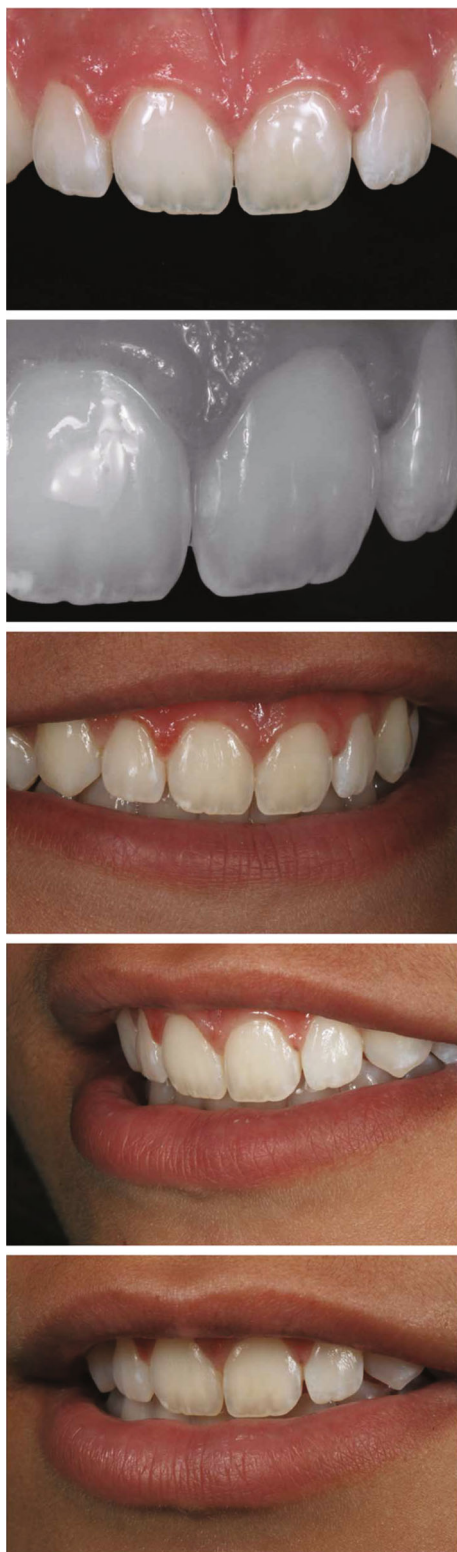
FIGURE 9: Final aspect of the upper anterior teeth. Note the color harmony provided by the association of enamel macroabrasion and partial veneer in composite resin.

The final aspect can be seen in Figure 9.
