Case Series

Complications after Dynamic Hip Screw Osteosynthesis of Proximal Femoral Fractures at Army Instructional Hospital-Libreville

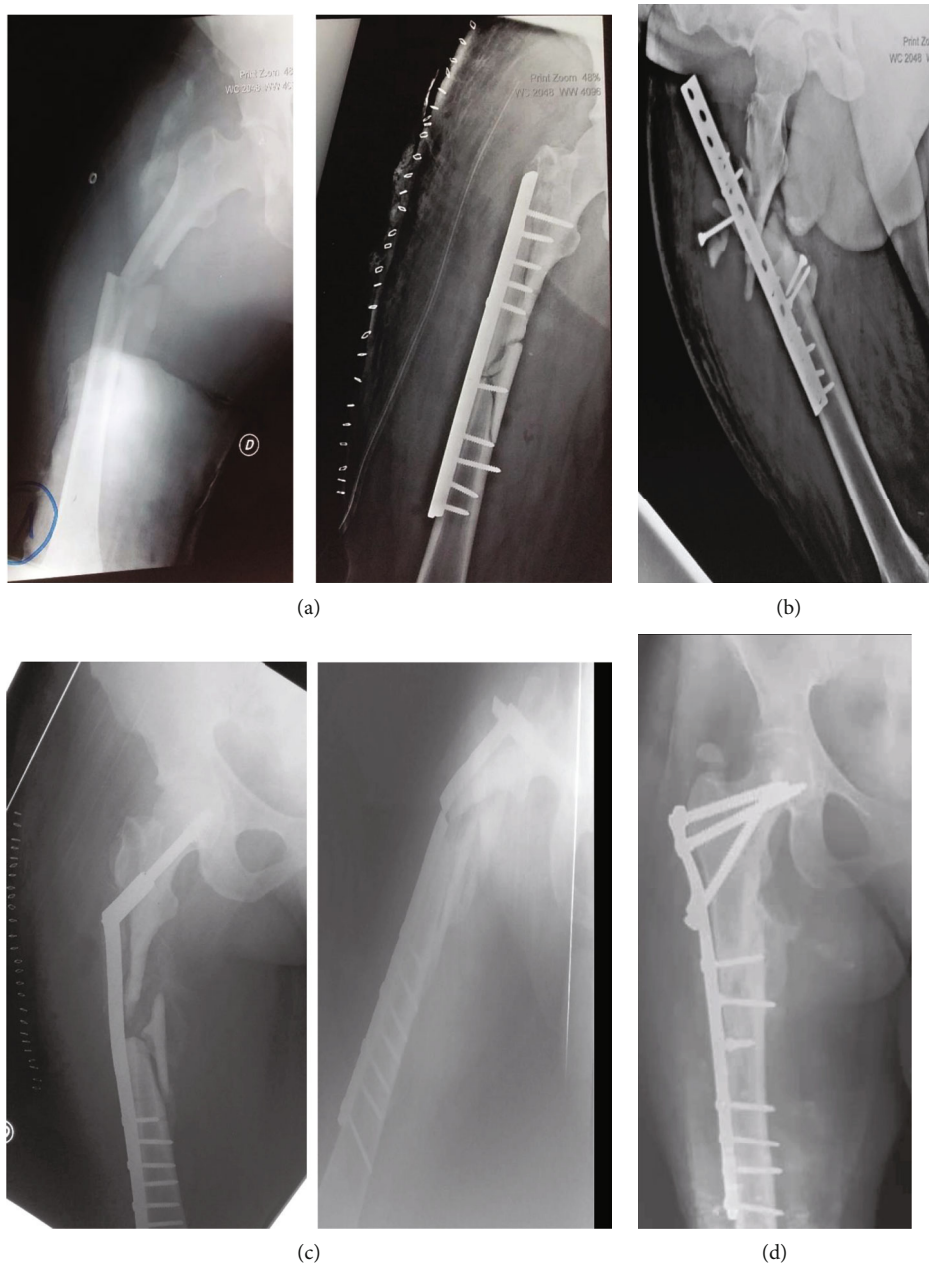
2.1. Case 1. 42-year-old patient, motorcycle driver, was a victim of a blunt trauma to the right thigh after a road traffic accident on his motorcycle. The diagnosis of subtrochanteric fracture classified 32C3 according to AO/OTA (Figure 1(a)) is made and a dynamic compressive plate osteosynthesis

performed in a clinic. The patient is referred to us 2 weeks postoperatively for posttraumatic plate removal (Figure 1(b)). The plate was deposited, and an osteosynthesis by the DHS system was performed. The evolution after six (6) postoperative months is marked by atrophic pseudarthrosis and a rupture of the plate in the 8th month (Figure 1(c)). The management consisted of a cure of nonunion, a spongy graft, and the internal fixation by a locking plate for proximal femur (Figure 1(d)). At the last follow-up (9 months), the functional [5] and radiological results (presence of callus) were very good.

FIGURE 1: X-ray of case 1: ((a) subtrochanteric fracture; (b) missed fixation of DCP; (c) atrophic nonunion with fracture of the DHS system; (d) locked plate osteosynthesis).

There are few articles about the metal breakage after the DHS osteosynthesis. For Hrubina et al. [8], there is metal breakage of K-wire, cortical screws, and sliding screw. We have seen a metal breakage of plate (case 1) and sliding screw (case 4).

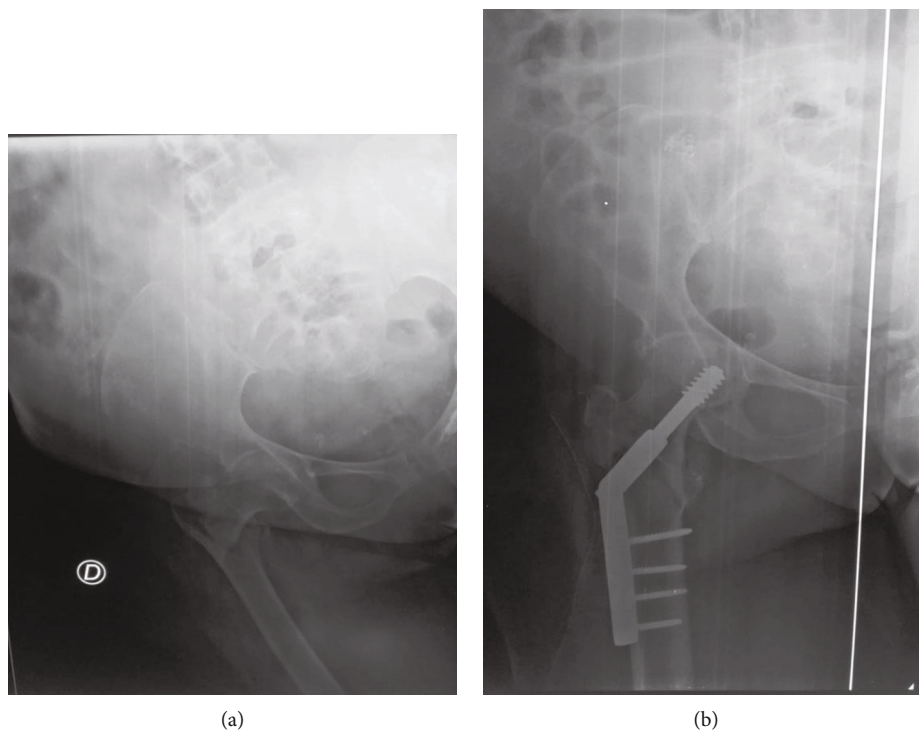
2.4. Case 4. A 65-year-old male farmer sustained injuries when a motorbike hit him onto his right hip. At presentation, he was hemodynamically stable, and radiographs confirmed a minimally displaced pertrochanteric fracture of the right hip class 31A1.3 according to AO/OTA (Figure 4). The fracture was stabilized using DHS system after 72h. The patient had an uneventful peri-operative period and was allowed partial weight bearing. At his six

week outpatients' clinic appointment, radiographs showed callus and sliding screw fracture. He was therefore permitted full weight bearing after the removed of DHS system. One year after surgery, radiographs showed vicious callus with very good functional result [5]. He has returned to full-time work and is able to participate in low-impact recreational sporting activity.

FIGURE 4: X-rays of patient 4. (a) Pertrochanteric fracture type 31A1.3 AO/OTA. (b) Osteosynthesis by DHS.
