Case Report

Medial Pelvic Migration of the Lag Screw after Intramedullary Nailing for Trochanteric Femoral Fracture

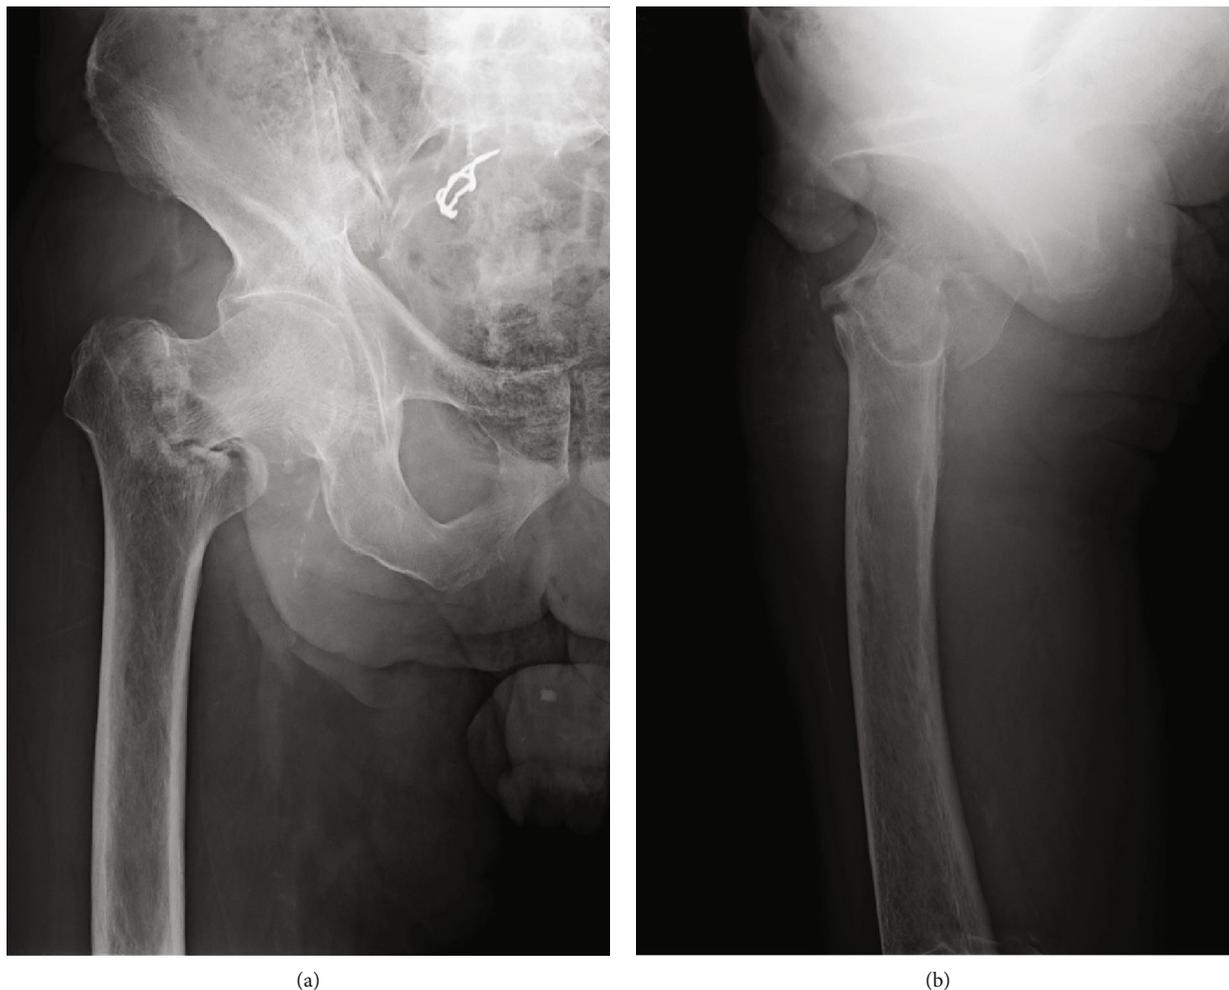
FIGURE 1: Anteroposterior (a) and lateral (b) radiographs taken on initial presentation showing a trochanteric fracture with a greater trochanteric fragment in the right femur, which are classified as AO type 31A2.2 and Jensen type 3.

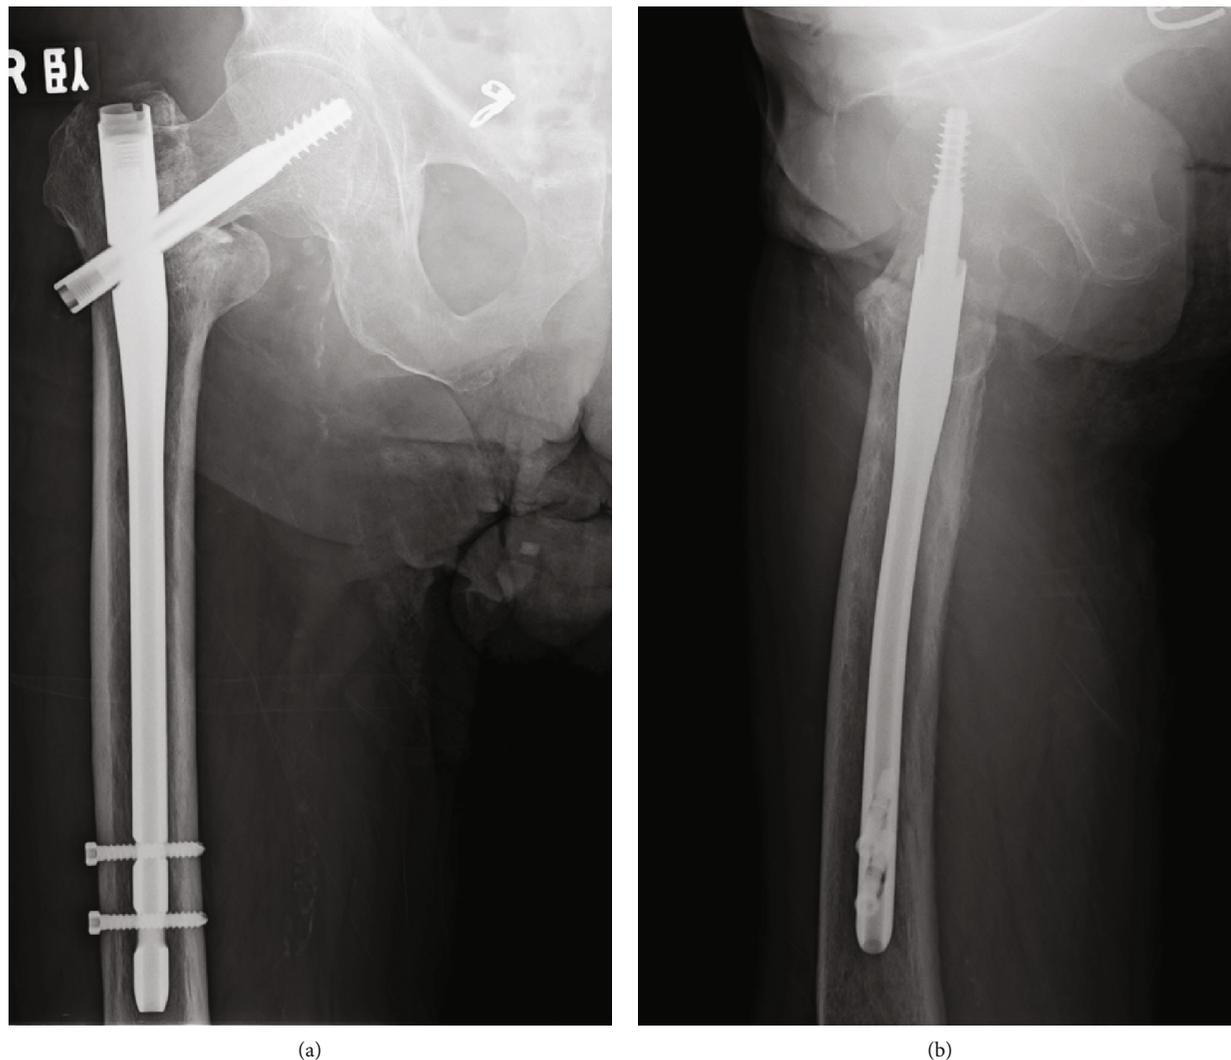
FIGURE 2: Radiographs after the osteosynthesis of the right trochanteric fracture. Anteroposterior (a) and lateral (b) views of the right femur showing insufficient reduction and poor placement of the lag screw after implantation of a gamma 3 long nail.

In our case, we considered that the toggling caused by a combination of the greater trochanteric fragment and stove-pipe canal, insufficient reduction, poor placement of the lag

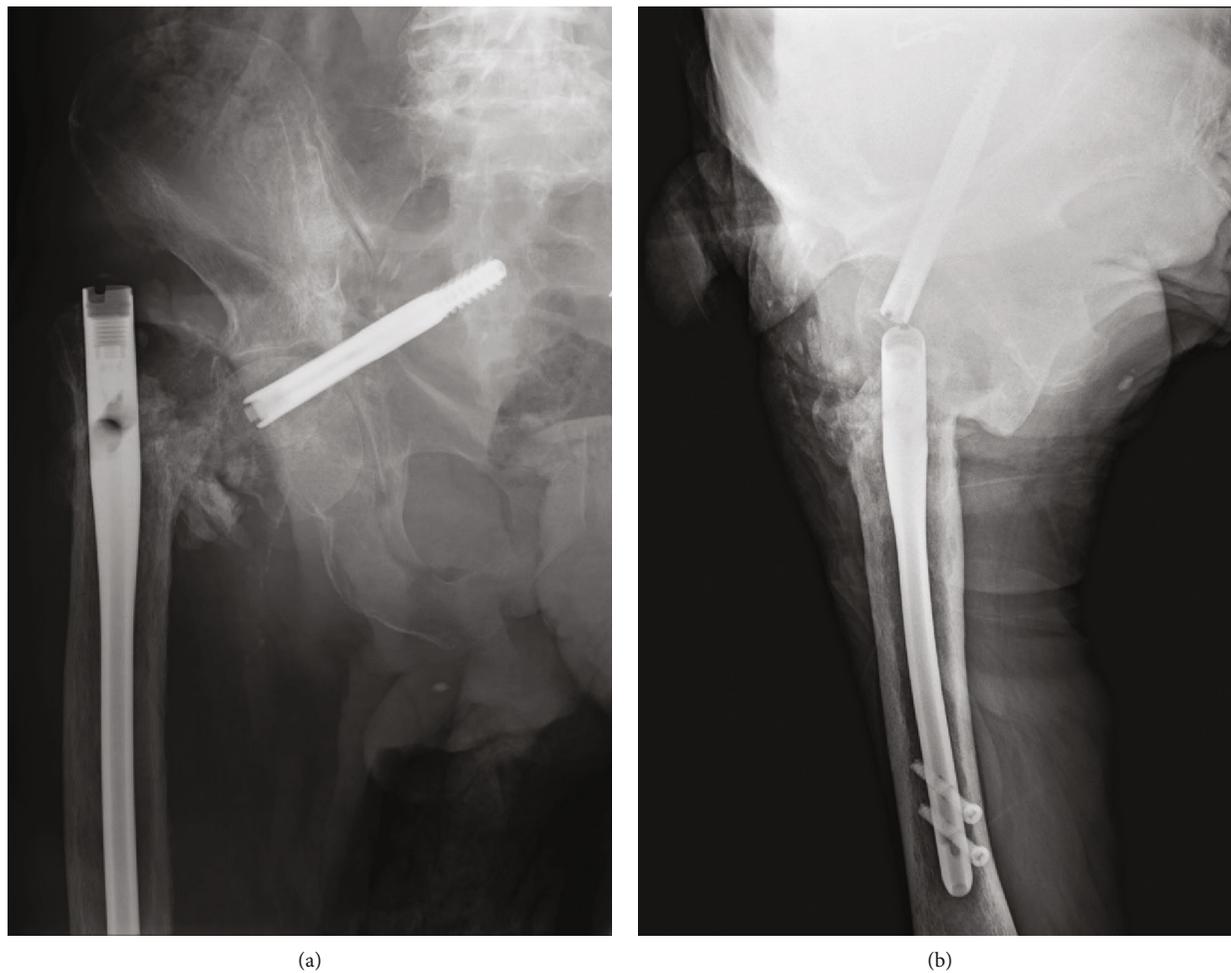
revealed that the intramedullary nail was disassembled with bone fragment displacement. The lag screw penetrated into the pelvis through the femoral head and acetabulum (Figure 3). No intra-abdominal organ injuries were confirmed on a contrast-enhanced computed tomography scan. The lag screw was located between the internal and external iliac vessels, and tangent to the small intestine; however, no signs of pneumoperitoneum or hematuria were present (Figure 4).

FIGURE 3: Radiographs showing redisplacement of the fracture and intrapelvic migration of the lag screw through the femoral head and the medial wall of the acetabulum.

excessive telescoping of the lag screw. Nagura et al. reported that incorrect engagement of the set screw on the lag screw caused its loosening and complete deviation [15]. In the present case, the sliding of the lag screw was not restricted, and the lag screw migrated into the pelvis through the femoral head and medial wall of the acetabulum. The removed implant had no structural defects; however, the set screw was not inserted to the proper depth. The migration was found to be the result of the inappropriate insertion of the set screw to control the lag screw.

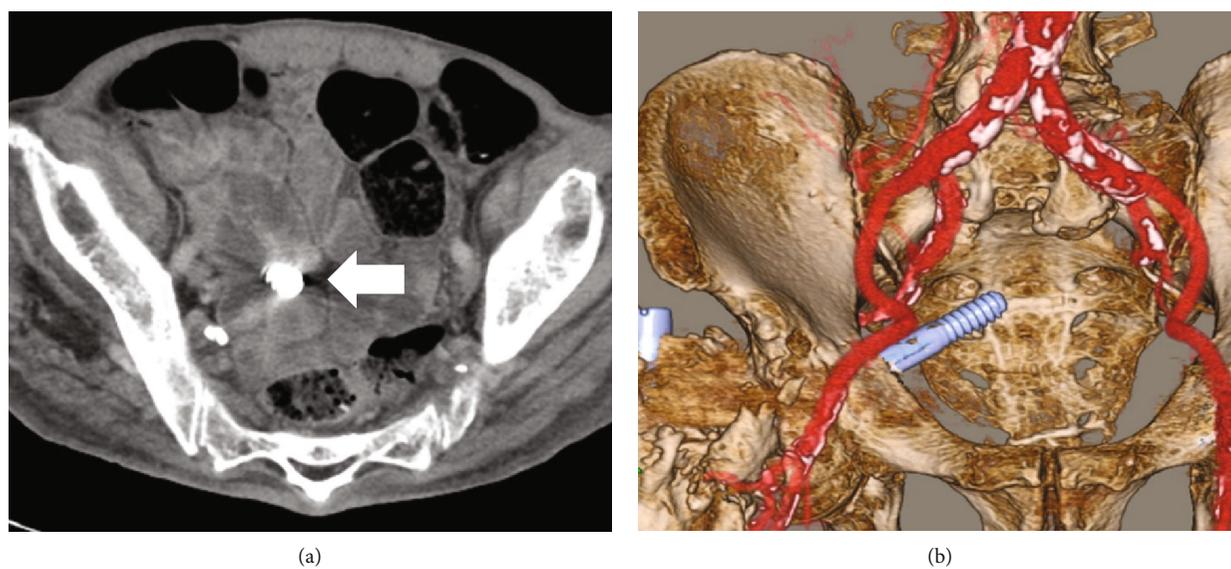
FIGURE 4: A contrast-enhanced computed tomography scan showing the lag screw located deep in the pelvis, between the internal and external iliac vessels, and tangent to the intestine. (a) Axial view (arrow, lag screw) and (b) reconstructed 3D image.

To prevent future concomitant injury of the blood vessels, ureter, and intestine, we decided to remove the implants. If the lag screw had been adhering to the intestine, the threaded part of the screw could damage the intestine when removing the lag screw from the femoral side. Therefore, we considered that removing the lag screw under direct view from the pelvic side would be safer. Laparoscopic removal of the lag screw was then performed by gastrointestinal surgeons. Intestinal damage was not observed, and after peeling the peritoneum around the lag screw, the screw was pulled out with forceps (Figure 5). The nail and distal locking screw were then removed by orthopedic surgeons. Furthermore, it was found that the set screw was not inserted to the proper depth. Considering invasion and the fact that he was already

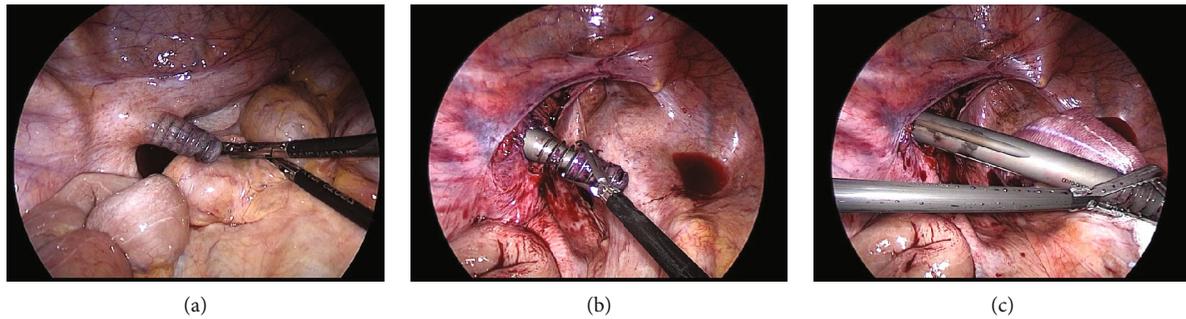
FIGURE 5: Laparoscopic views showing the lag screw, intestine, and peritoneum: (a) damage to the intestine was not observed; (b) the peritoneum around the lag screw was peeled; (c) the lag screw was pulled out with forceps.

In previous reports, lag screws were removed from the femoral side in all cases. Tauber and Resch reported a case of sigmoid perforation after removing the migrated lag screw from the femoral side [16]. Thus, to avoid intestinal damage caused by the threaded part of the lag screw, we removed it from the pelvic side. Subsequently, no intestinal damage occurred during laparoscopic surgery. Similarly, it may be safer to remove the lag screw through laparoscopic surgery than through removal from the femoral side, because adhesions to the peritoneum or intestine can be directly observed.

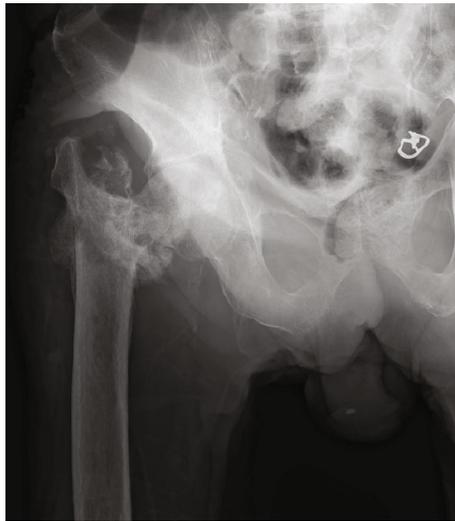
The postoperative period was uneventful. At 1 year post-operatively, the patient remained wheelchair-bound without pain. A follow-up radiograph revealed nonunion of the right trochanter of the femur (Figure 6).

FIGURE 6: A radiograph at 1 year after implant removal showing nonunion of the right trochanter of the femur.
