Research Article

Natural Composite Reinforced by Lontar (*Borassus flabellifer*) Fiber: An Experimental Study on Open-Hole Tensile Strength

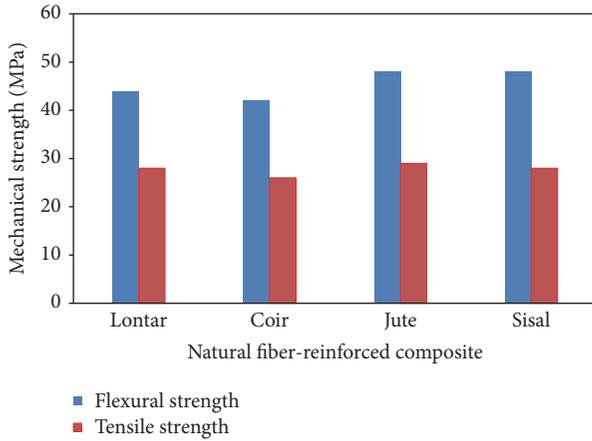
FIGURE 1: Mechanical strength of natural fiber-reinforced composites.

of lontar fiber were reported in the literature [6–9] and suggested that these fibers can be utilized as reinforcement component in natural composite manufacturing. It is also found that the lontar fibers are inexpensive, abundantly available, and ecofriendly and hence it is essential to explore the potential utility of these fibers in the technical world, as seen in Figure 1 showing the comparison between lontar fiber and other natural fibers [9].

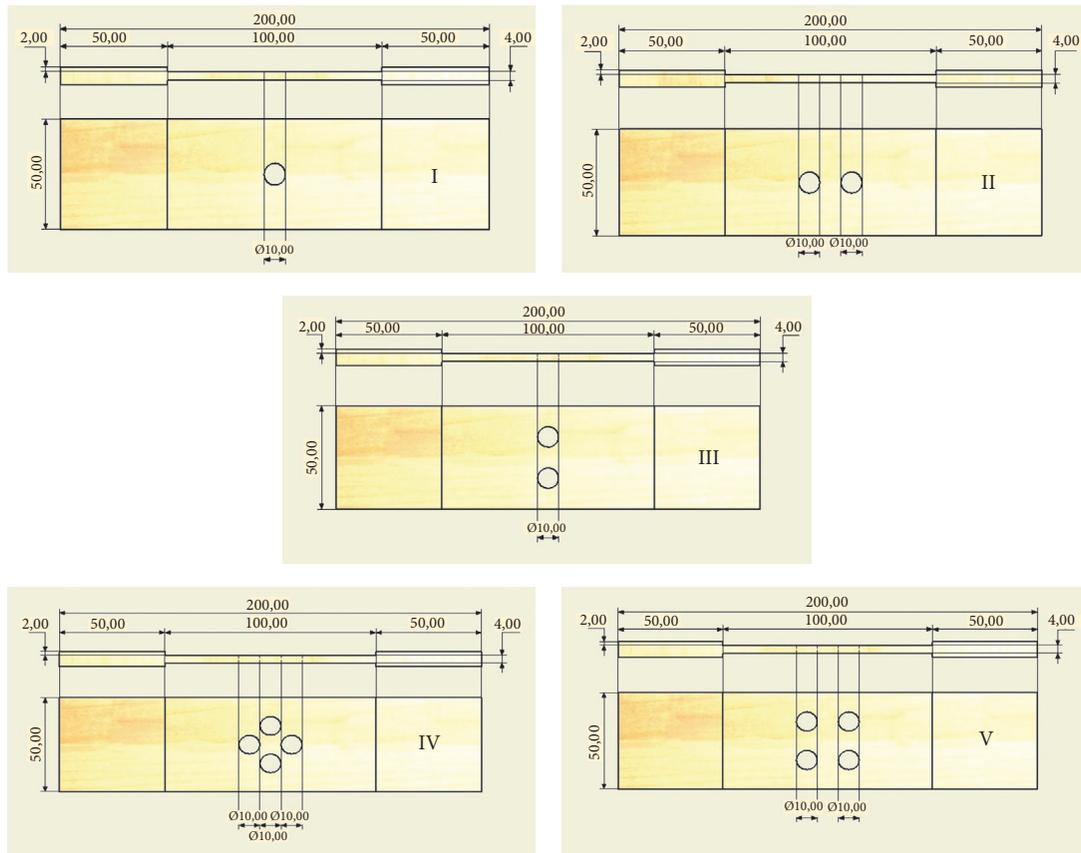
FIGURE 2: Specimen geometry (all dimensions in mm).

A plan view of hole patterns is shown in Figure 2.

The composite specimen used in this study was reinforced by lontar fiber with 5 cm of fiber length. In order to consider the interface problem between fiber and matrix, lontar fibers were initially washed with distilled water and dried for 24 h. Then the lontar fibers were treated with 4% NaOH for 2 h at the room temperature. The treated fibers were washed with distilled water and dried at ambient conditions till the moisture was removed from the fiber by natural means and showed no residual NaOH. The composite specimen was produced by hand lay-up process that contains 32% of lontar fiber volume. The percentage of lontar fiber volume was obtained from the rule of mixture model of weight fraction from each constituent. The unsaturated polyester was used as the matrix throughout 4 mm of specimen thickness. The orientations of fibers occurred randomly against each other. In order to investigate open-hole tensile strength, five configurations of hole patterns were studied. Configuration

I contains an open hole and configurations II and III have two holes with parallel and perpendicular patterns to loading direction. Configurations IV and V have four holes with diamond and square patterns.

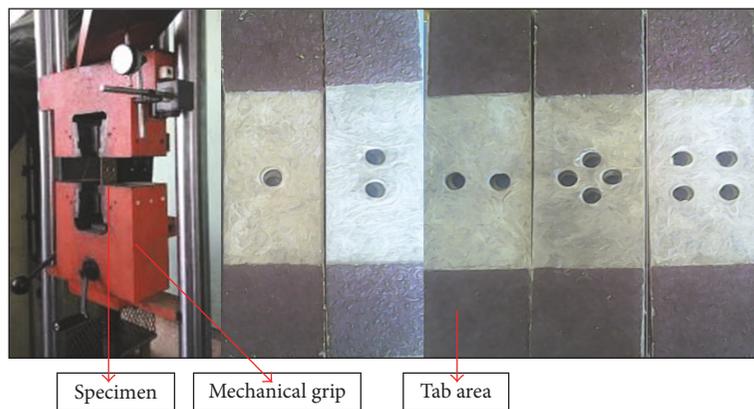
FIGURE 3: Test setup and lontar fiber-reinforced composite specimens.

Test was carried out with a servohydraulic testing machine with a capacity of 100 kN. The machine was equipped with a standard load cell and mechanical grips. Specimens were aligned and mounted first in the lower and afterwards in the upper grips of the test station. After

mounting the specimens, any loading due to the gripping was minimized through controller panel. A unit of dial indicator was used to record all the test results such as load and displacement. Then, the tests were considered to begin. Static tensile tests were performed under a constant cross-head speed of 1 mm/min. The test procedure was based on standard ASTM D5766 which consists of five specimens of each test for, respectively, each type of hole configuration. Figure 3 shows the test setup and all types of specimens.

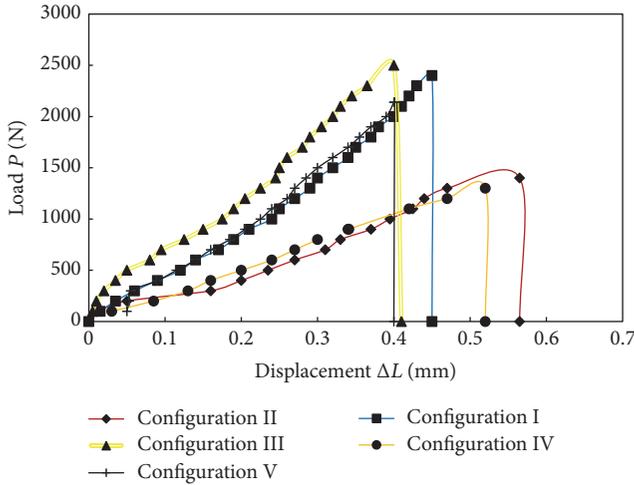
FIGURE 4: Tensile curves of lontar fiber-reinforced composites with different hole configurations.

The tensile behavior of lontar fiber-reinforced composites was investigated. Tensile test has been performed on all test samples until final fracture. Three specimens for each type of hole configuration were tested. Figure 4 shows the load versus displacement curves in static condition for the test specimens.

These curves show the effect of varying the hole configuration on the tensile behavior of the test specimens. Each curve exhibits a typical brittle behavior with sudden failure. The highest ultimate tensile load of 2400 N is shown in configuration III. Figure 5 shows the relationship curve of stress and strain.

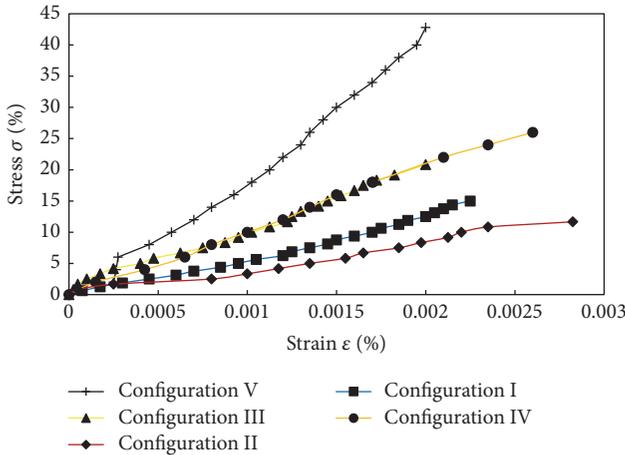
FIGURE 5: Stress-strain curves of lontar fiber-reinforced composites with different hole configurations.

The curves indicate the stress versus strain curve obtained from tensile test in which stress is resulting from given load and strain is derived from global displacement. The stress-strain curve shows linear relationship. This is typical brittle material with a sudden failure of composite material under tensile loading in static condition. There was no clear

evidence of nonlinearity in the stress-strain curves, except at the beginning of the test which was possibly caused by the realignment of the fibers and could be corresponding to grip movement. To calculate the stress, two approaches reported by previous study can be used [23]. The first calculation of the net stress is defined as

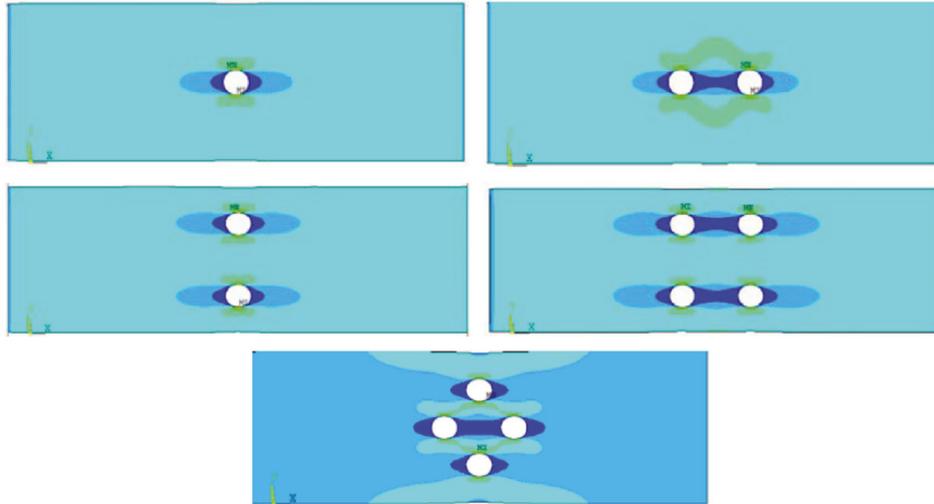
FIGURE 6: Stress contour around the hole [10].

Combine two approaches to calculate the stress; locally, the presence of the hole gives the lower area on specimen around the hole area. Therefore, the stress calculation increases and results in local stress between areas under different hole configuration. Specimens with four holes (diamond and square pattern) have smaller area compared to other hole configurations consisting of one or two holes. At the same time and load period, the area that contains more holes causes smaller area, thus increasing the stress. It is indicated in Figure 5 that four-hole specimen produces the highest stress. This indicates that the tensile load is evenly distributed in no-hole areas close to the edge of the specimen so that the stress is increased. Furthermore, this phenomenon on stress level of hole configurations was also confirmed by previous study [22], where it was shown that laminate with more holes has an effect on the increment of residual strength which is generated by stress redistribution on net section area. Dan-Jumbo et al. [10] also found higher normalized stress of 0° fiber orientation for ply generated by four-hole configurations graphite/epoxy composite compared with one-hole or two-hole configurations due to the stress distribution, as illustrated in Figure 6, where the dark shaded area along with the loading direction represents zero stress area.

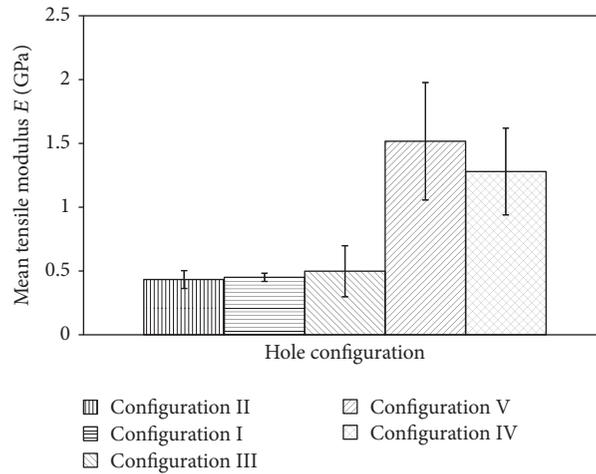
FIGURE 7: Tensile modulus of lontar fiber-reinforced composites with different hole configurations.

The highest UTS for this lontar fiber-reinforced composites specimen is around 44 MPa, resulting in highest modulus measurement of 1.5 GPa as seen in Figure 7.

stress areas. These different conditions of stress-strain for different hole configuration ultimately have an effect on tensile modulus measurement.

In addition, different tensile modulus also possibly indicates the highly nonhomogenous substructure derived from fabrication process of hand lay-up method. It means that

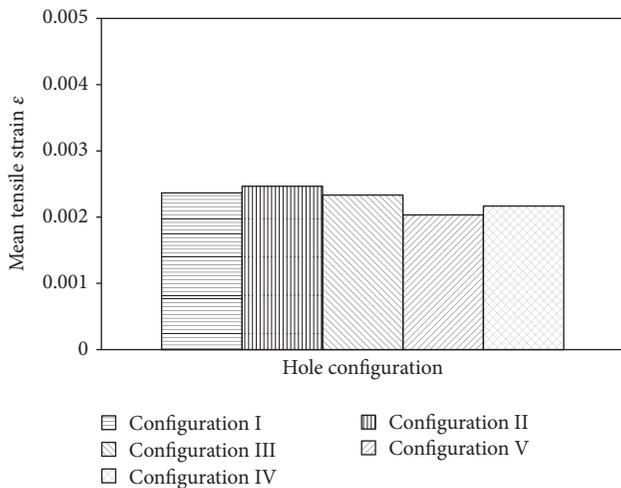
FIGURE 8: Tensile strain of lontar fiber-reinforced composites with different hole configuration.

It can be noted that the differences in tensile modulus may also be originated by different local strain variations occurring at the surface of the specimen, as indicated in Figure 8.

From Figure 8, specific area of four-hole specimens experiences smaller strain propagation compared to specimen containing one-hole or two-hole pattern due to the redistributed stress and no stress passes through the hole, thus resulting in the lowest stress and strain at the area along the hole location, as seen in Figure 9, which also is a finding in the previous study [10].

From this condition, we can assume that area containing more holes (four-hole pattern) will experience lowest stress areas compared to specimen containing less holes (one or two holes). As a result, specific area of four-hole pattern experiences smaller strain propagation due to the lowest

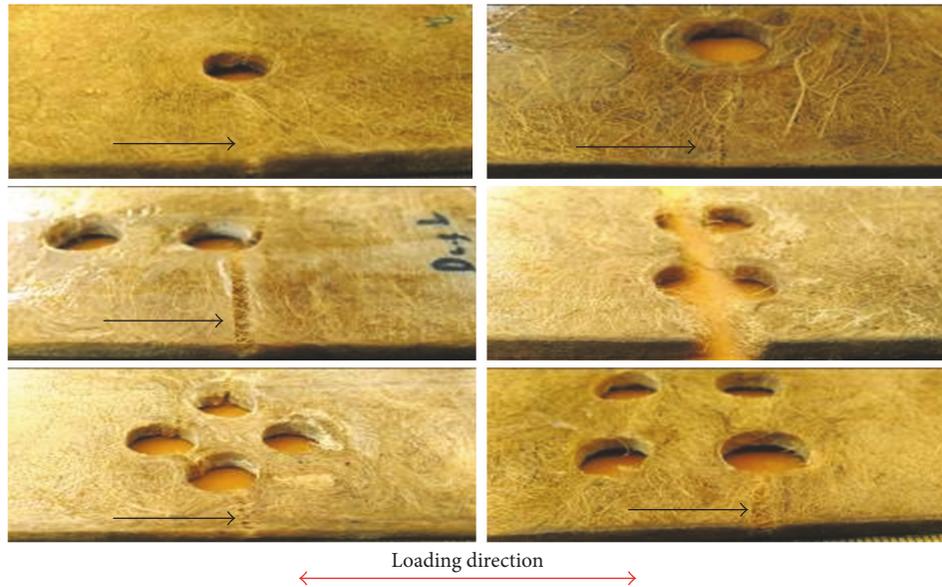
FIGURE 10: Macroscopic view of final failure form of lontar fiber-reinforced composites.

the fabrication defects such as void, resin-rich areas and fiber kinking through the entire thickness of the specimen dictate the surface strain behavior of lontar fiber-reinforced composites. These specimens fail in a brittle type as seen in Figure 10.

The brittle failure of lontar fiber-reinforced composites specimens with different hole configurations in tension is fairly straight and transverse to the loading axis at the edge of the hole, as shown by the black arrow in Figure 10. The presence of the hole increases stress concentration that leads to strength degradation and initiates damage during the test. It was found that damage starts at the edge of the hole and propagated along the width where the highest stress concentration occurs. The initiation damage occurs in the

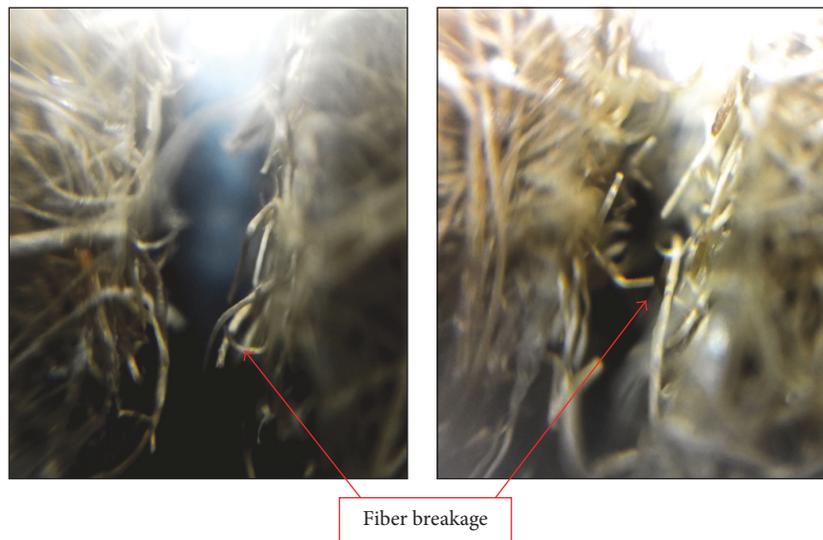
FIGURE 11: Macroscopic view of final failure form of lontar fiber-reinforced composites failure.

form of matrix cracking. The damage area expanded by the delamination of the fiber and the matrix at the interface located at the edge of the hole. It has been observed that, after initial damage, the specimens continued to sustain the tensile load under increasing displacements. In this damage area, matrix cracking occurs until the end of width side of specimen. As tensile load increased, the interfacial failure appears in form of delamination, which in fact is a result of matrix cracking propagation. In the final stage of damage propagation, when the critical point was reached, damage area reaches the end of width side of the specimen and specimen ultimately failed mainly due to the fiber breakage, as seen in detail in Figure 11. It means that fiber in the laminates is no longer able to hold or carry the increasing of given

load and damage has occurred completely. In general, there are no different damage mechanisms between different hole configurations of lontar fiber-reinforced composites. This kind of damage phenomenon was also described by previous study [12] for quasi-isotropic carbon/epoxy composite.

- (6) The appearance of the interfacial failure in form of delamination is in fact a result of initial damage propagation of matrix cracking along with the increase of tensile load.

- (7) The damage of lontar fiber-reinforced composites with different hole configurations in tension is fairly straight and transverse to the loading axis, where the initiation damage occurs in the form of matrix cracking and ultimately failed mainly due to the fiber breakage.
