Research Article

Microbiological Sealing Analysis of a Tapered Connection and External Hexagon System

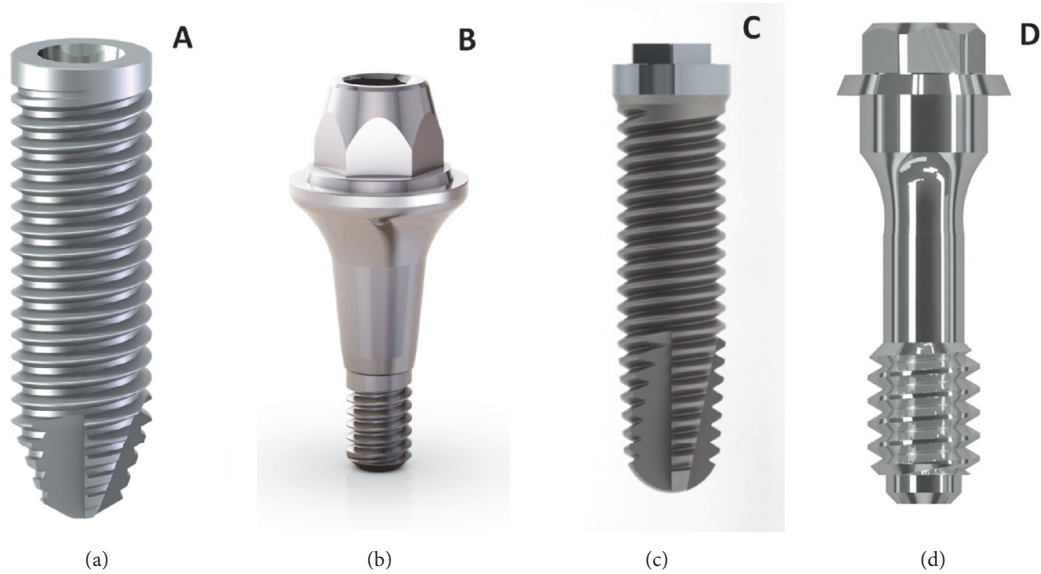
FIGURE 1: Implants and irrespective prosthetic abutments. Titaoss max CMX (a), universal tapered abutment (b), Titaoss external hexagon (c), and mini abutment EH platform 4.1 (d).

Two types of implant-abutment connections manufactured and commercialized in Brazil by the company Intraoss (São Paulo, SP, Brazil) were analyzed. The tapered implant connections were 4.0 mm by 11 mm with a tapered platform

of 11.5°, whereas the external hexagons were 3.75 mm by 10 mm (Table 1). The materials used in this study (implants, prosthetic components, and torque wrench) were provided by the manufacturers with no conflict of interests.

Twelve sets of indexed tapered connection components and twelve sets of external hexagon connection components were used (Figure 1) for microbiological analysis as previously described [10]. For each model, an implant with its respective prosthetic abutment was used as a negative control and a set without the abutment as a positive control of microbial contamination.

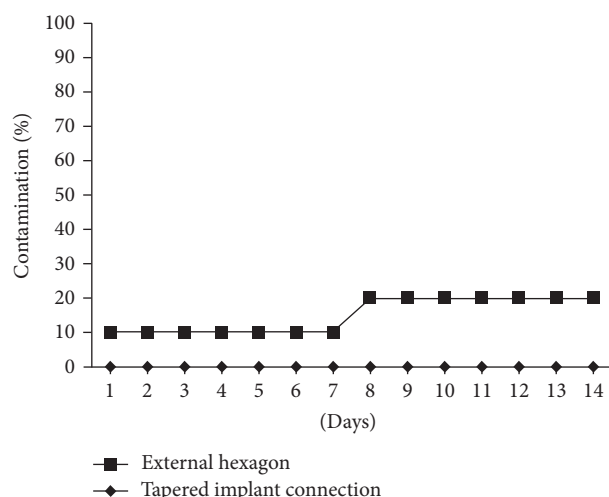
FIGURE 2: Contamination follow-up expressed as percentage over 14 days.

Figure 2 illustrates the 14-day follow-up of specimen, where the group containing the indexed tapered connection showed no contamination. In the group of external hexagon, one sample was contaminated on the first and the 8th days, whereas two sets (20%) were contaminated at the 14th day.

Failure of the abutment/implant interface seal was observed via turbidity or presence of deposits in the culture broth in 2/10 (20%) of the external hexagon interface. On the other hand, 0/10 (0%) tapered implant connections were contaminated, though no significant difference was detected between the groups ($p = 0.4737$, Fisher's exact test). No turbidity was observed either in the tubes containing the microbrushes used as the control for abutment/implant interface contamination or in the negative controls.
